Alabama Statewide Airport Pavement Management Program Update

Demopolis Regional Airport (DYA)

Final Report

February 2022

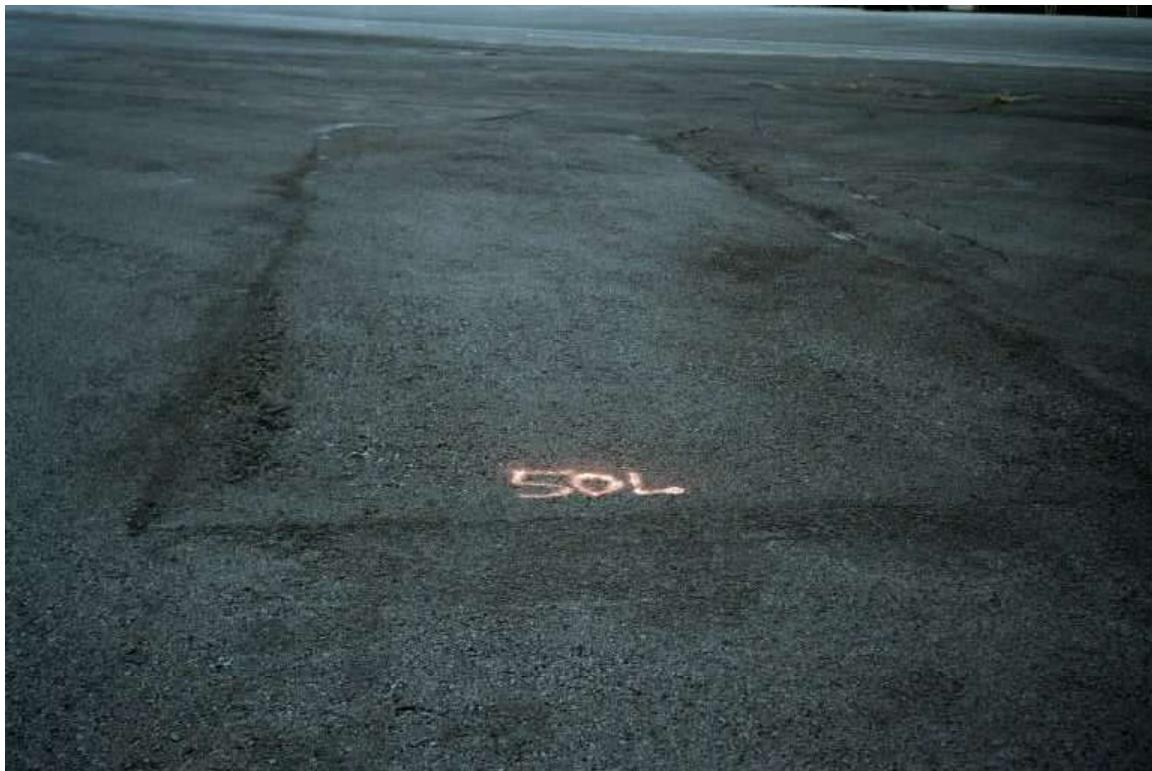
Figure C.7: Asphalt Patching.

Repair patching and utility cut patching is considered a defect, regardless of how well it performs or was constructed.

- ◆ Low - No action;
- ◆ Medium - seal cracks, repair the distresses in the patch or replace the patch;
- ◆ High - replace the patch.

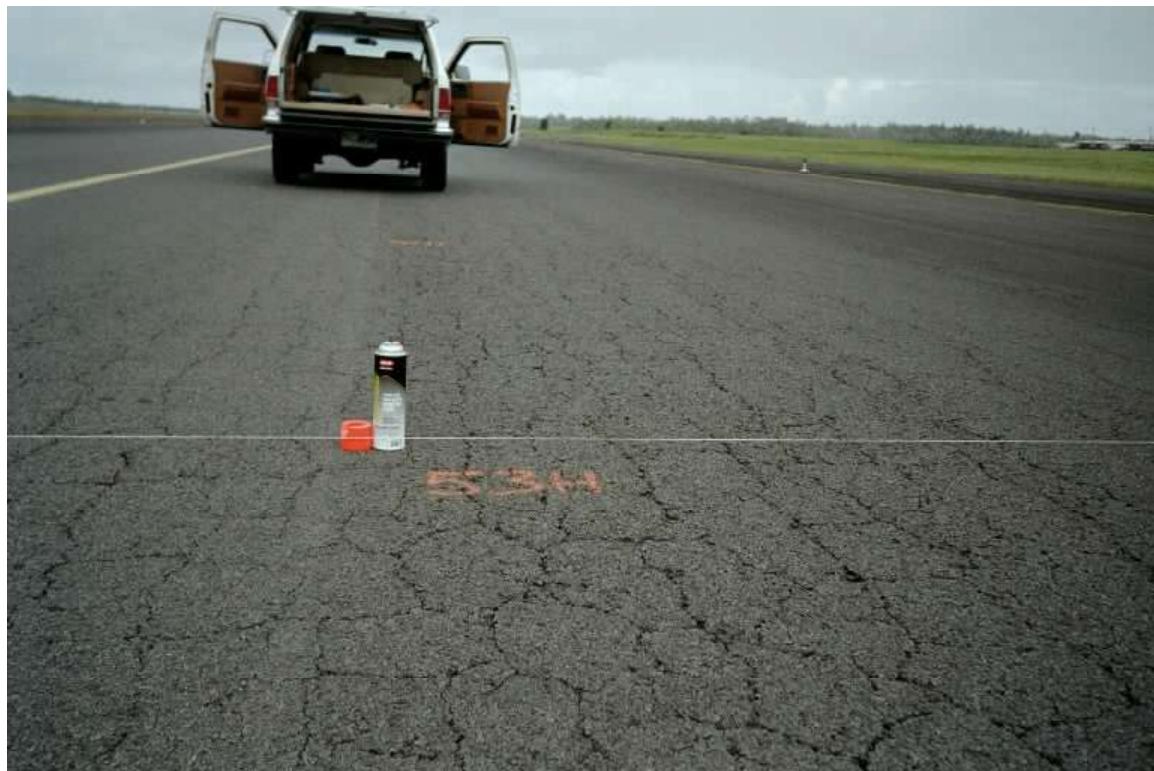
Figure C.9: AC Rutting.

A rut is a surface depression in the wheel path; however, in many instances ruts are noticeable only after a rainfall, when the wheel paths are filled with water. Pavement uplift may occur along the sides of the rut. Rutting stems from a permanent deformation in any of the pavement layers or sub-grade, usually caused by consolidation or lateral movement of the materials due to traffic loads. Significant rutting can lead to major structural failure of the pavement.

- ◆ Low - No action;
- ◆ Medium - patch and/or overlay;
- ◆ High - patch and/or overlay.

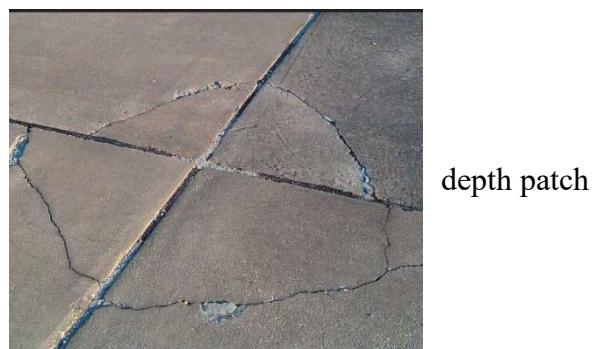
Figure C.11: PCC Corner Break.

A corner break is a crack that intersects the joints at a distance less than or equal to one-half the slab length on both sides, measured from the corner of the slab. For example, a slab with dimensions of 25 by 25 feet that has a crack intersecting the joint 5 feet from the corner on one side and 17 feet on the other side is not considered a corner break; it is a diagonal crack. However, a crack that intersects 7 feet on one side and 10 feet on the other is considered a corner break. A corner break differs from a corner spall in that the crack extends vertically through the entire slab thickness, while a corner spall intersects the joint at an angle. Load repetition combined with loss of support and curling stresses usually causes corner breaks.

- ◆ Low - No action or seal cracks;
- ◆ Medium - seal cracks;
- ◆ High - seal cracks, apply a full or replace the slab.

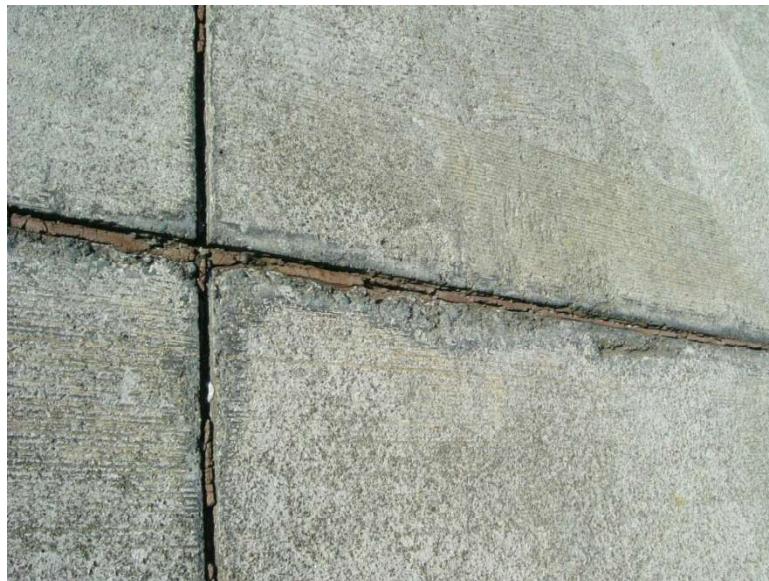
Figure C.13: PCC Joint Seal Damage.

Joint seal damage is any condition, which enables soil or rocks to accumulate in the joints or allow significant infiltration of water. Accumulation of incompressible materials in the joint prevents the slab from expanding and may result in buckling, shattering, or spalling. Pliable joint filler bonded to the edges of the slabs protects joints from the accumulation of materials and also prevents water from seeping down and softening the foundation supporting the slab. Typical types of joint seal damage are: 1) stripping the joint sealant; 2) extrusion of joint sealant; 3) weed growth; 4) hardening of the filler; 5) loss of bond to the slab edges; and 6) lack or absence of sealant in the joint.

- ◆ Low - No action;
- ◆ Medium - seal joints;
- ◆ High - seal joints.

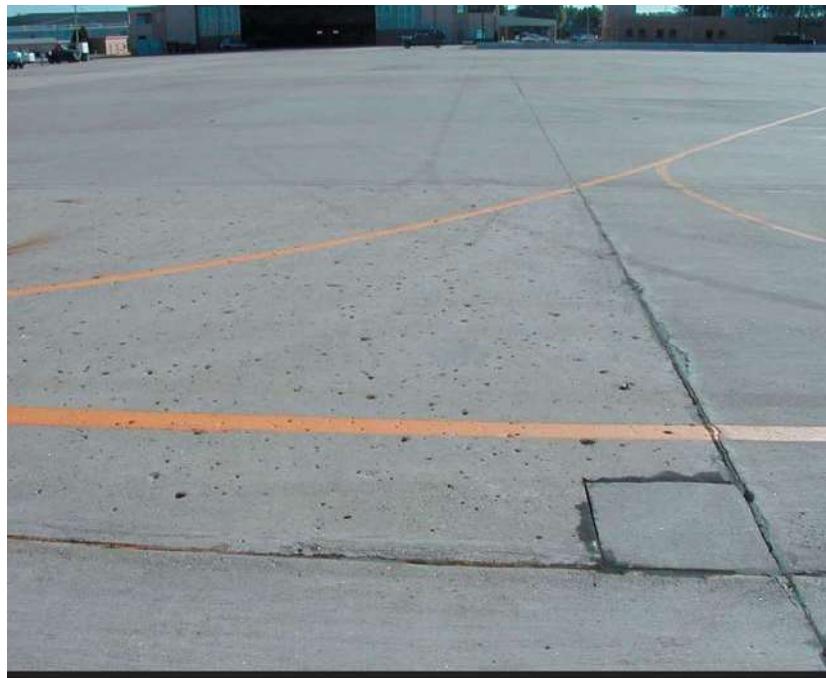
Figure C.16: Popouts.

No degrees of severity are defined for popouts. However, popouts must be extensive before they are counted as a distress; i.e., average popout density must exceed approximately three popouts per square yard over the entire slab area.
