Alabama Statewide Airport Pavement Management Program Update

H L Sonny Callahan Airport (CQF)

Final Report

February 2022

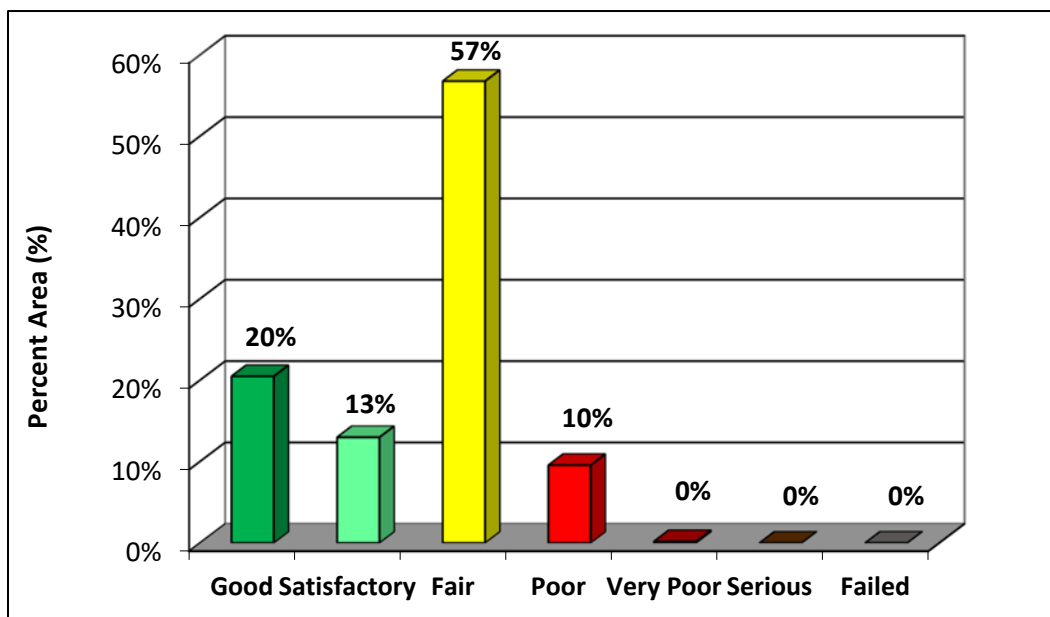
Figure 3.3: Pavement Condition by Percent of Area.

Figure 3.3 shows the distribution of the CQF pavement network by condition. Approximately 10 percent of the network is in “Poor” or worse condition.

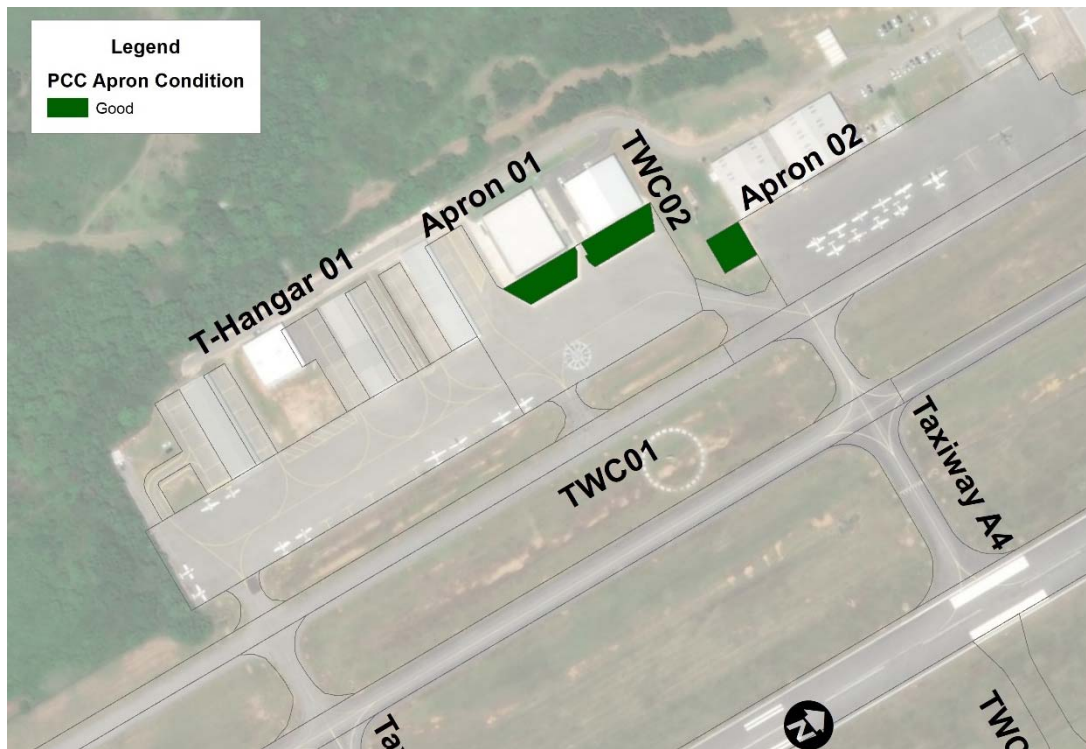
Figure 3.4: PCC Apron Condition Rating.

As stated earlier, the project scope did not include a detailed pavement condition survey for any Portland Cement Concrete (PCC) aprons. For these pavements, a rating of “Good”, “Fair”, or “Poor” was assigned based on the overall pavement condition. Figure 3.4 shows the condition of the PCC aprons at CQF.
