# Alabama Statewide Airport Pavement Management Program Update

**Isbell Field (4A9)**

**Final Report**

**February 2022**

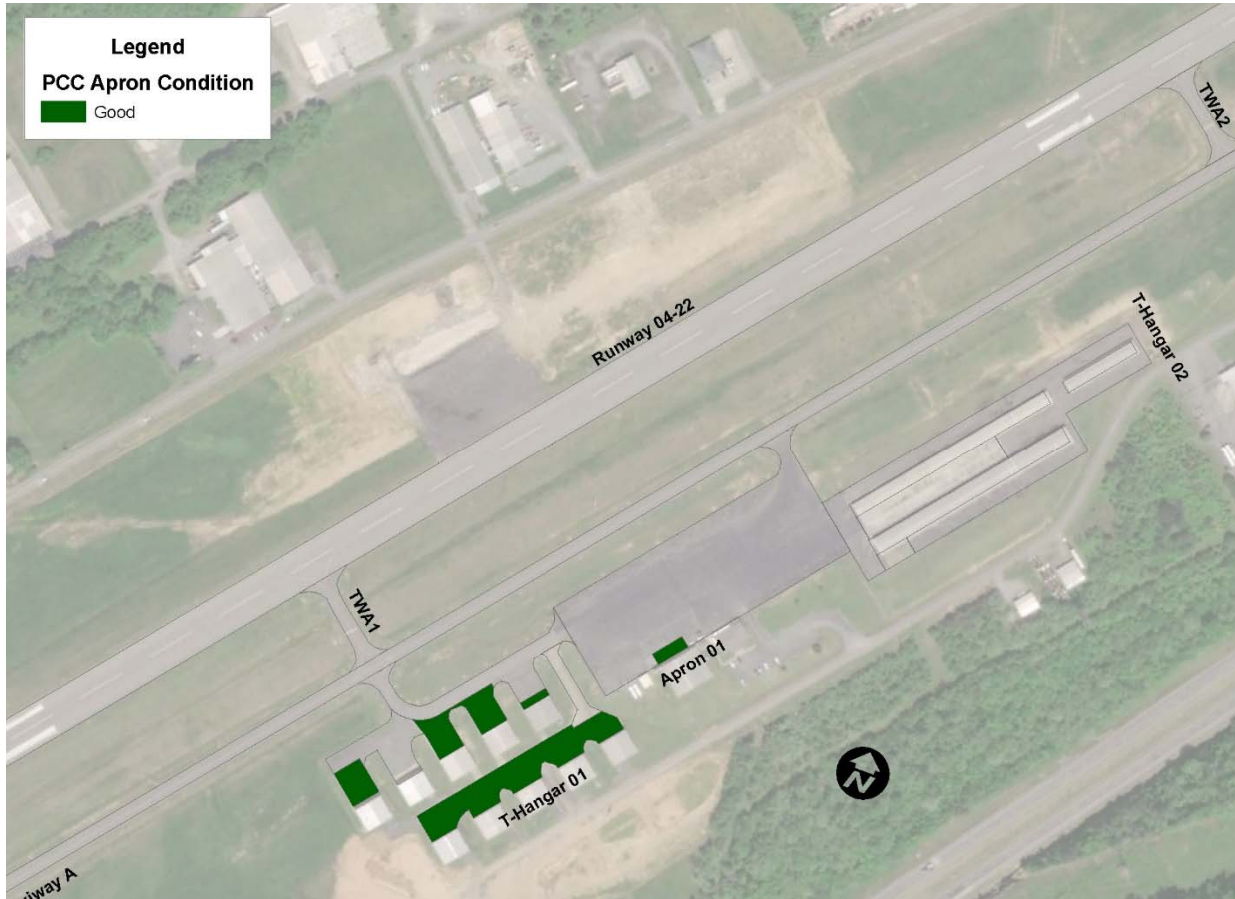
Figure 3.4: PCC Apron Condition Rating.

As stated earlier, the project scope did not include a detailed pavement condition survey for any Portland Cement Concrete (PCC) aprons. For these pavements, a rating of “Good”, “Fair”, or “Poor” was assigned based on the overall pavement condition. Figure 3.4 shows the condition rating for the PCC aprons at 4A9.
