Alabama Statewide Airport Pavement Management Program Update

**Wetumpka Municipal Airport
(08A)**

Final Report

February 2022

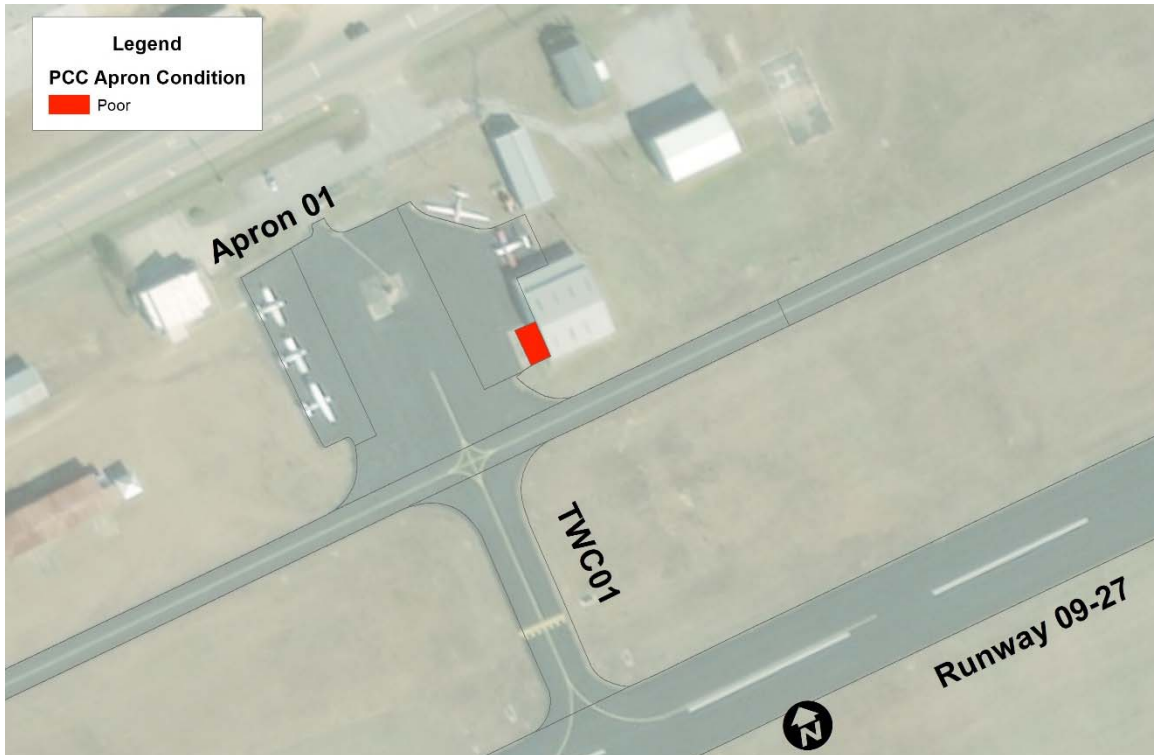
Figure 3.4: PCC Apron Condition Rating.

As stated earlier, the project scope did not include a detailed pavement condition survey for any Portland Cement Concrete (PCC) aprons. For these pavements, a rating of “Good”, “Fair”, or “Poor” was assigned based on the overall pavement condition. Figure 3.4 shows the condition of the PCC aprons at O8A.
