Subject: Annual Inspection Report
Albertville Regional Airport – Thomas J. Brumlik Field (8A0)

**Annual Inspection Report
Albertville Regional Airport – Thomas J. Brumlik Field
(8A0)
Albertville, Alabama**

September 29, 2021

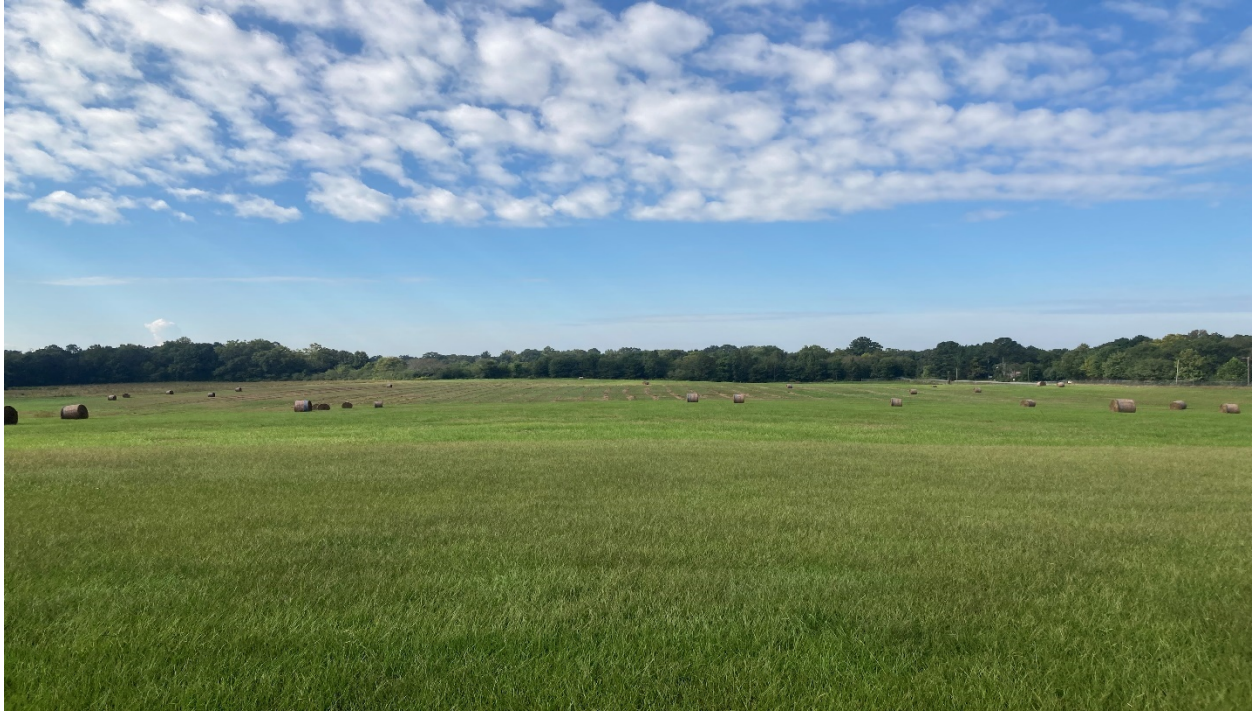
Photo #1 – Runway 05 Approach

- Runway 05 – No obstructions (See Photo #1).
- Runway 23 – No obstructions (See Photo #2).

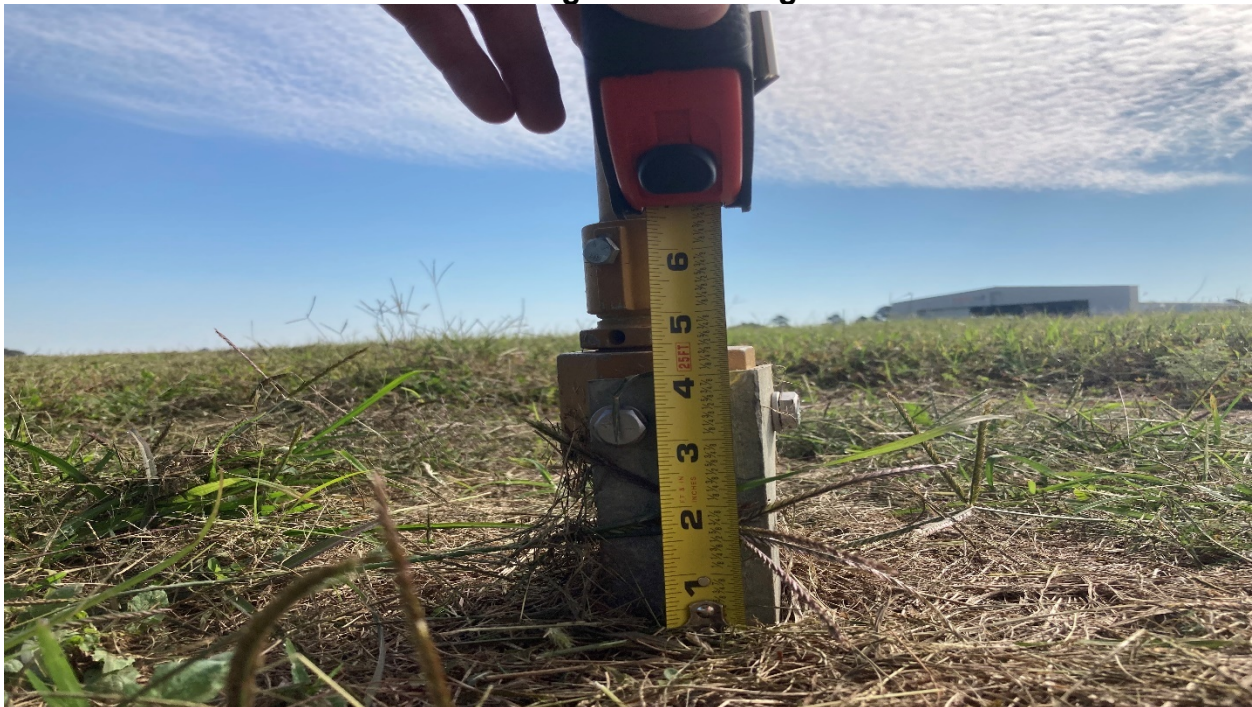
Photo #3 – Light Fixture Angle Iron

- The angle iron base of the first runway light fixture north of the taxiway to the old northwest apron exceeds 3 inches above ground (See Photo #3).

- Bring grade up around light fixtures so that any non-frangible components do not project more than 3 inches above the surface. This must be done in a manner that does not cause humps or hazardous surface variations.

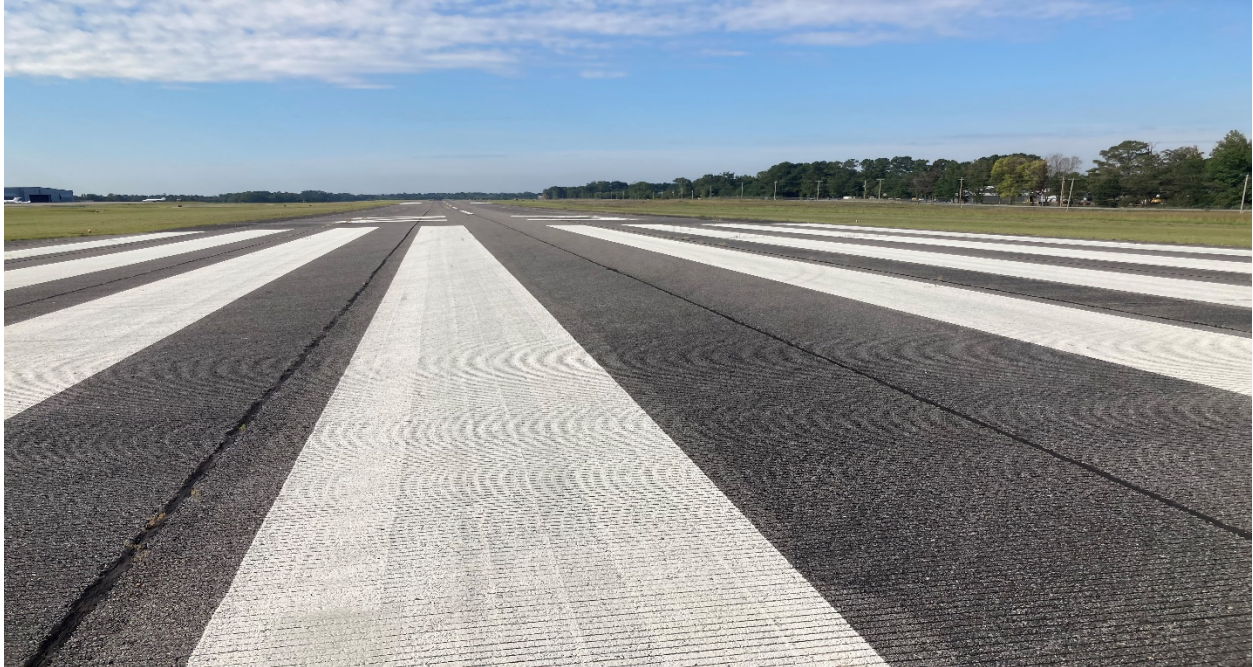
Photo #4 – Runway 23 NPI Markings

- The airport markings are in overall **GOOD** condition with apron markings **FAIR** due to fading (See Photo #4, #5).

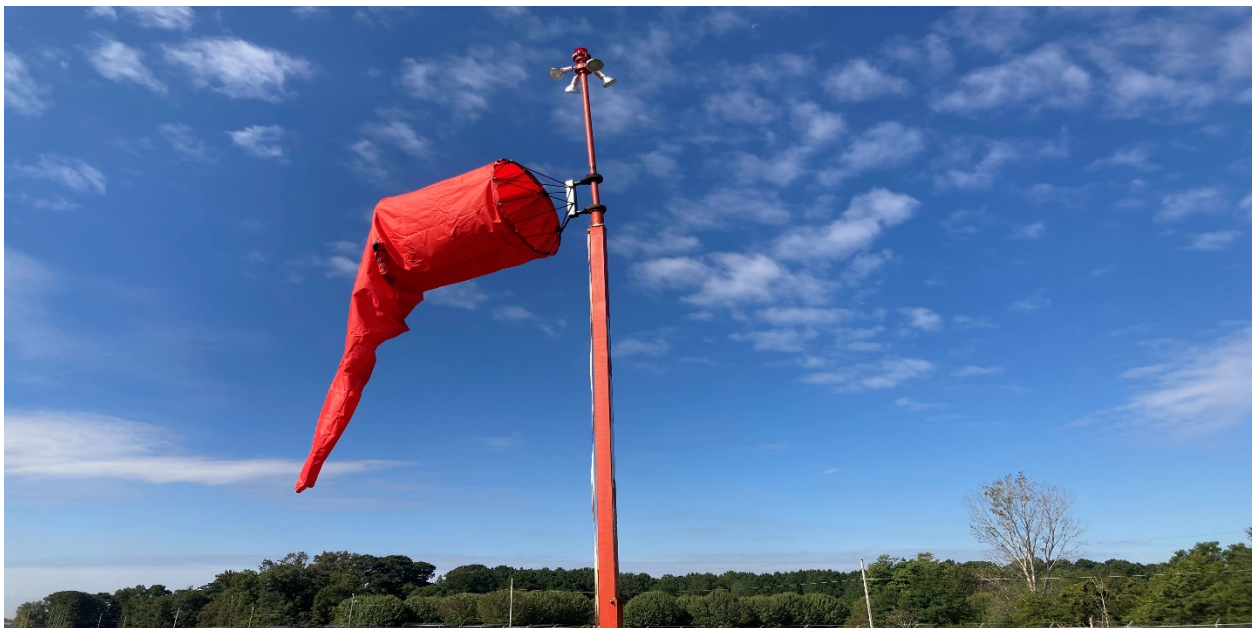
Photo #6 – Wind Direction Indicator

- The wind direction indicator (windsock) is in **GOOD** condition (See Photo #6).

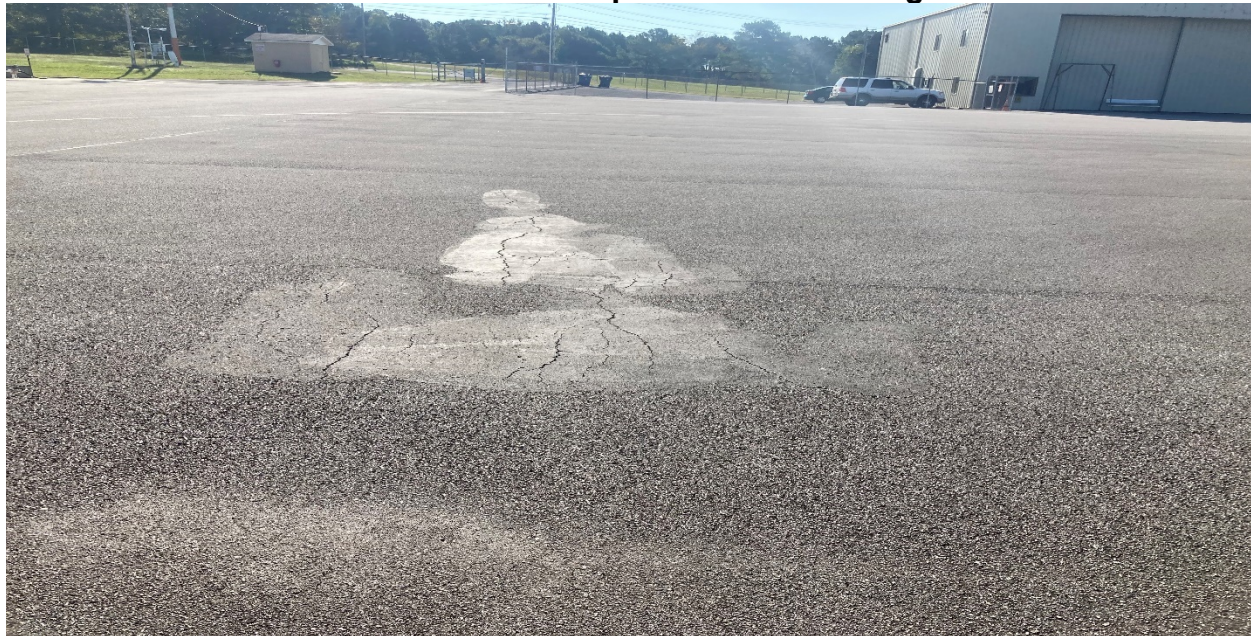
<i>Apron</i>	GOOD. The main apron is in overall good condition with isolated areas of cracking in patches (See Photo #7). The southwest portion of the apron is in FAIR condition due to cracking and vegetation growth.
<i>Taxiways</i>	FAIR. Taxiway surface is in overall fair condition with areas of POOR condition due to widespread transverse cracking and areas of alligator cracking between A2 and A3 (See Photo #8).
<i>Runway</i>	FAIR. Cracking with vegetation growth is present along the runway surface (See Photo #9).
<i>Taxilanes</i>	FAIR to POOR. Taxilanes southwest of the FBO are in FAIR condition with widespread cracking and raveling around the pavement joint (See Photo #10). The taxilanes between the northeast hangars are in POOR condition due to extensive alligator cracking and one area of severe raveling and pavement FAILURE caused by water runoff (See Photo #11, #12).

Photo #7 – Main Apron Patch Cracking

- It is recommended that the airport sponsor should contact their consultant to plan for future pavement maintenance projects.
- Proceed with Taxiway Rehabilitation plan as listed on the airport's Capital Improvement Plan (CIP).

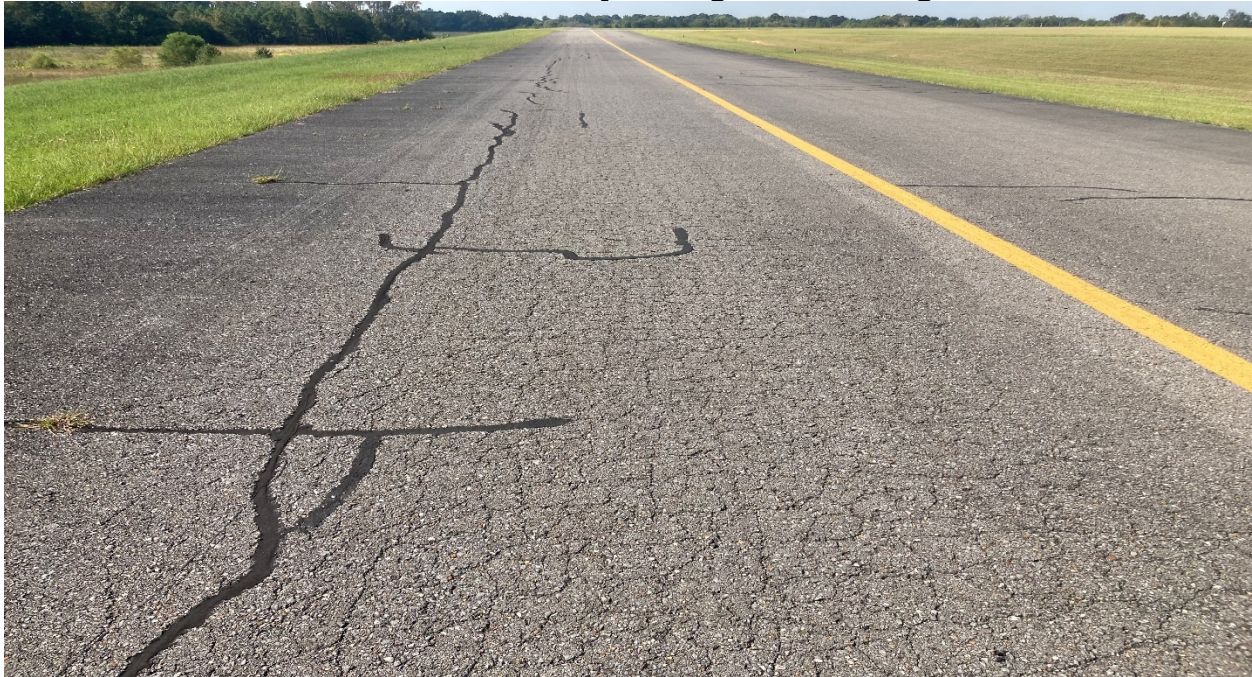
Photo #8 – Taxiway A Alligator Cracking

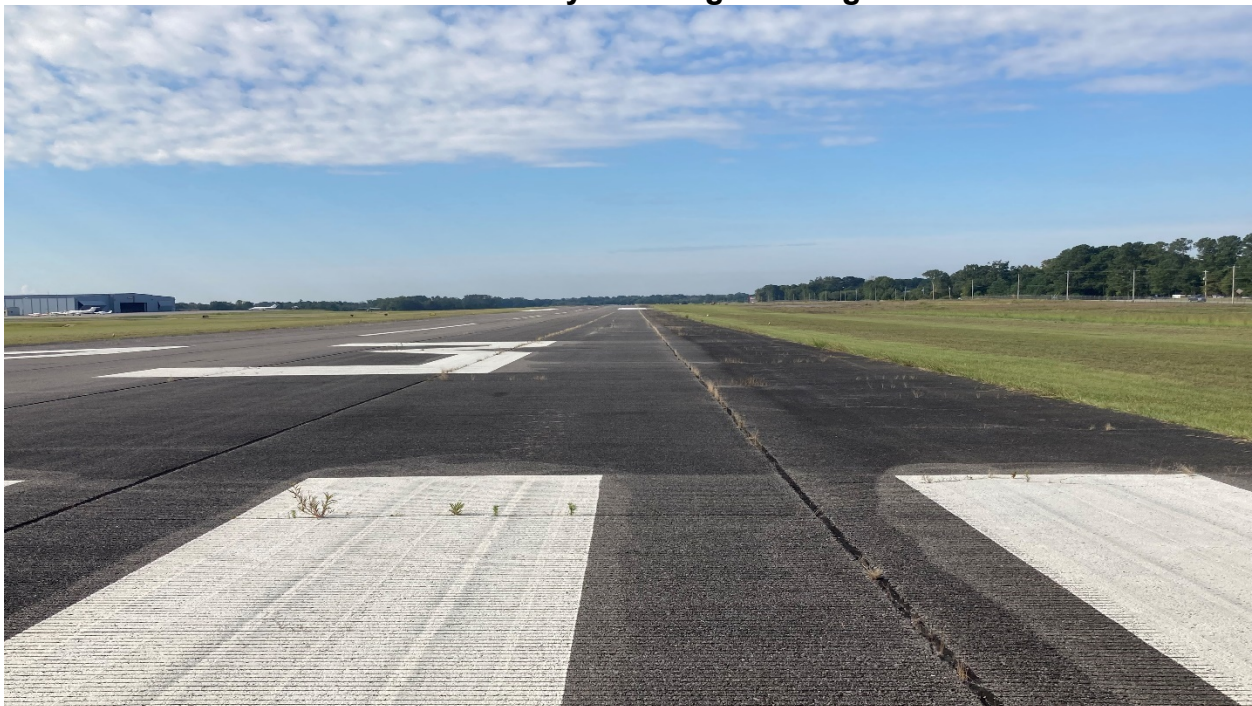
Photo #9 – Runway cracking with vegetation

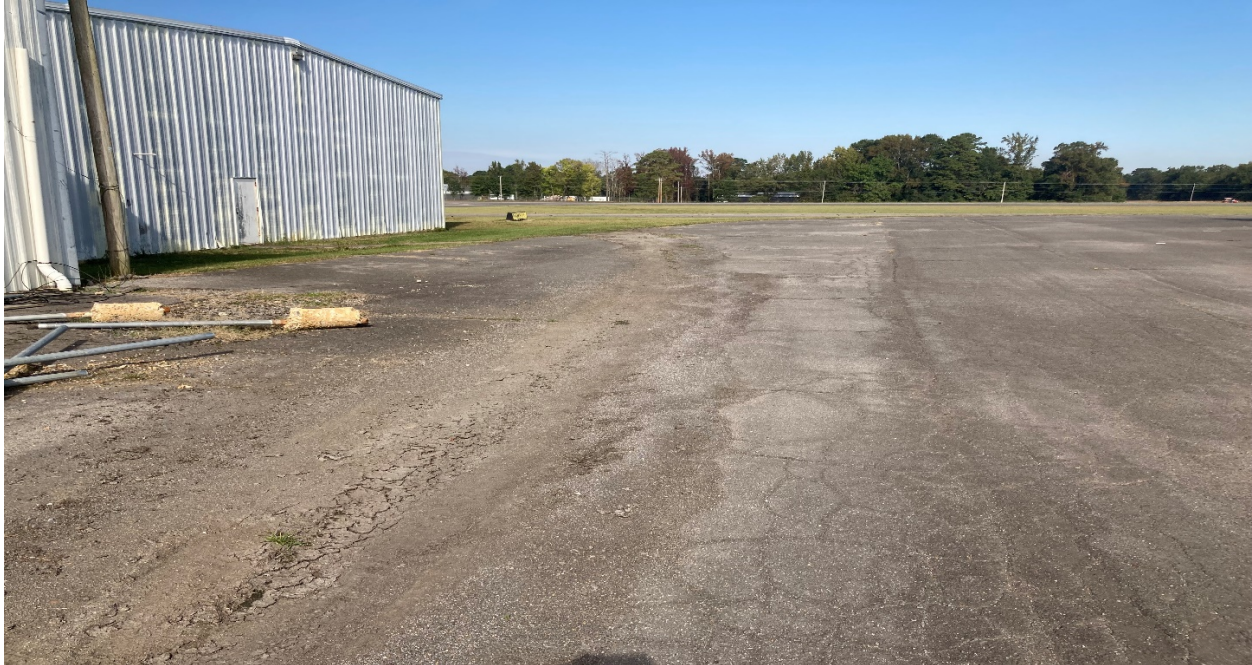
Photo #12 – Taxiway Pavement Failure

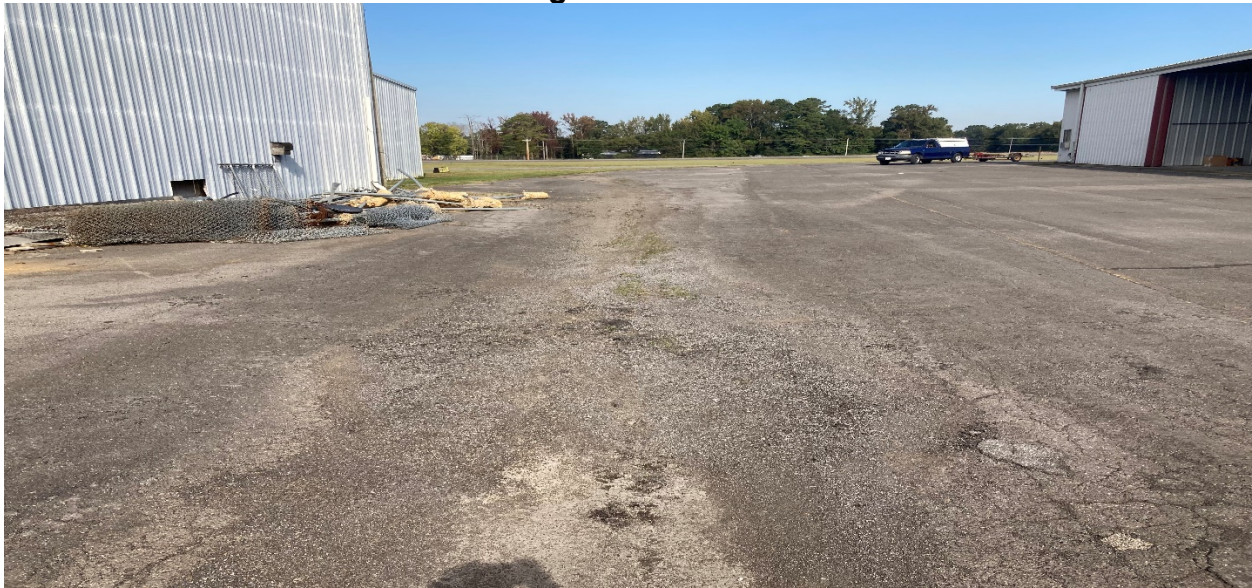
- Old fencing and posts are being stored in a movement area (See Photo #13).

Photo #13 – Fencing Materials in Movement Area

- Remove fencing materials from airport movement area.
