**Subject: Annual Inspection Report**  
**Thomas C. Russell Field (ALX)**

# **ANNUAL INSPECTION REPORT**

**THOMAS C. RUSSELL FIELD  
ALEXANDER CITY, ALABAMA**

In accordance with the provisions of the Code of Alabama 23-1-357, an inspection of the **Thomas C. Russell Field** was conducted by **Mr. Jason Hare, Mr. Bennett Head, and Mr. Mark Bowron** with the Alabama Department of Transportation Aeronautics Bureau on **April 12, 2023**.

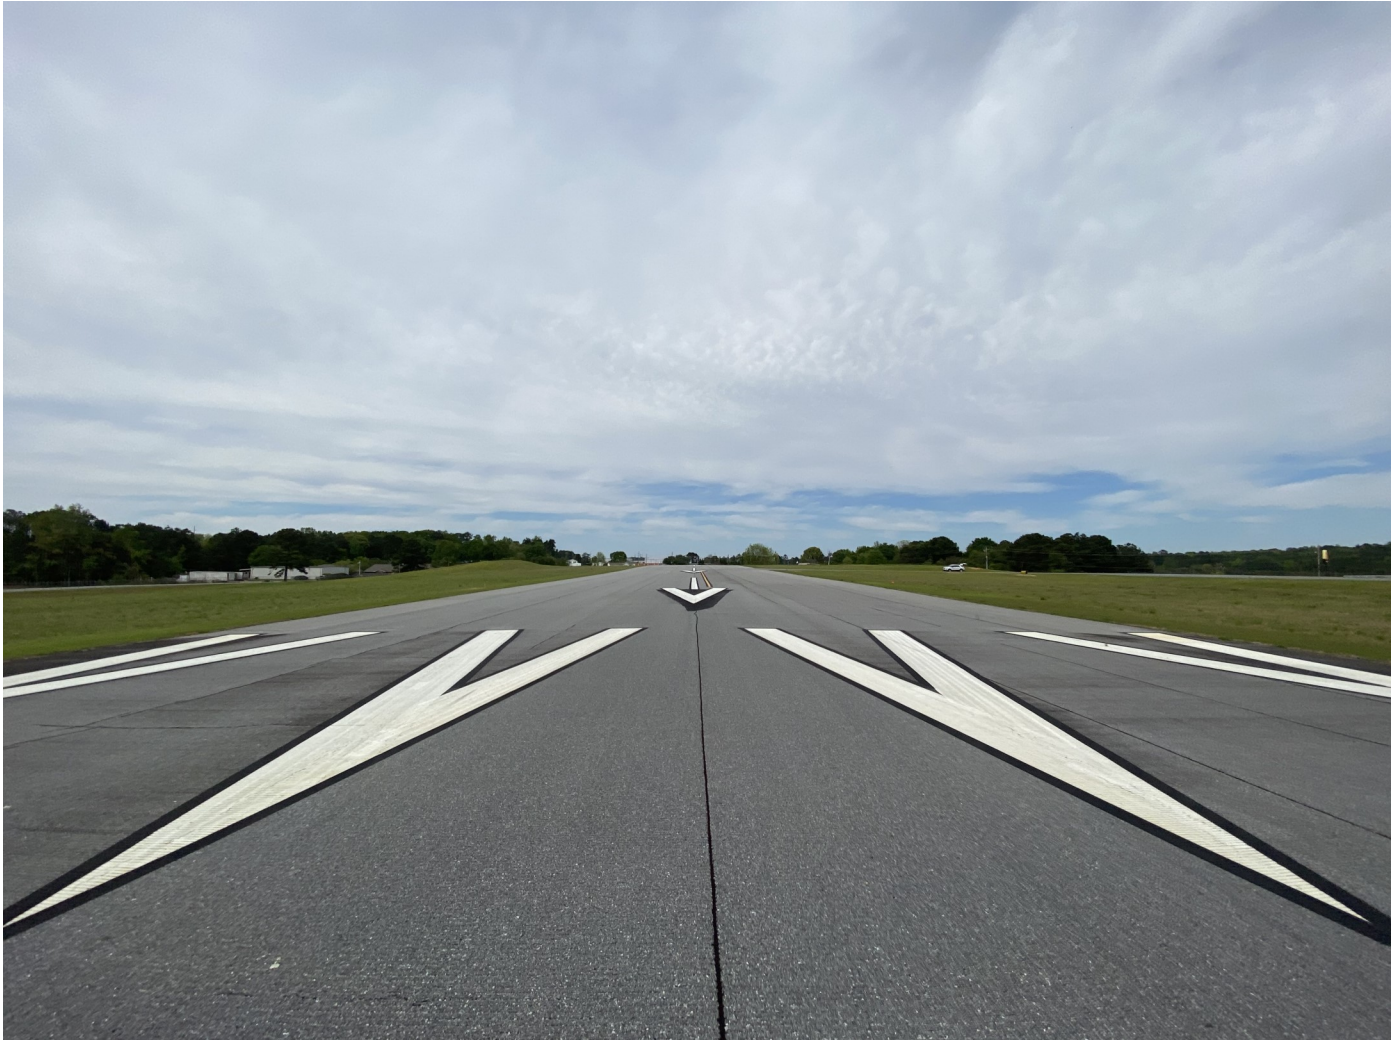
### Approach and Departure Paths—RUNWAY 18

No obstructions located in the ALDOT Approach/Departure Path of Runway 18. However, there are several trees that violate the FAA Part 77 Surface. Please see Appendix #2 for more information.

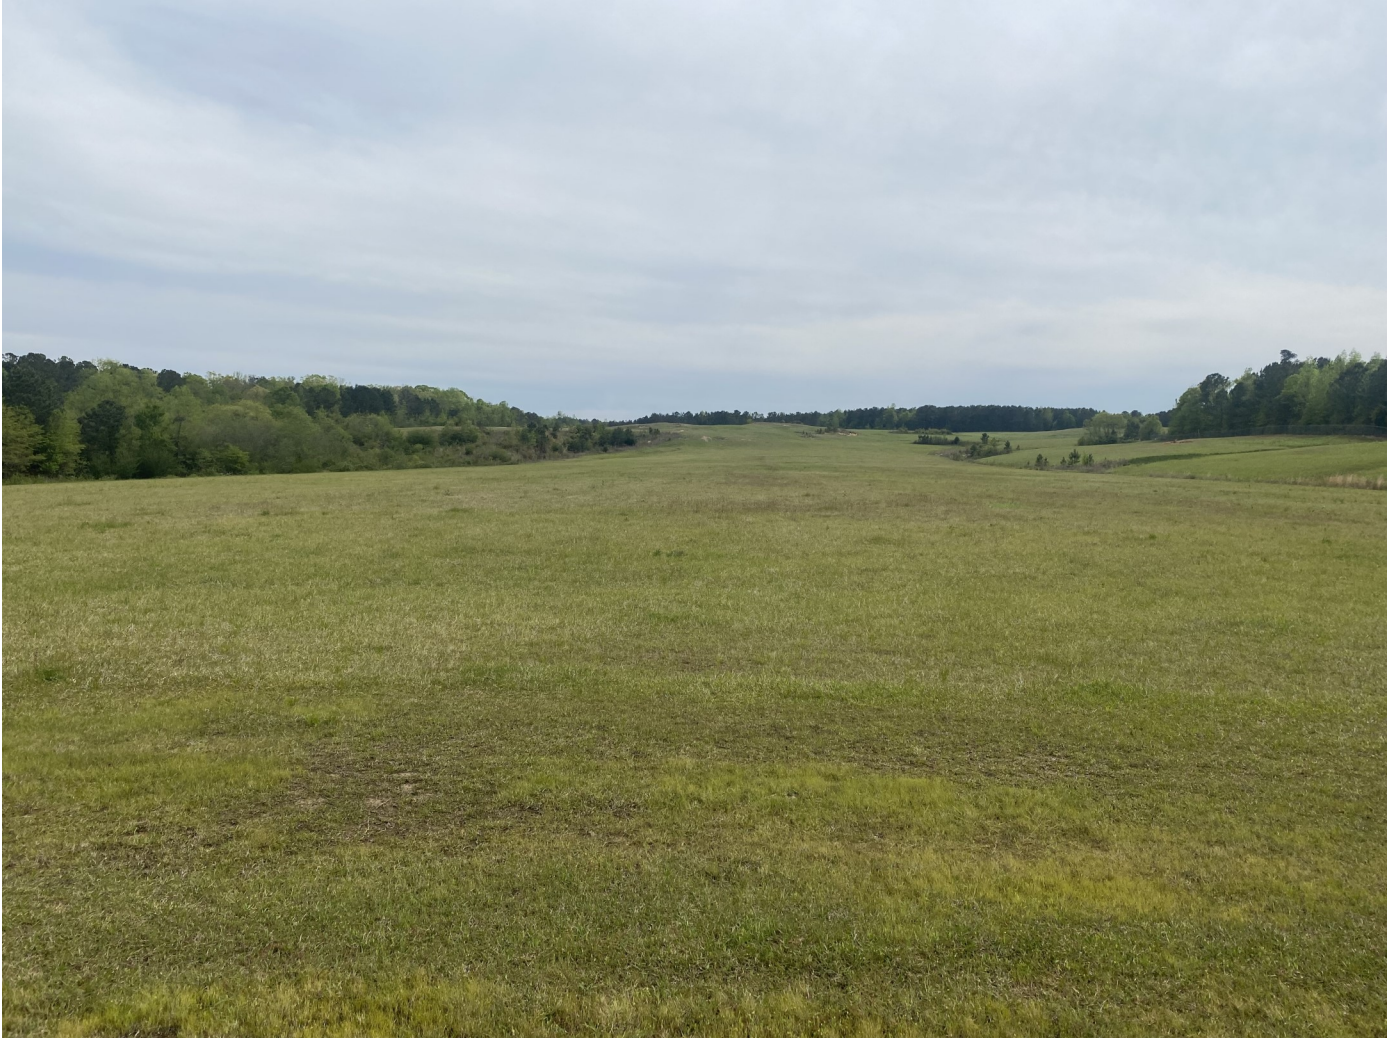
### Approach and Departure Paths—RUNWAY 36

No obstructions located in the ALDOT Approach/Departure Path of Runway 36. However, there are several trees that violate the FAA Part 77 Surface. Please see Appendix #3 for more information.

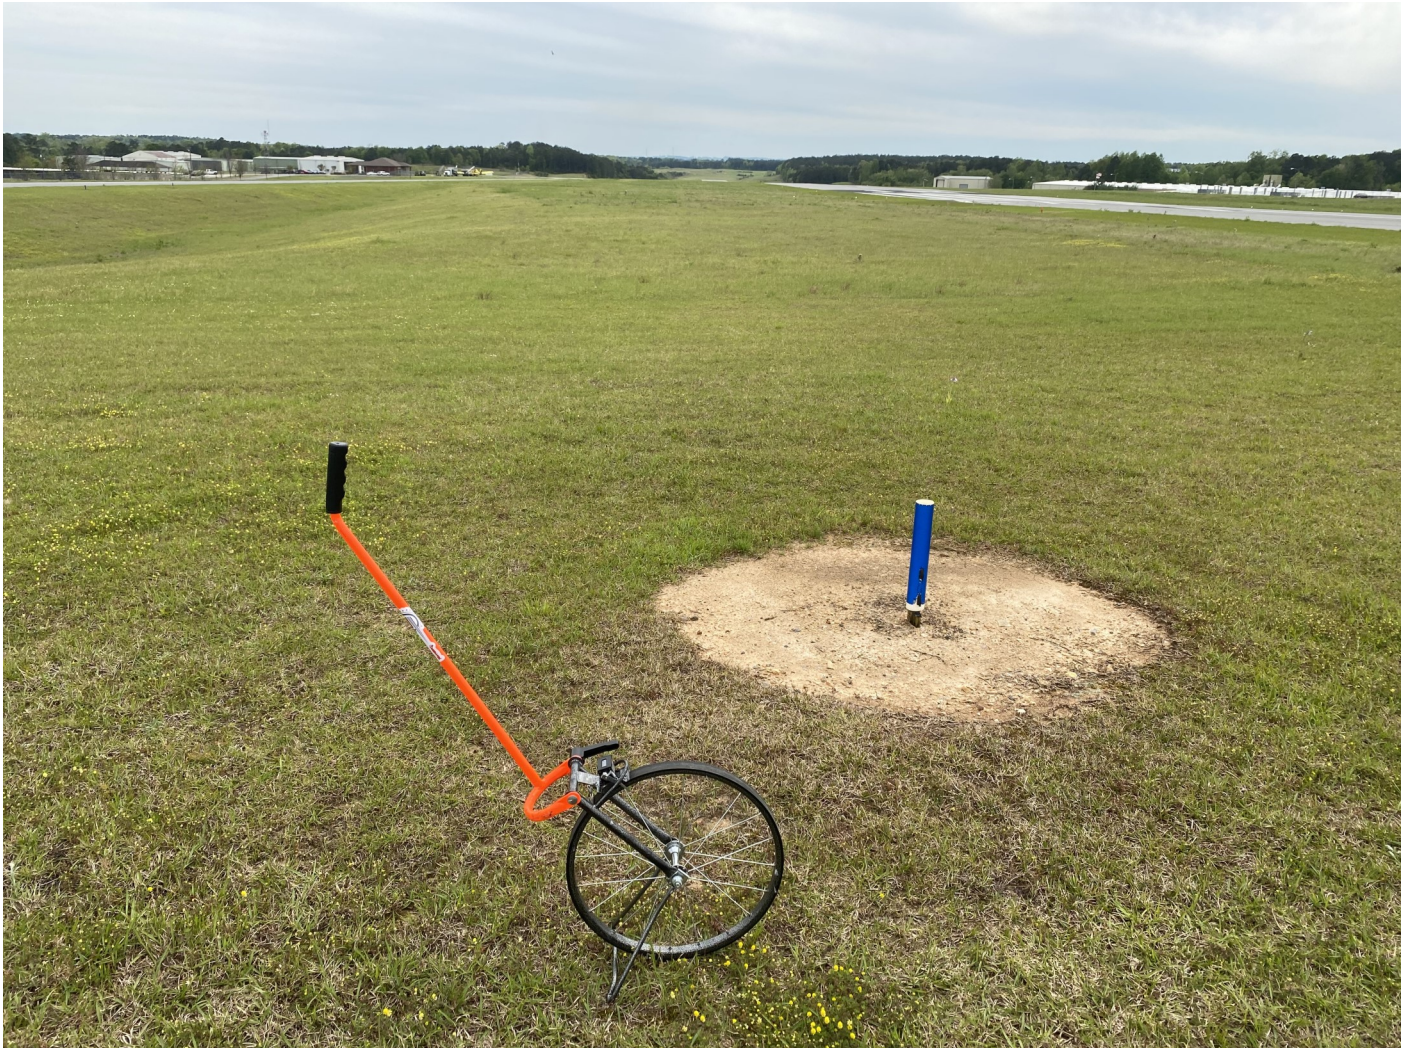
## Primary Surface

Primary Surface **meets** state licensing standards.

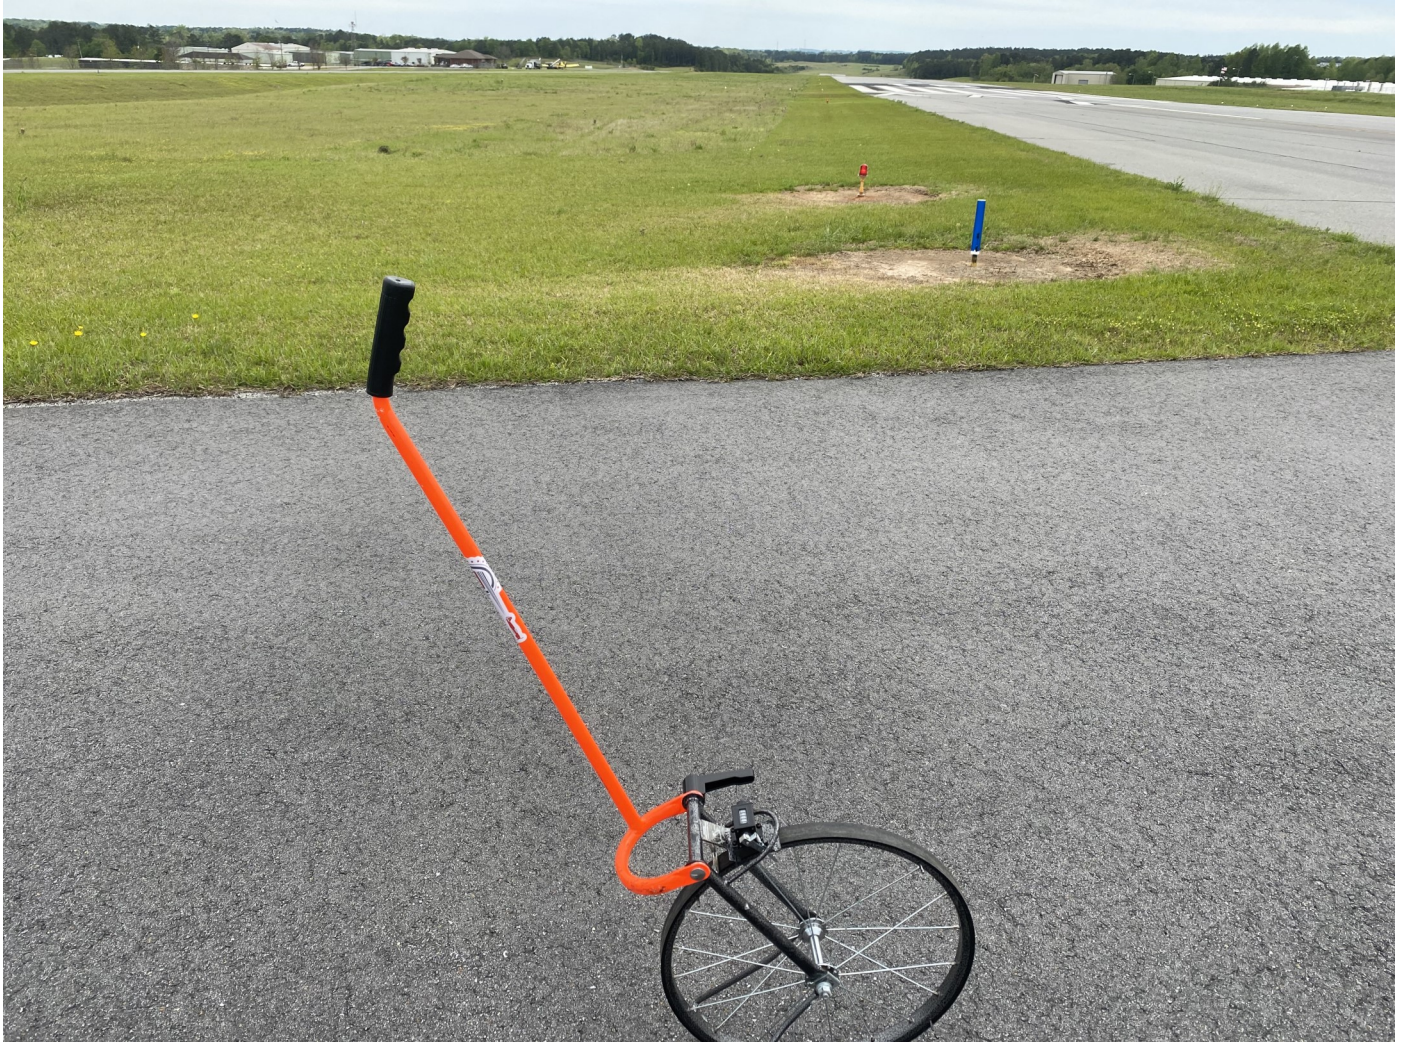
### Runway Safety Area

Runway Safety Area **meets** state licensing standards.

As noted in the past inspection, the stakes for the runway lights are higher than three inches. Please make sure that the new light stakes do not exceed three inches when the new lights are installed.

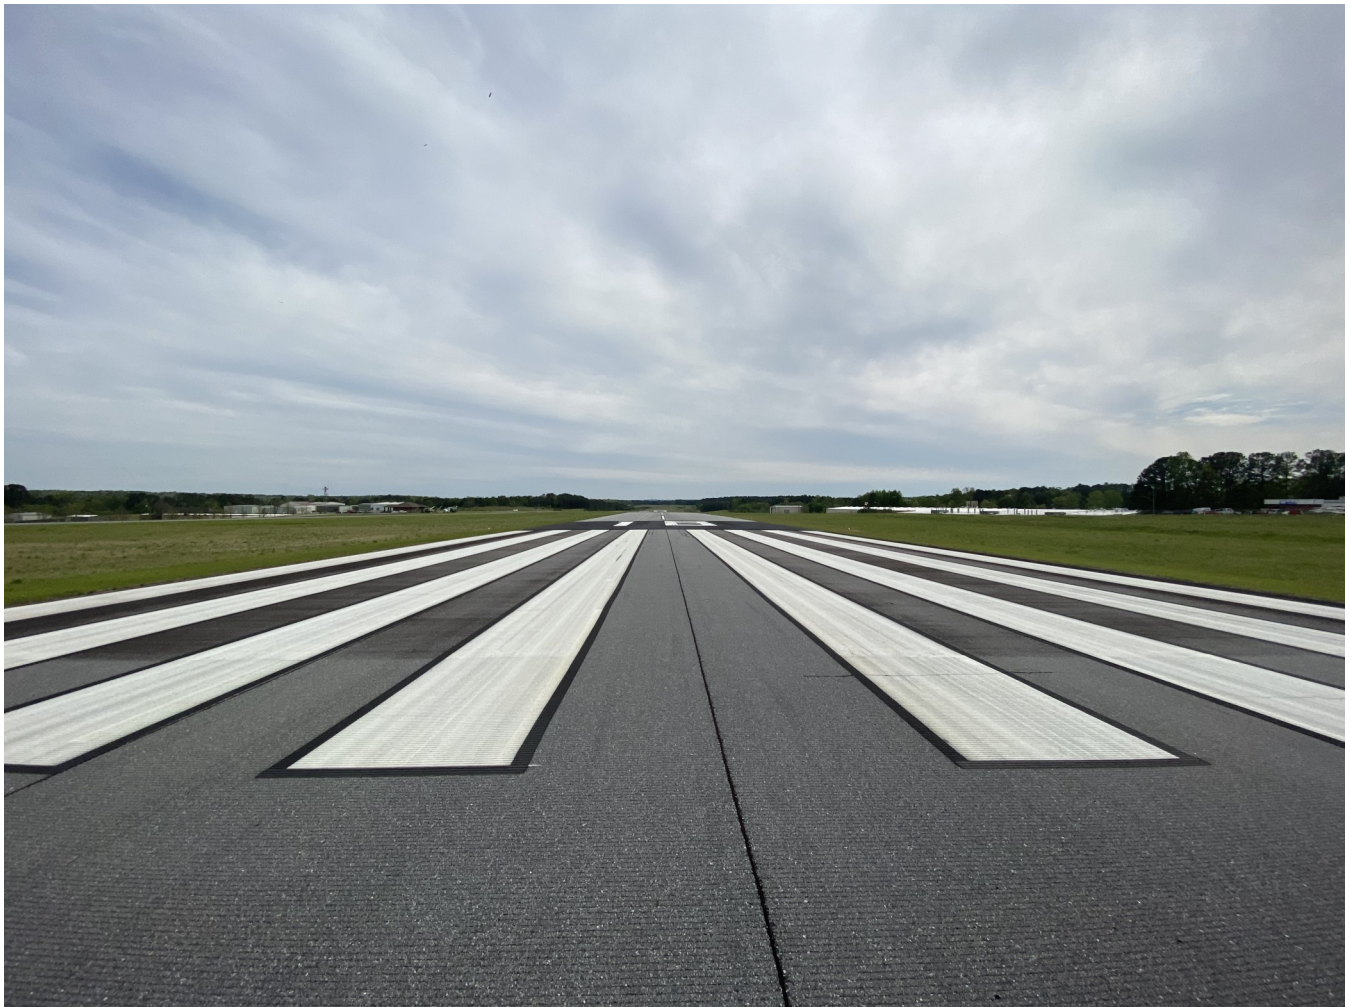
### Airport Markings—Runway

Runway markings are in **GOOD** condition.

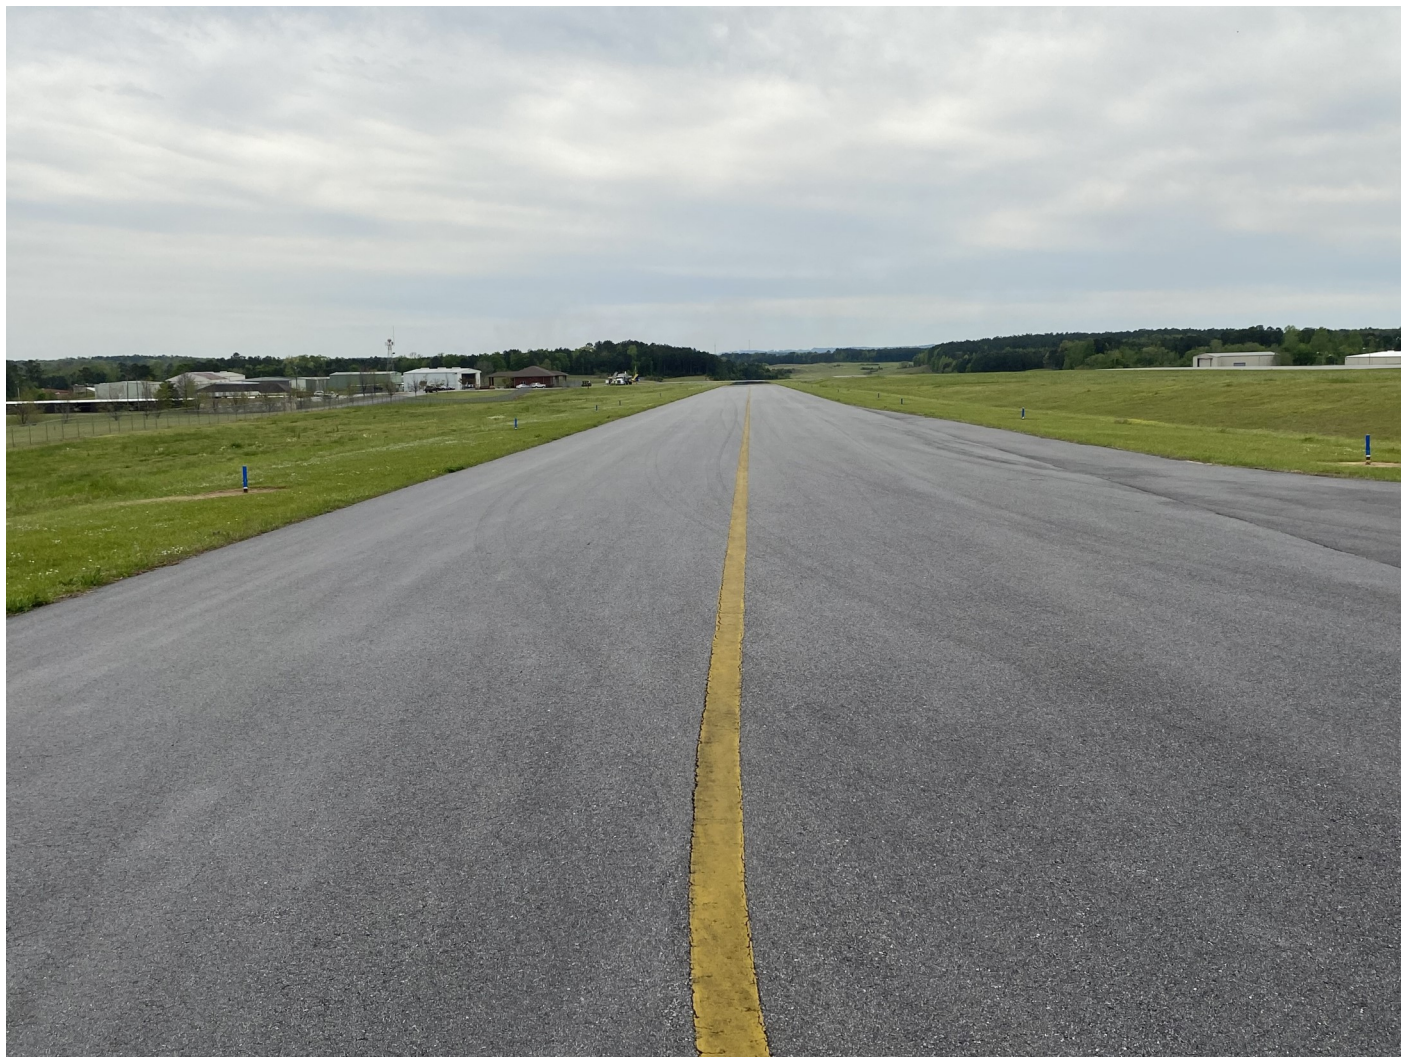
### Airport Markings—Taxiway

Taxiway markings to Runway 18 and 36 are in **GOOD** condition.

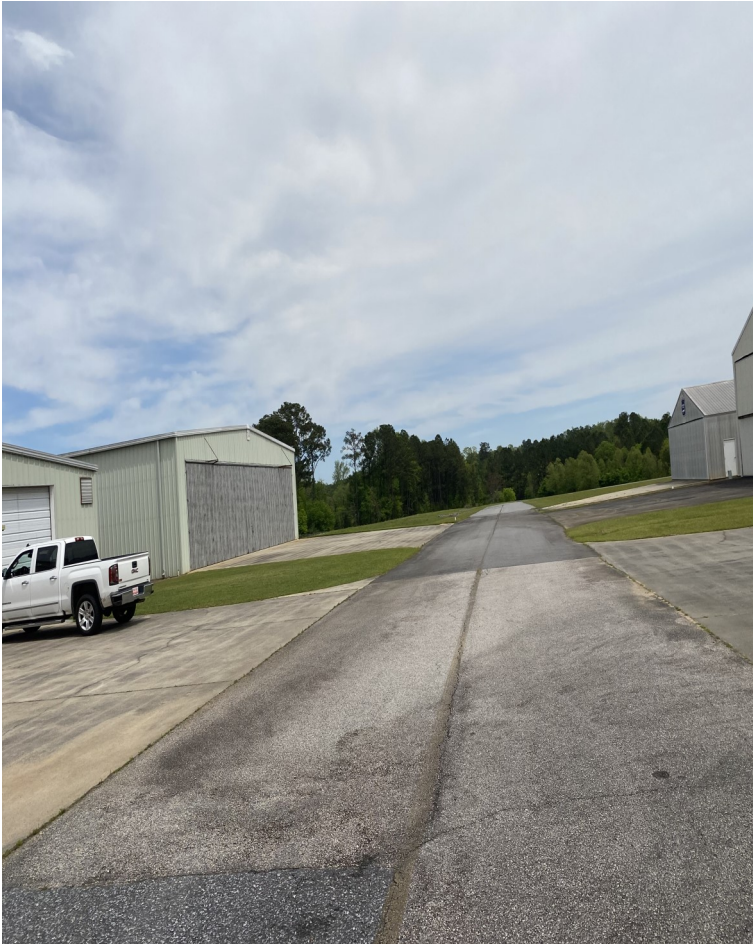
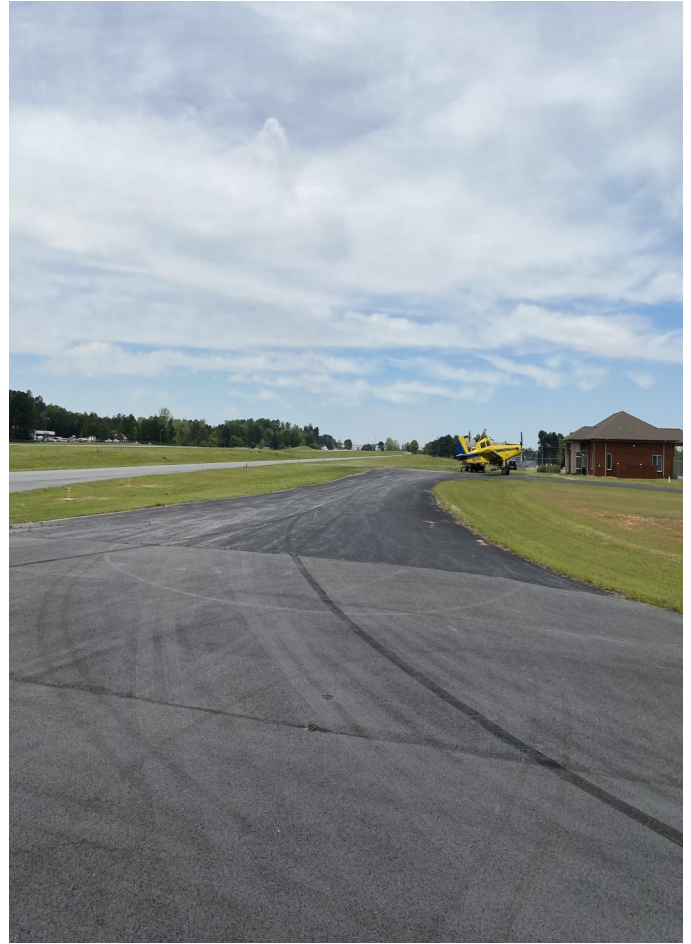
### Airport Markings—Taxiway

Taxiway markings on portions of apron and taxiways to hangars are in **POOR** condition.

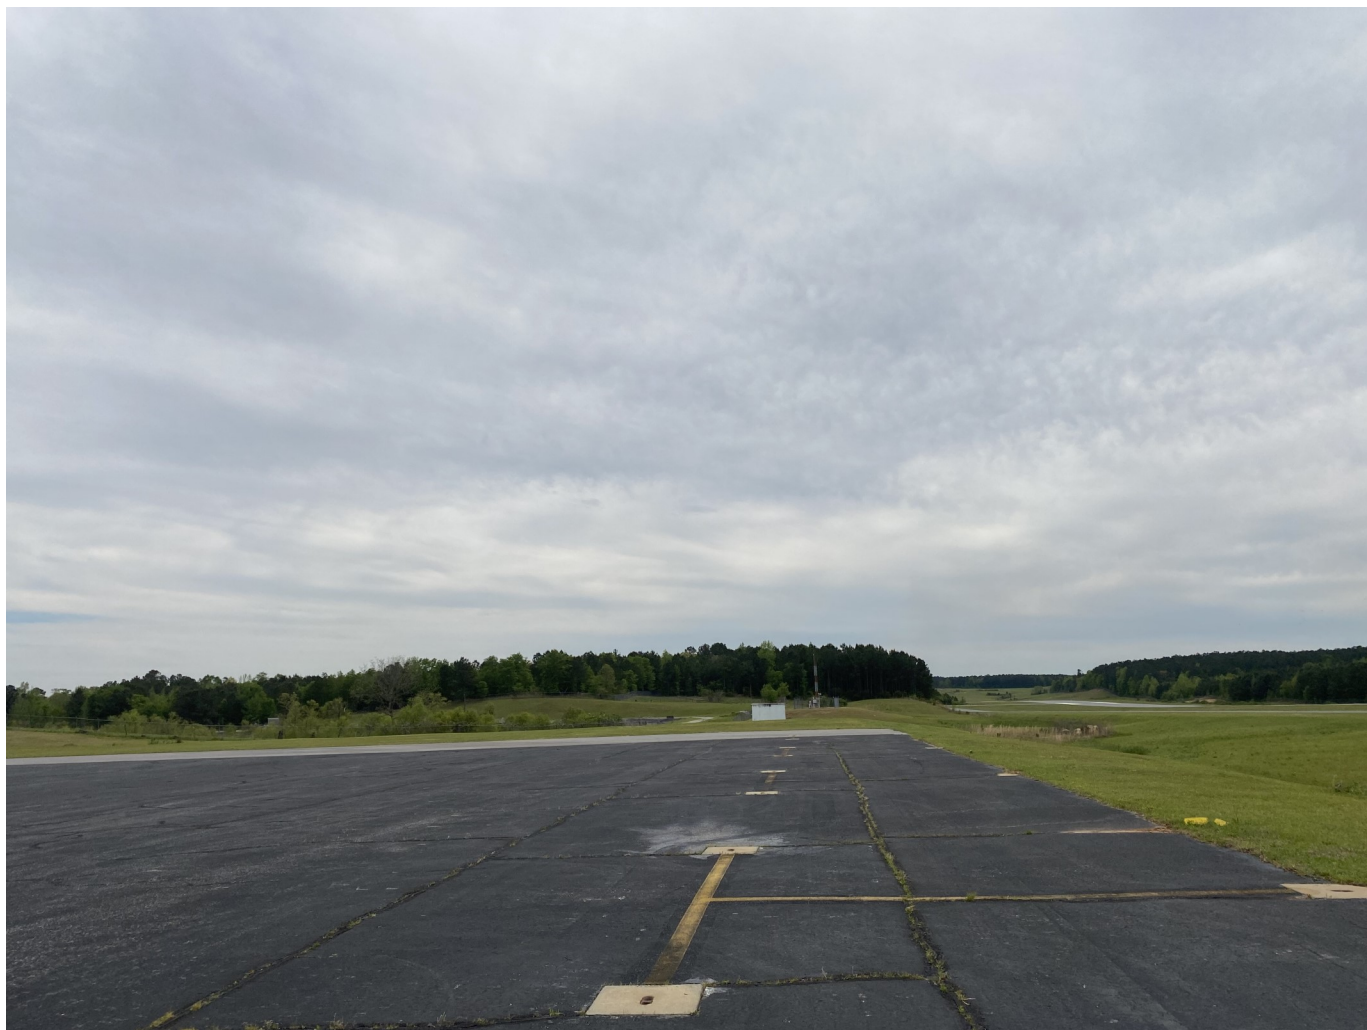
### Airport Markings—Apron

Apron markings are in **POOR** condition.

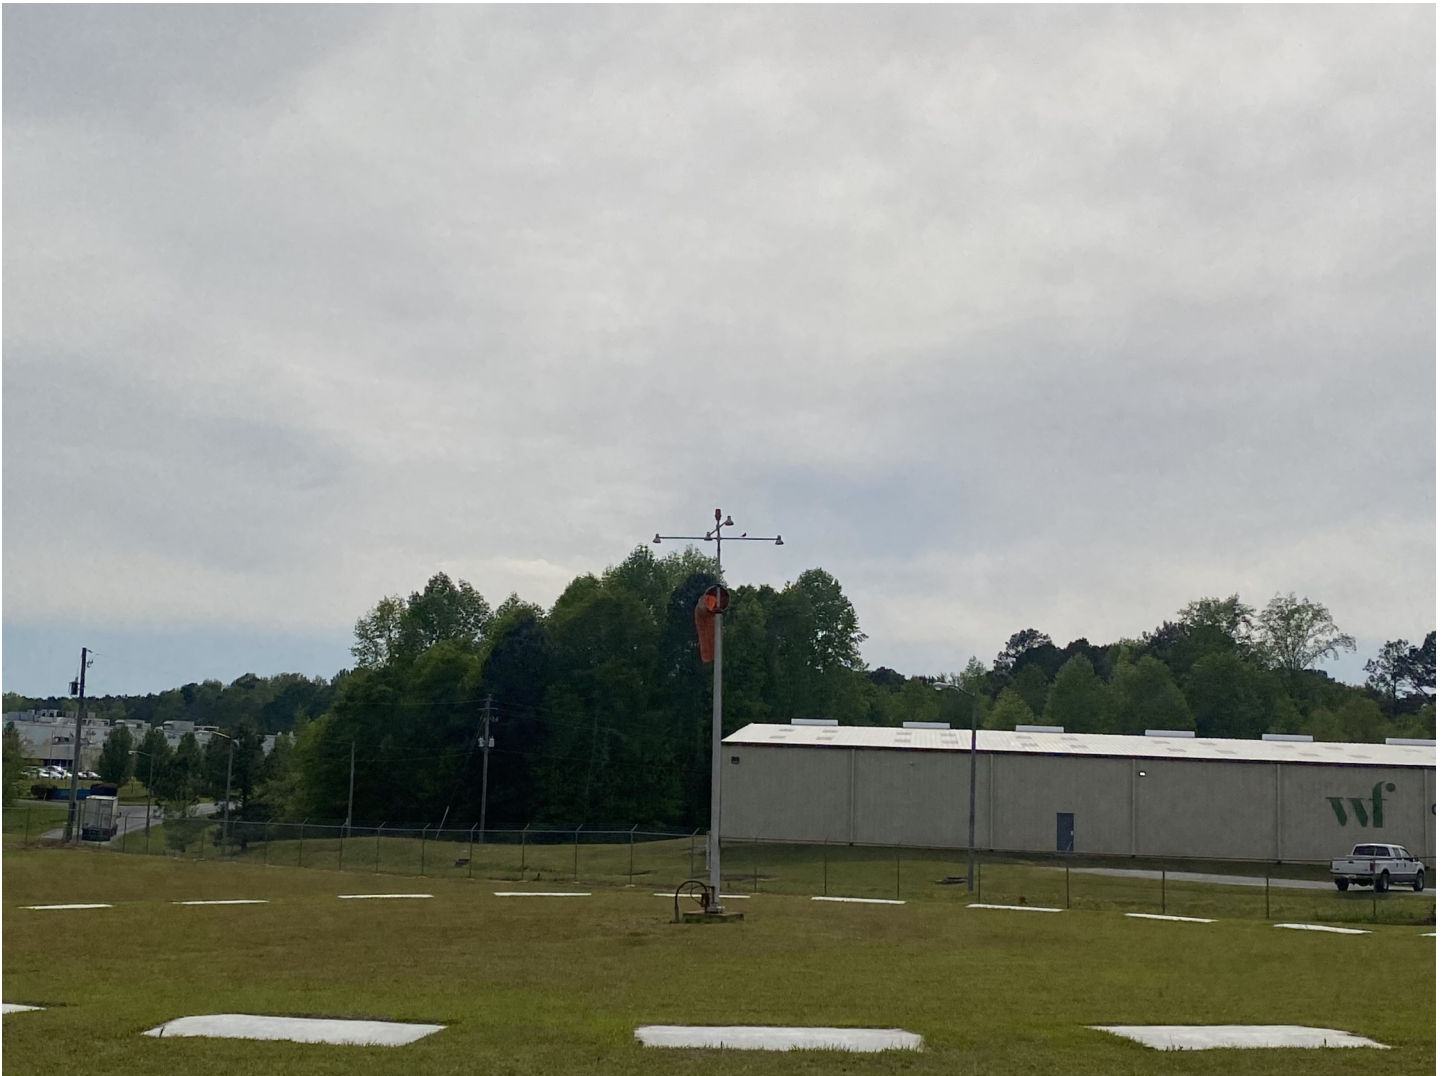
### Wind Direction Indicator

Wind direction indicator is in **FAIR** condition. Windsock is starting to fade and should be replaced soon.

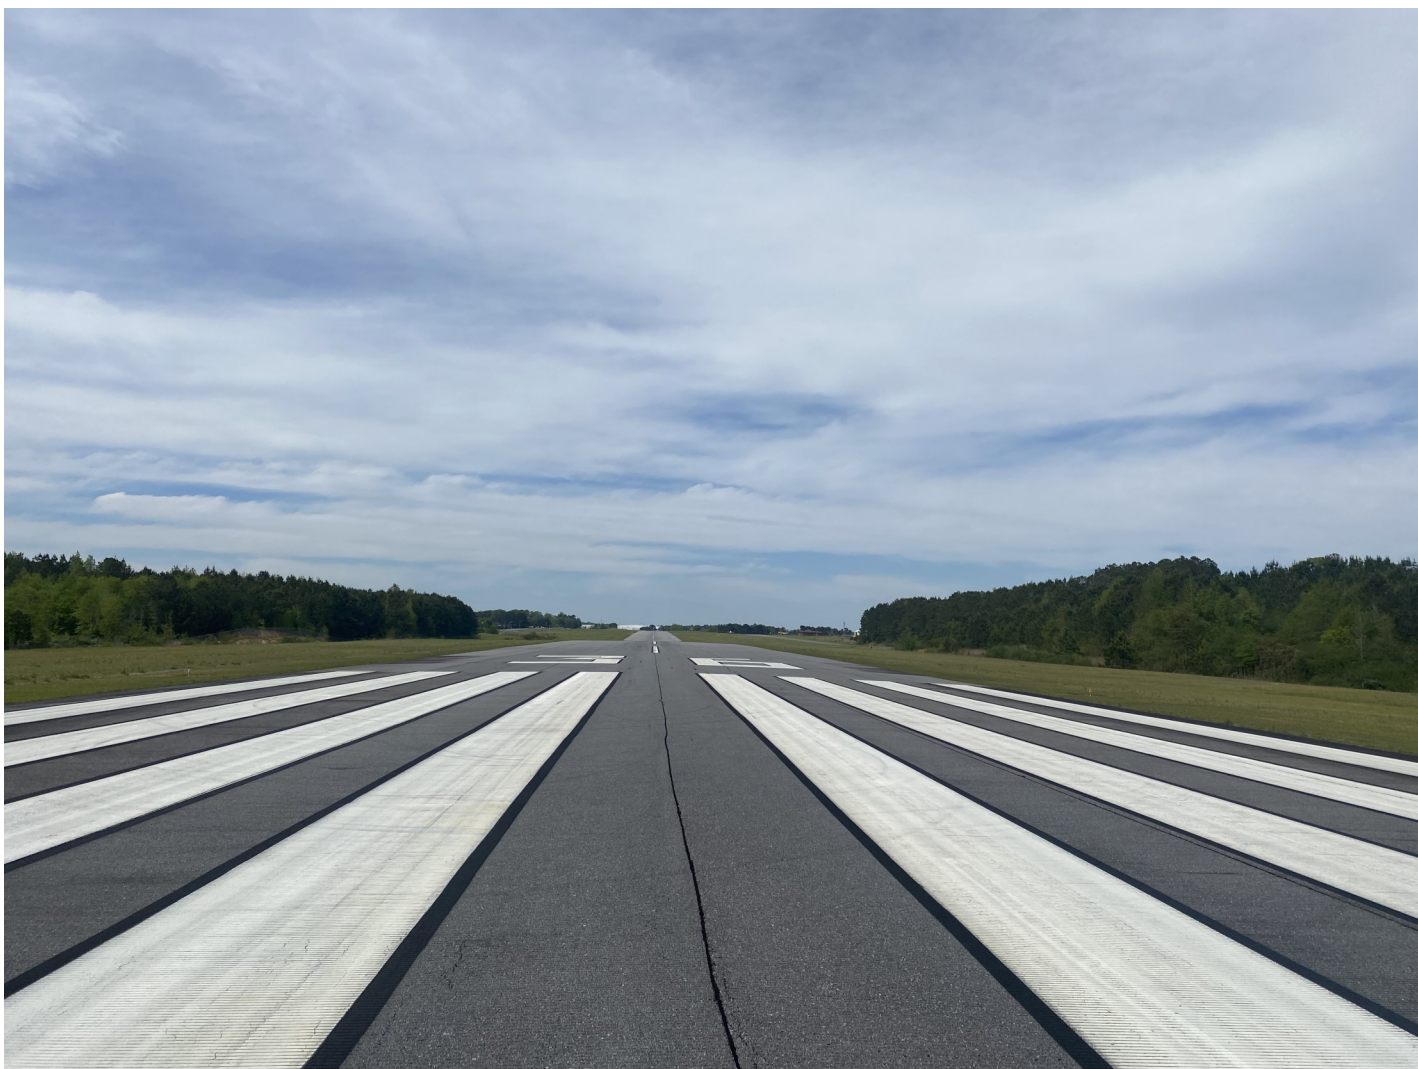
### Runway, Taxiway and Apron Conditions—RUNWAY

Runway surface is in **GOOD** condition.

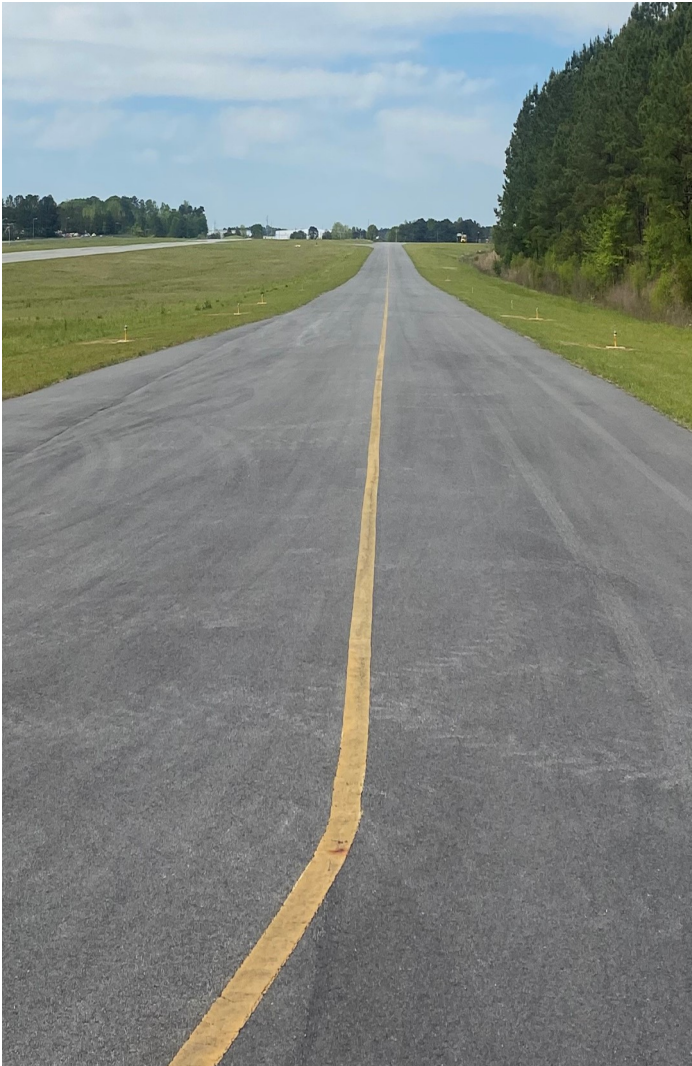
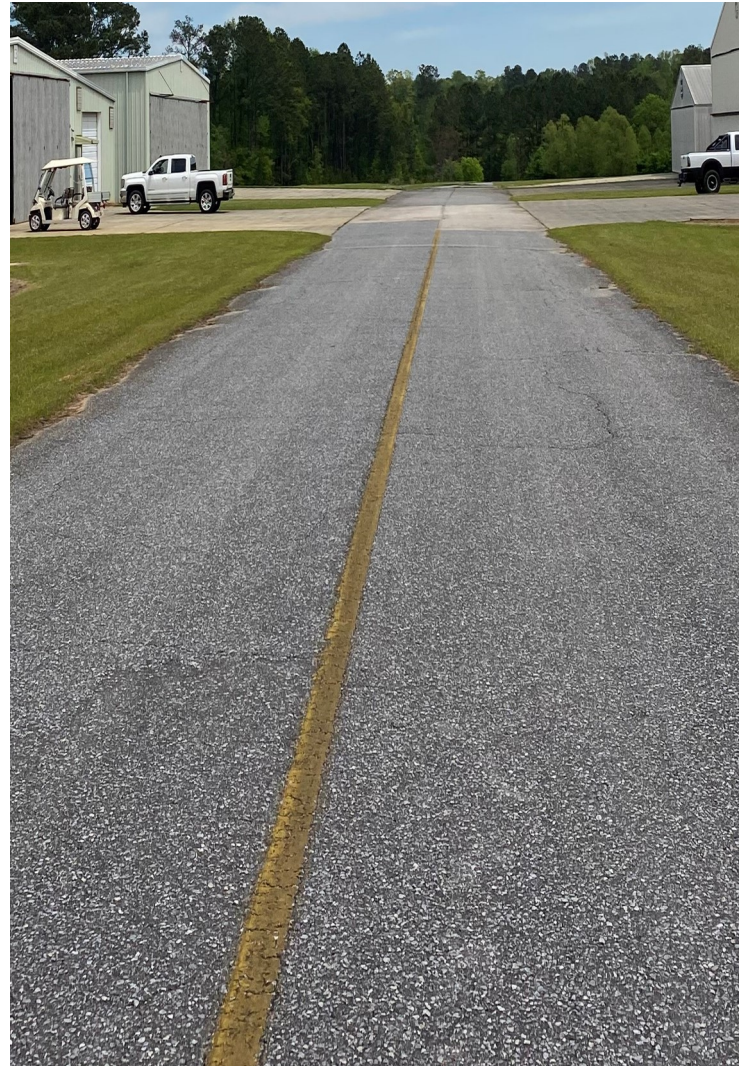
### Runway, Taxiway and Apron Conditions—TAXIWAY

Taxiway surface is generally in **GOOD** condition. Taxiway surface to hangars are generally in **POOR** condition.

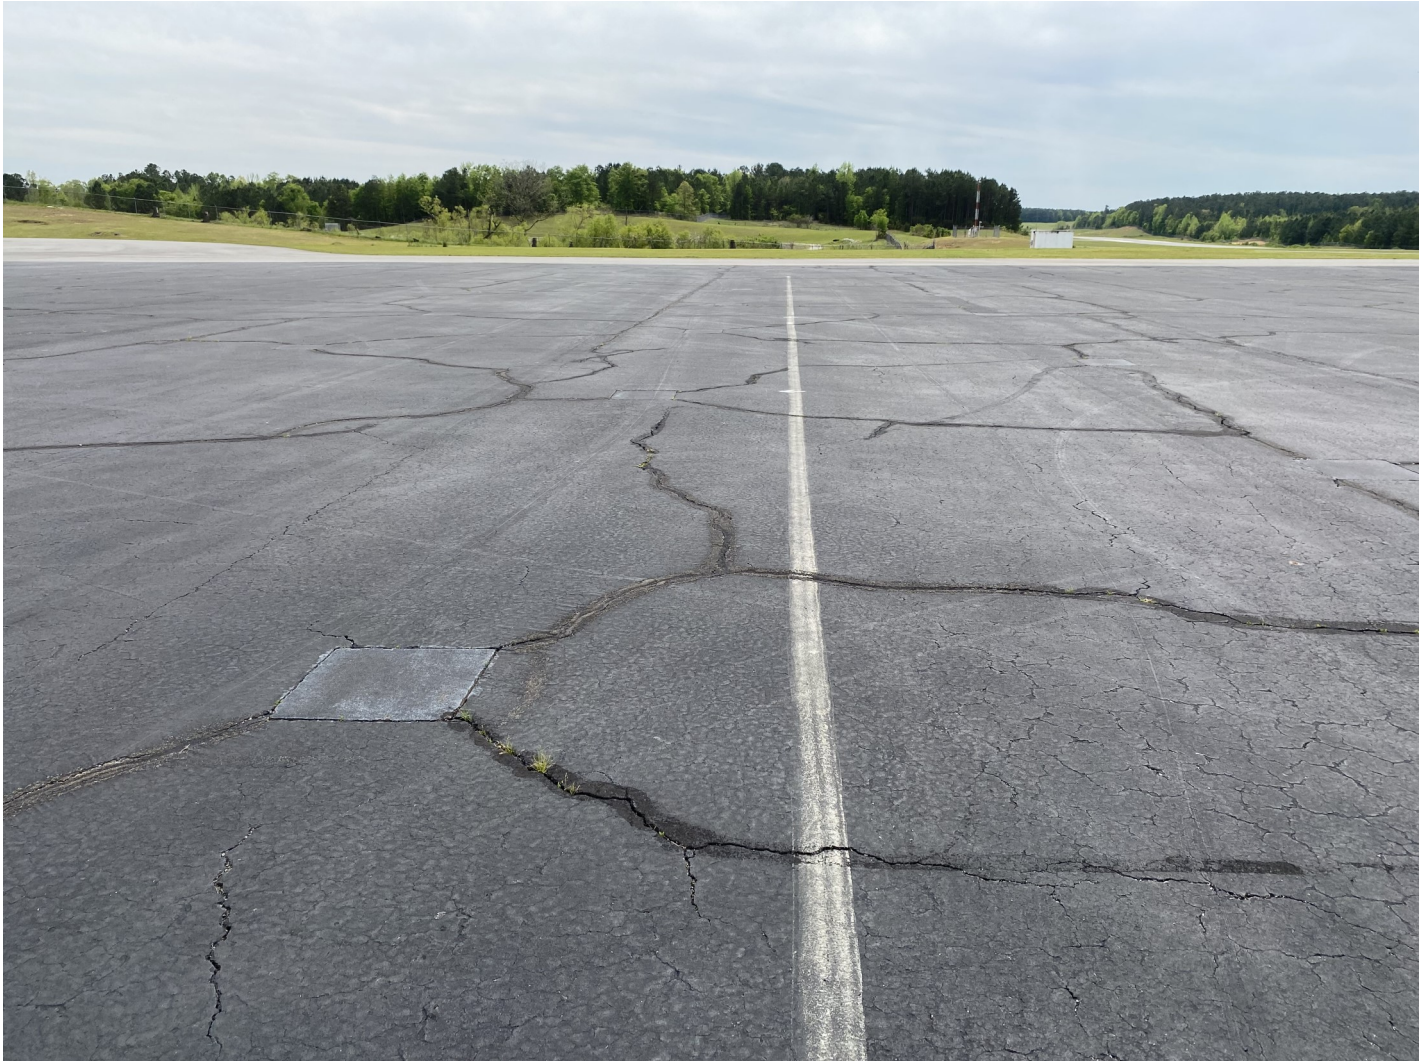
### Runway, Taxiway and Apron Conditions—APRON

Apron surface is overall in **FAIR** to **POOR** conditions in certain areas. There is extensive longitudinal and transverse cracking. There is alligator cracking in certain areas.

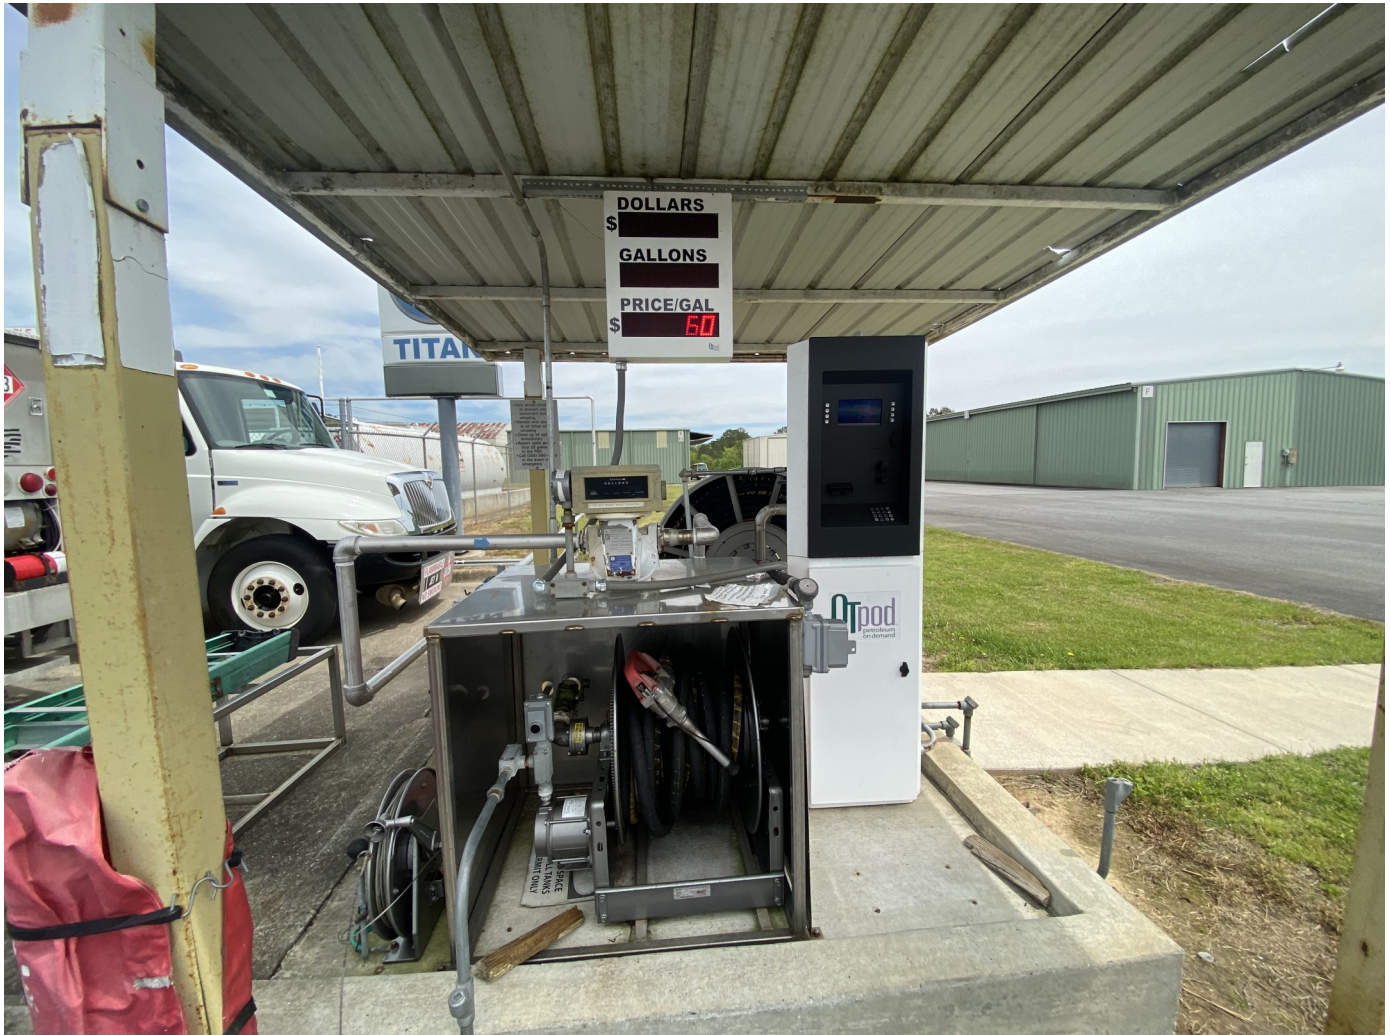
### Fueling Area Requirements

The fueling area meets the requirements established by the Alabama Department of Transportation. However, the State of Alabama Department of Agriculture may have additional requirements for fueling systems that were not considered during this inspection.

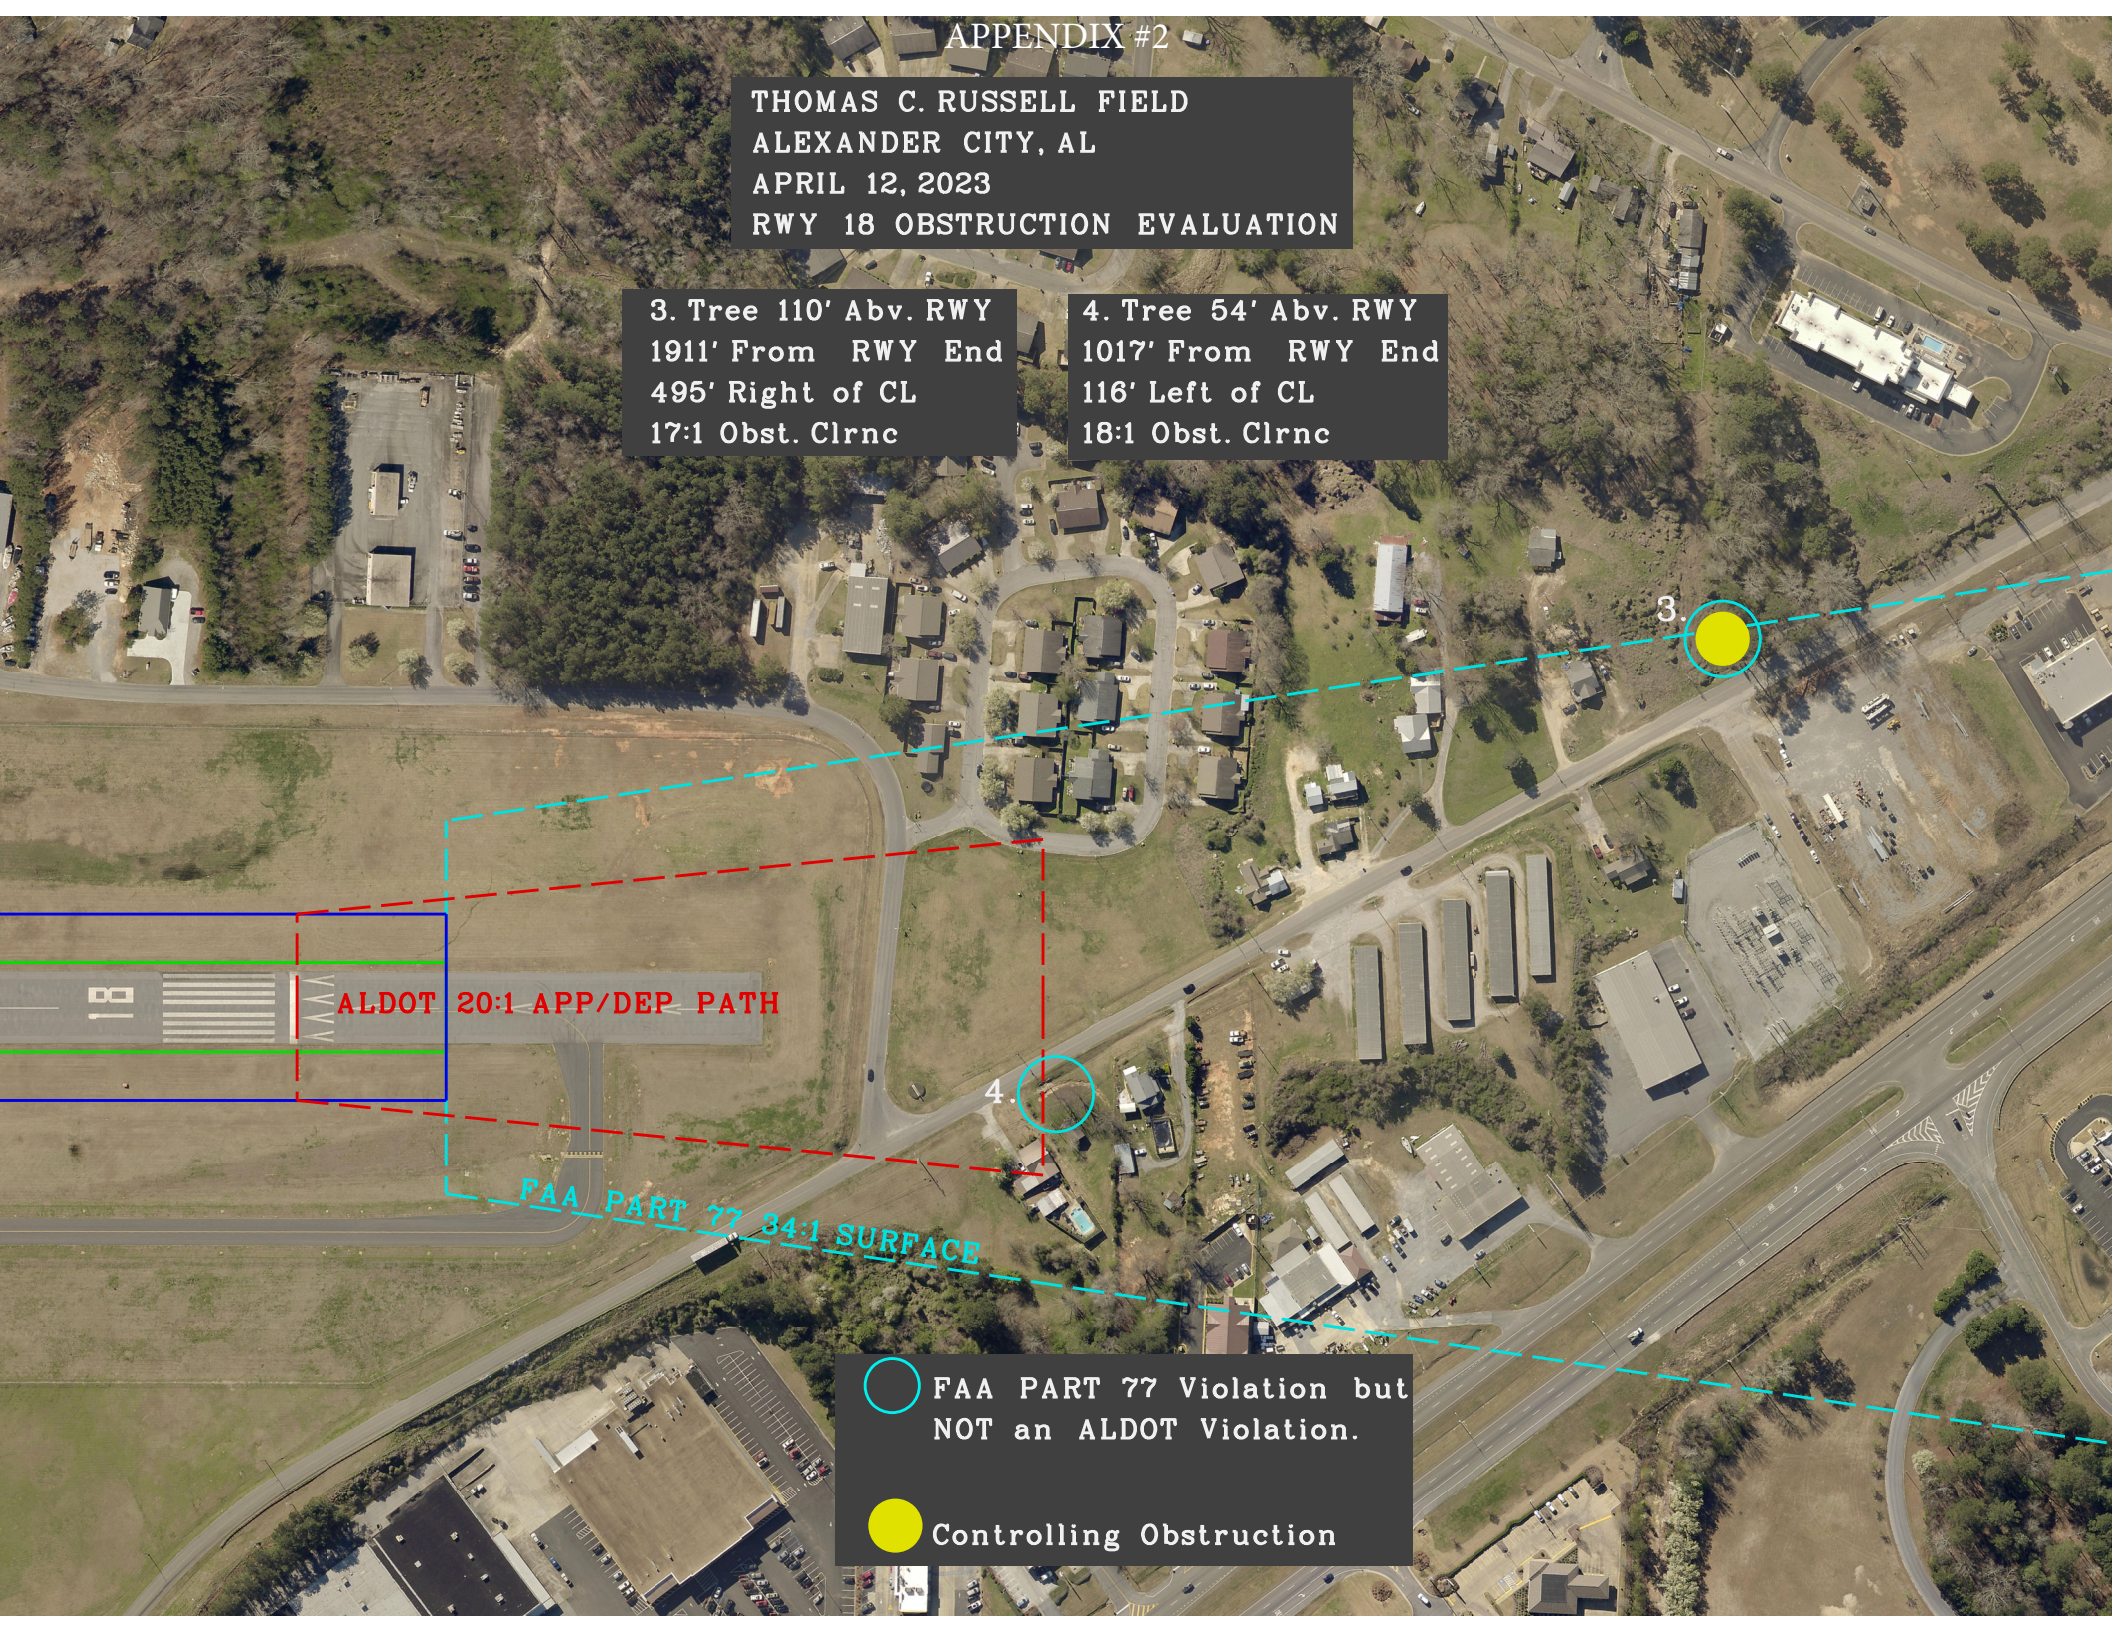
THOMAS C. RUSSELL FIELD  
ALEXANDER CITY, AL  
APRIL 12, 2023  
RWY 18 OBSTRUCTION EVALUATION

3. Tree 110' Abv. RWY  
1911' From RWY End  
495' Right of CL  
17:1 Obst. Clrnc

4. Tree 54' Abv. RWY  
1017' From RWY End  
116' Left of CL  
18:1 Obst. Clrnc
