**Subject: Annual Inspection Report**  
**Thomas C. Russell Field (ALX)**

# **ANNUAL INSPECTION REPORT**

**THOMAS C. RUSSELL FIELD  
ALEXANDER CITY, ALABAMA**

In accordance with the provisions of the Code of Alabama 23-1-357, an inspection of the **Thomas C. Russell Field** was conducted by **Mr. Jason Hare, Mr. Bennett Head, and Mr. Mark Bowron** with the Alabama Department of Transportation Aeronautics Bureau on **April 12, 2023**.

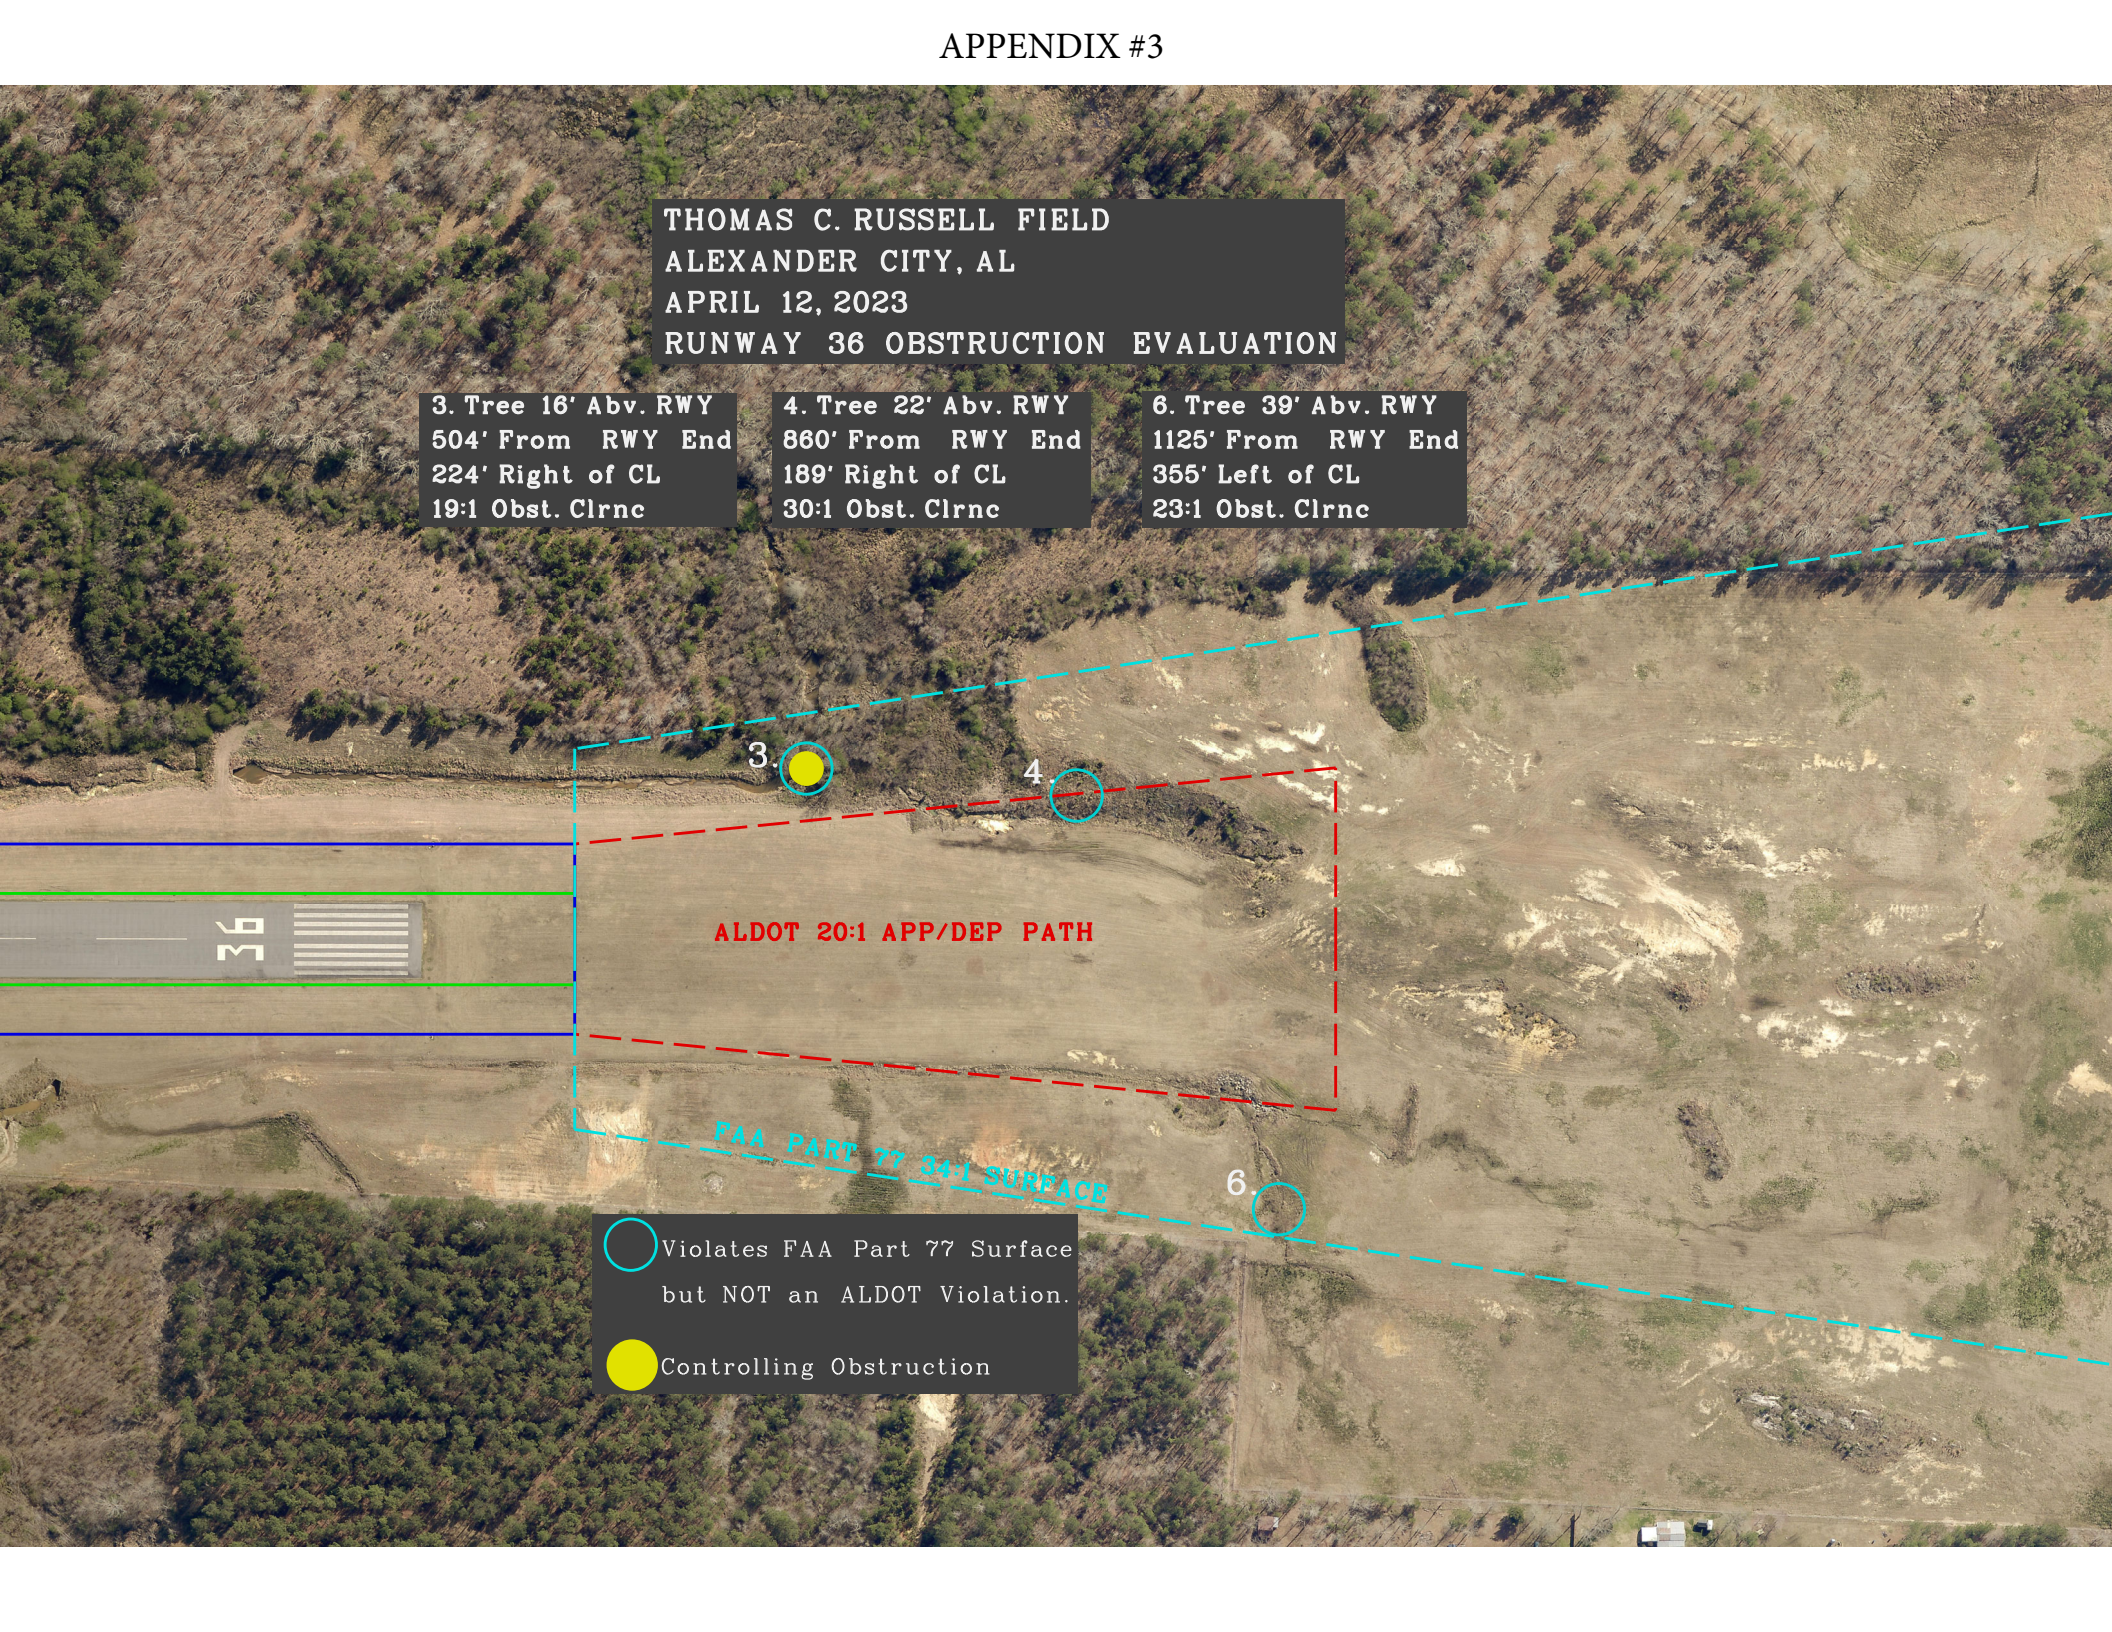
THOMAS C. RUSSELL FIELD  
ALEXANDER CITY, AL  
APRIL 12, 2023  
RUNWAY 36 OBSTRUCTION EVALUATION

3. Tree 16' Abv. RWY  
504' From RWY End  
224' Right of CL  
19:1 Obst. Clrnc

4. Tree 22' Abv. RWY  
860' From RWY End  
189' Right of CL  
30:1 Obst. Clrnc

6. Tree 39' Abv. RWY  
1125' From RWY End  
355' Left of CL  
23:1 Obst. Clrnc
