Subject: Annual Inspection Report
Auburn University Regional Airport (AUO)

Auburn University Regional Airport (AUO)

**Annual Inspection Report
Auburn University Regional Airport
Auburn, Alabama**

May 17, 2022

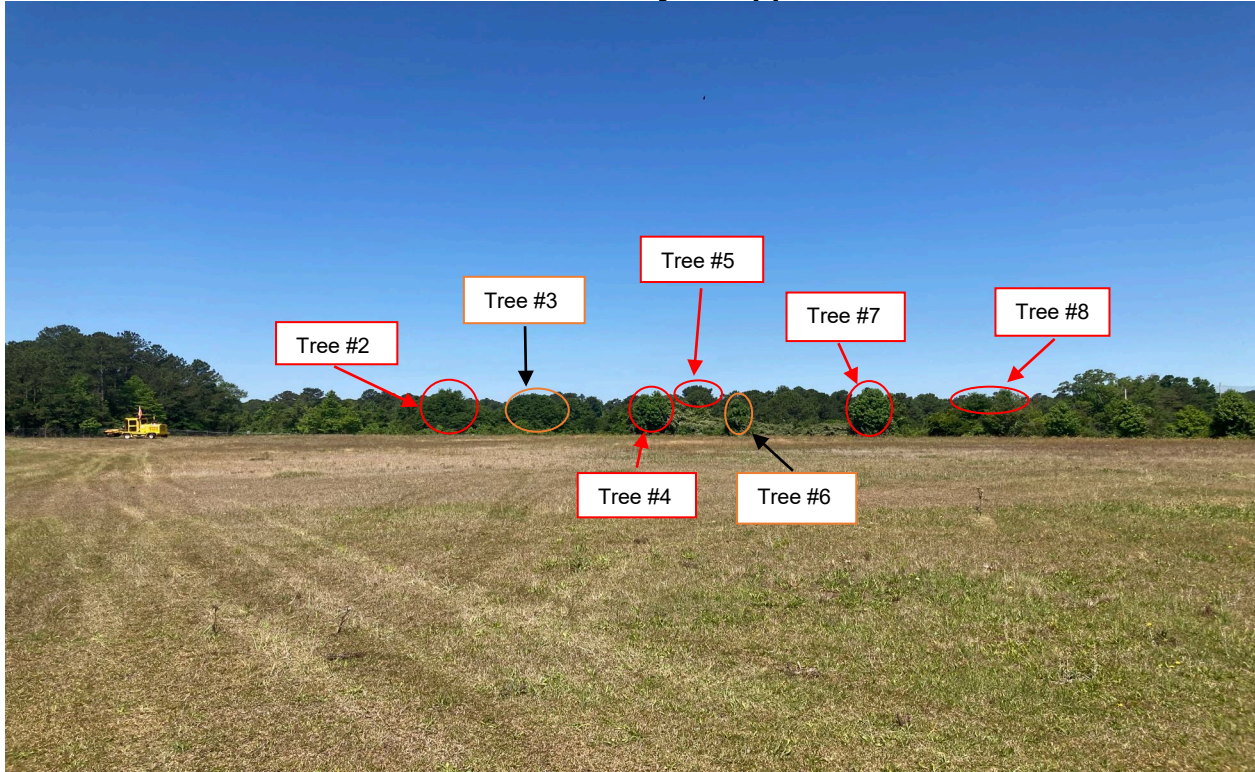
Photo #1 – Runway 11 Approach

- Runway 11 – Obstructions identified as Tree #2, #4, #5, #7, and #8 violate the ALDOT 20:1 Approach/Departure Path. Obstructions identified as Tree #3 and #6 will soon violate the ALDOT Surface (See Photo #1 and Appendix 2).
- Runway 18 – Obstructions identified as Tree #5, #6, and #8 violate the ALDOT 20:1 Approach/Departure Path. Obstructions identified as Tree #7, #9, and #10 will soon violate the ALDOT Surface (See Photo #2 and Appendix 3).
- Runway 29 – No obstructions violate the ALDOT 20:1 Approach/Departure Path; however, obstruction identified as Tree #3 violates the FAA Part 77 34:1 Approach Surface (See Photo #3).
- Runway 36 – No obstructions violate the ALDOT 20:1 Approach/Departure Path; however, obstructions identified as Tree #1, #2, #3, #4, and #5 violate the FAA Part 77 50:1 Precision Instrument Approach Surface (See Photo #4).

- Remove all obstructions within the ALDOT 20:1 Approach/Departure Path.
- Proceed with Runway 18 Runway Safety Area Project listed on the Airport's Capital Improvement Plan (CIP).
- Obstructions detailed in this report are representative and may not identify all obstructions.

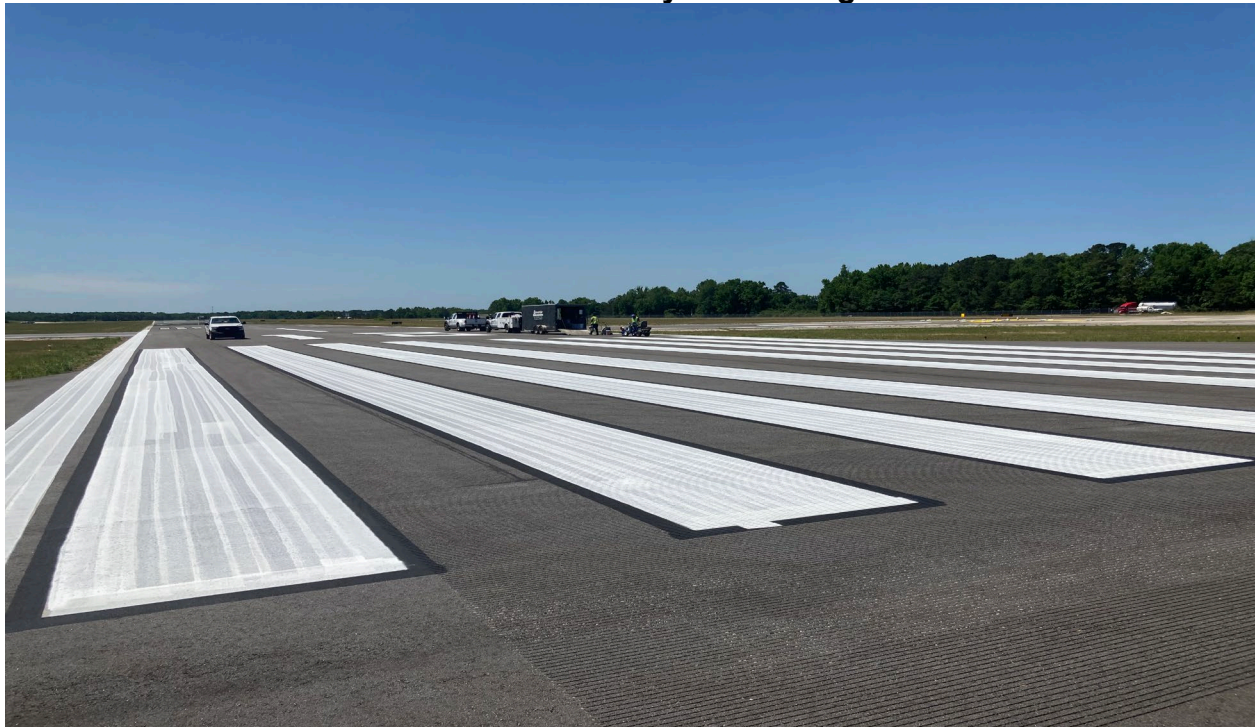
Photo #5 – Runway 18 Markings

- Runway 18/36 markings are in **EXCELLENT** condition. Re-marking was underway at time of inspection (See Photo #5).
- Runway 11/29 markings are in **FAIR** condition (See Photo #6).
- North portion of Taxiway A markings are in **GOOD** condition.
- South portion of Taxiway A and Taxiway B markings are in **FAIR** condition due to fading (See Photo #7).
- Taxiway C and Taxiway T markings are in **POOR** condition. Taxiway C markings south of the main apron are almost non-existent (See Photo #8).

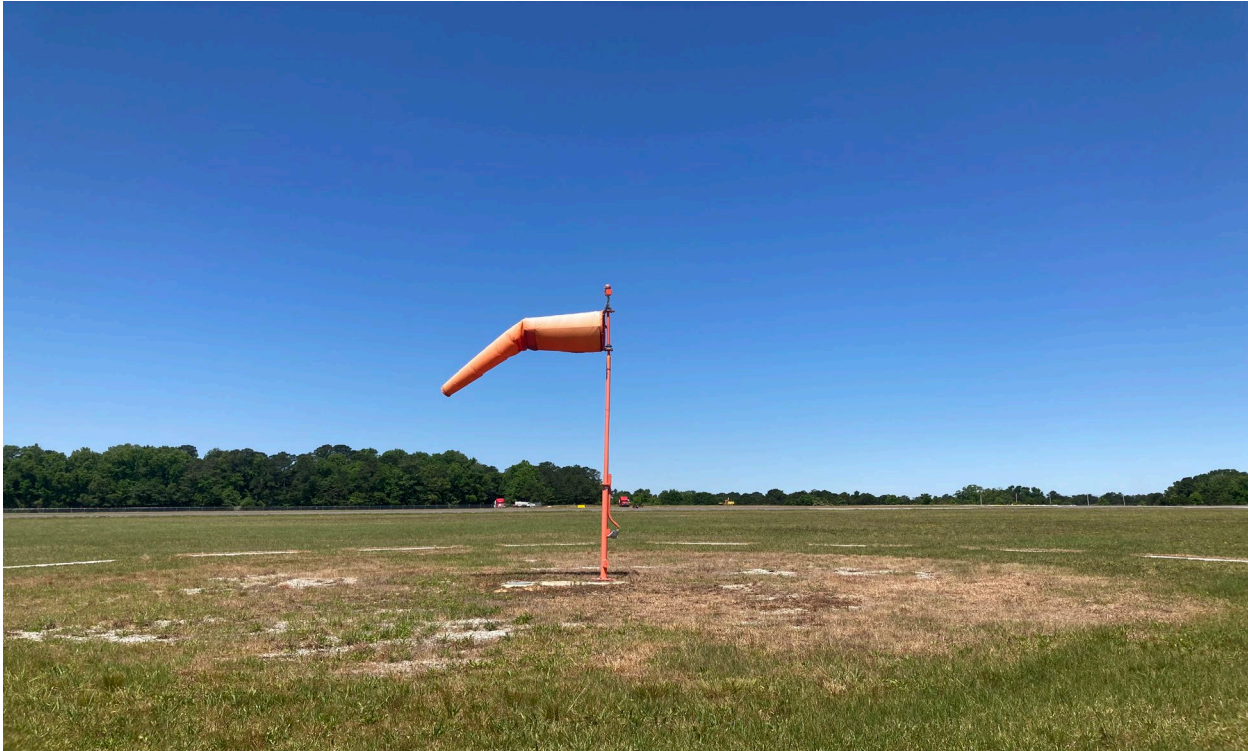
Photo #9 – Wind Direction Indicator

- The wind direction indicator (wind cone) is operational and in **FAIR** condition due to fading (See Photo #9).

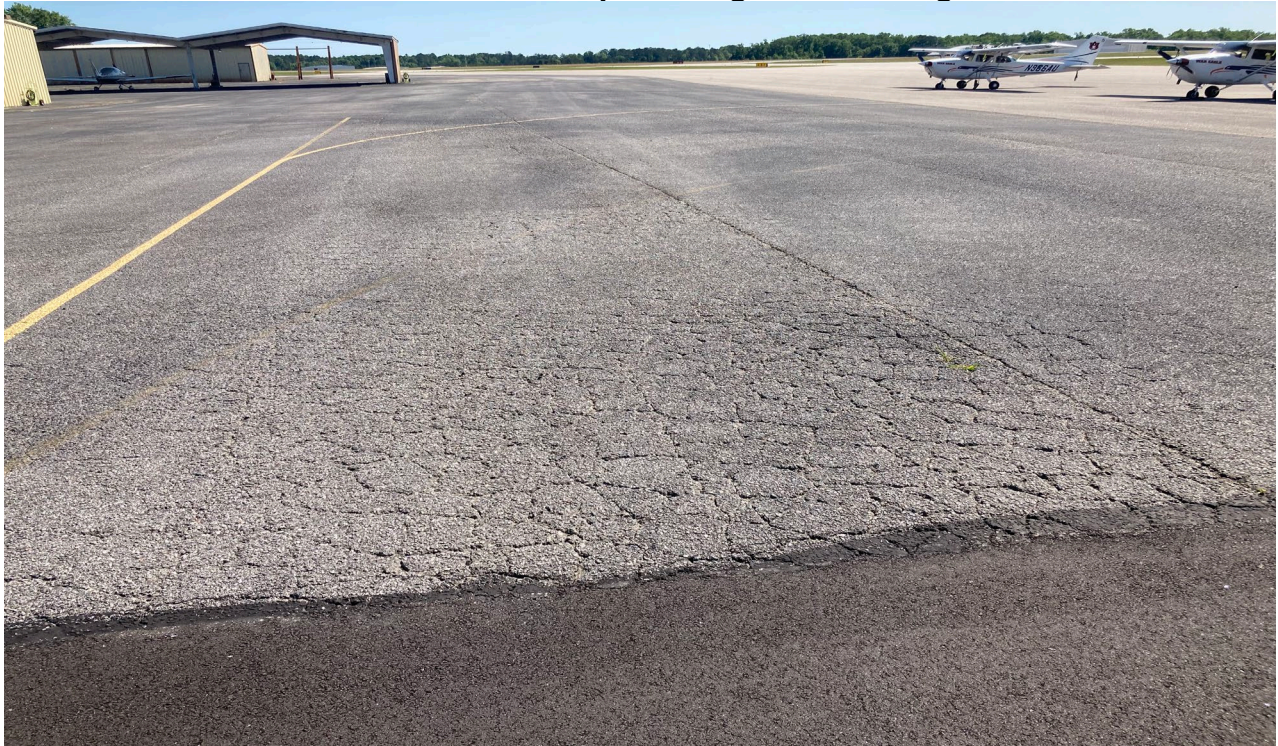
<i>Main Apron</i>	<u>FAIR.</u> Joint and longitudinal cracking throughout apron surface.
<i>West Apron</i>	Mostly <u>FAIR</u> ; however, the northwest portion near the T hangars is in <u>POOR</u> condition due to alligator cracking and raveling producing Foreign Object Debris (FOD), vegetation growth, and pavement <u>FAILURE</u> in some areas (See Photo #10 and #11).
<i>Runway 18/36</i>	<u>EXCELLENT</u>
<i>Runway 11/29</i>	<u>GOOD</u>
<i>Taxiway A North</i>	<u>GOOD</u>
<i>Taxiway A South</i>	Overall <u>FAIR</u> , with one area experiencing longitudinal cracking approximately one inch wide and a surface variation of approximately ½", and vegetation growth (See Photo #12).
<i>Taxiway B</i>	<u>GOOD</u>
<i>Taxiway C</i>	<u>FAIR.</u> Longitudinal cracking is starting to appear on Taxiway C south of the main apron.

Photo #10 – West Apron Alligator Cracking

- Proceed with pavement maintenance project planned for a portion of the West Apron and Taxiway T.
- Proceed with Apron and Taxiway rehabilitation projects as listed on the airport's Capital Improvement Plan (CIP).
- Plan a pavement rehabilitation project for Taxiway C and northwest portion of the West Apron near T hangars.

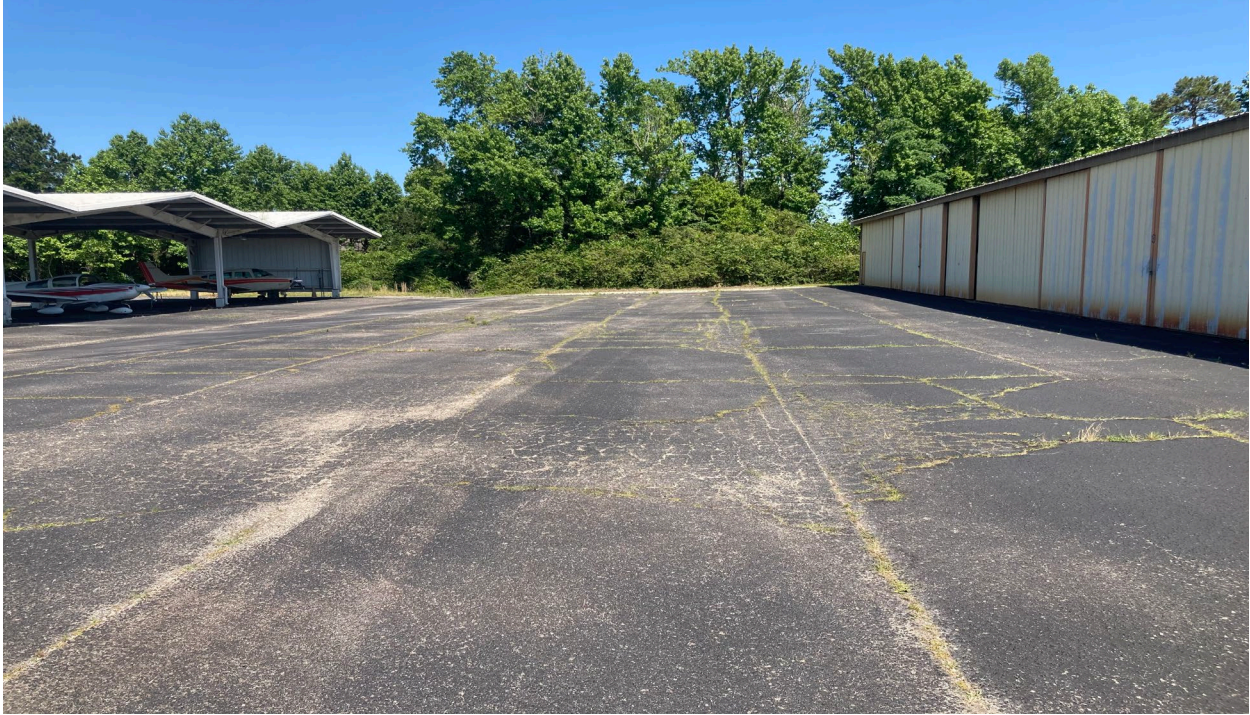
Photo #11 – West Apron Vegetation Growth

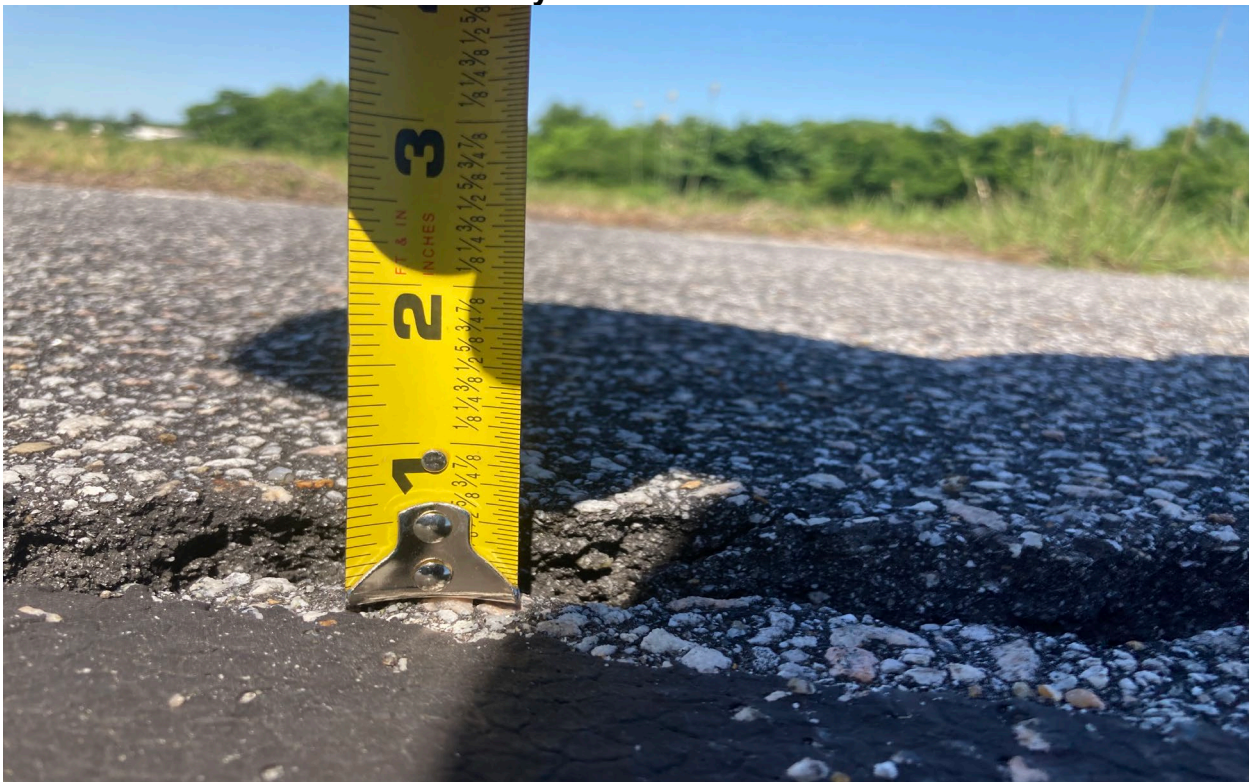
Photo #12 – Taxiway A Pavement Surface Variation

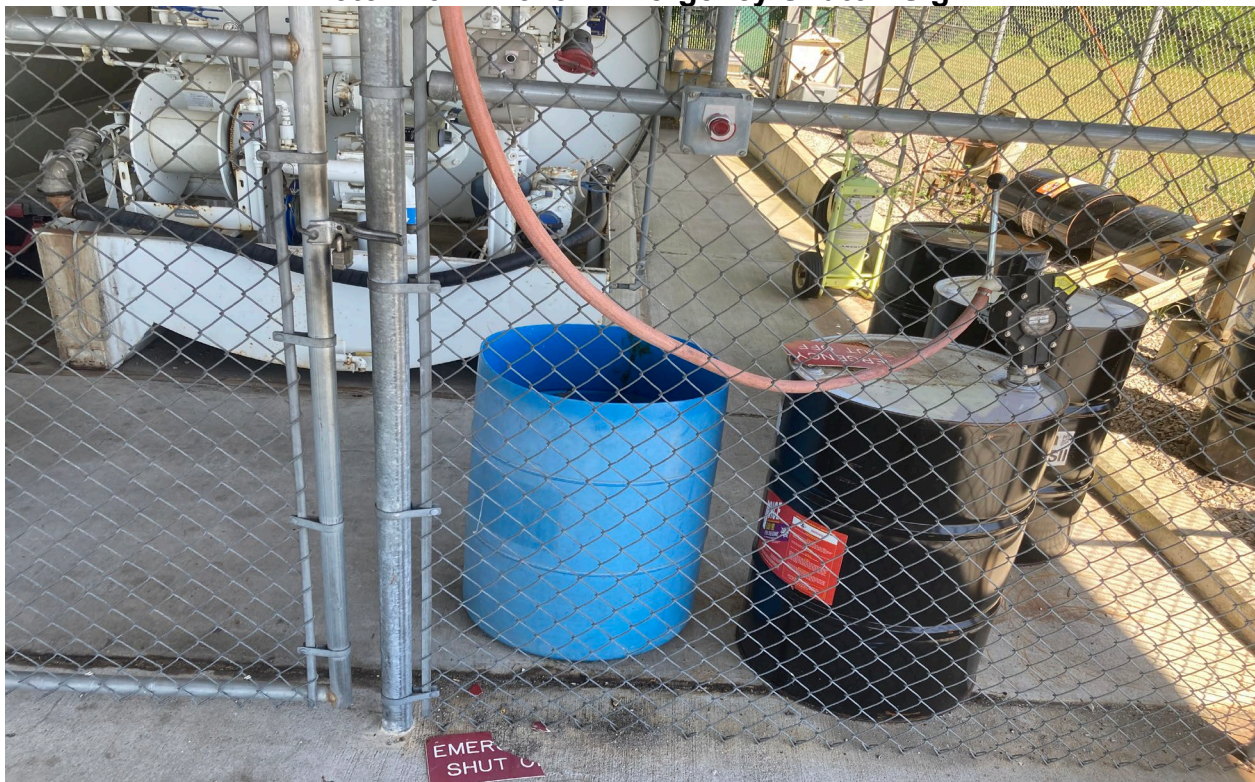
- The fueling area meets the requirements established by the Alabama Department of Transportation; However, the State of Alabama Department of Agriculture and Industries may have additional requirements for fueling systems that were not considered during this inspection.
- The sign identifying the emergency fuel shutoff switch has been broken off (See Photo #13).

Photo #13 – Broken Emergency Shutoff Sign

- Replace signage for emergency fuel shutoff switch.

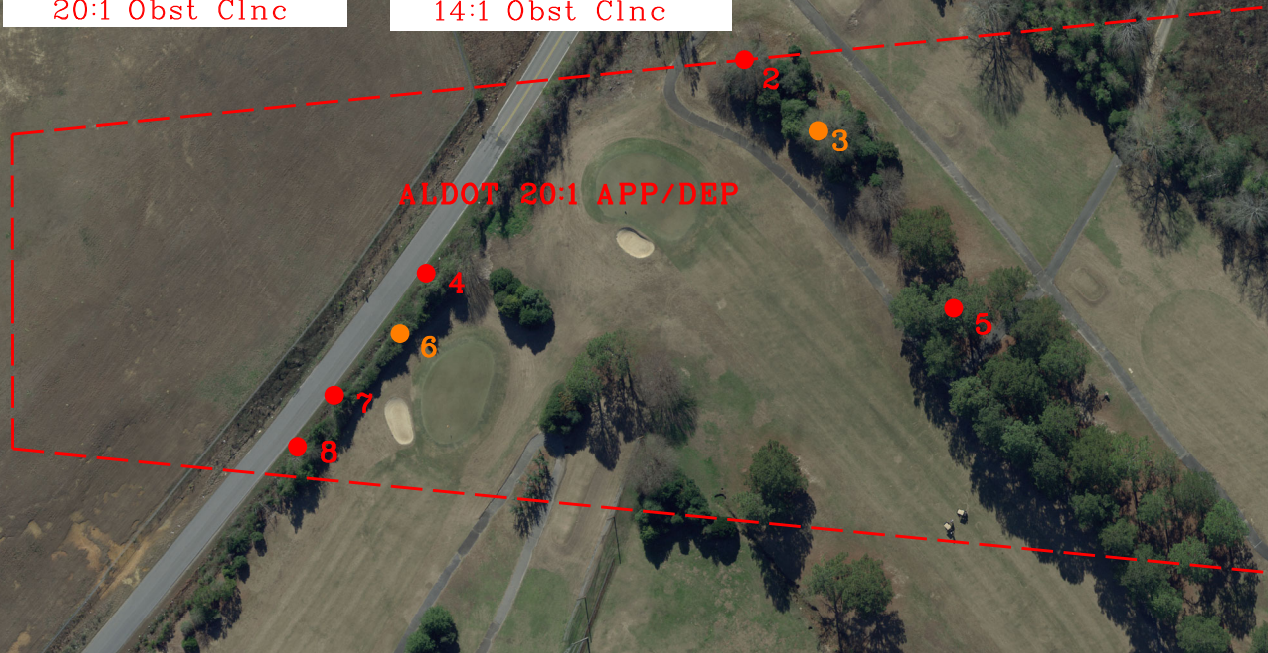
Auburn University Regional Airport
Auburn, AL.
Runway 11
Obstruction Evaluation
May 17, 2022

2. Tree 33' Abv. RWY
782' From RWY
183' Right of CL
17:1 Obst Clnc

4. Tree 20' Abv. RWY
529' From RWY
14' Right of CL
16:1 Obst Clnc

6. Tree 14' Abv. RWY
508' From RWY
26' Left of CL
22:1 Obst Clnc

8. Tree 17' Abv. RWY
426' From RWY
124' Left of CL
13:1 Obst Clnc

3. Tree 28' Abv. RWY
840' From RWY
127' Right of CL
23:1 Obst Clnc

5. Tree 37' Abv. RWY
948' From RWY
14' Left of CL
20:1 Obst Clnc

7. Tree 18' Abv. RWY
456' From RWY
83' Left of CL
14:1 Obst Clnc

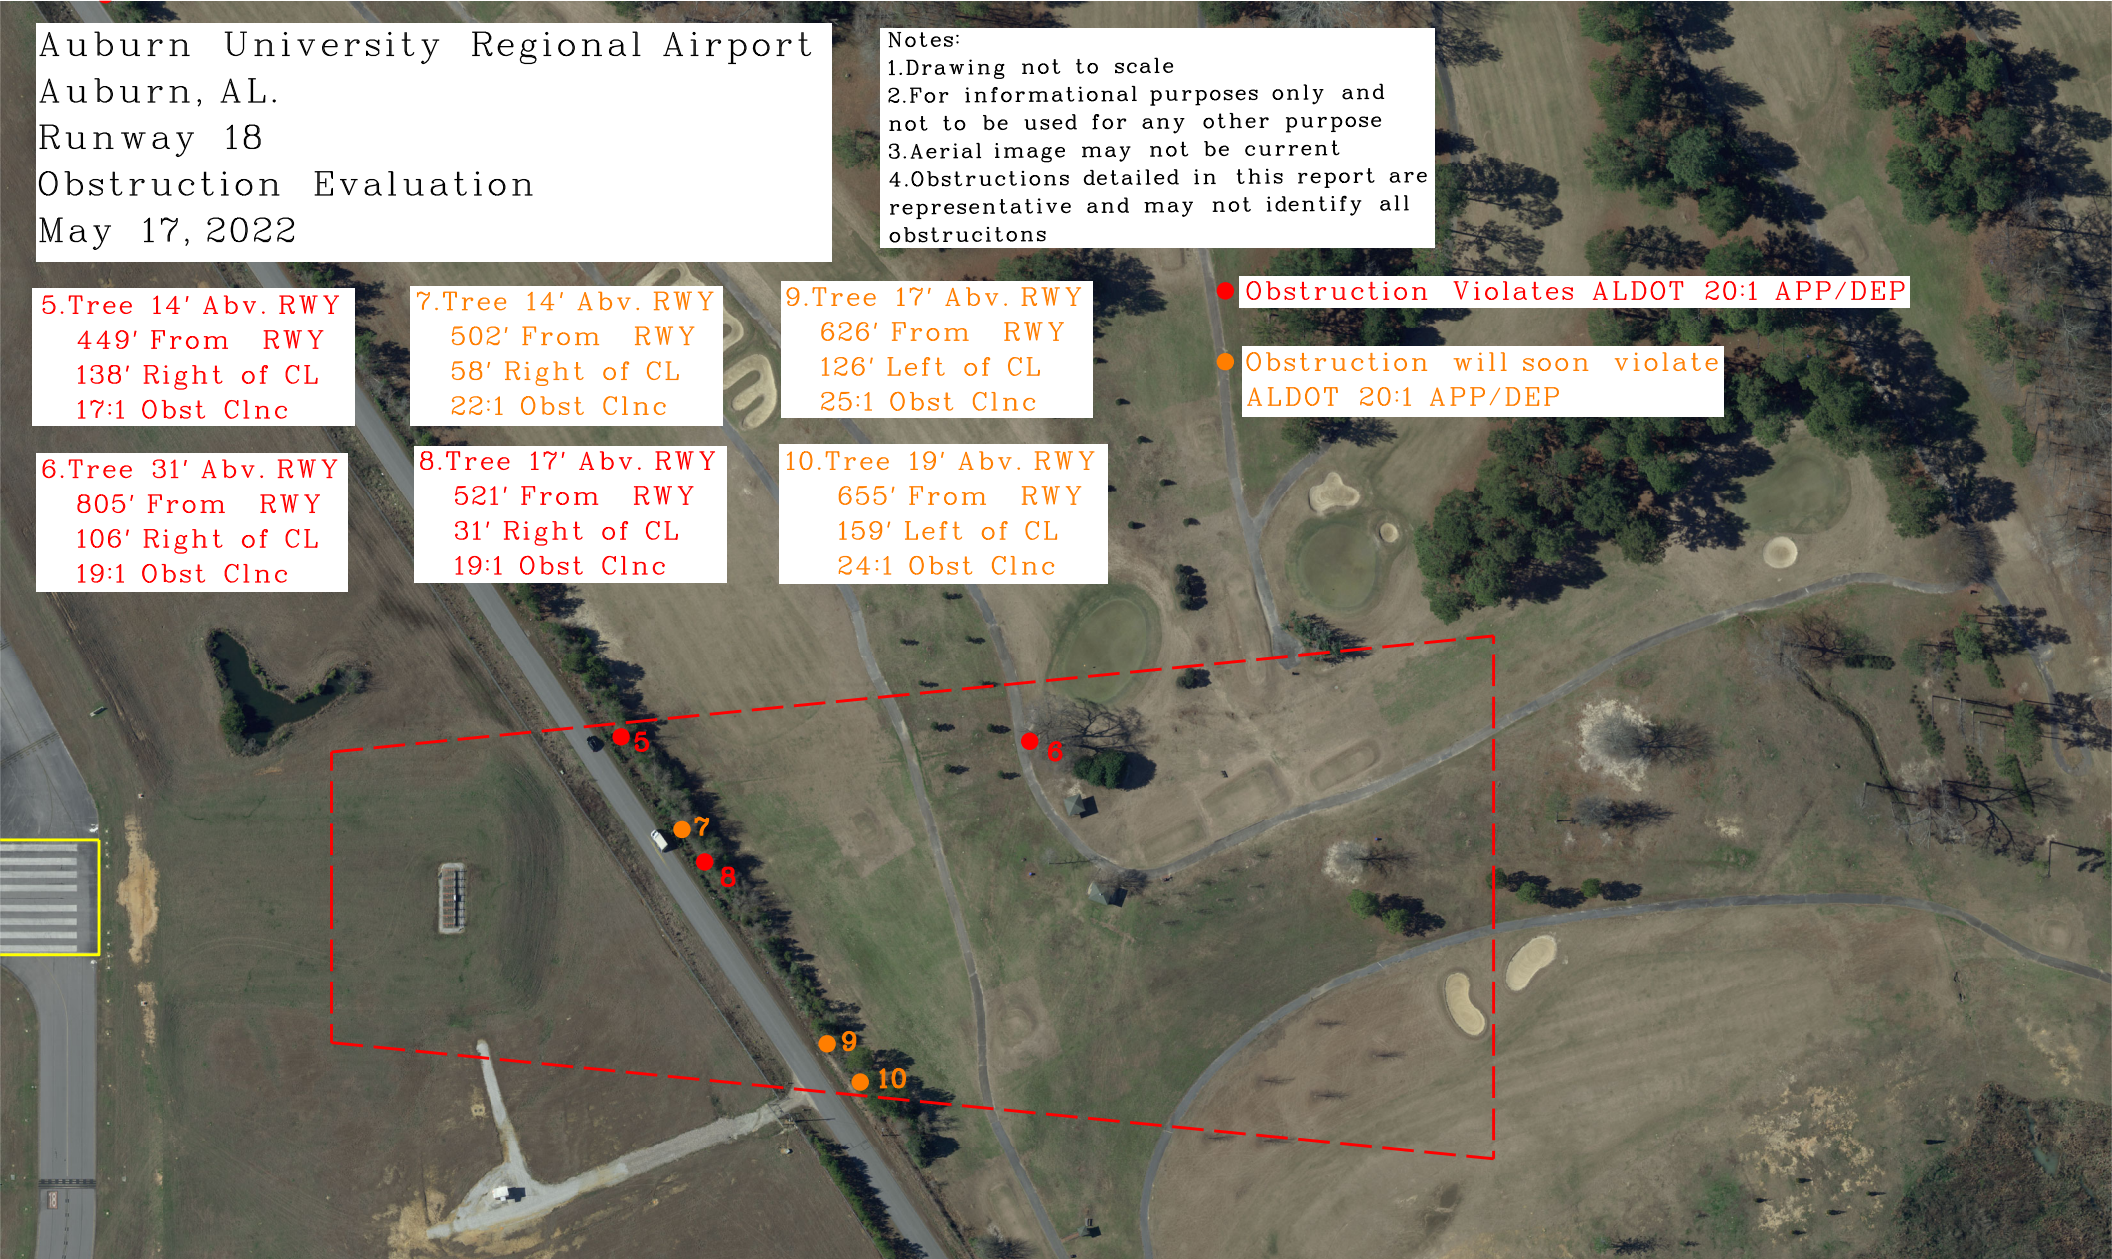
Auburn University Regional Airport
Auburn, AL.
Runway 18
Obstruction Evaluation
May 17, 2022

5.Tree 14' Abv. RWY
449' From RWY
138' Right of CL
17:1 Obst Clnc

7.Tree 14' Abv. RWY
502' From RWY
58' Right of CL
22:1 Obst Clnc

9.Tree 17' Abv. RWY
626' From RWY
126' Left of CL
25:1 Obst Clnc

6.Tree 31' Abv. RWY
805' From RWY
106' Right of CL
19:1 Obst Clnc

8.Tree 17' Abv. RWY
521' From RWY
31' Right of CL
19:1 Obst Clnc

10.Tree 19' Abv. RWY
655' From RWY
159' Left of CL
24:1 Obst Clnc
