Annual Inspection Report Bibb County Airport (0A8)

Annual Inspection Report July 19, 2019

Bibb County Airport (0A8) Centreville, Alabama

July 19, 2019

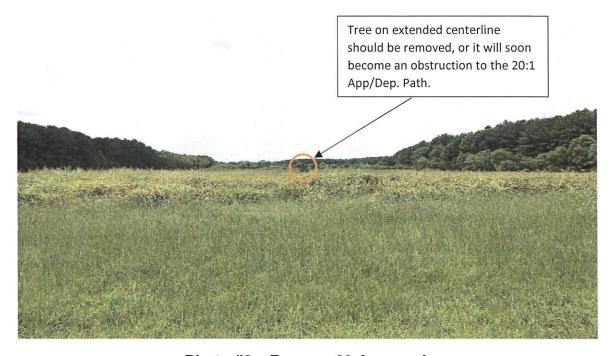
Photo #1 - Runway 10 Approach

- ➤ Runway 10 No obstructions, however, there is a tree that will soon become an obstruction to the ALDOT 20:1 App/Dep. Path. (See Photo #1).
- ➤ Runway 28 **VIOLATION.** The trees identified as #3, #4, and #6, along with their associated tree groups are obstructing the 20:1 Approach and Departure Path (See Photo #2 and Appendix #2). The tree line behind the fence should be removed to prevent further obstructions.

➤ Remove all obstructions to the Approach and Departure Path. The obstructions detailed in this report are representative and may not include all obstructions in the approach and departure path. The vegetation behind the fence line should be removed to prevent further obstructions.

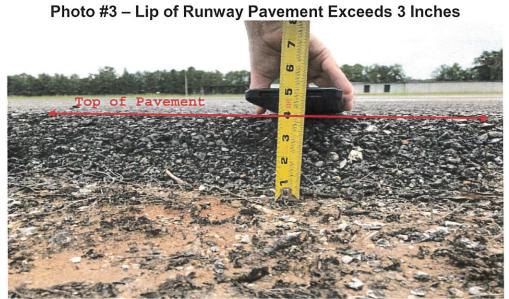
- The runway safety area does not meet state licensing requirements, as there are areas where the lip of the pavement exceed the 3-inch limit (See Photo #3).
- ➤ Harsh erosion was observed all throughout the Runway Safety Area (See Photo #4).
- ➤ Tall grass is obstructing runway lighting and is posing a hazard in the Safety Area (See Photo #5).

- ➤ Bring grade up in Runway Safety Area so that lip of pavement does not exceed 3-inch limitation.
- Arrest erosion.
- Mow grass.

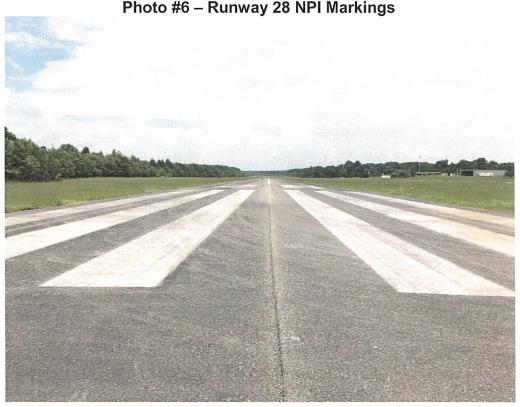
Photo #6 - Runway 28 NPI Markings

The airport markings are in **FAIR** condition (See Photo #6).

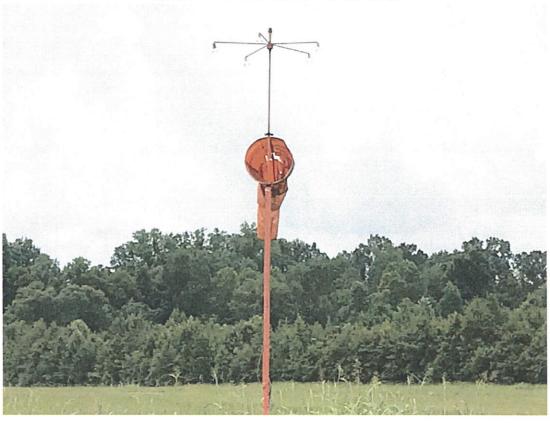
Photo #7 – Wind Direction Indicator

> The wind direction indicator (wind cone) is in POOR condition, being torn and faded (See Photo #7). Lights were operational.

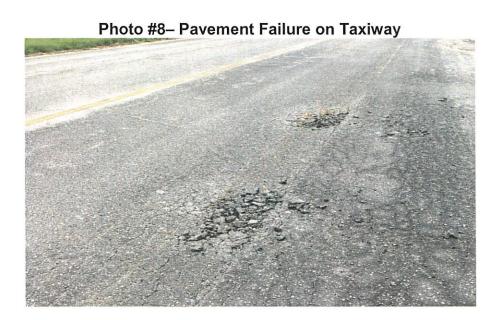
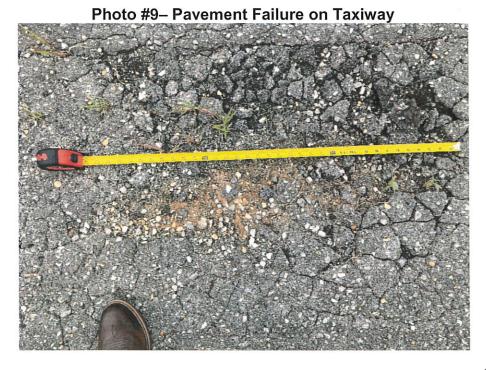
Ramp	FAIR. Cracking is visible, with vegetation appearing through the cracks. Examples of raveling and flushing can also be seen at various locations on the ramp.
Taxiways	POOR. Pavement failure is visible at various locations on the taxiway. Foreign object debris (FOD) is visible at most locations. (See Photos #8 & #9). Water retention areas are also visible.
Runway	FAIR. Minor cracking visible.

➤ It is highly recommended that the taxiway be closed to all aircraft operations until safety violations have been corrected. The airport should proceed with planned pavement maintenance but should contact airport engineer promptly to plan pavement rehabilitation on the taxiway.

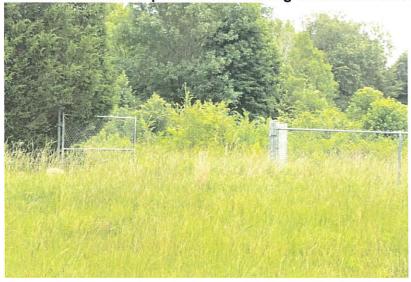
➤ An open, unsecured gate was observed on airport perimeter fence near the approach end of Runway 28 with tire tracks in the grass (See Photo #10).

- Keep gates closed and secured when not actively being used.
- > Ensure that no unauthorized access is being allowed.
