**Subject: Annual Inspection Report
Floralia Municipal Airport**

ANNUAL INSPECTION REPORT

February 10, 2022

**FLORALA MUNICIPAL AIRPORT (0J4)
FLORALA, ALABAMA**

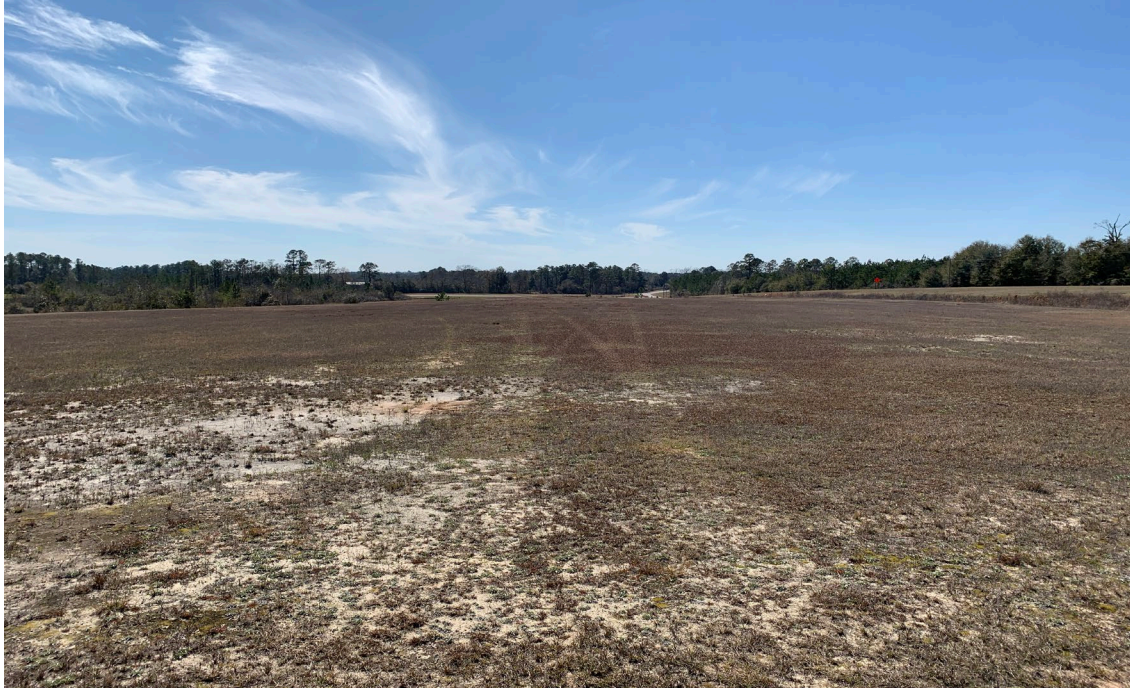
Photo # 1 – Runway 4

- Runway 4: No obstructions (See Photo #1)
- Runway 22: Tree identified as Tree #2 violates the Required ALDOT 20:1 Approach/Departure Path (See Photo #2 and Appendix 2)

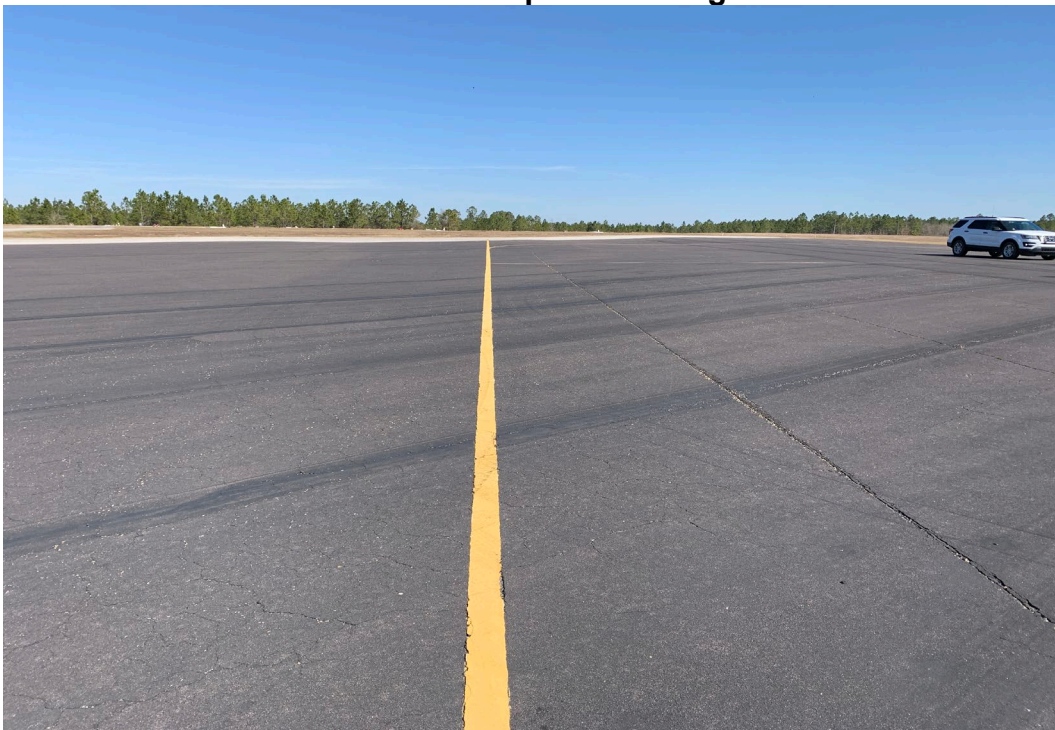
Photo # 3 – Apron Markings

- Apron and taxiway markings are in **GOOD** to **FAIR** condition, with some markings in **POOR** condition (See Photos #3 and #4).
- Runway markings are in **GOOD** condition; however they are beginning to become slightly obscured (See Photo #5)

- Clean taxiway and ramp markings that are in poor condition. If unable to clean, re-mark in accordance of FAA AC 150/5340-1M.

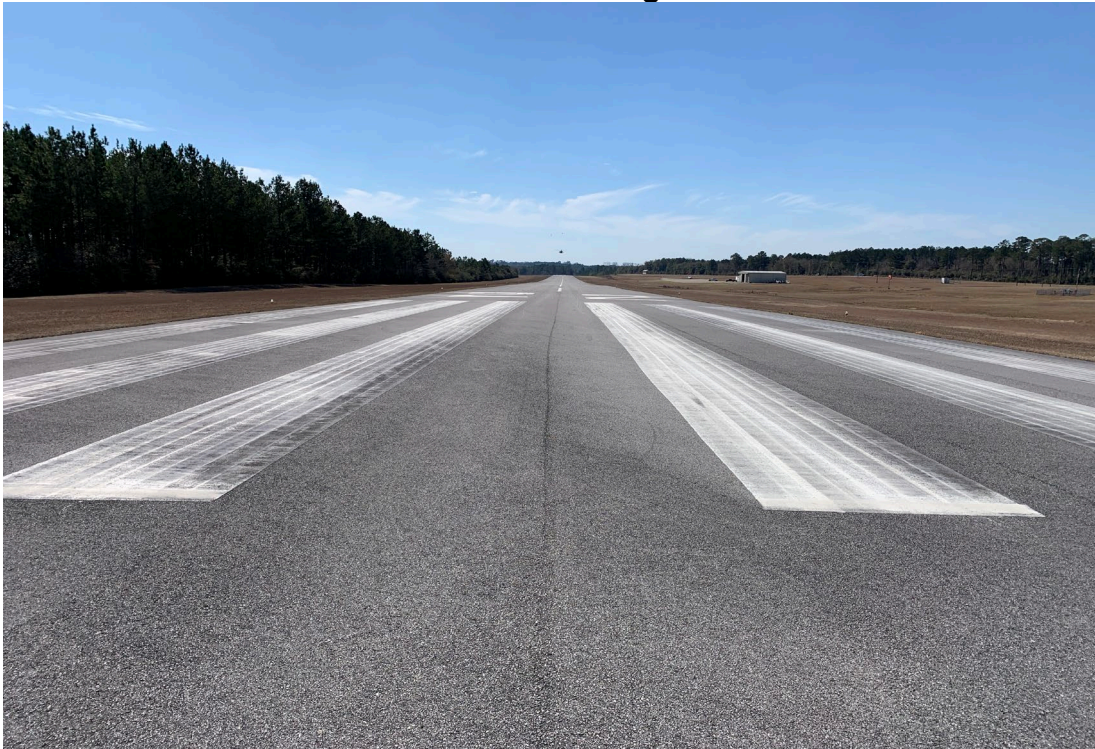
Photo # 5 – NPI Markings RWY 22

- The runway surface is in **GOOD** condition (See Photo #5).
- The apron surfaces are in mostly **FAIR** condition, with some areas in **POOR** condition and sections of the cold refueling area even experiencing total pavement **FAILURE** due to helicopter skid damage (See Photos #7, #8, and #9).
- Concrete hot-refueling apron is in **POOR** condition with area of **FAILURE**. Surface contains multiple slab cracks, spalling, and shattered slabs (See Photos #10, #11, and #12).

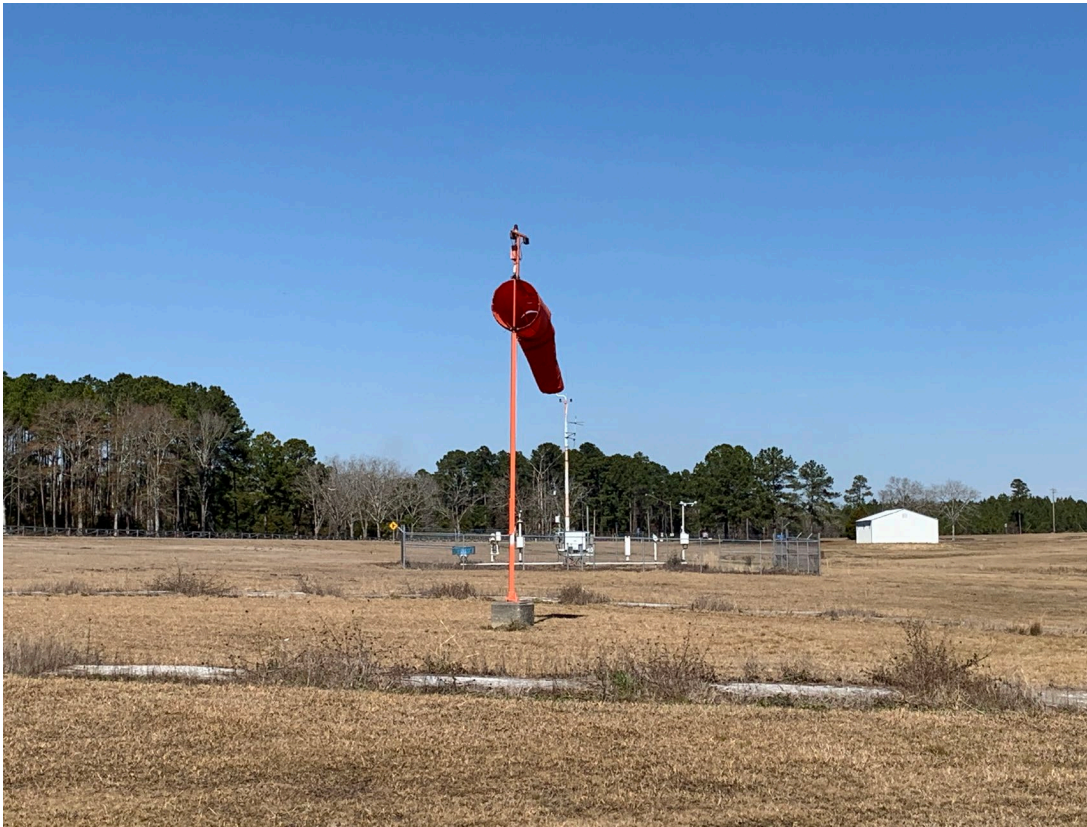
Photo # 6 – Wind Cone

- The wind direction indicator is torn.
- The segmented circle is faded and not being maintained (See Photo # 6).

- Replace wind direction indicator.
- Remove vegetation and paint segmented circle white. The segmented circle should be maintained to be clearly visible from the air.

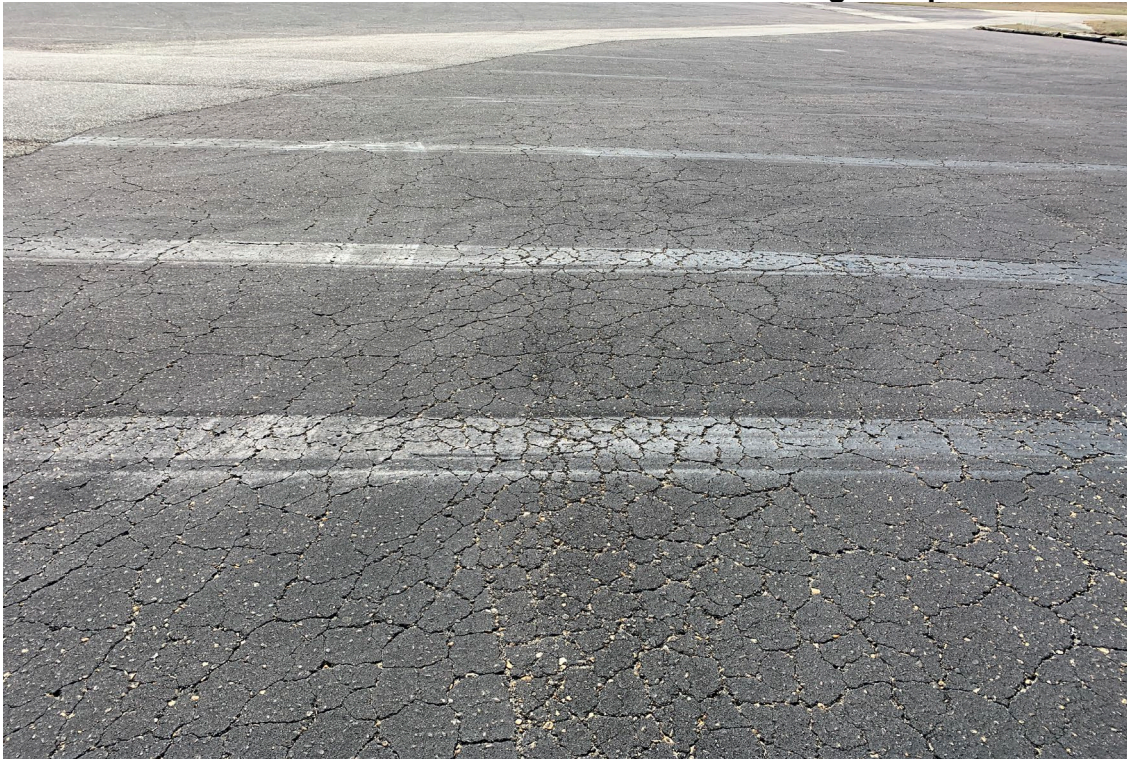
Photo # 7 — Extensive Micro-Surface Cracking on Apron

- Airport should plan a pavement rehabilitation project for the aprons and maintain airport pavement surfaces.
- It should be noted that the sections of failure on the cold refueling area present a high Foreign Object Debris/Damage (FOD) risk due to large, loose pieces of pavement and subgrade.
- The hot-refueling apron is being kept clean and there is very little FOD present there.

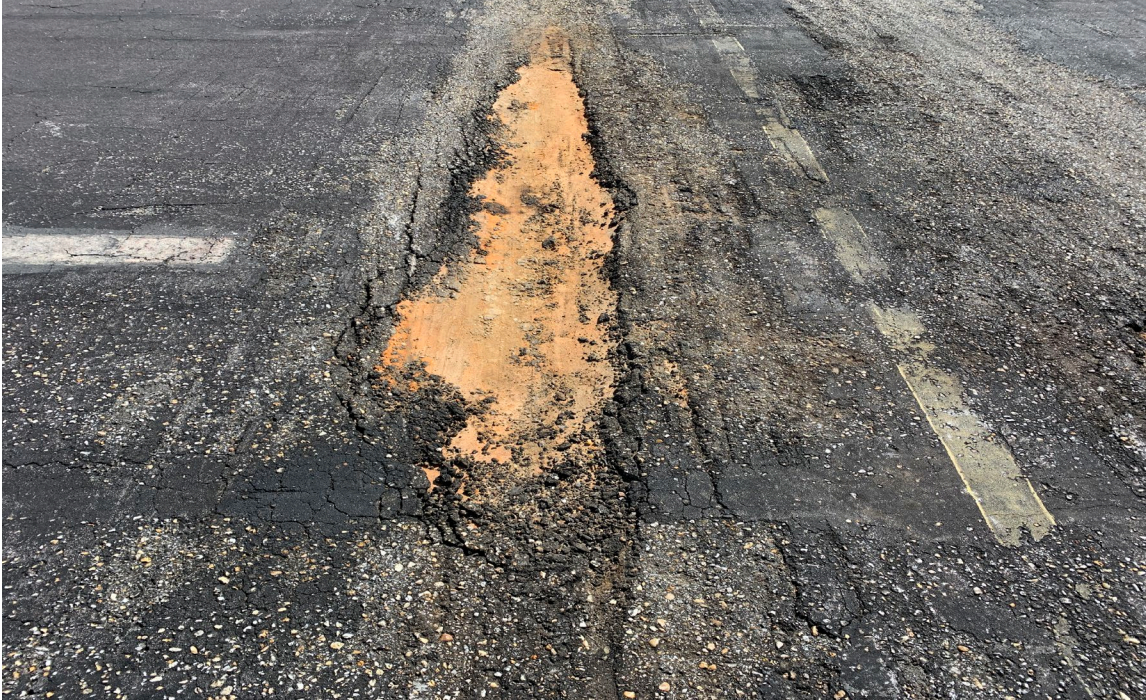
Photo # 8 – Severe Skid Damage (Failure) on Apron

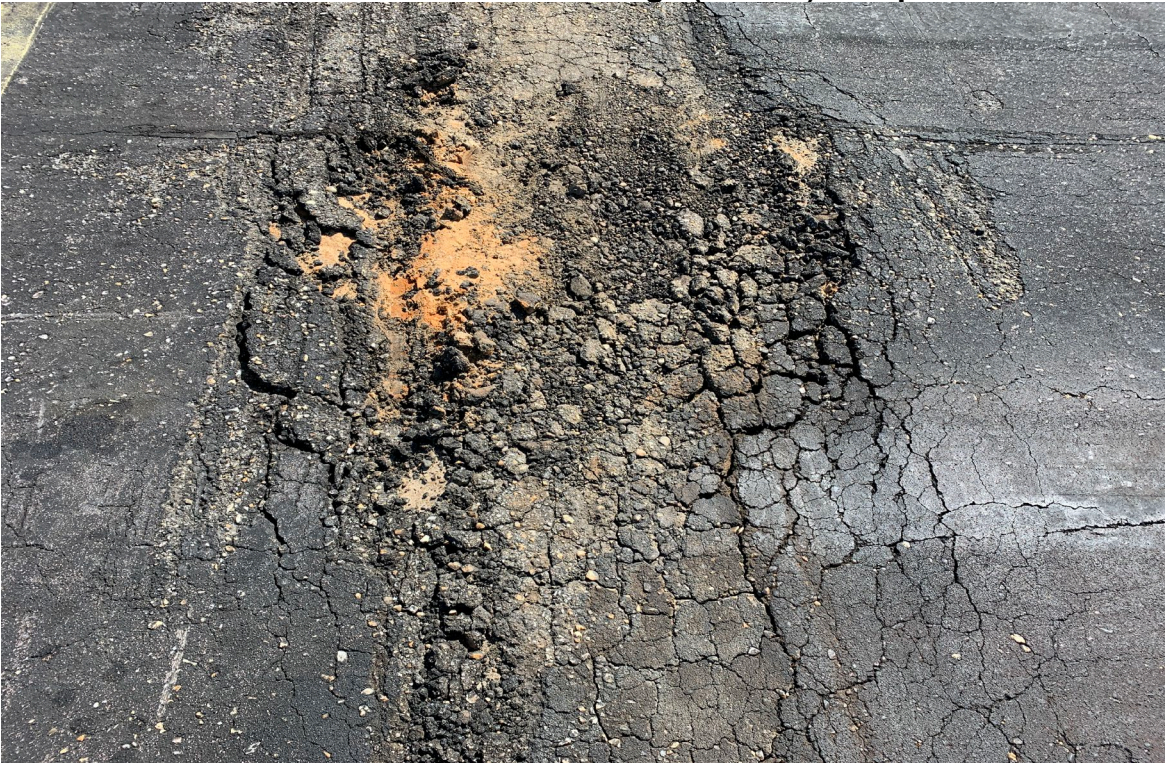
Photo # 9 – Severe Skid Damage (Failure) on Apron

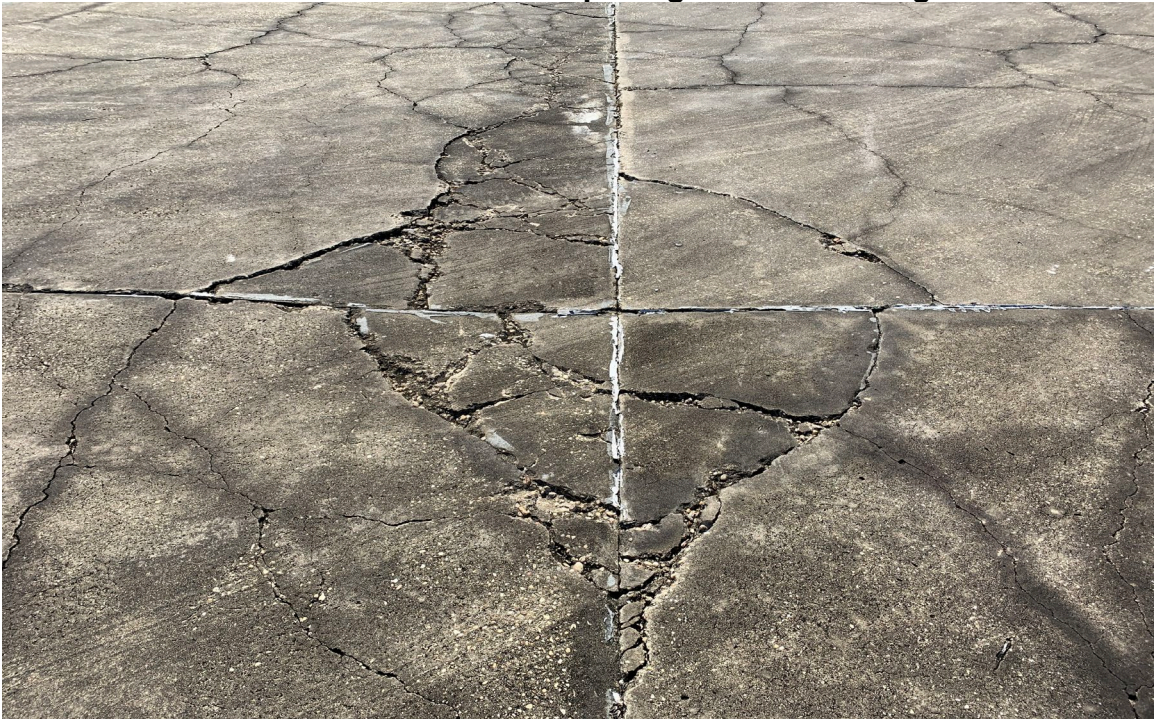
Photo # 11 – Severe Concrete Spalling and D-Cracking at Joint

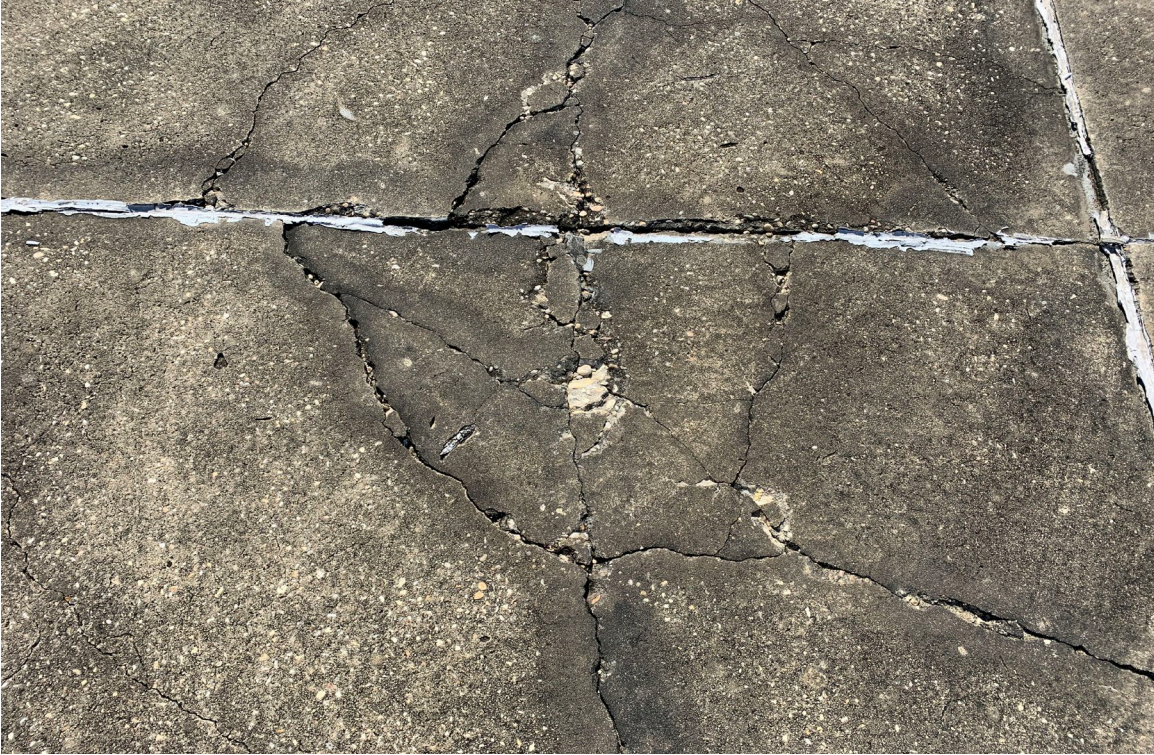
Photo # 12 – Concrete Spalling

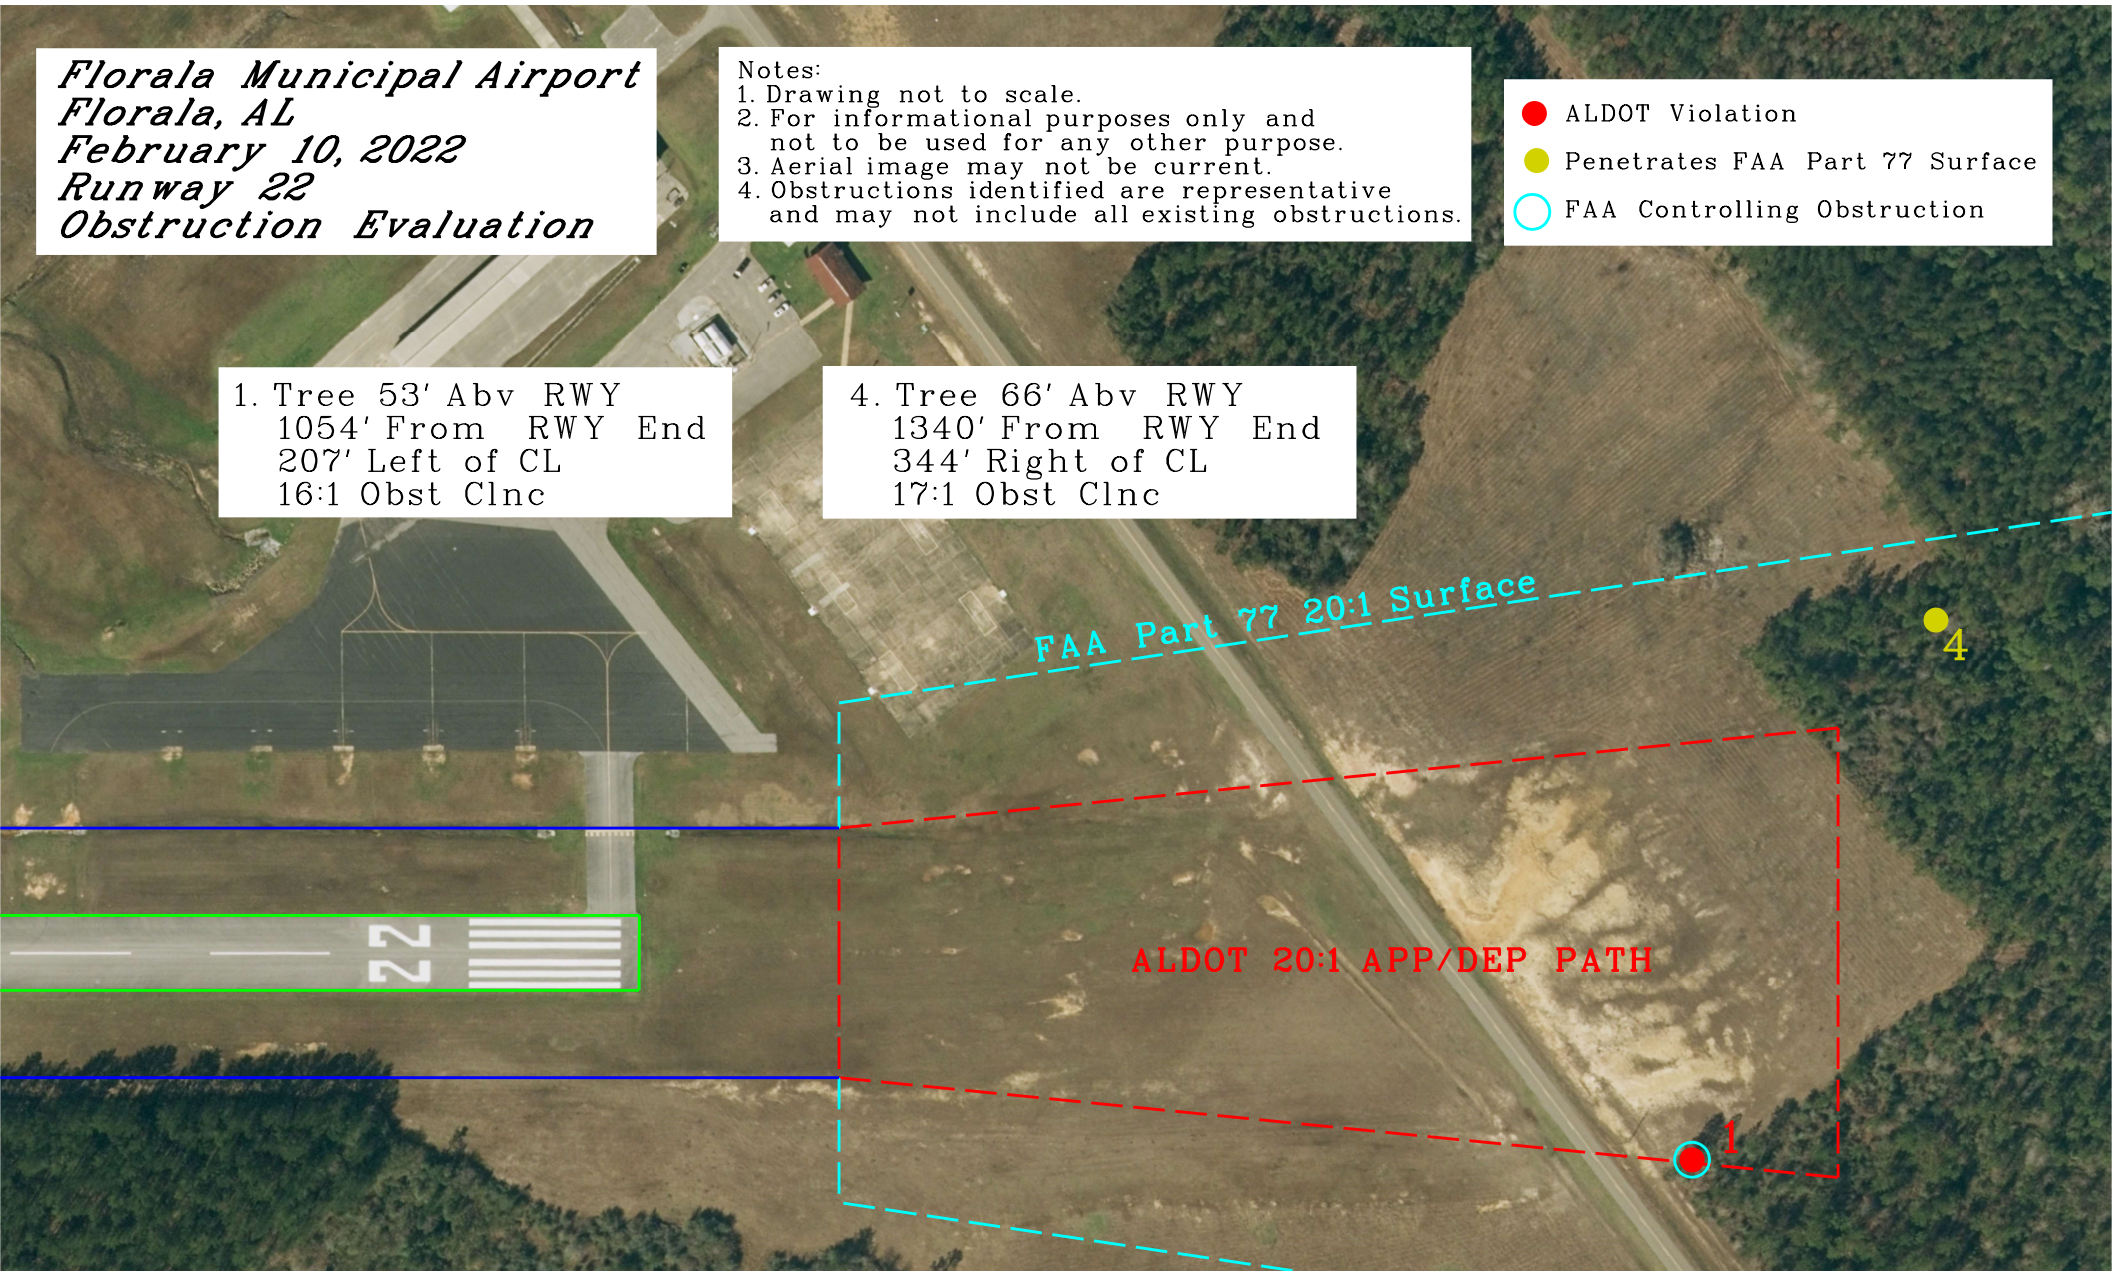
*Floralia Municipal Airport
Floralia, AL
February 10, 2022
Runway 22
Obstruction Evaluation*

1. Tree 53' Abv RWY
1054' From RWY End
207' Left of CL
16:1 Obst Clnc

4. Tree 66' Abv RWY
1340' From RWY End
344' Right of CL
17:1 Obst Clnc

- Remove all obstructions to the Required ALDOT 20:1 Approach/Departure Path.
- *Note: obstructions identified in this report are representative and may not include all existing obstruction violations.*
