**Subject: Annual Inspection Report
Northeast Alabama Regional Airport (GAD)**

**NORTHEAST ALABAMA REGIONAL AIRPORT
GADSDEN, ALABAMA**

Alabama Department of Transportation Aeronautics Bureau—Annual Airport Inspection Report

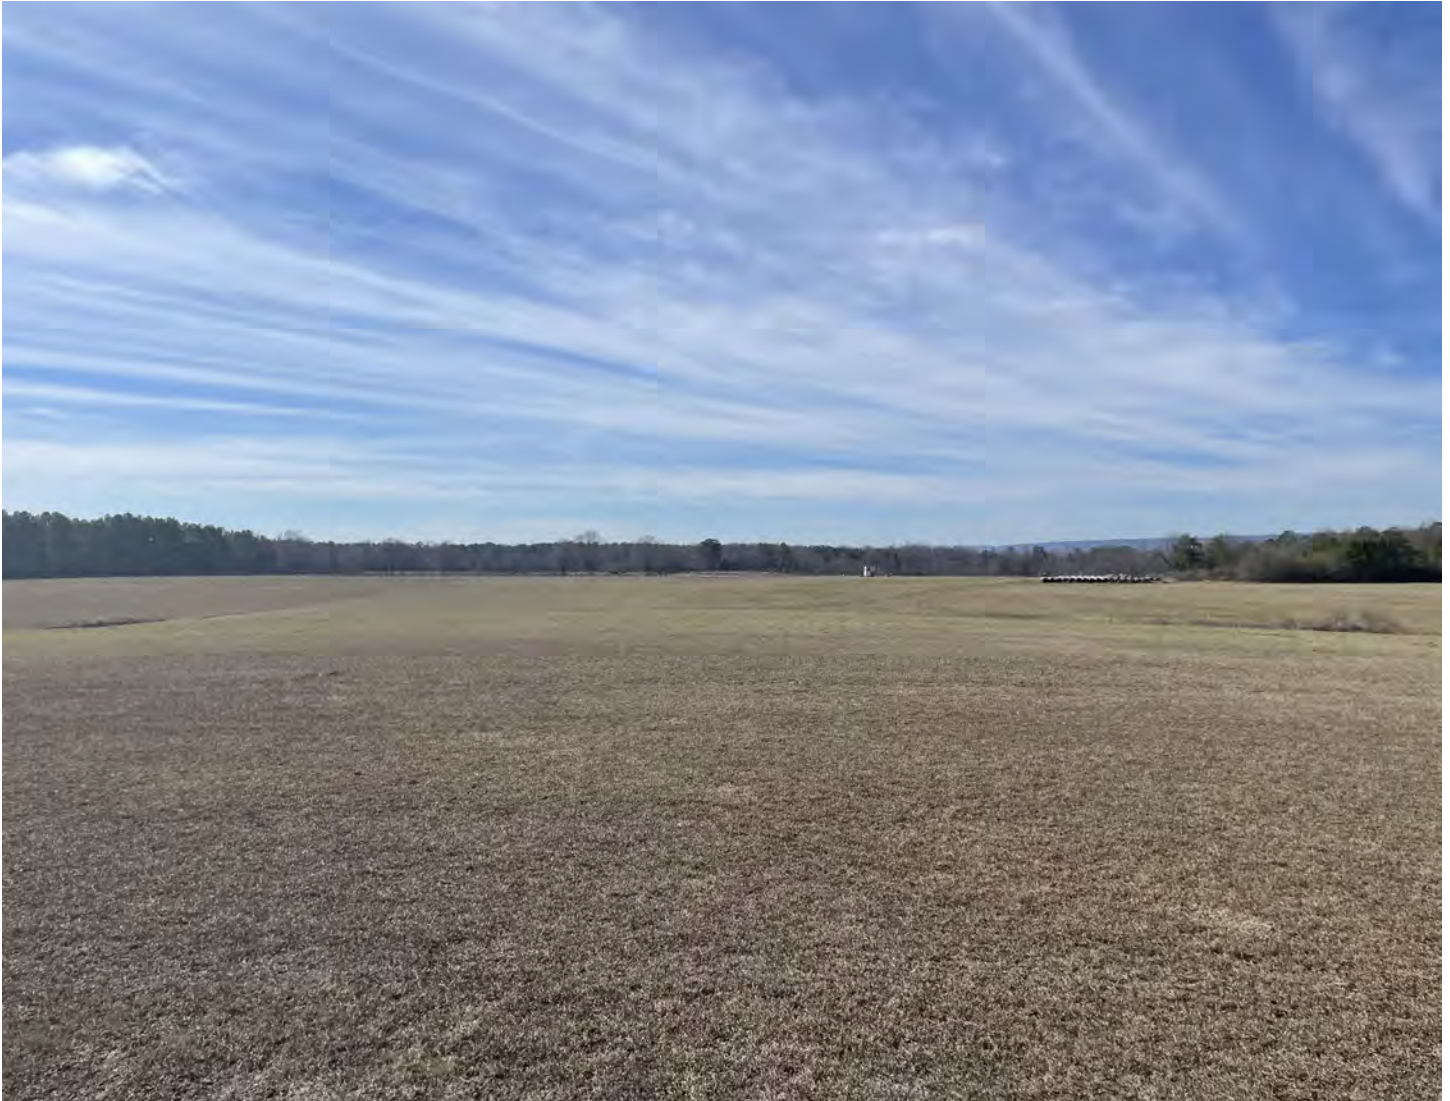
Approach and Departure Paths—Runway 6

MAINTENANCE: There were no obstructions in the ALDOT Approach/Departure Path of Runway 6. However, there are **two** trees that penetrate the FAA Part 77 34:1 Surface. **Please see Appendix #2.**

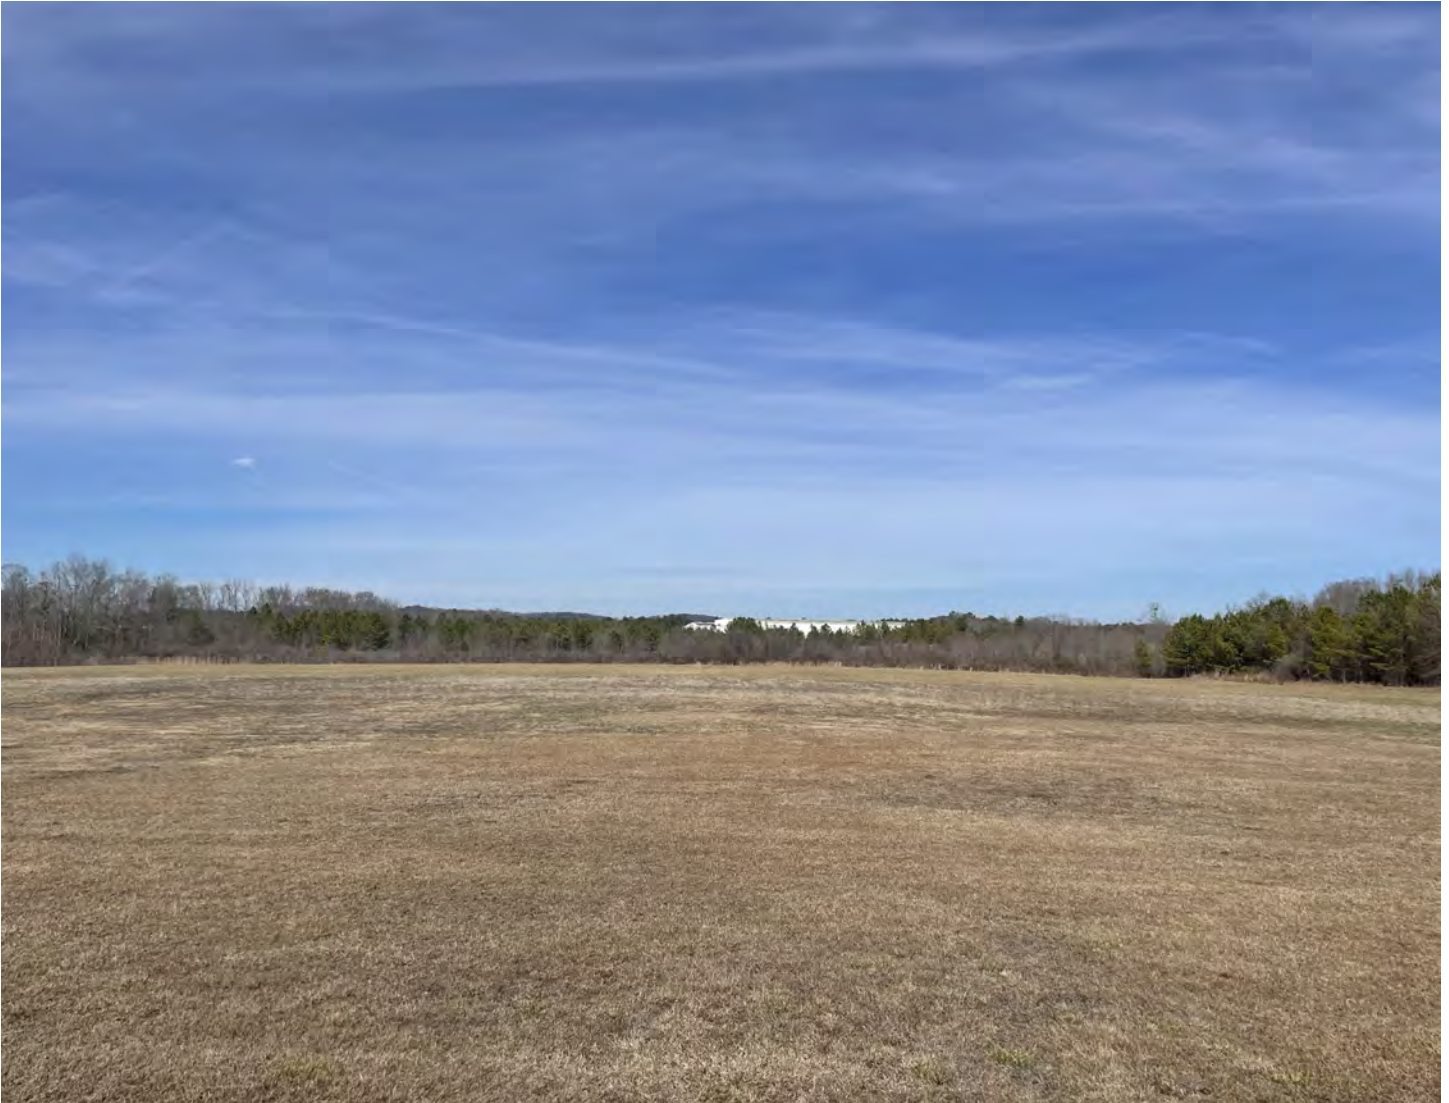
Approach and Departure Paths—Runway 18

MAINTENANCE: There were no obstructions in the ALDOT Approach/Departure Path of Runway 18. However, there are **four** trees that penetrate the FAA Part 77 Surface. **Please see Appendix #3.**

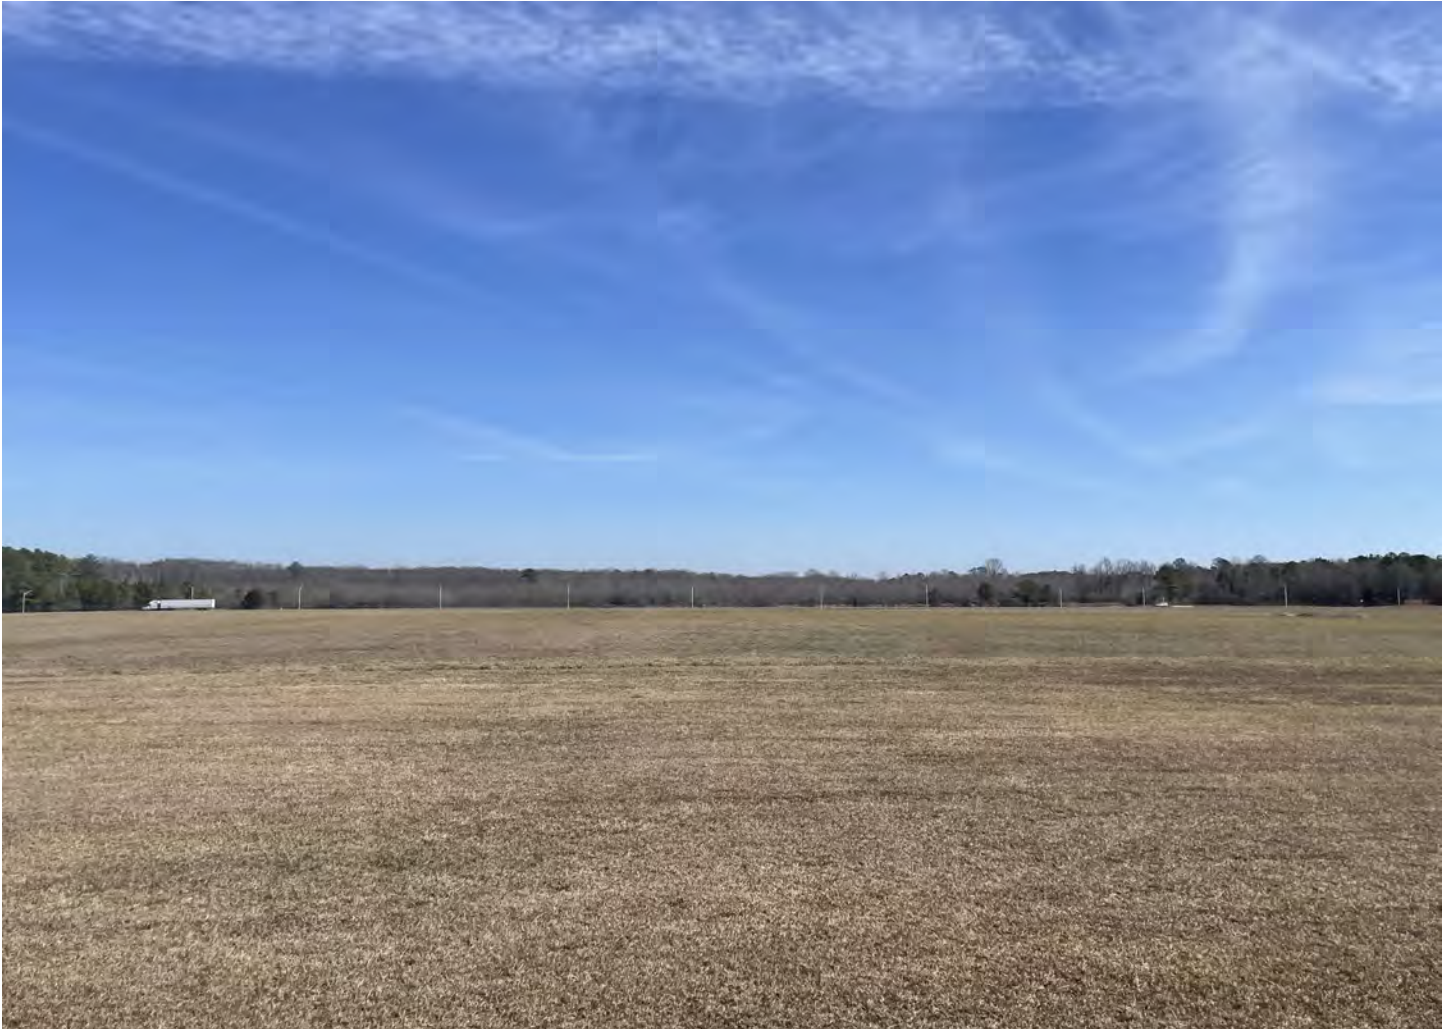
Approach and Departure Paths—Runway 24

MAINTENANCE: There were no obstructions in the ALDOT Approach/Departure Path of Runway 24. However, there is **one** tree that penetrates the FAA Part 77 Surface. **Please see Appendix #4.**

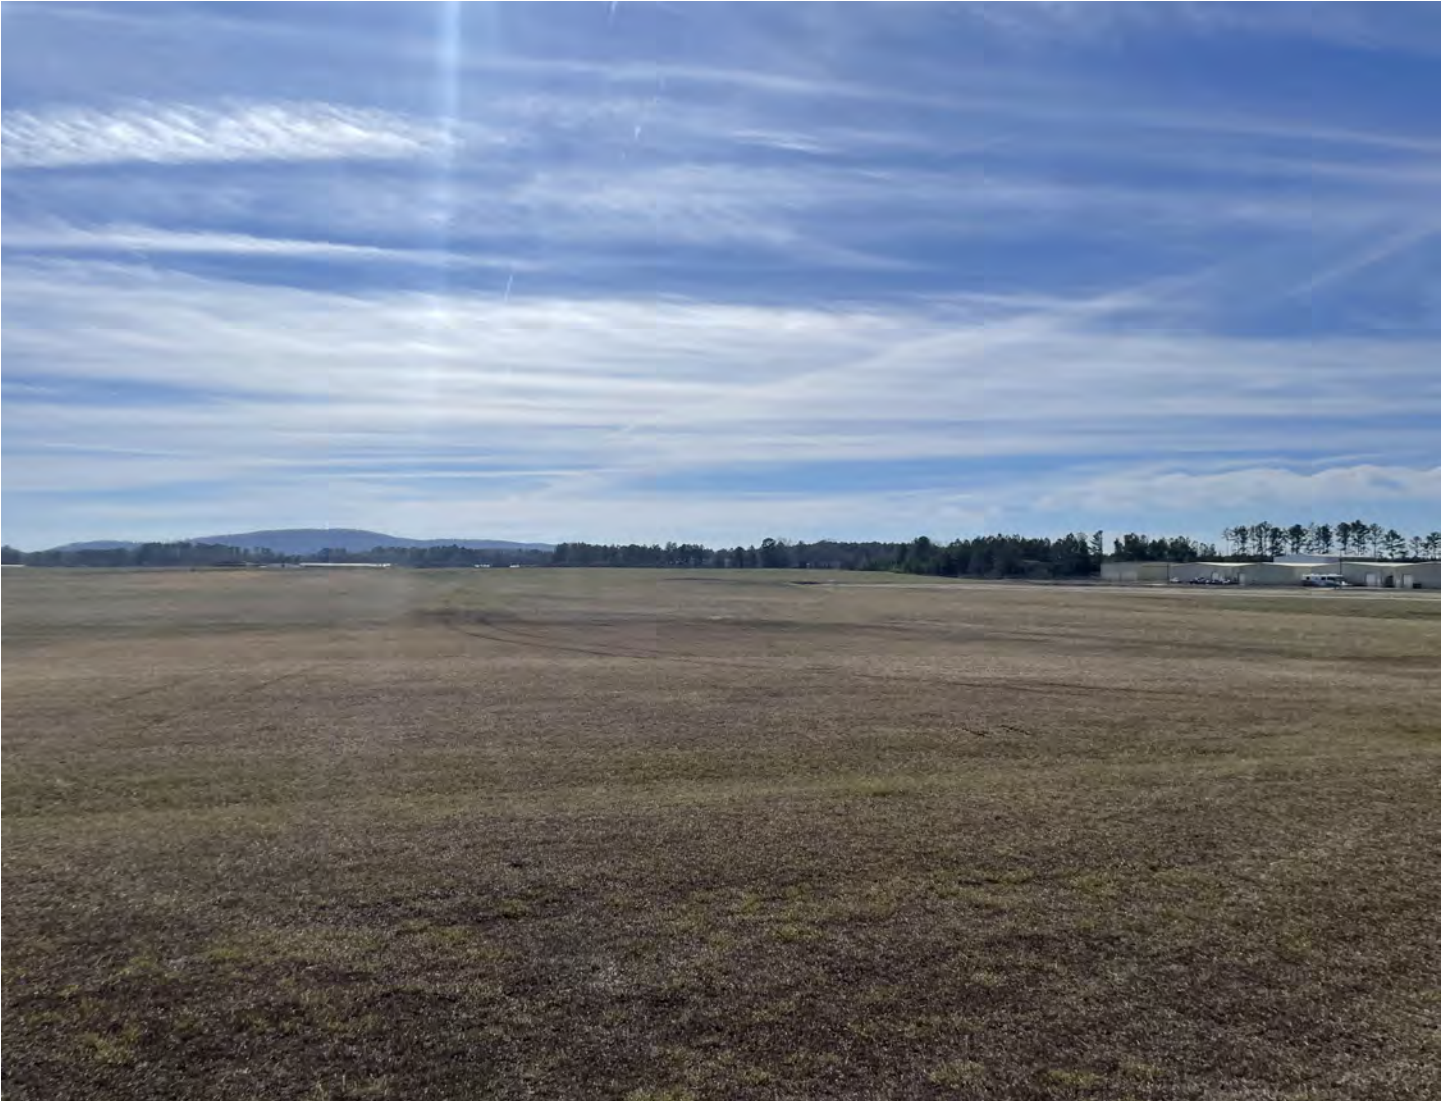
Approach and Departure Paths—Runway 36

MAINTENANCE: There were no obstructions in the ALDOT Approach/Departure Path of Runway 36. However, there is **one** tree that penetrates the FAA Part 77 Surface. **Please see Appendix #5.**

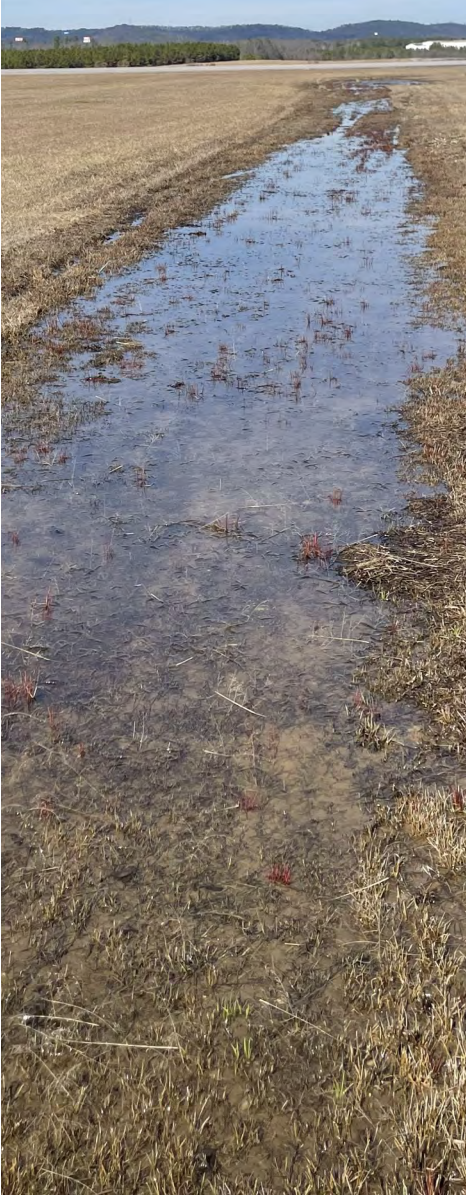
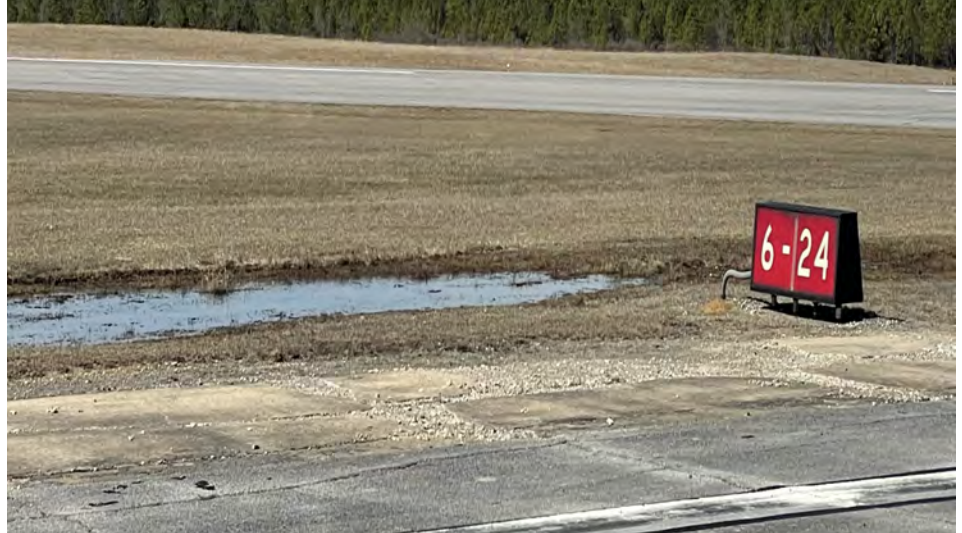
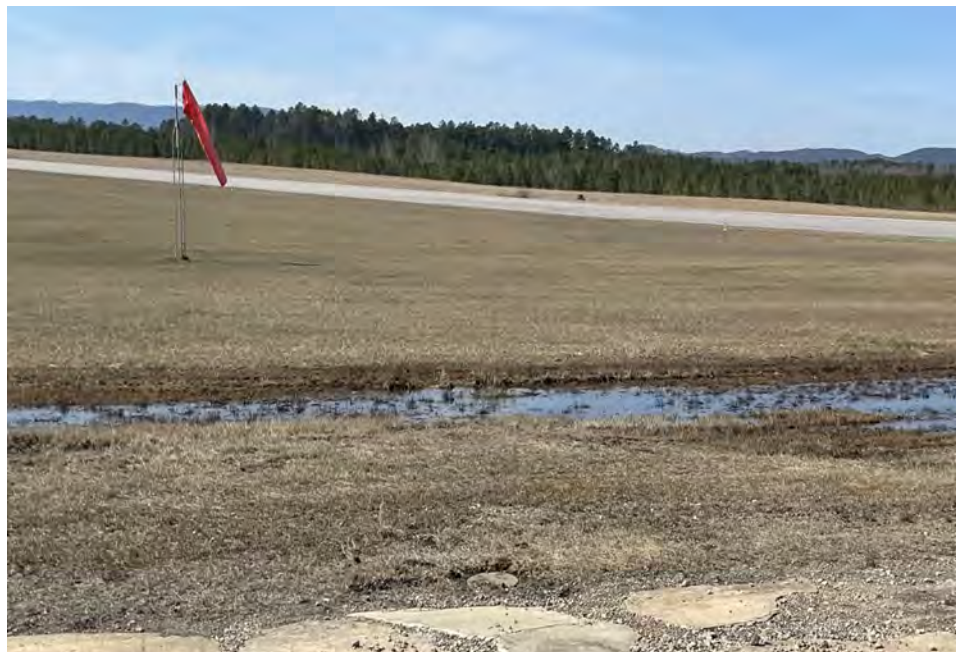
MAINTENANCE: Primary Surface **MEETS** state licensing standards. There is ponding inside the Primary Surface west of Runway 36. Water is being retained and settling in areas where the ground is lower in elevation than the surrounding land. Please talk to your Airport Consultant about a possible project to improve the drainage in this area.

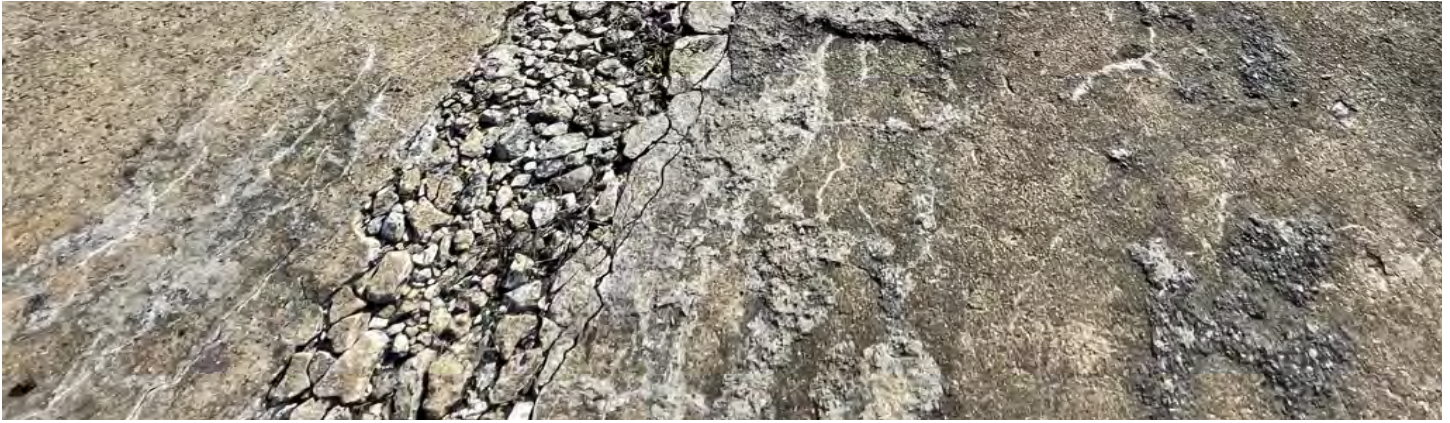
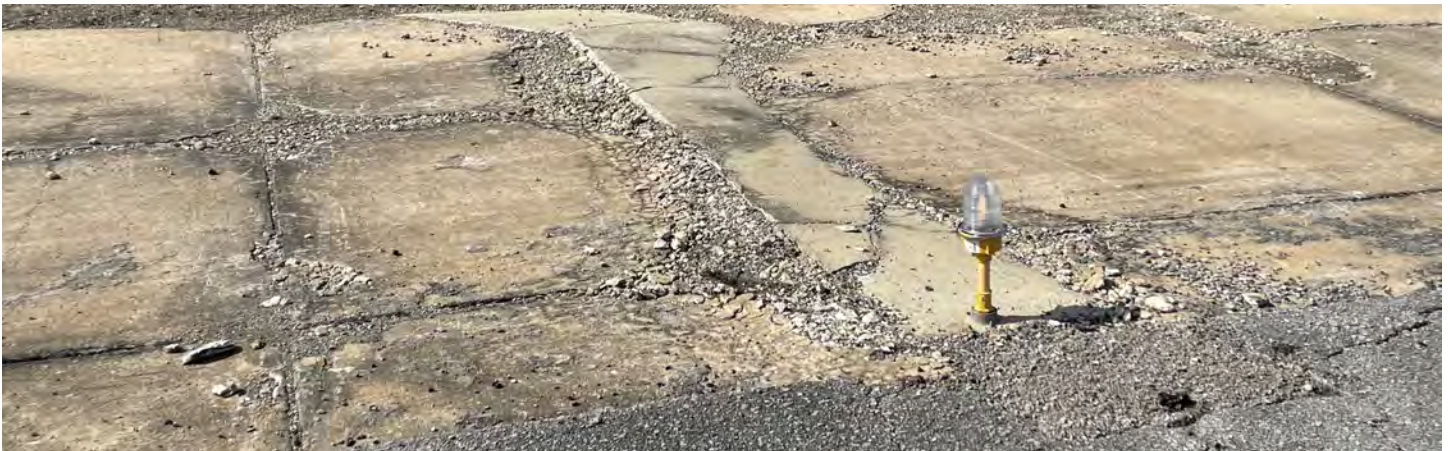
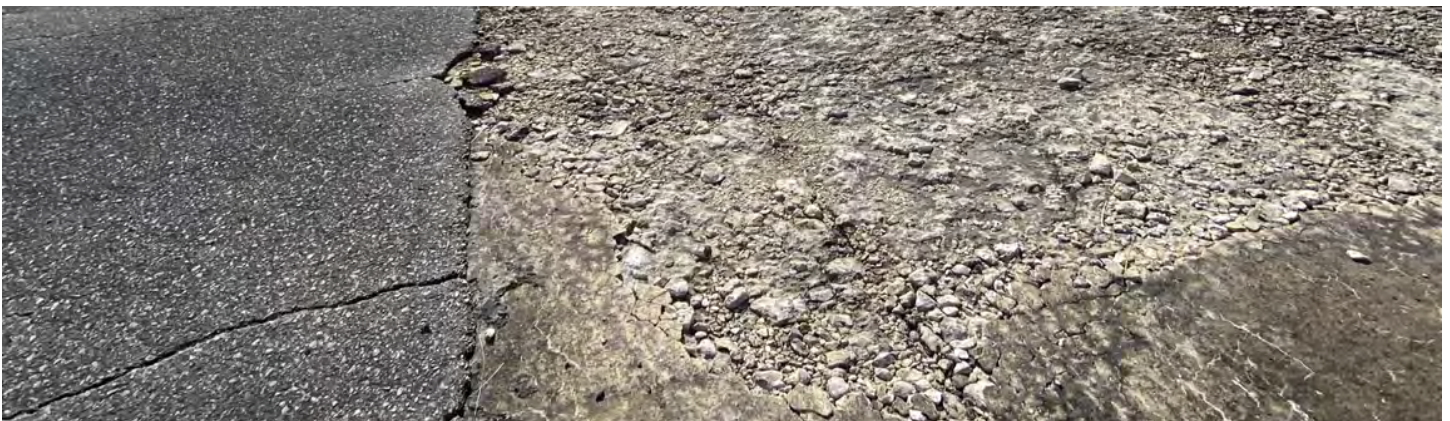
MAINTENANCE: Runway Safety Area **MEETS** state licensing standards. However, the edges of Runway 18/36 are severely cracked, generating large amounts of gravel and loose pavement. Please clear the Runway Safety Area of loose pavement fragments and gravel to mitigate the FOD hazard it presents.

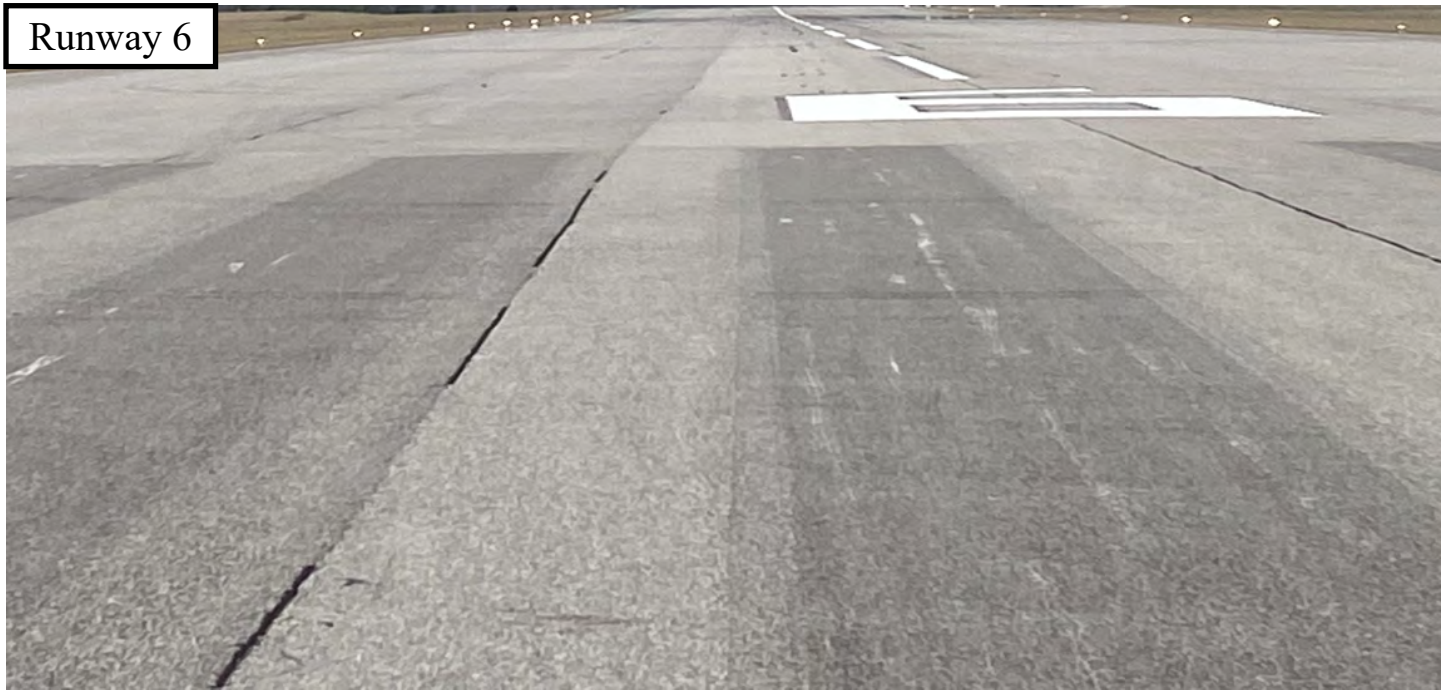
Runway 6

MAINTENANCE: Runway 6/24 identifier and centerline markings are in **GOOD** condition. However, Runway 6/24 threshold markings are in **POOR** condition. Please clean or repaint threshold markings.

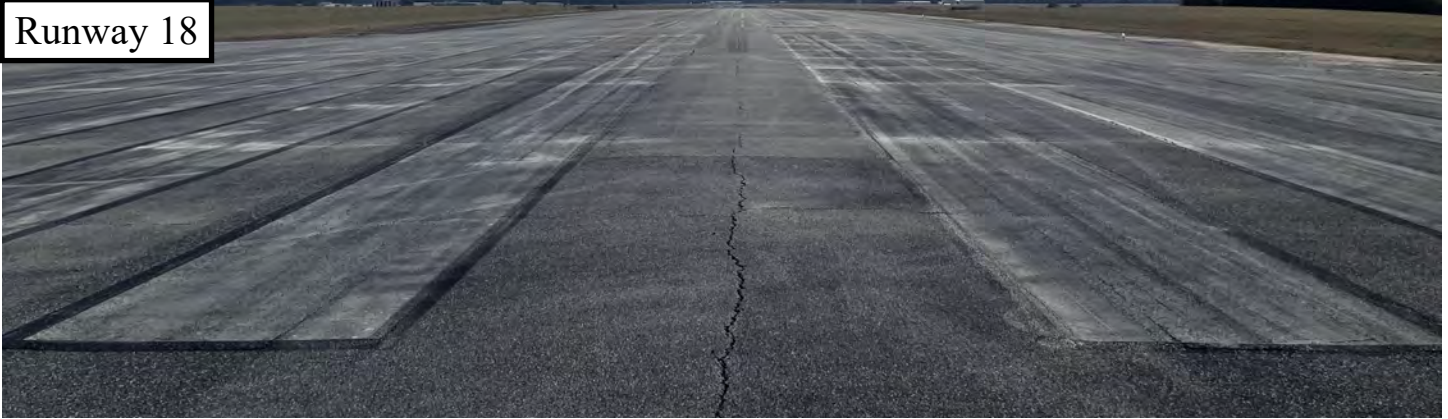
MAINTENANCE: Runway 18 identifier and threshold markings are in **POOR** condition. Runway 36 identifier and threshold markings are in **FAIR** condition. Runway 18/36 side stripe markings and centerline are in **FAIR** condition and slightly faded. Please clean faded markings or repaint markings if necessary.

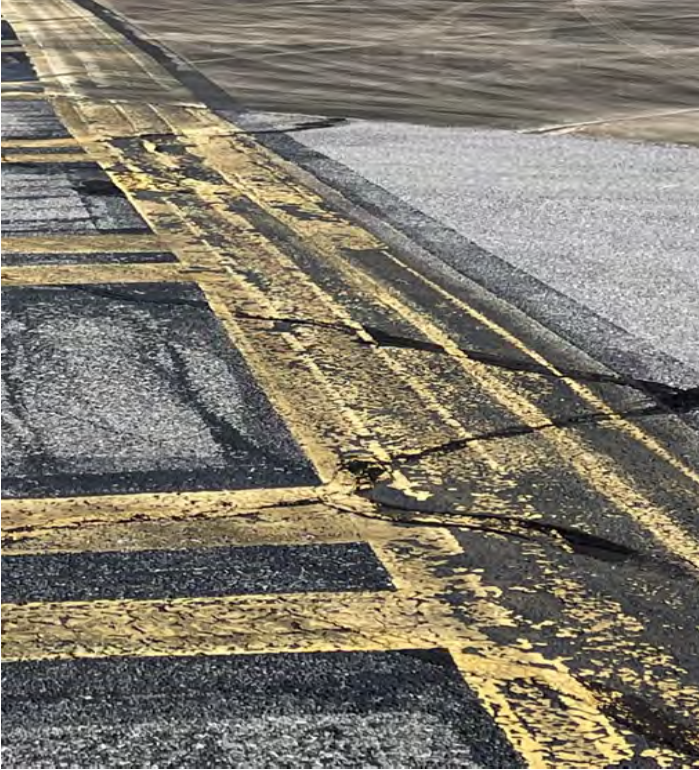
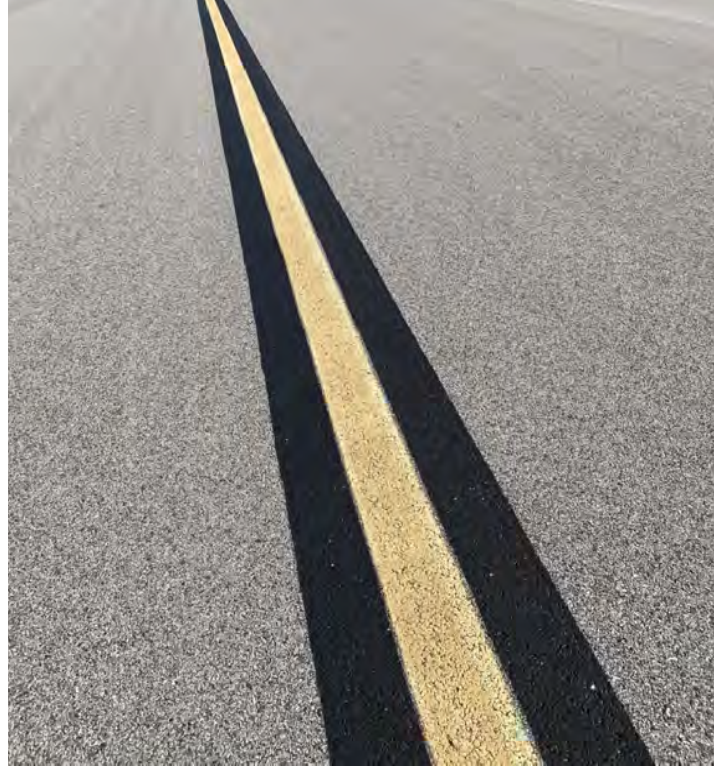
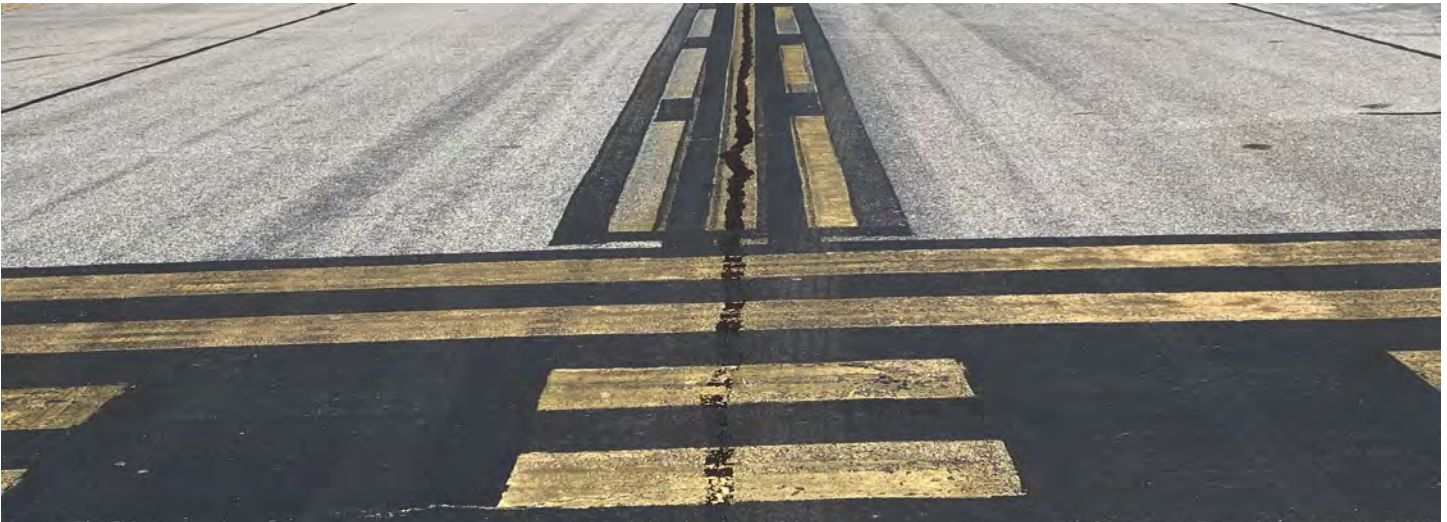
Airport Markings—Taxiway

MAINTENANCE: Taxiway markings range from **POOR** condition to **GOOD** condition on the airfield. Please clean or repaint markings that are severely faded.

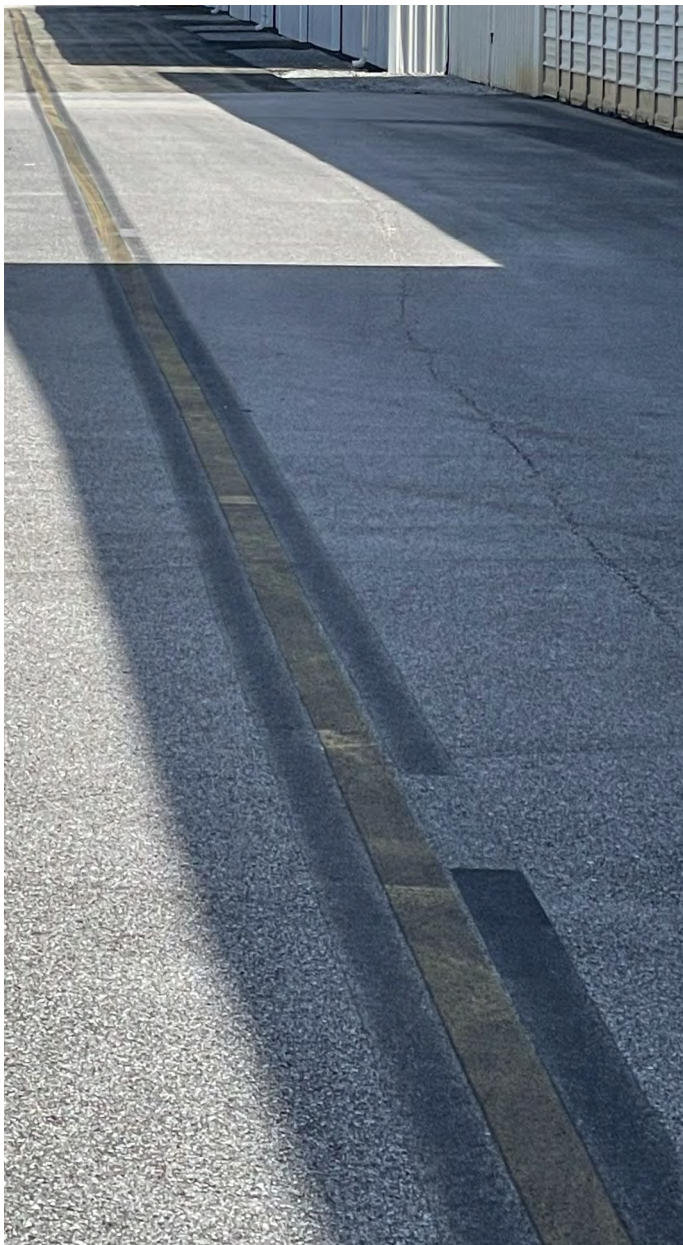
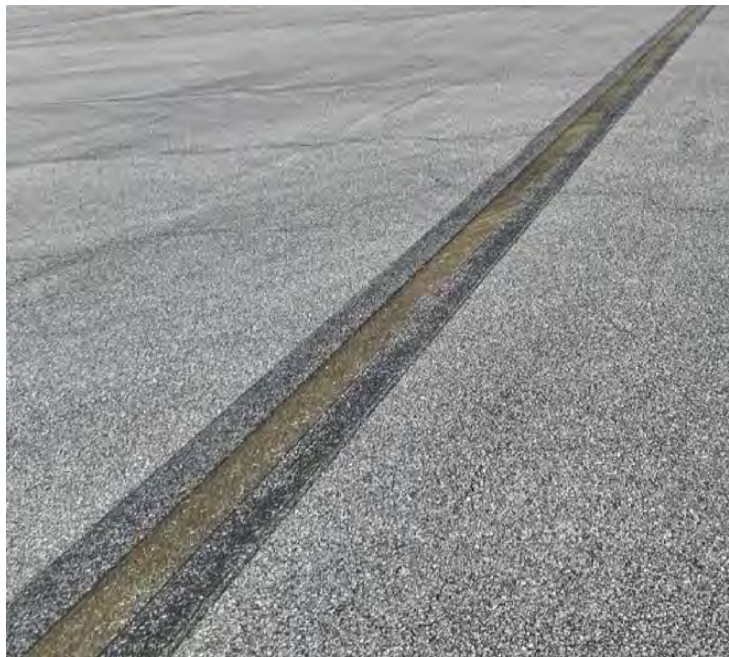
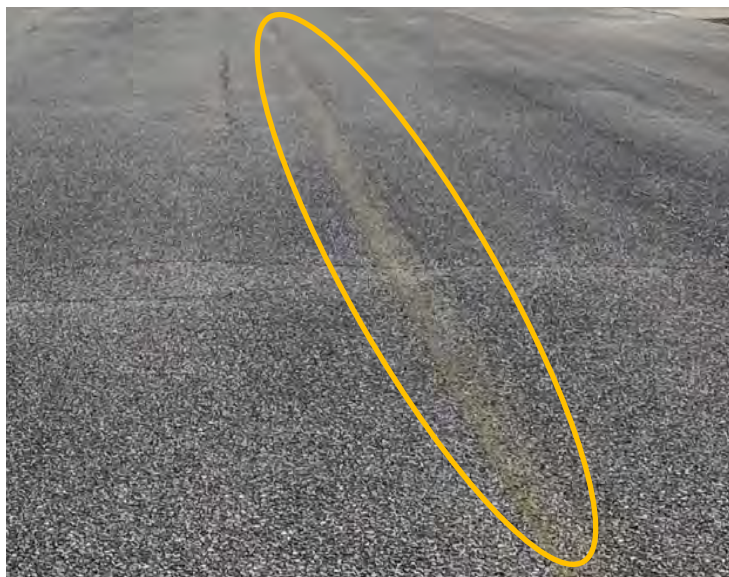
Airport Markings—Apron

MAINTENANCE: The apron markings are generally in **POOR** condition and are entirely faded in some areas. Please clean markings or repaint markings if necessary.

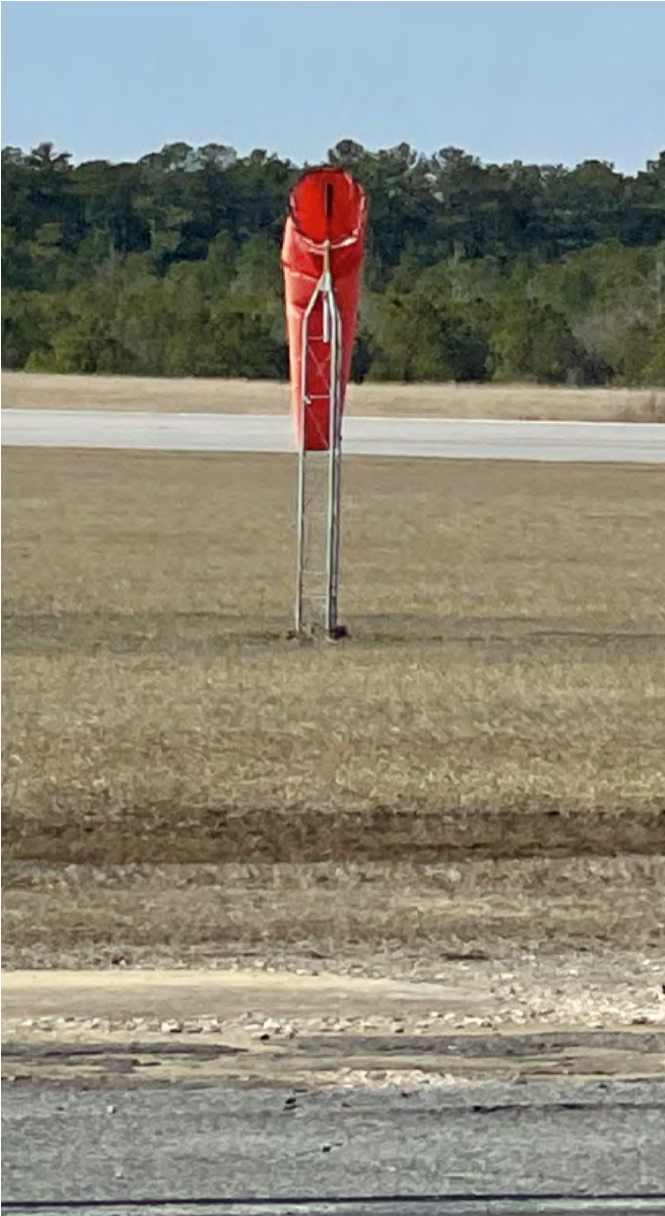
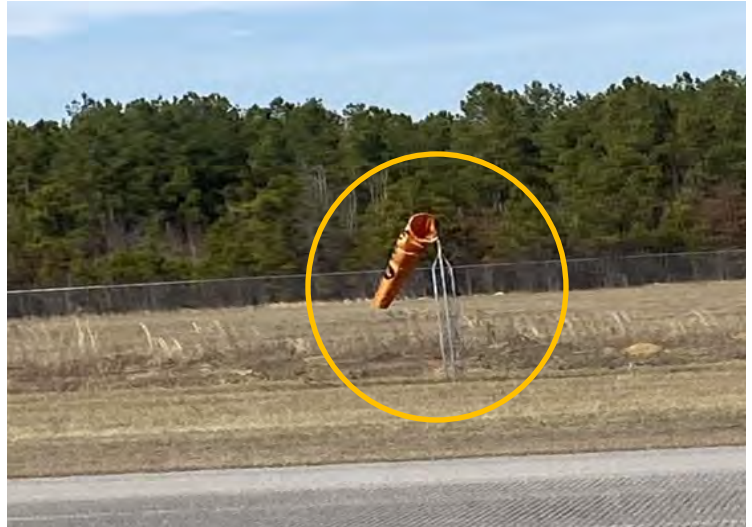
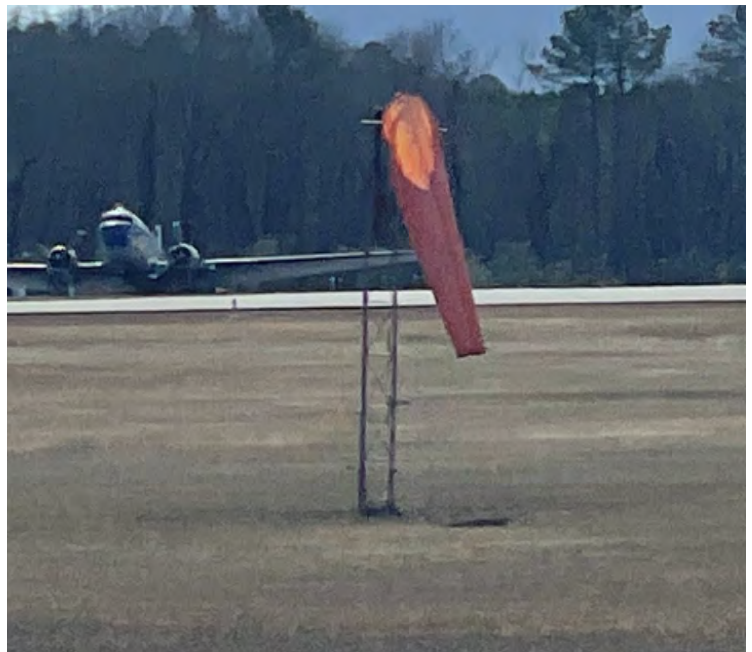
Wind Direction Indicator

MAINTENANCE: There are multiple wind direction indicators on the airfield. Most wind direction indicators are generally in **GOOD** condition, however one indicator (circled) is slightly faded and in **FAIR** condition and needs to be replaced soon.

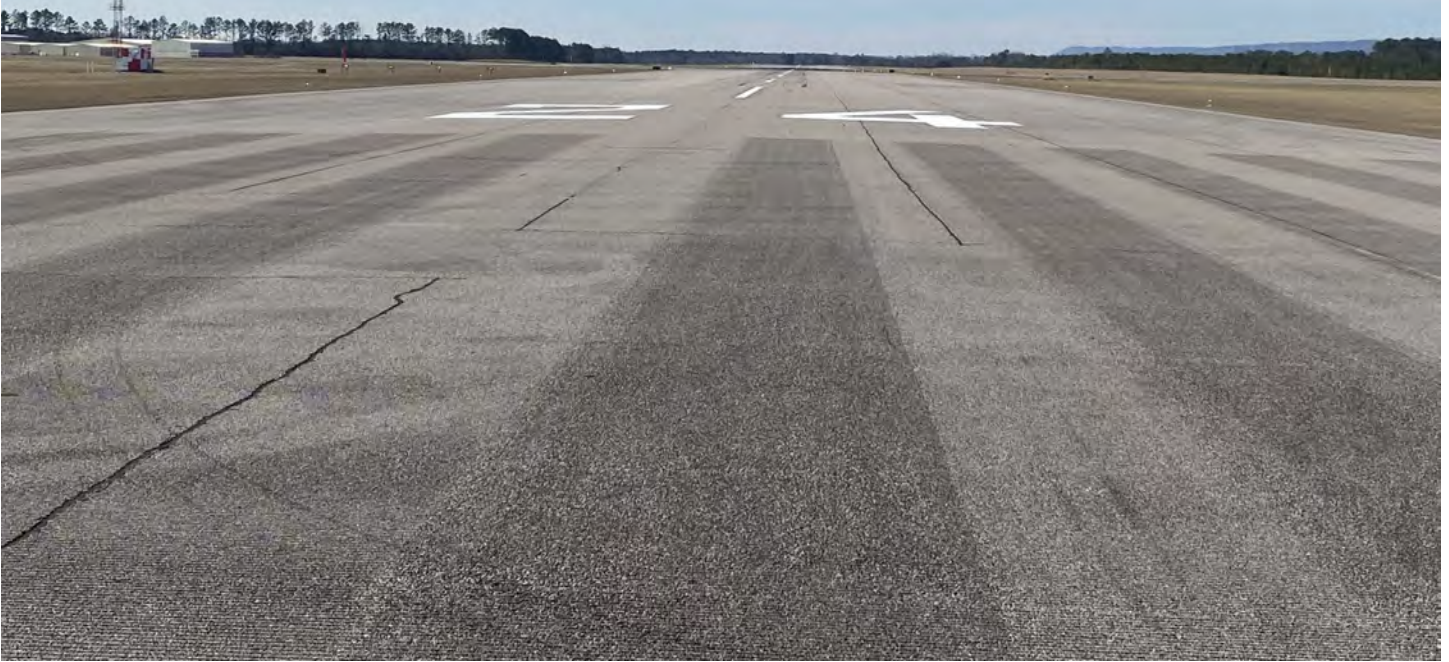
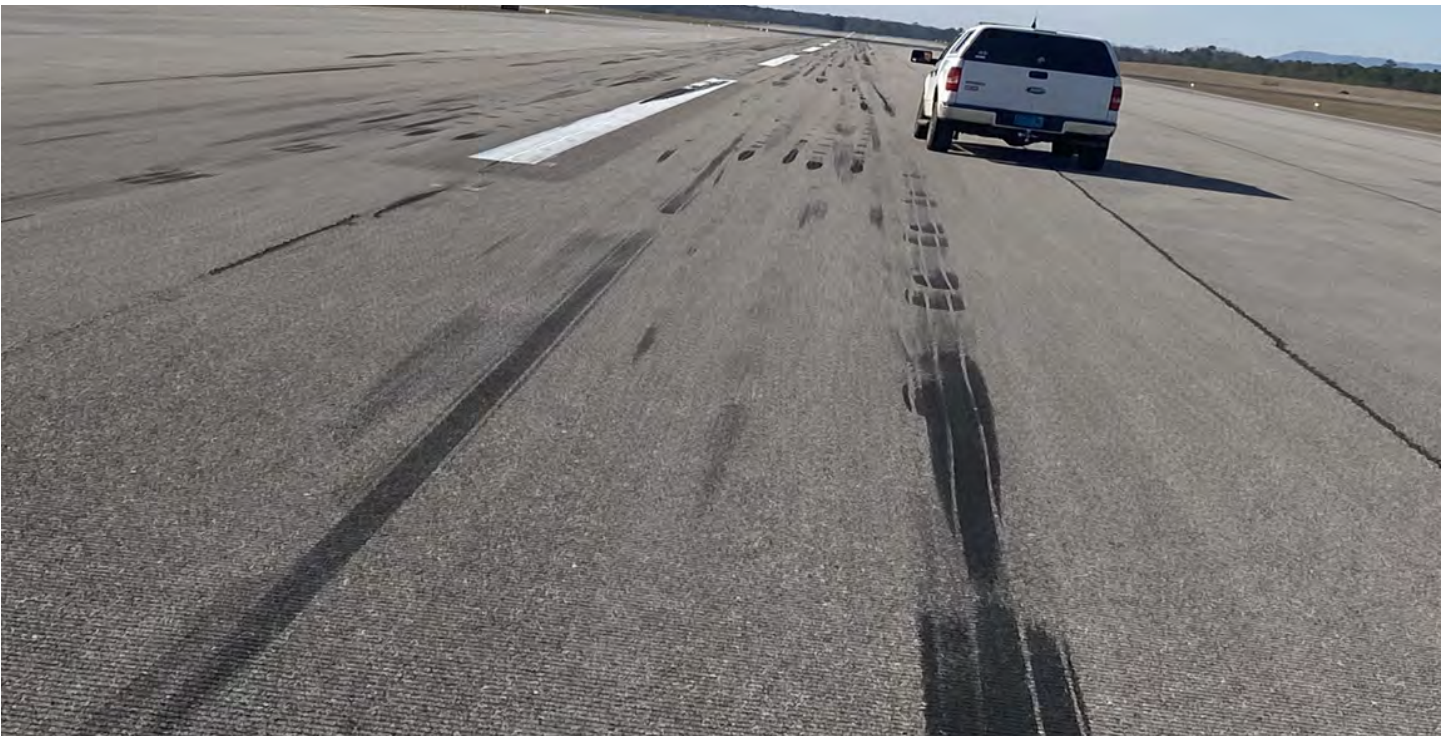
Runway, Taxiway and Apron Conditions—RUNWAY 6/24

Runway 6/24 surface is in **GOOD** condition.

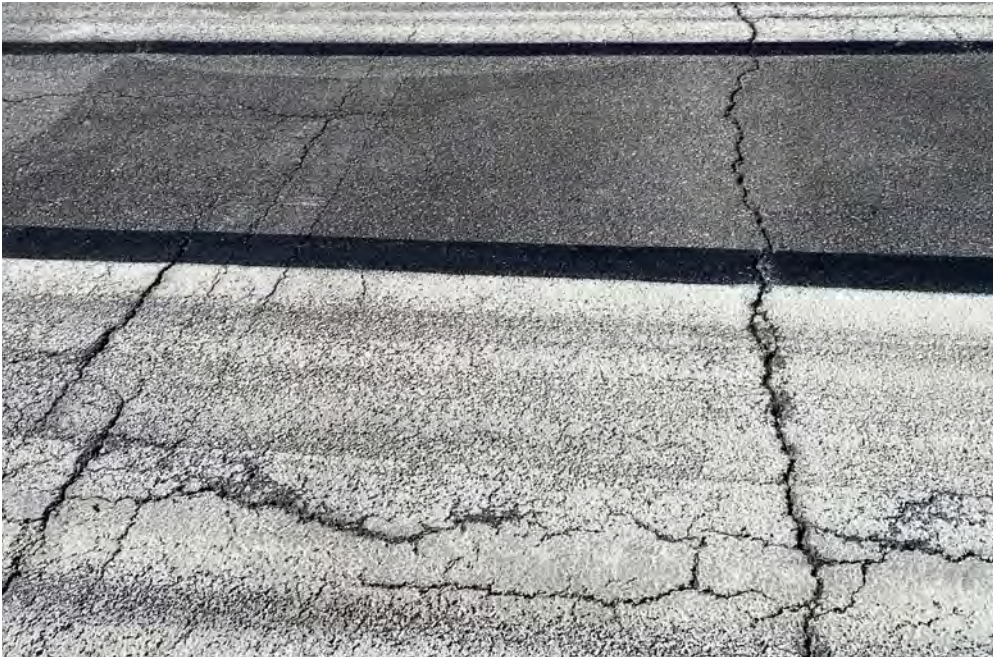
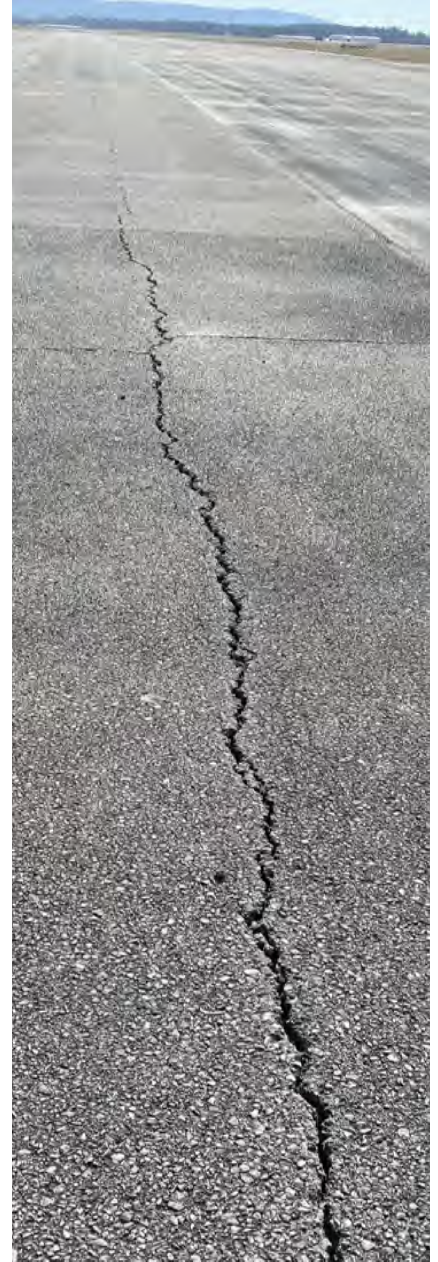
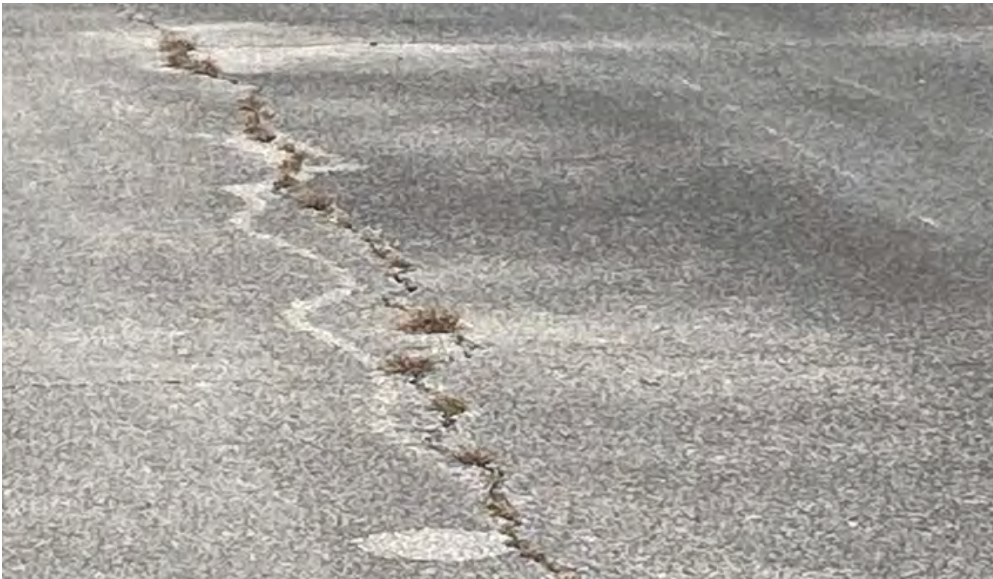
Runway, Taxiway and Apron Conditions—RUNWAY 18/36

MAINTENANCE: Runway 18/36 surface is in **FAIR** condition. Slight cracking exists on some areas of the pavement. Vegetation is growing inside some of these cracks. Please seal cracks and clear vegetation from pavement cracks.

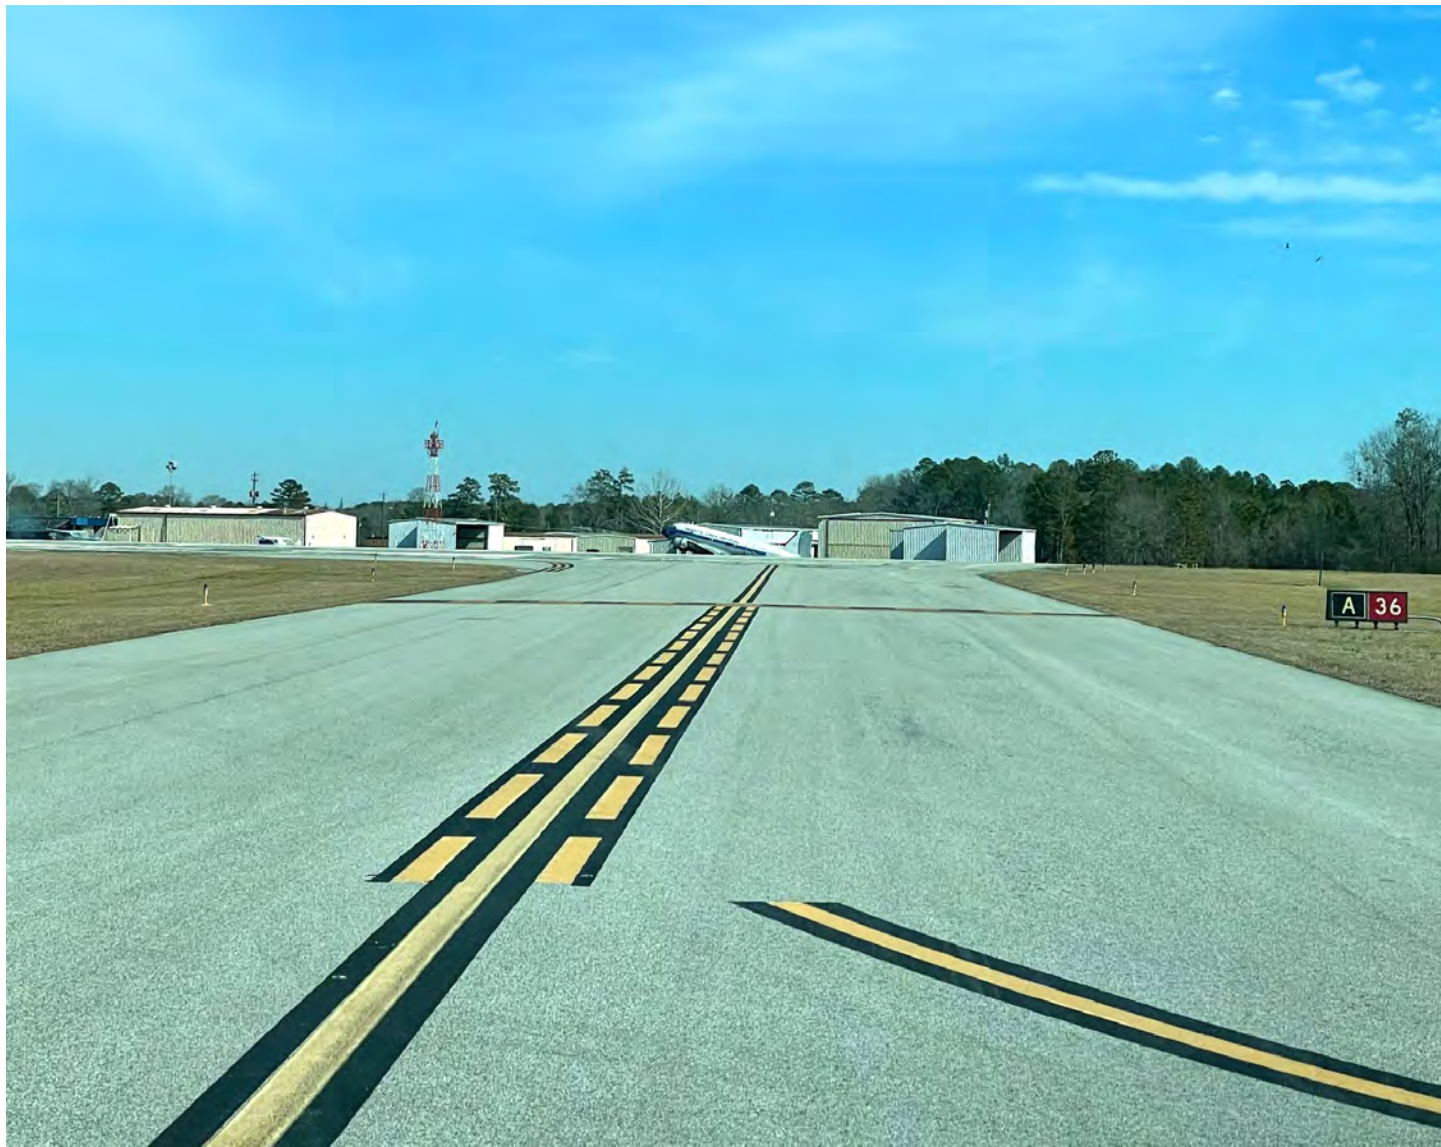
Runway, Taxiway and Apron Conditions—TAXIWAY

Taxiway surfaces are in **GOOD** condition.
