**Subject: Annual Inspection Report
Northeast Alabama Regional Airport (GAD)**

**NORTHEAST ALABAMA REGIONAL AIRPORT
GADSDEN, ALABAMA**

Alabama Department of Transportation Aeronautics Bureau—Annual Airport Inspection Report

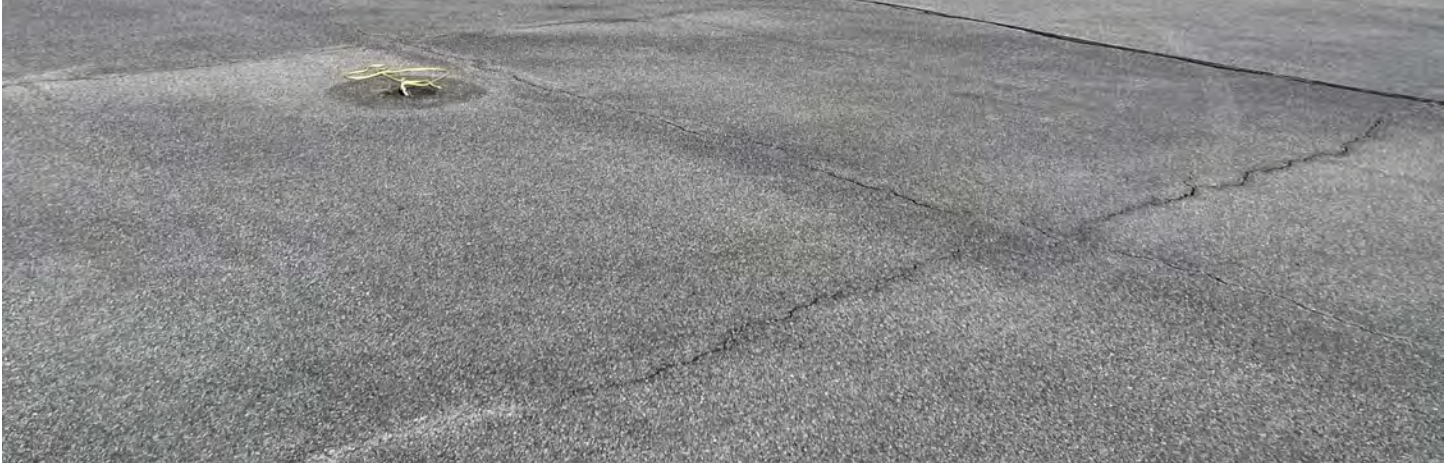
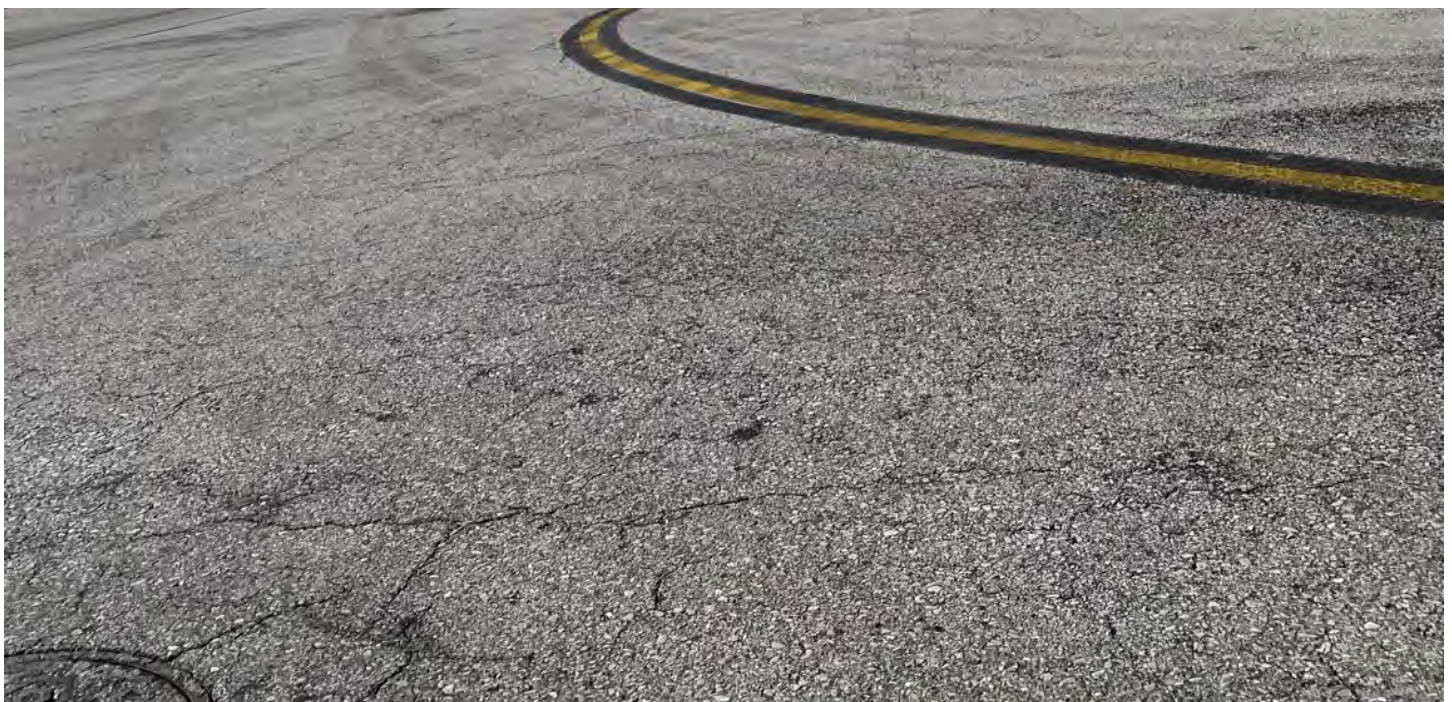
Runway, Taxiway and Apron Conditions—APRON

Apron surfaces are in **FAIR** condition. Apron surface is slightly cracked in some areas.

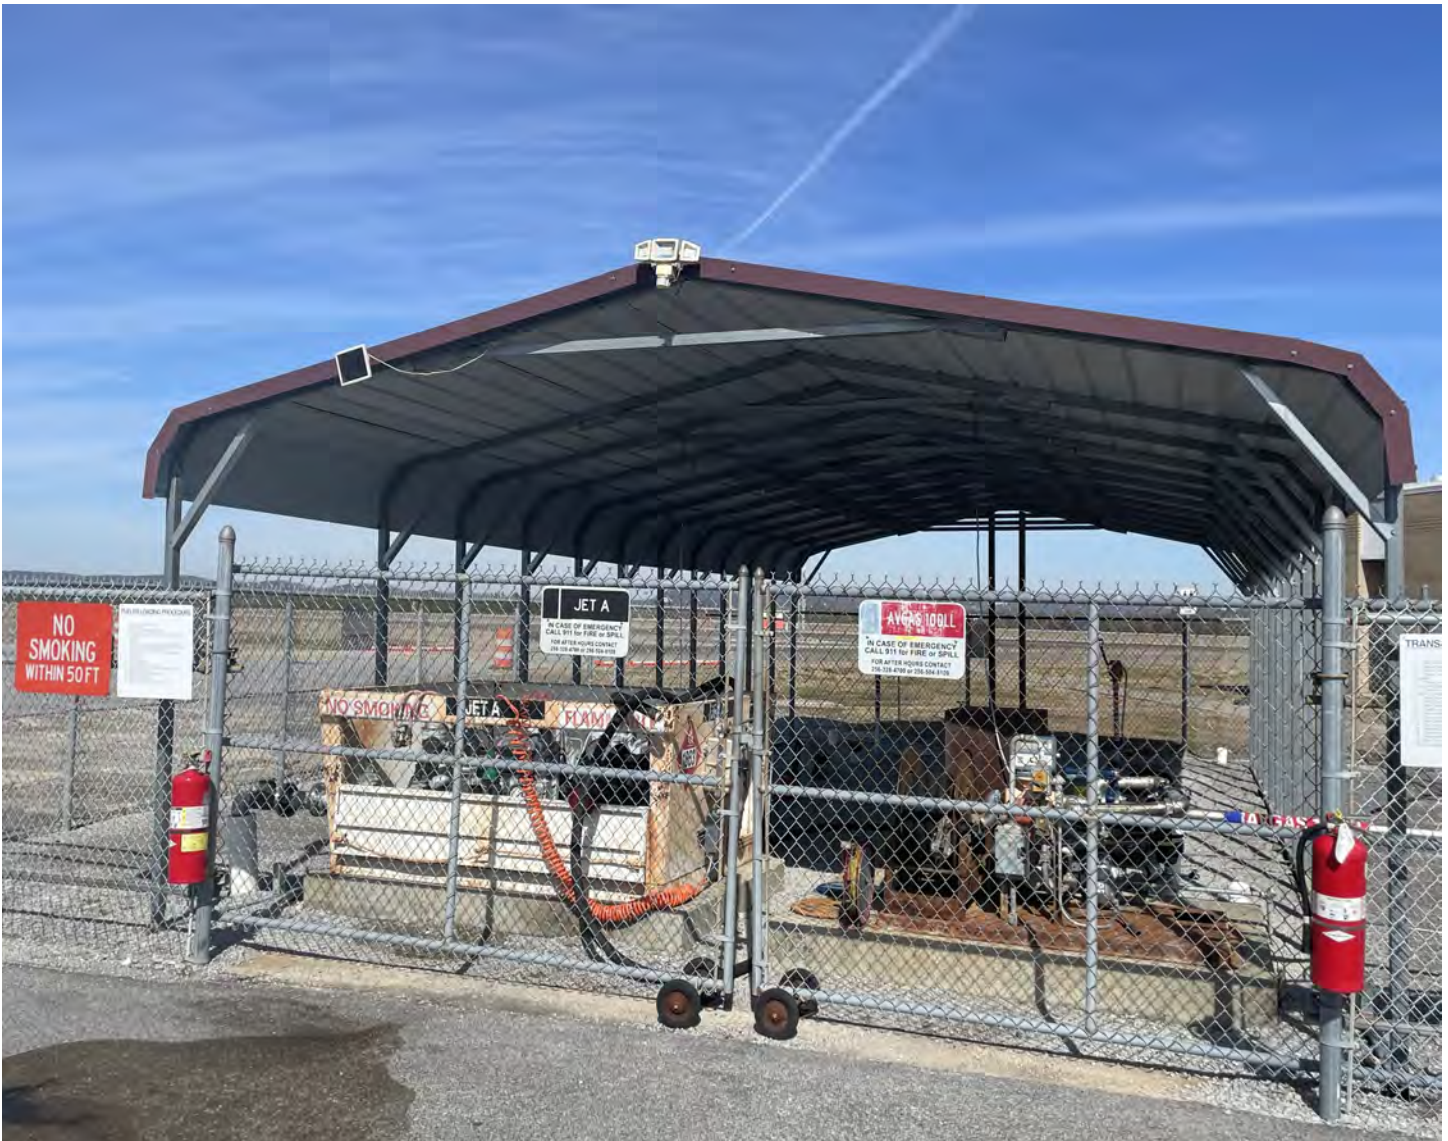
Fueling Area Requirements

The fueling area **MEETS** the requirements established by the Alabama Department of Transportation. However, the State of Alabama Department of Agriculture may have additional requirements for fueling systems that were not considered during this inspection.

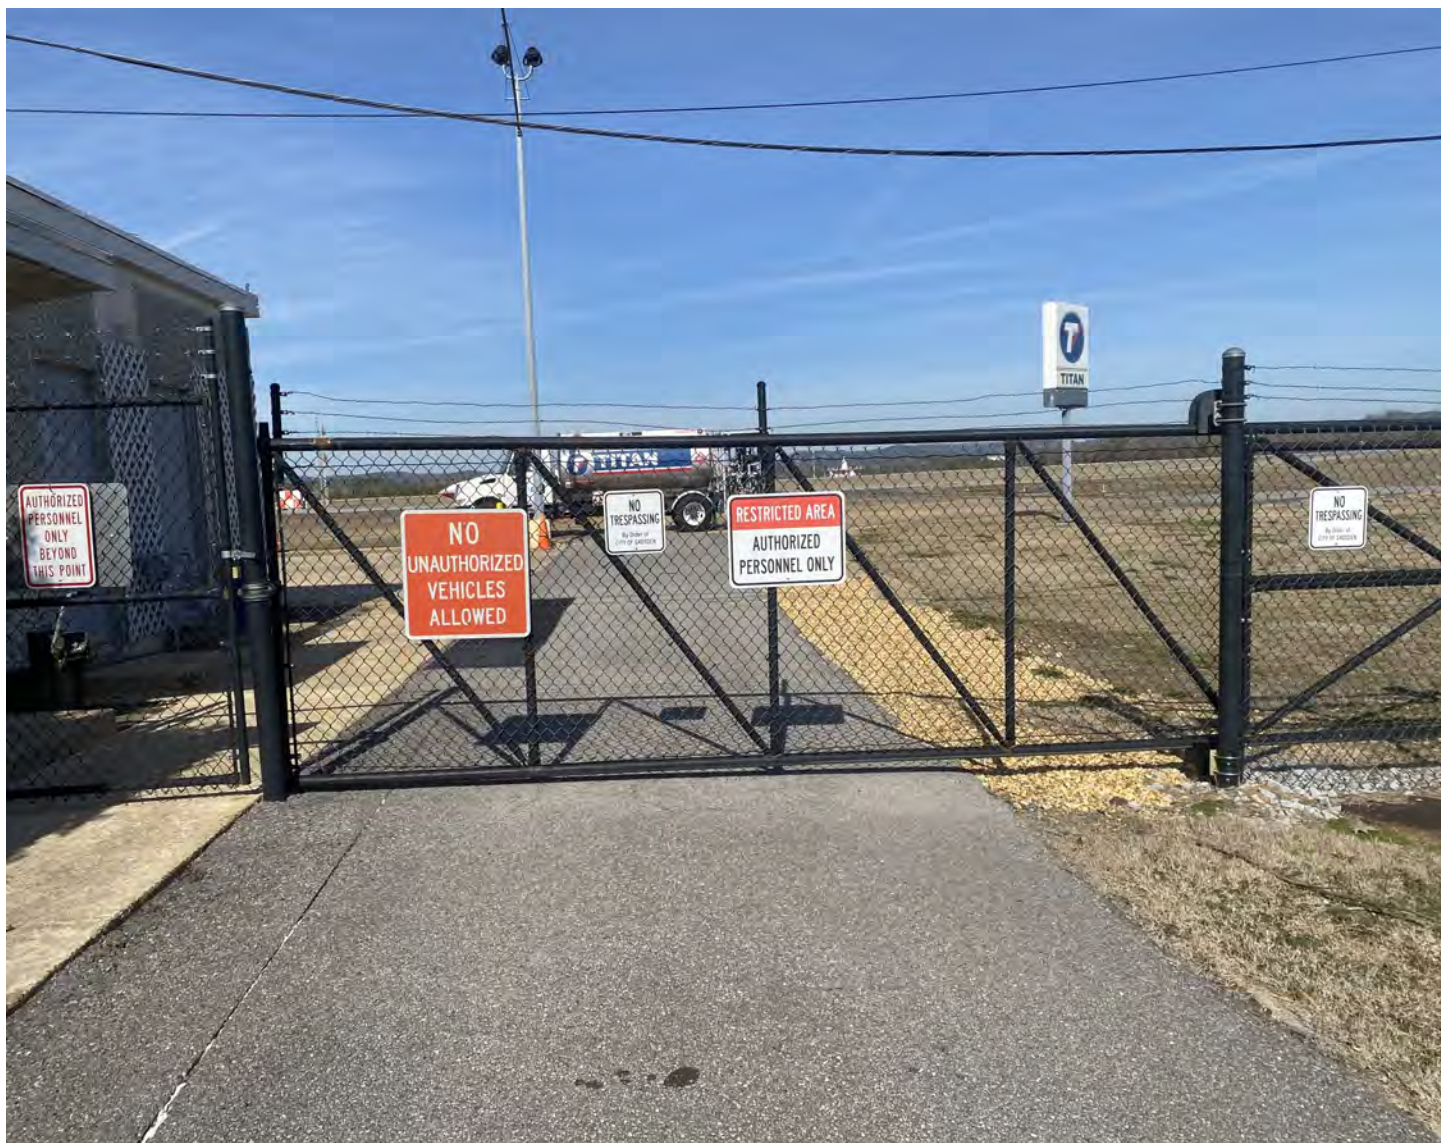
Prohibited Activities

No prohibited activities were observed during this inspection. All gates were locked and airfield access was secure.

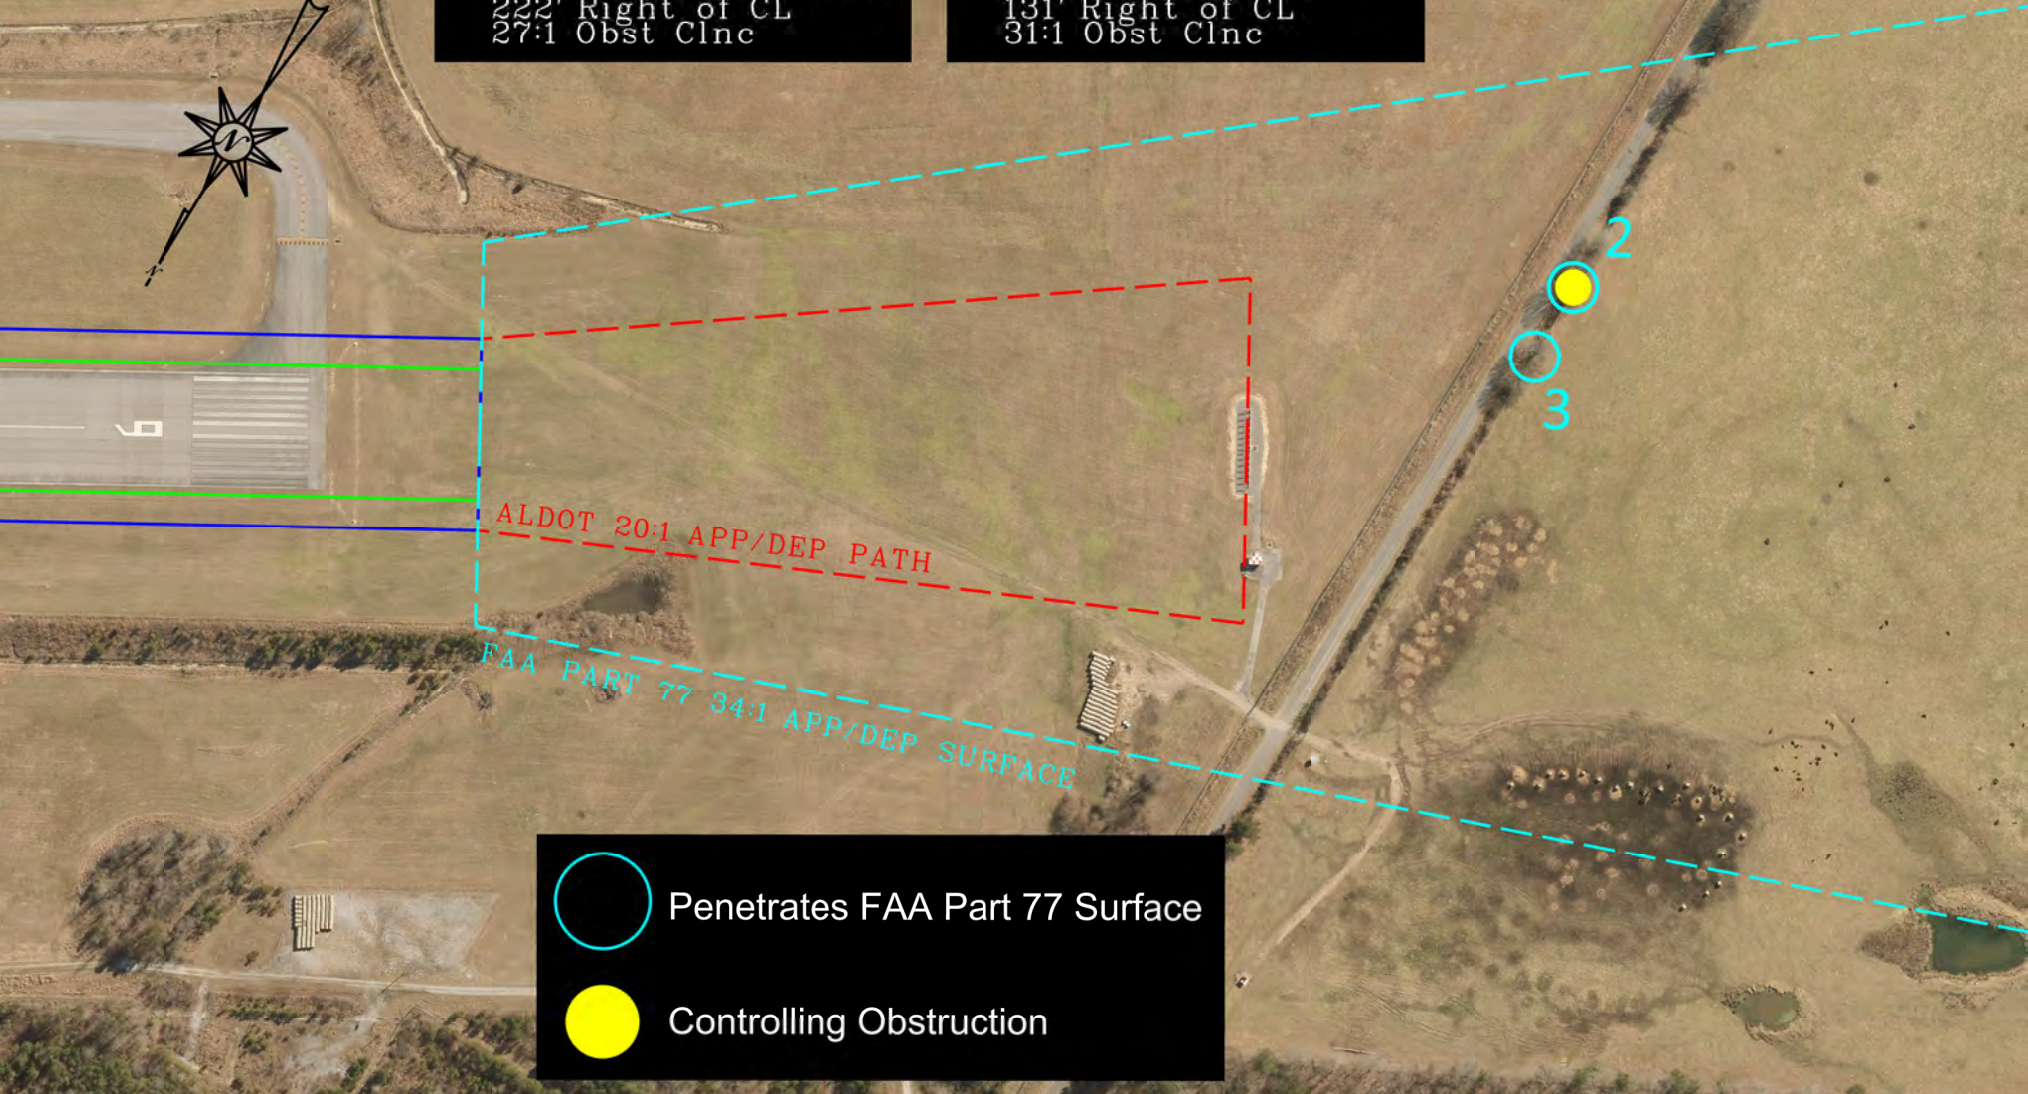
APPENDIX 2

2. Tree 52' Abv RWY
1621' From RWY End
222' Right of CL
27:1 Obst Clnc

3. Tree 44' Abv RWY
1573' From RWY End
131' Right of CL
31:1 Obst Clnc

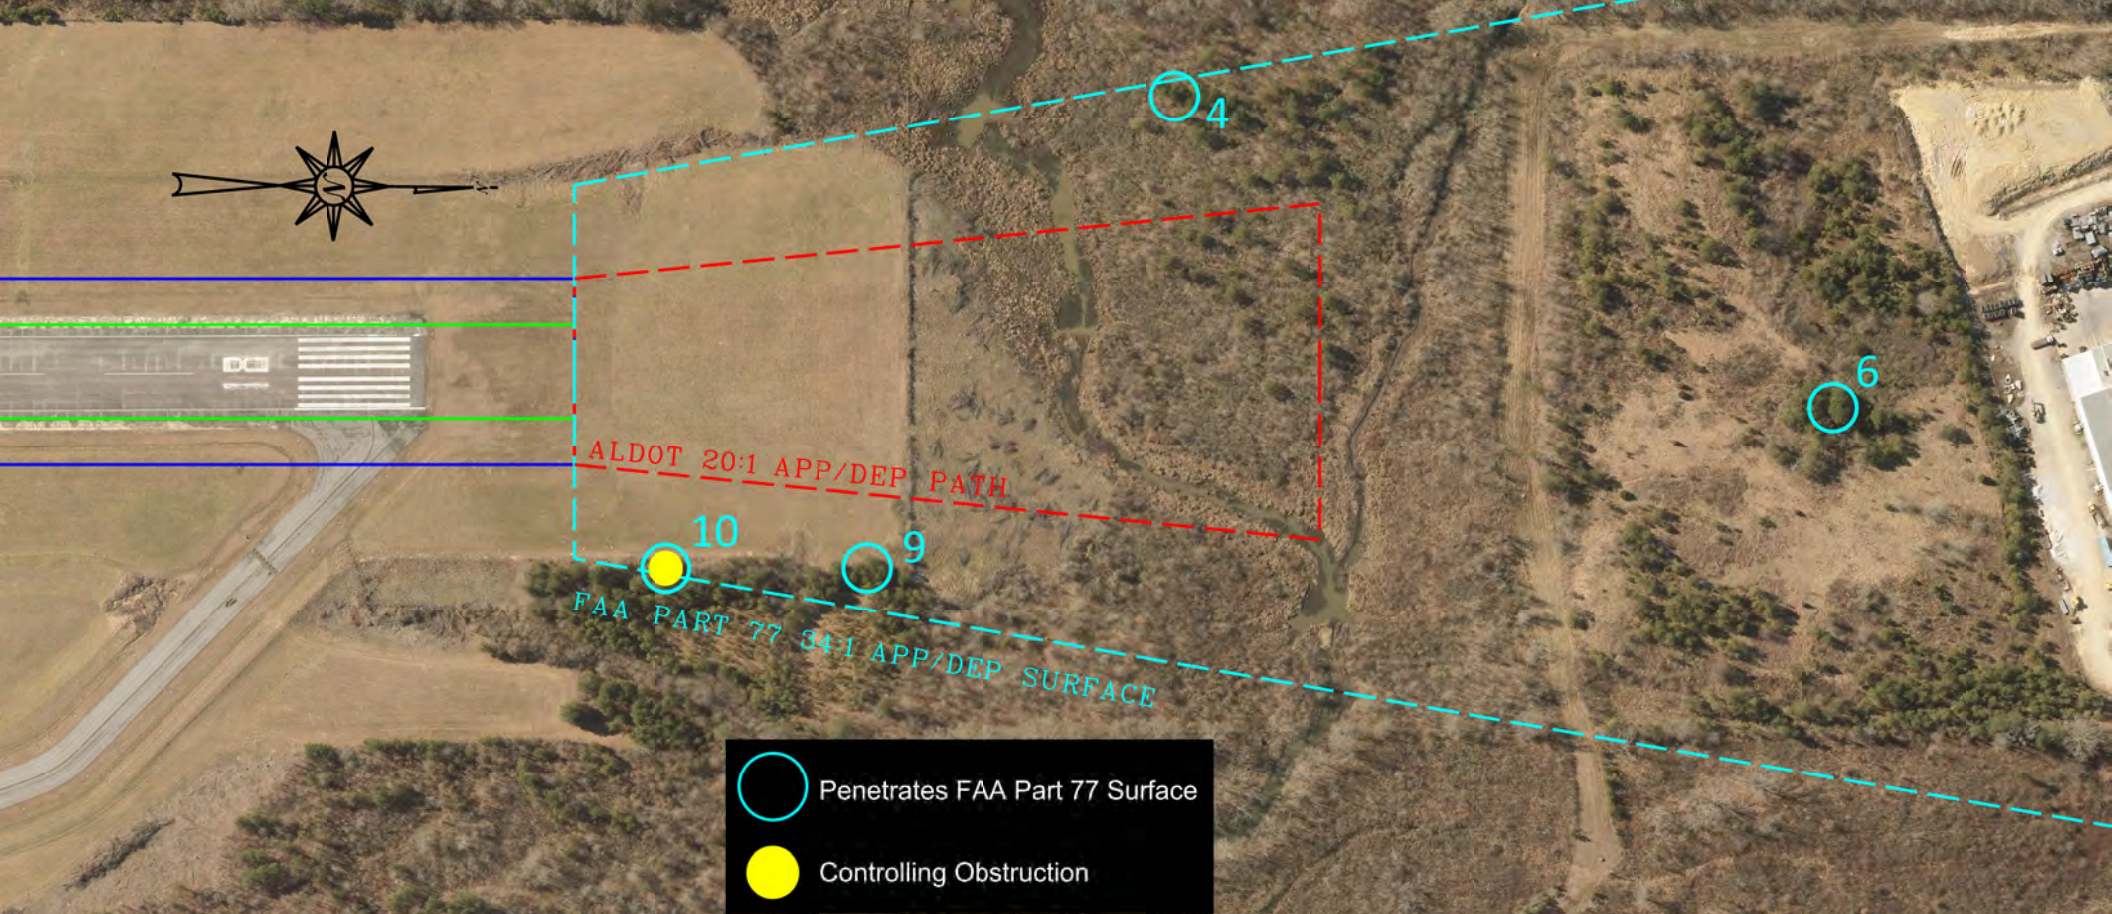
APPENDIX 3

4. Tree 32' Abv RWY
1005' From RWY End
369' Right of CL
25:1 Obst Clnc

6. Tree 52' Abv RWY
1887' From RWY End
48' Left of CL
32:1 Obst Clnc

9. Tree 27' Abv RWY
592' From RWY End
262' Left of CL
14:1 Obst Clnc

10. Tree 36' Abv RWY
322' From RWY End
262' Left of CL
3:1 Obst Clnc
