**Subject: Annual Inspection Report**  
**Robbins Field Airport (20A)**

## Alabama Department of Transportation Aeronautics Bureau—Annual Airport Inspection Report

In accordance with the provisions of the Code of Alabama 23-1-357, an inspection of the **Robbins Field Airport (20A)** was conducted by **Mr. Bennett Head** with the Alabama Department of Transportation Aeronautics Bureau on **May 31, 2023**.

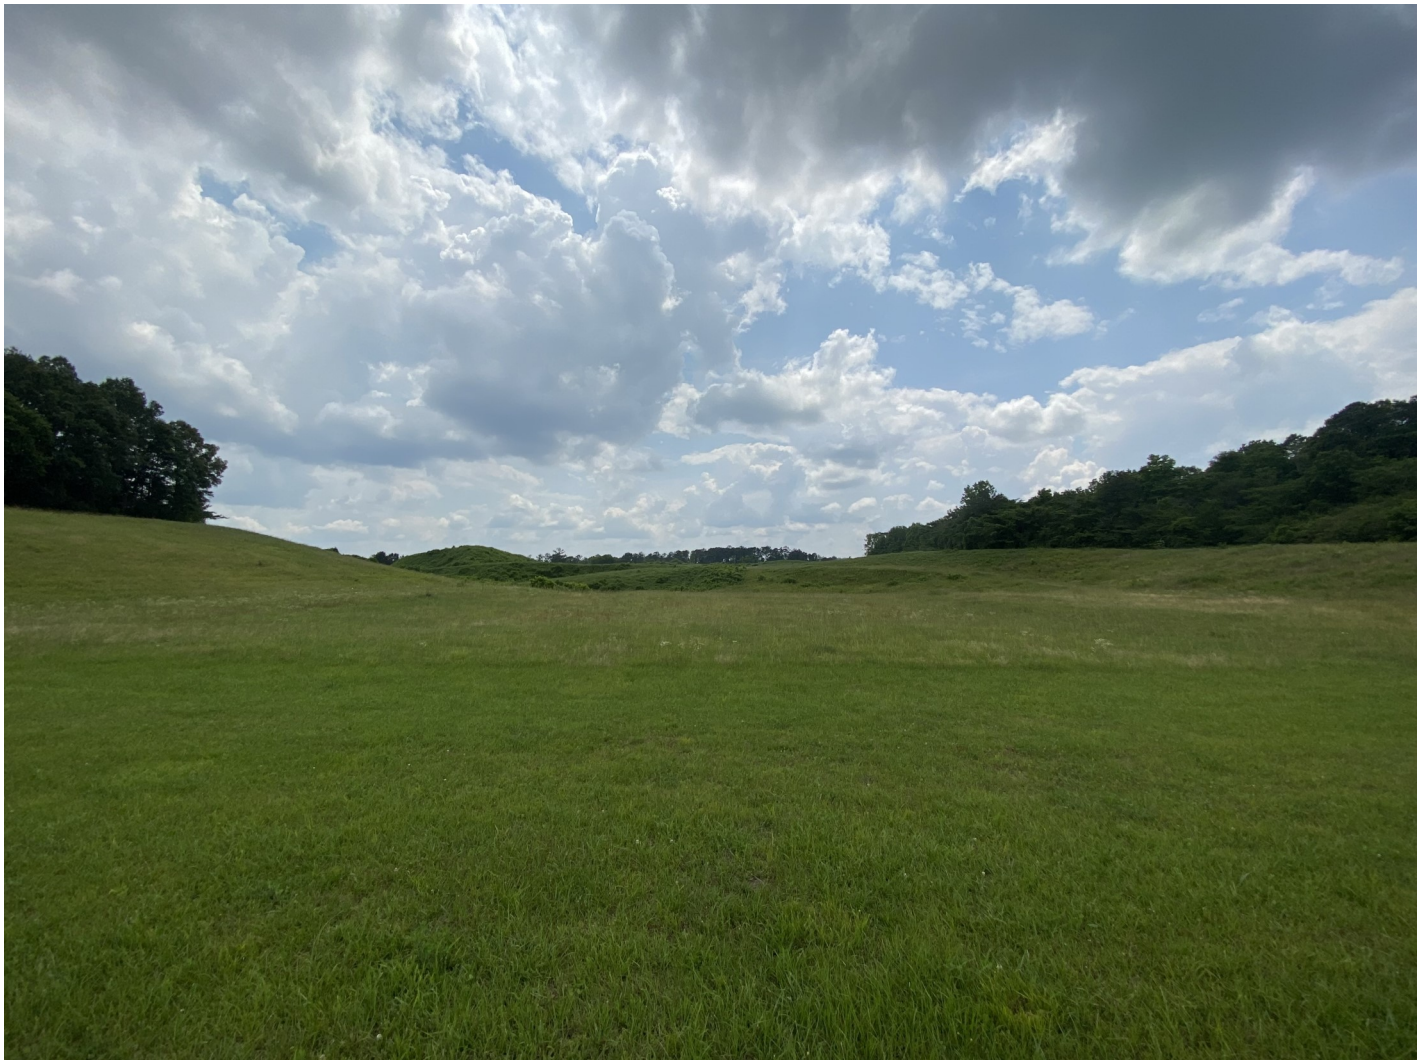
### Approach and Departure Paths—RUNWAY 6

No obstructions located in the ALDOT Approach/Departure Path of Runway 6. However, there were FAA part 77 penetrations found. Please see Appendix #2 for more information.

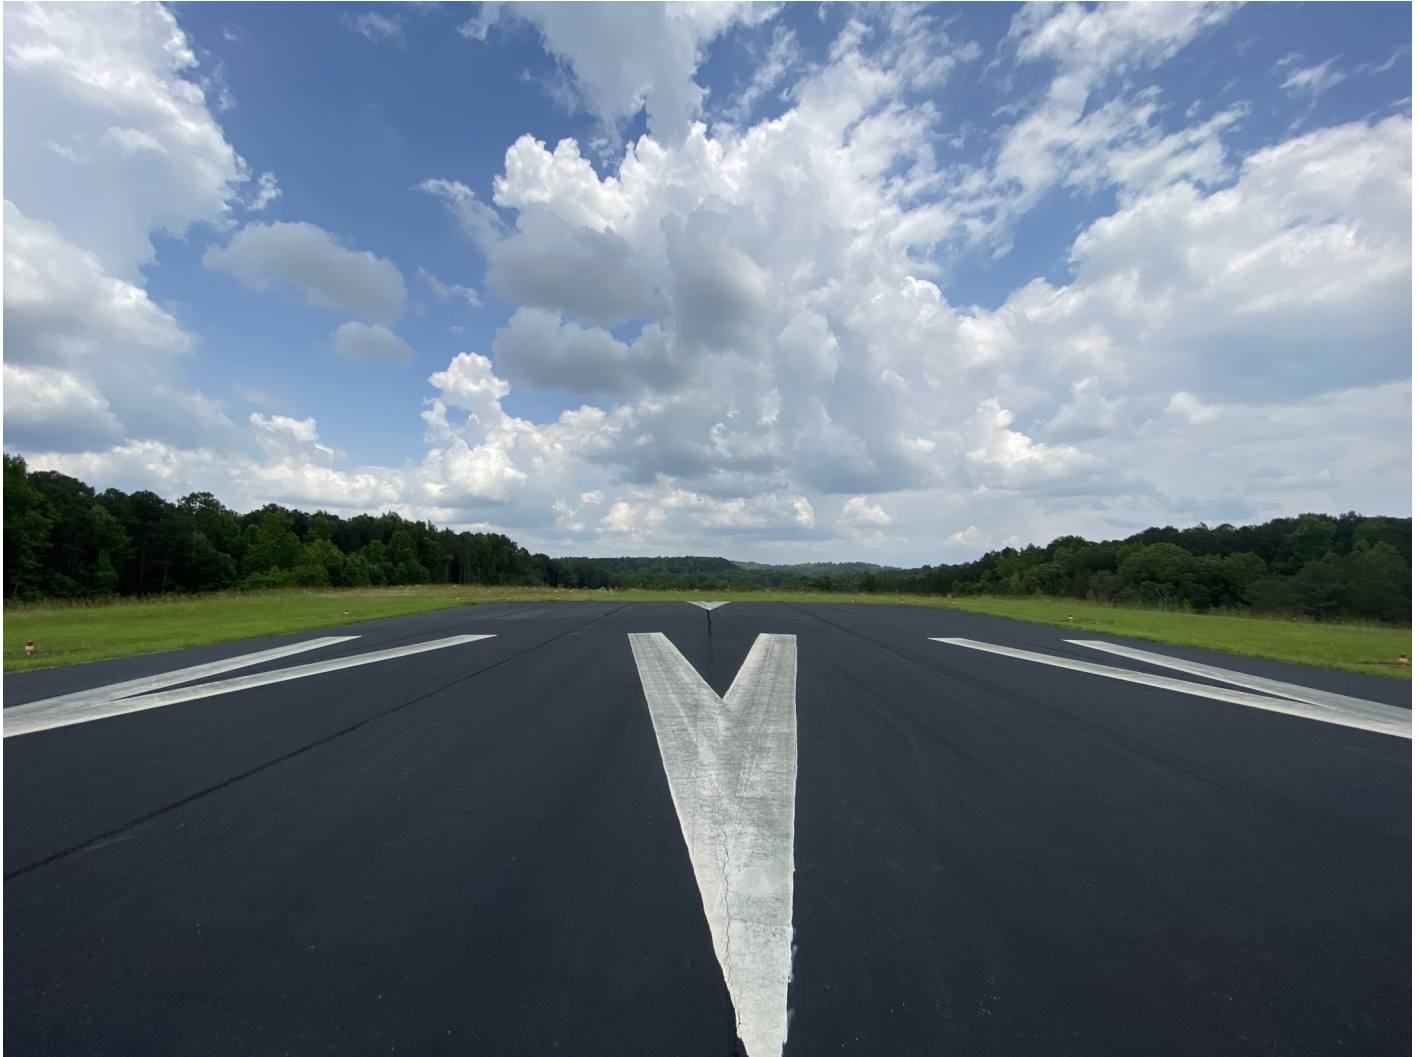
### Approach and Departure Paths—RUNWAY 24

No obstructions located in the ALDOT Approach/Departure Path of Runway 24. However, there were FAA part 77 penetrations found. Please see Appendix #3 for more information.

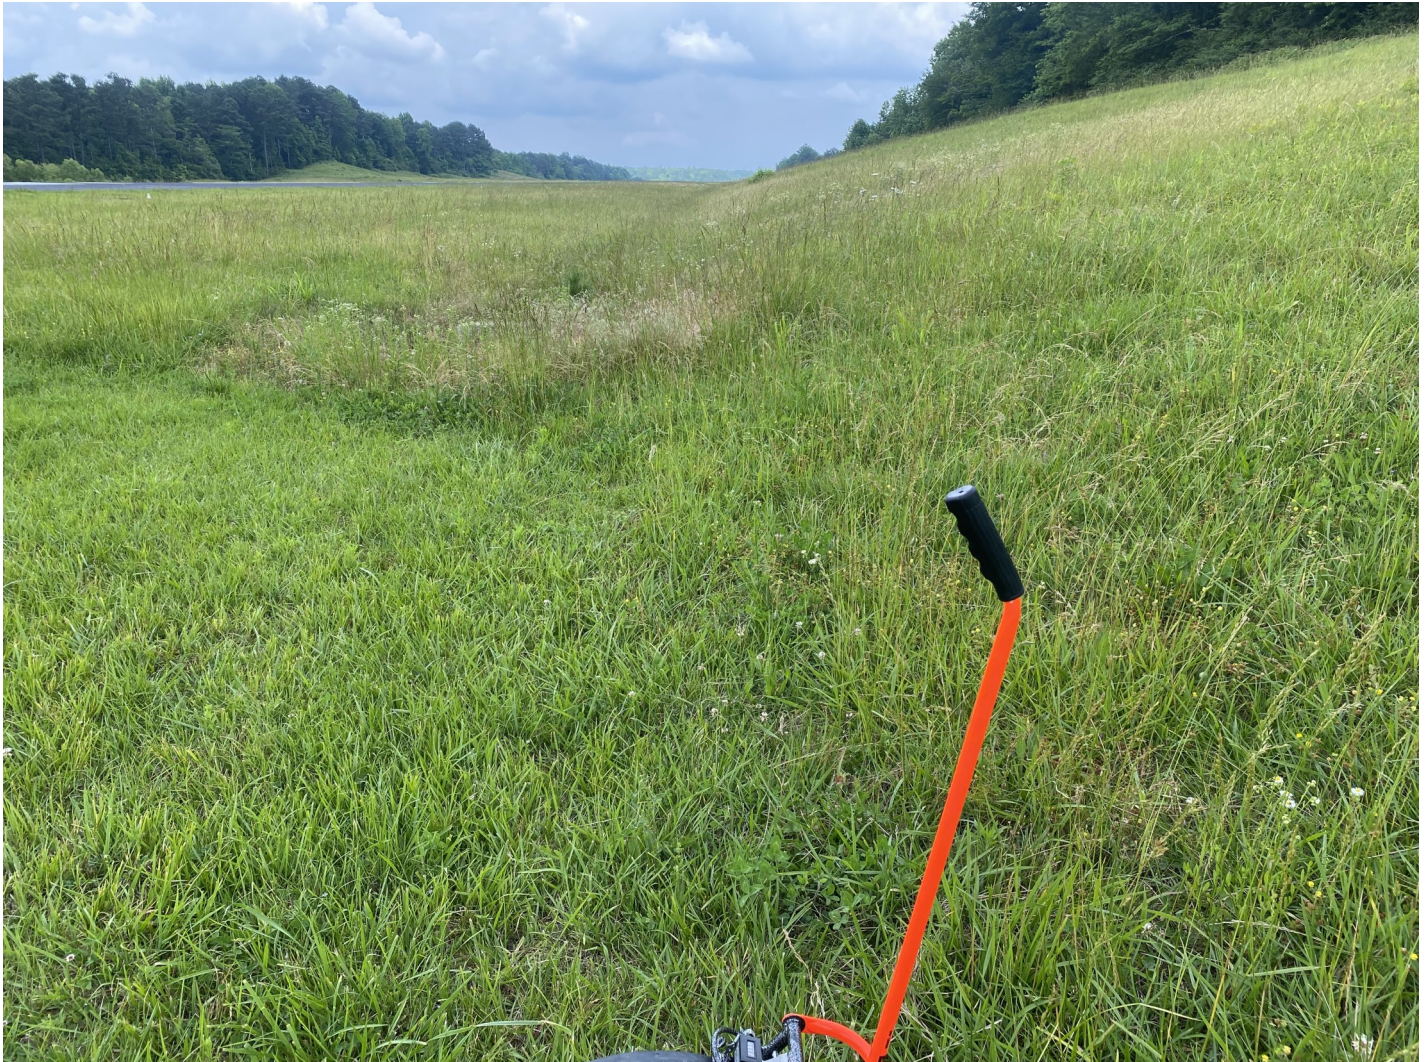
### Primary Surface

The Primary Surface **meets** state licensing standards.

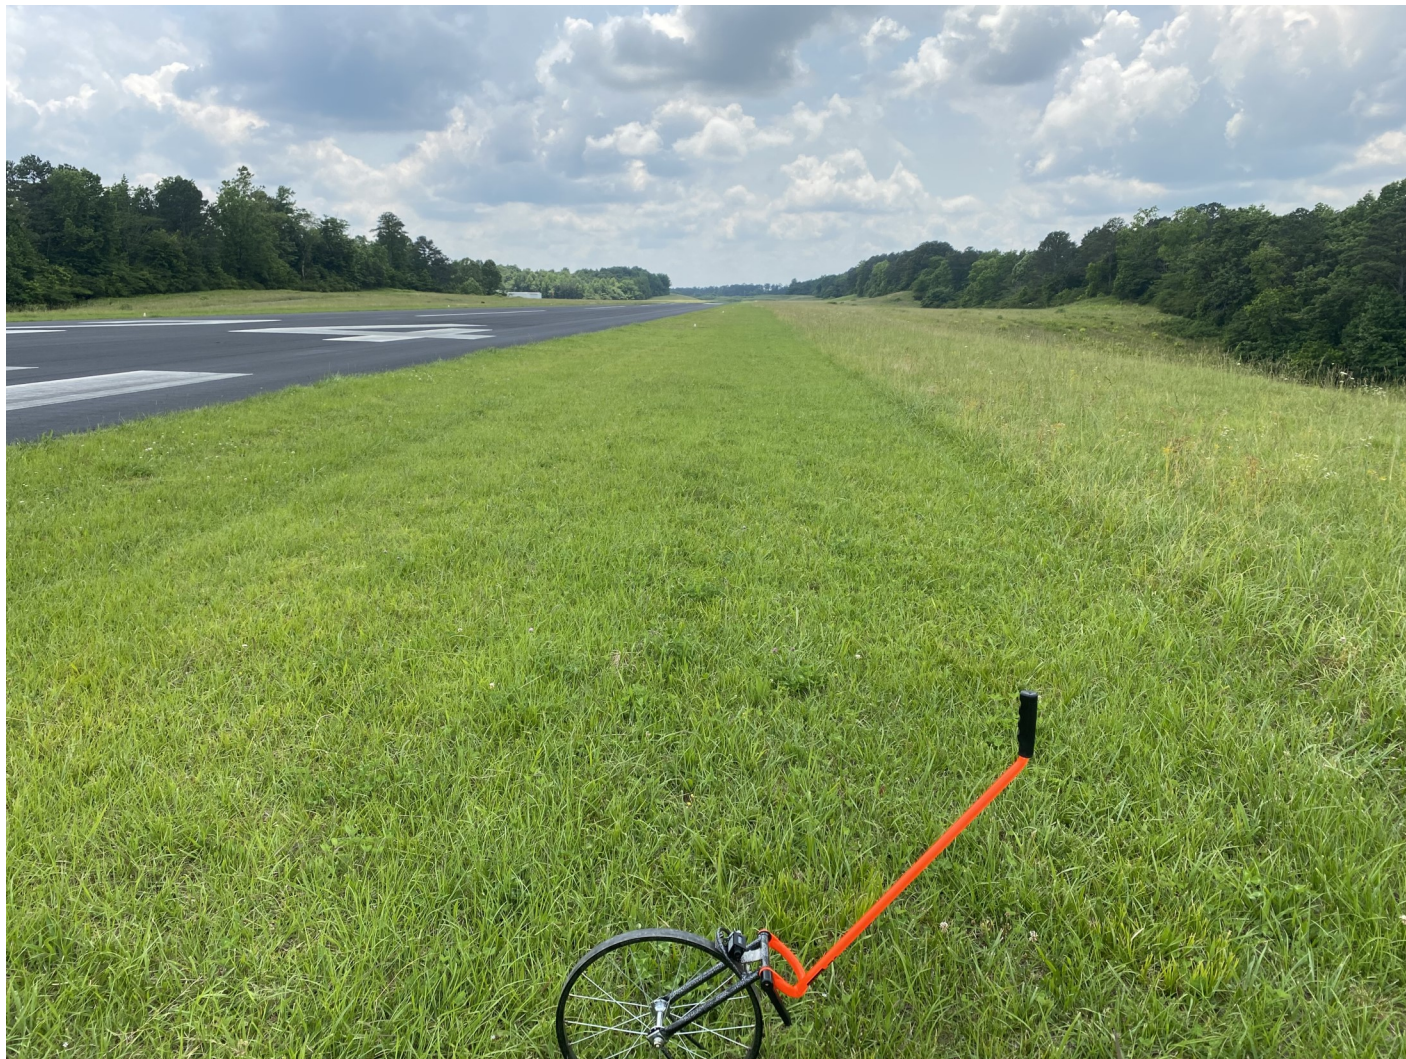
### Runway Safety Area

Runway Safety Area **meets** state licensing standards.

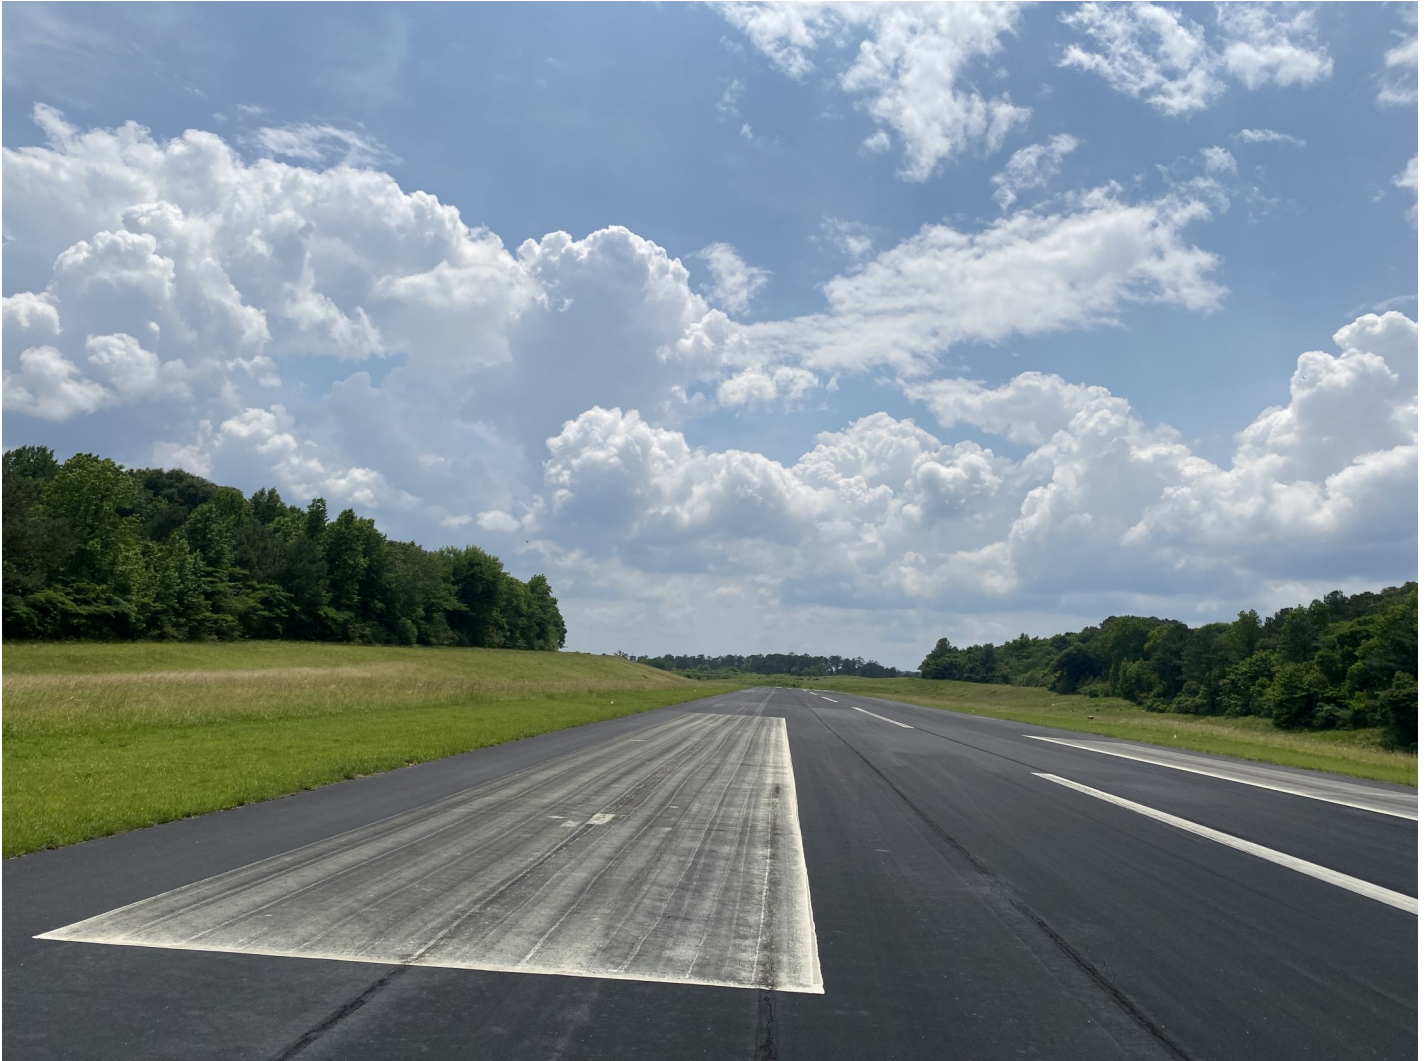
### Airport Markings—Runway

Runway markings are in **FAIR** condition.

**Maintenance Required:** Clean Runway markings. If markings are unable to be cleaned, remark in accordance with FAA AC 150/5340-1M.

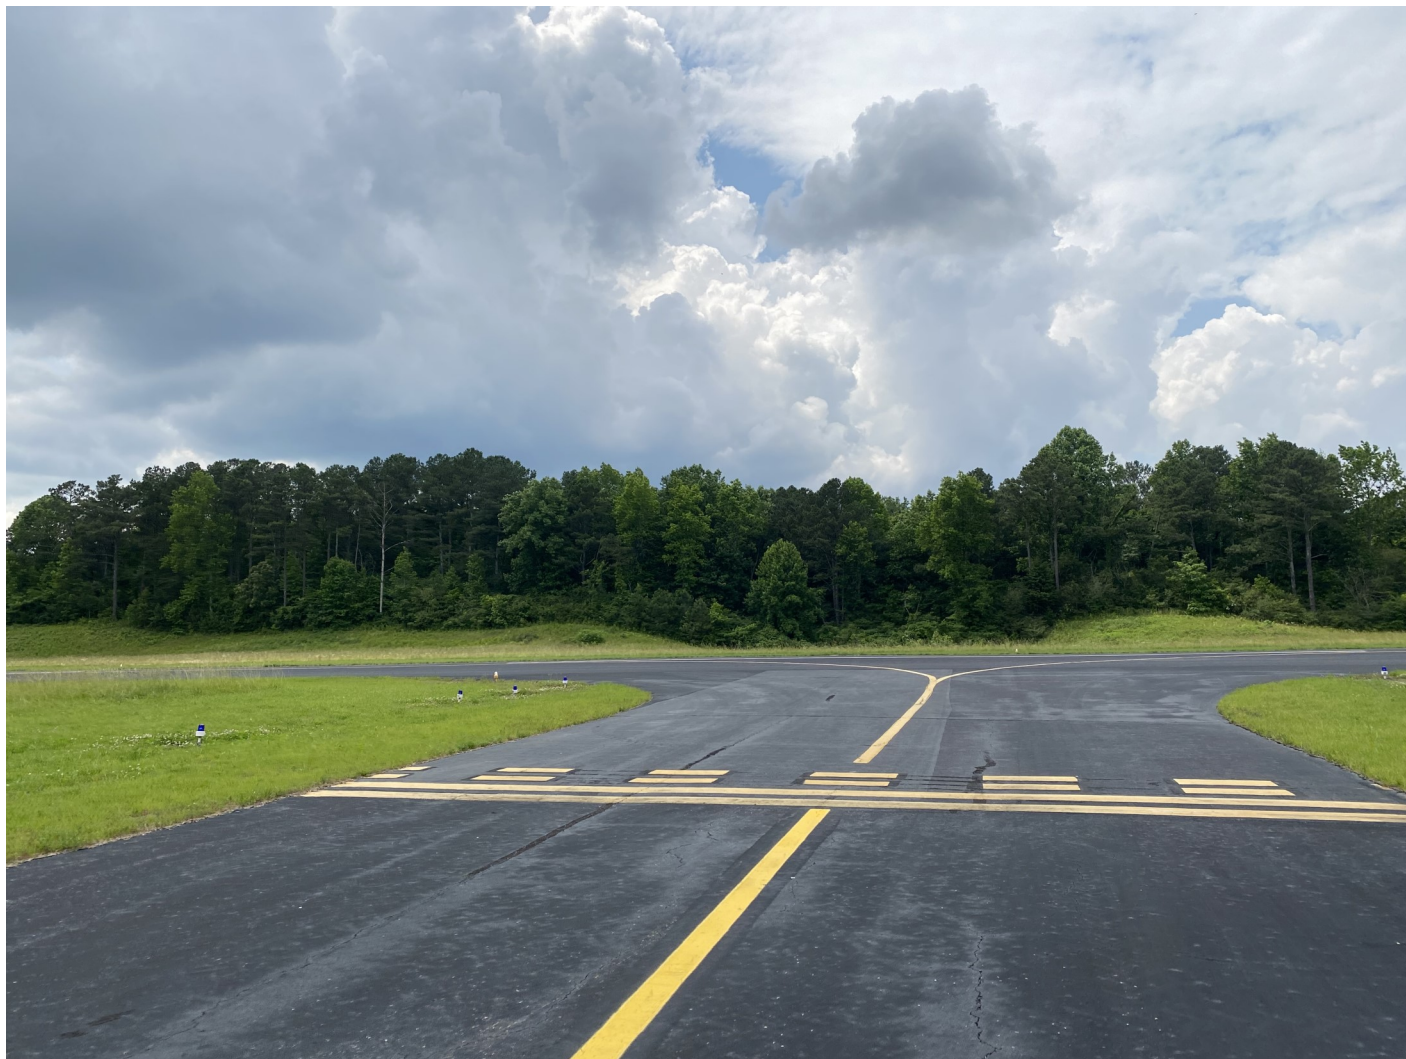
### Airport Markings—Taxiway

Taxiway markings are in **GOOD** condition. Hold short marking is beginning to fade.

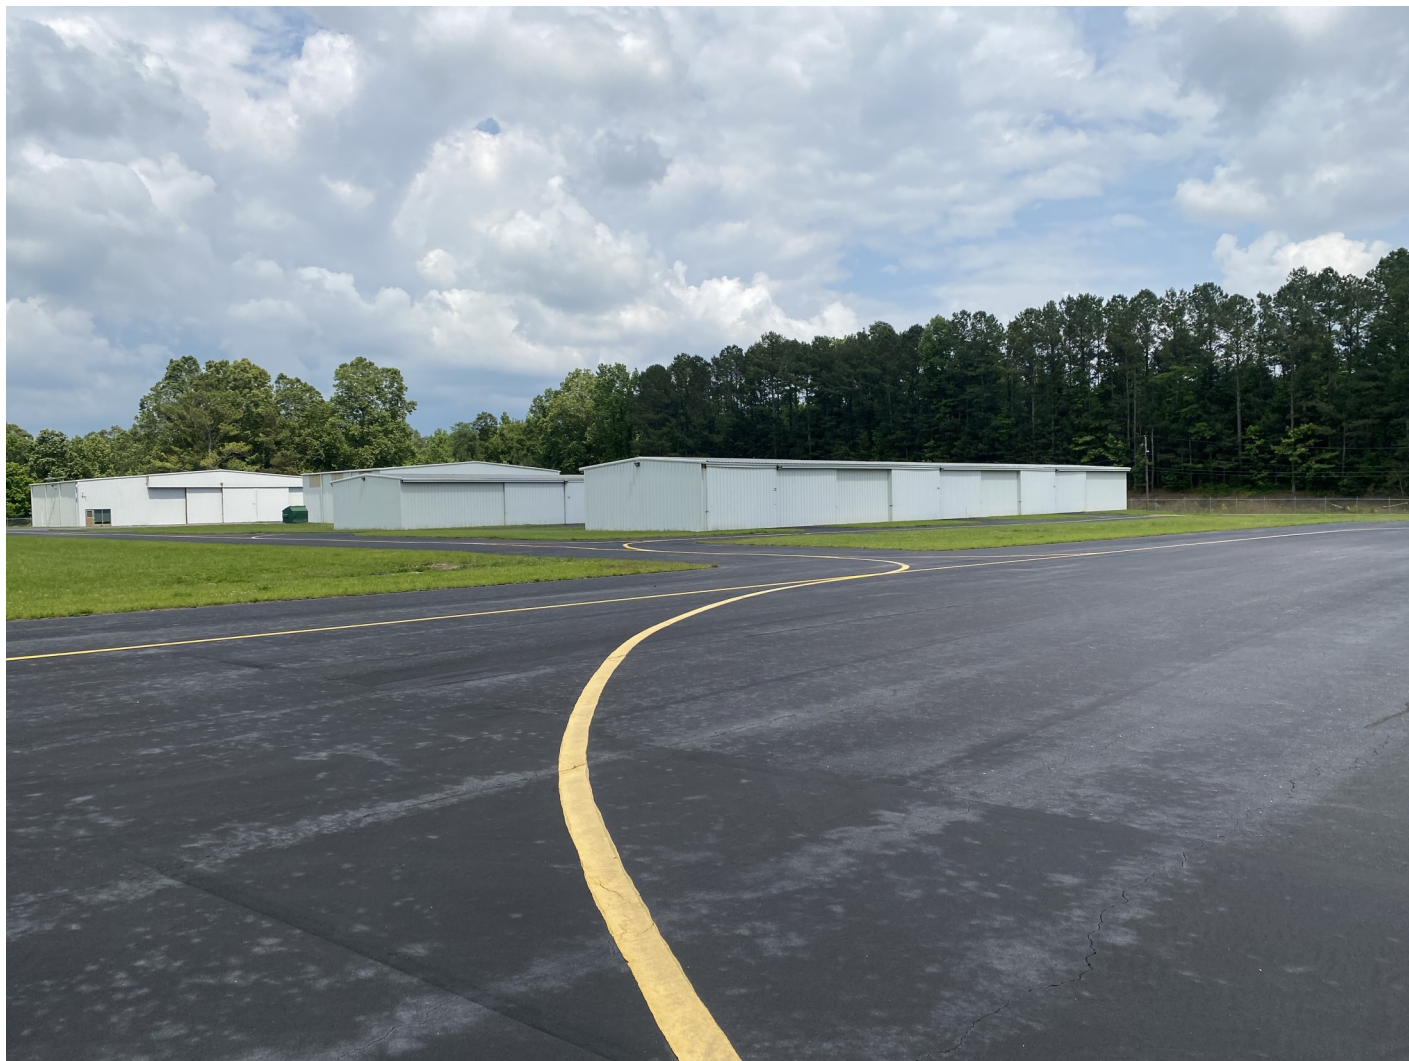
### Airport Markings—Apron

Apron markings are in **GOOD** condition.

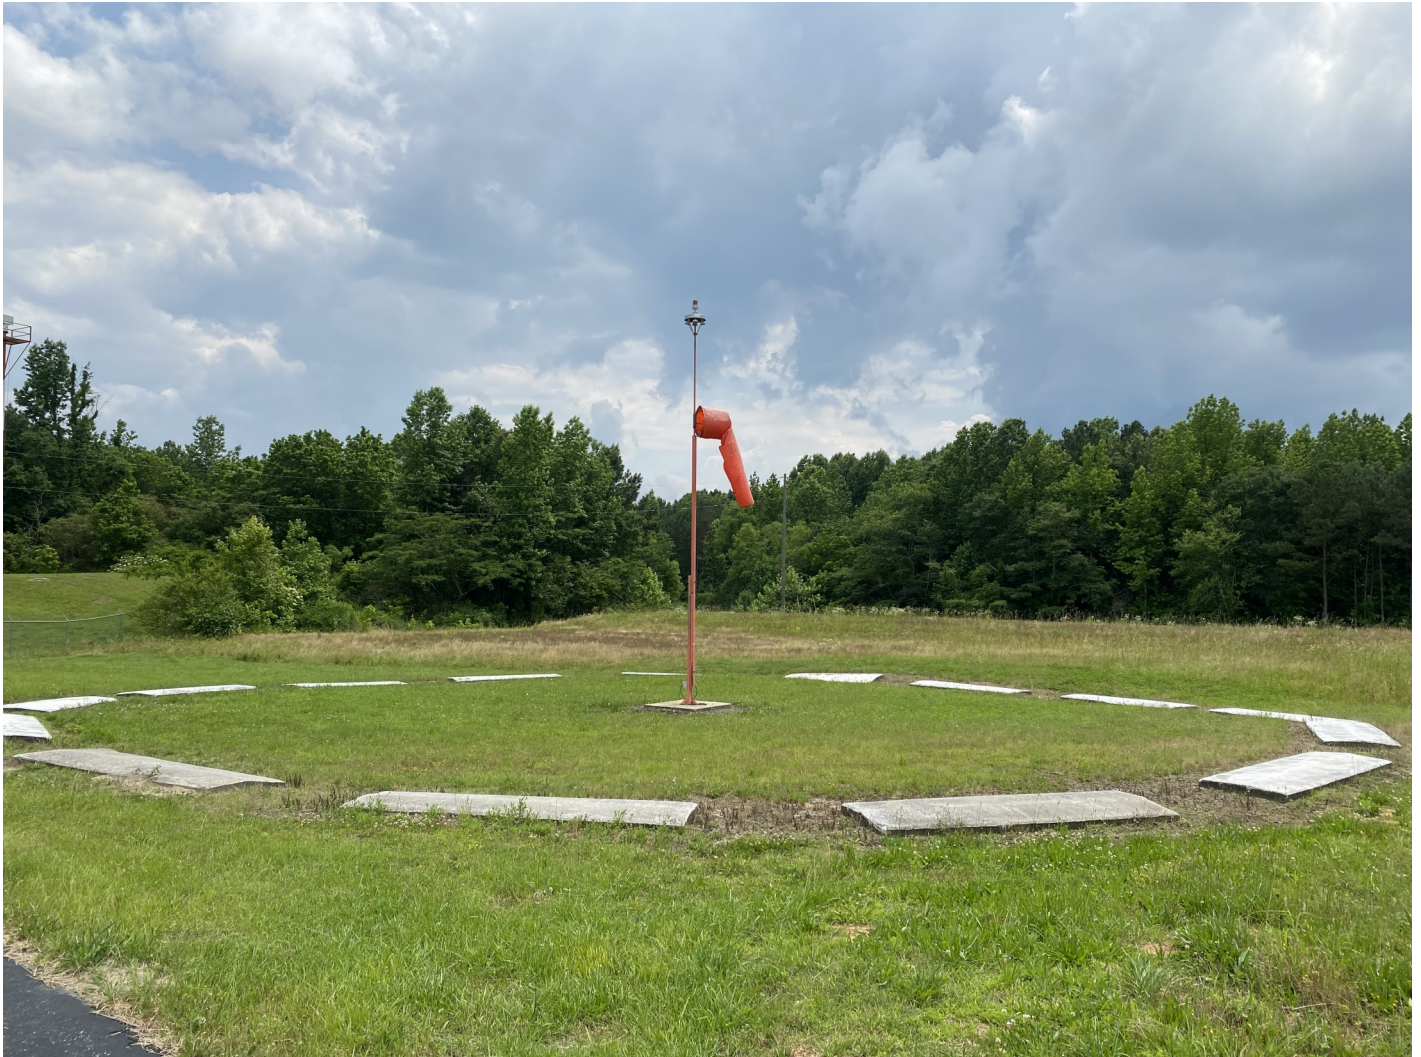
### Wind Direction Indicator

Wind direction indicator is in **GOOD** condition.

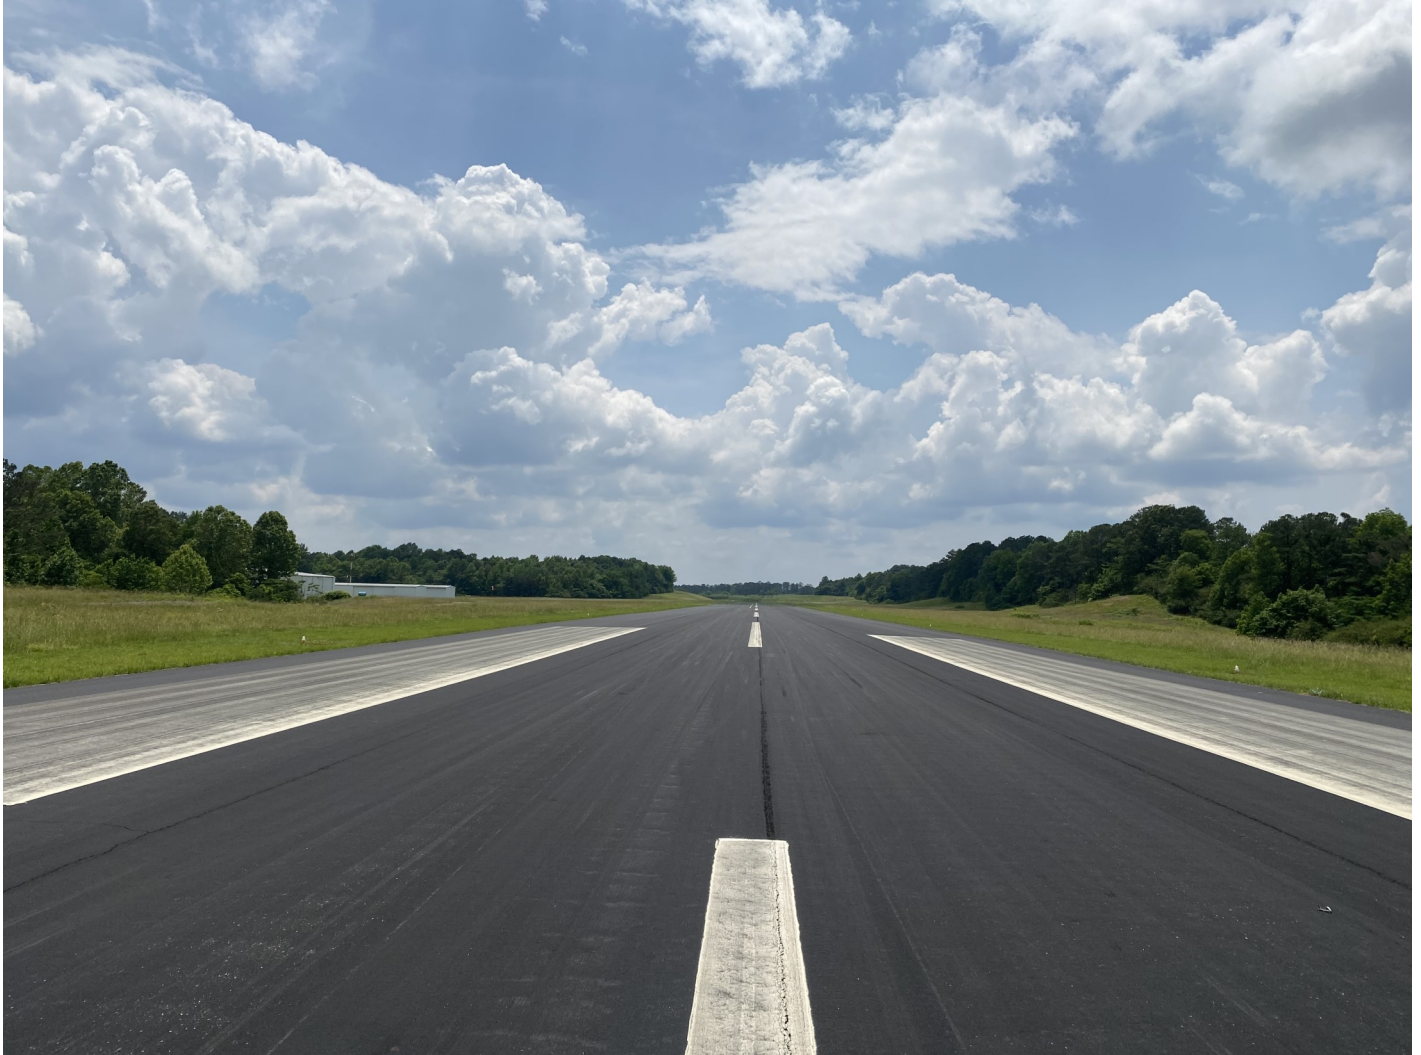
### Runway, Taxiway and Apron Conditions—RUNWAY

Runway surface is in **GOOD** condition.

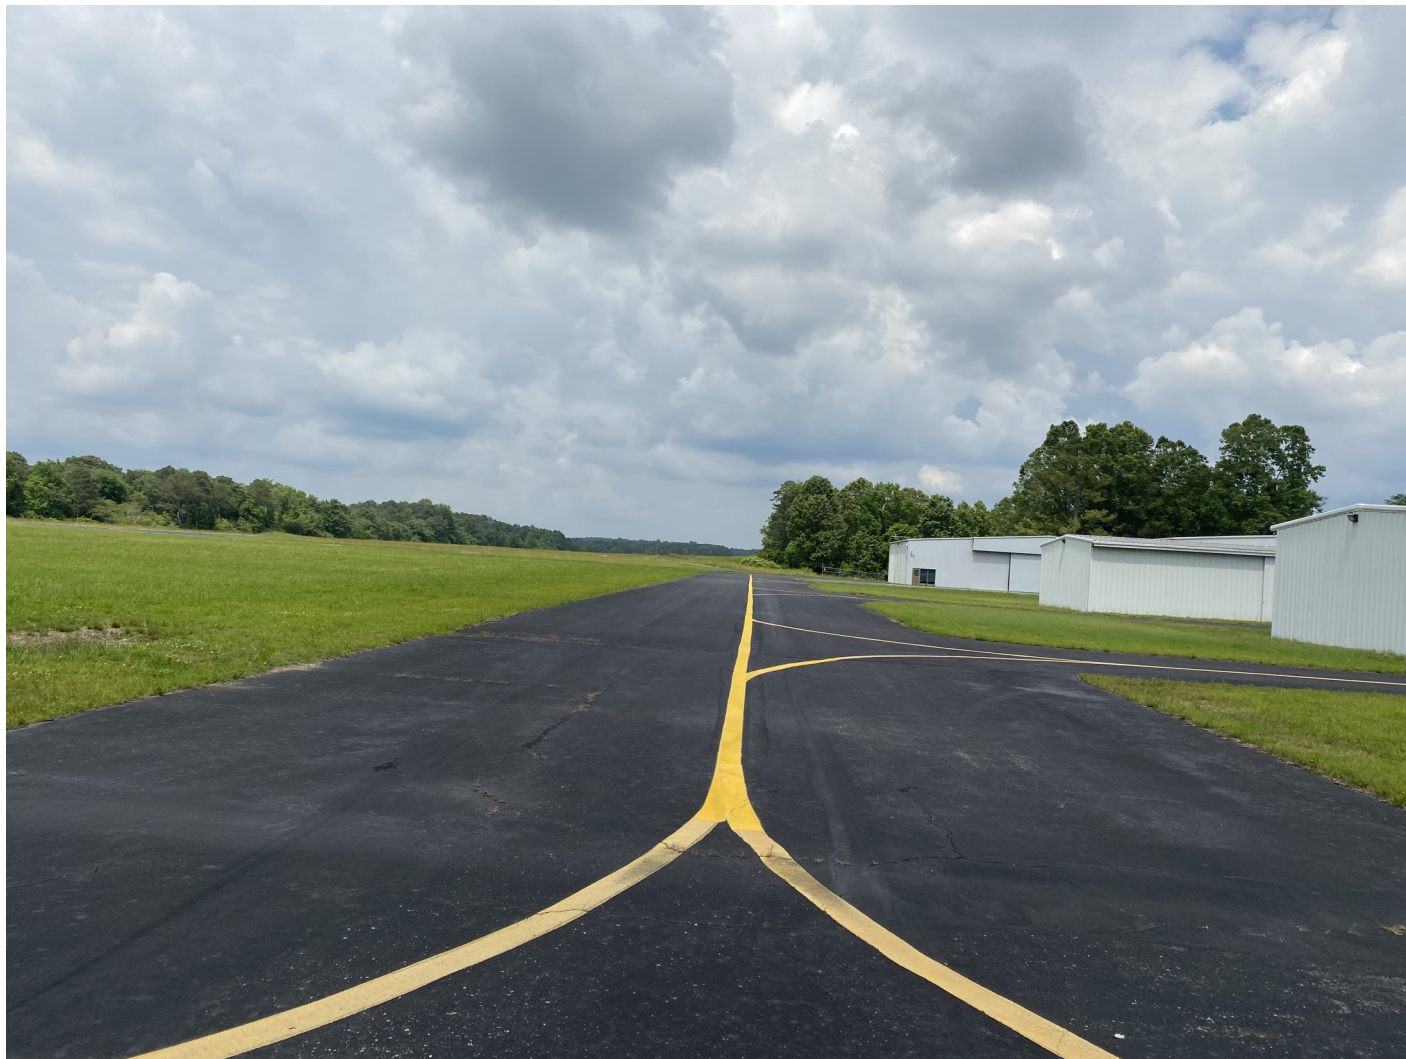
### Runway, Taxiway and Apron Conditions—TAXIWAY

The Taxiway surface is in **GOOD** condition.

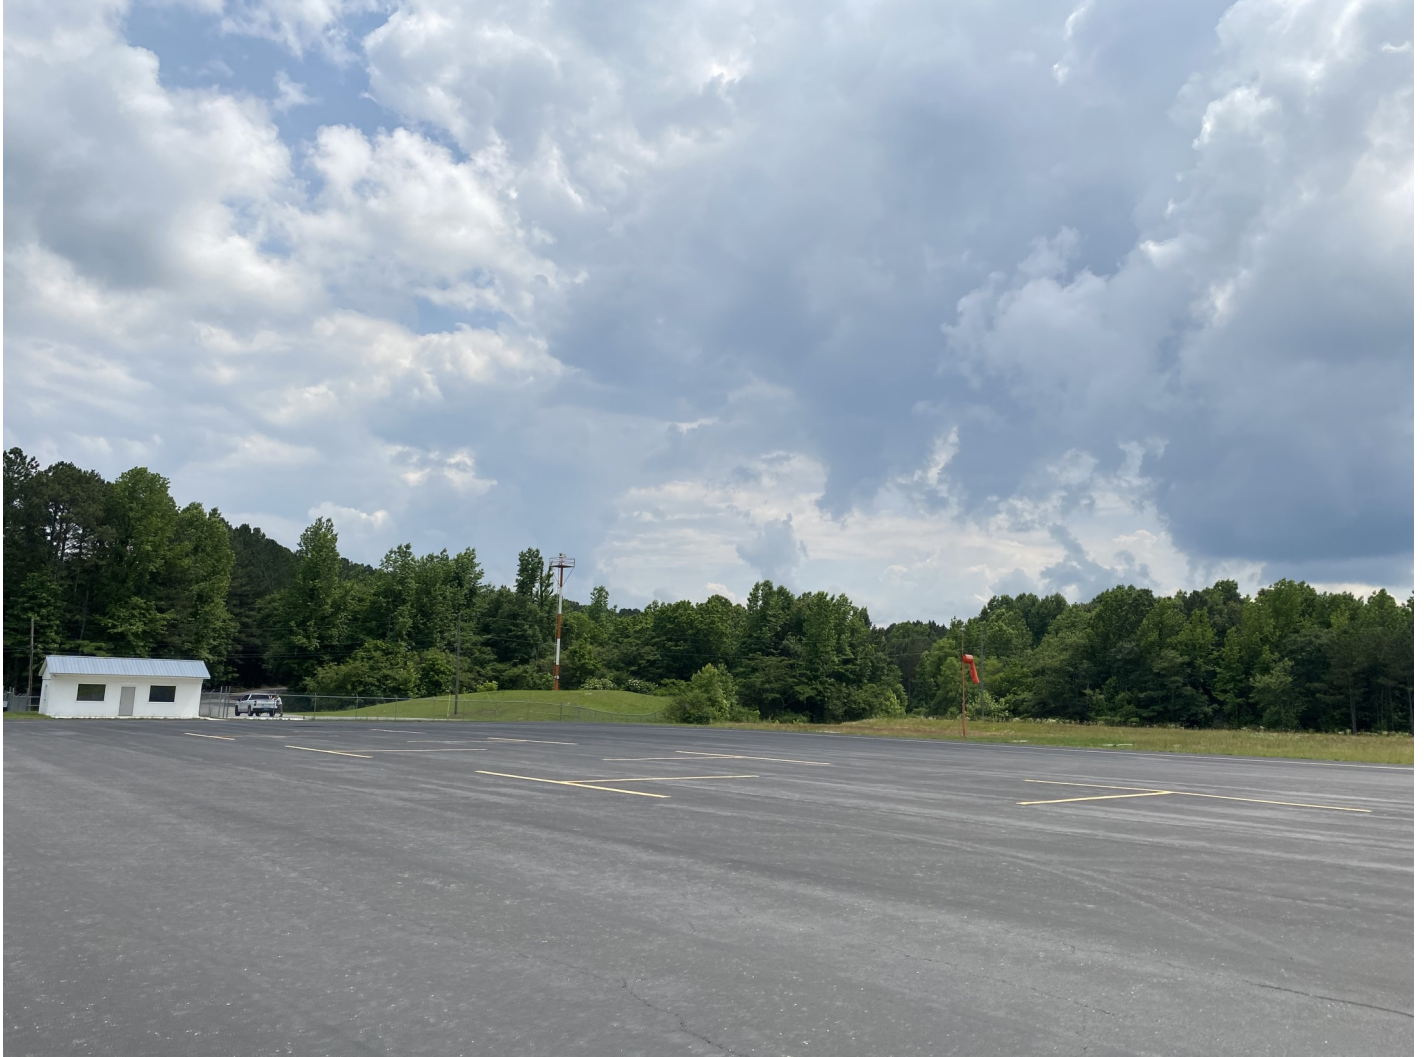
### Runway, Taxiway and Apron Conditions—APRON

Apron surface is in **GOOD** condition.

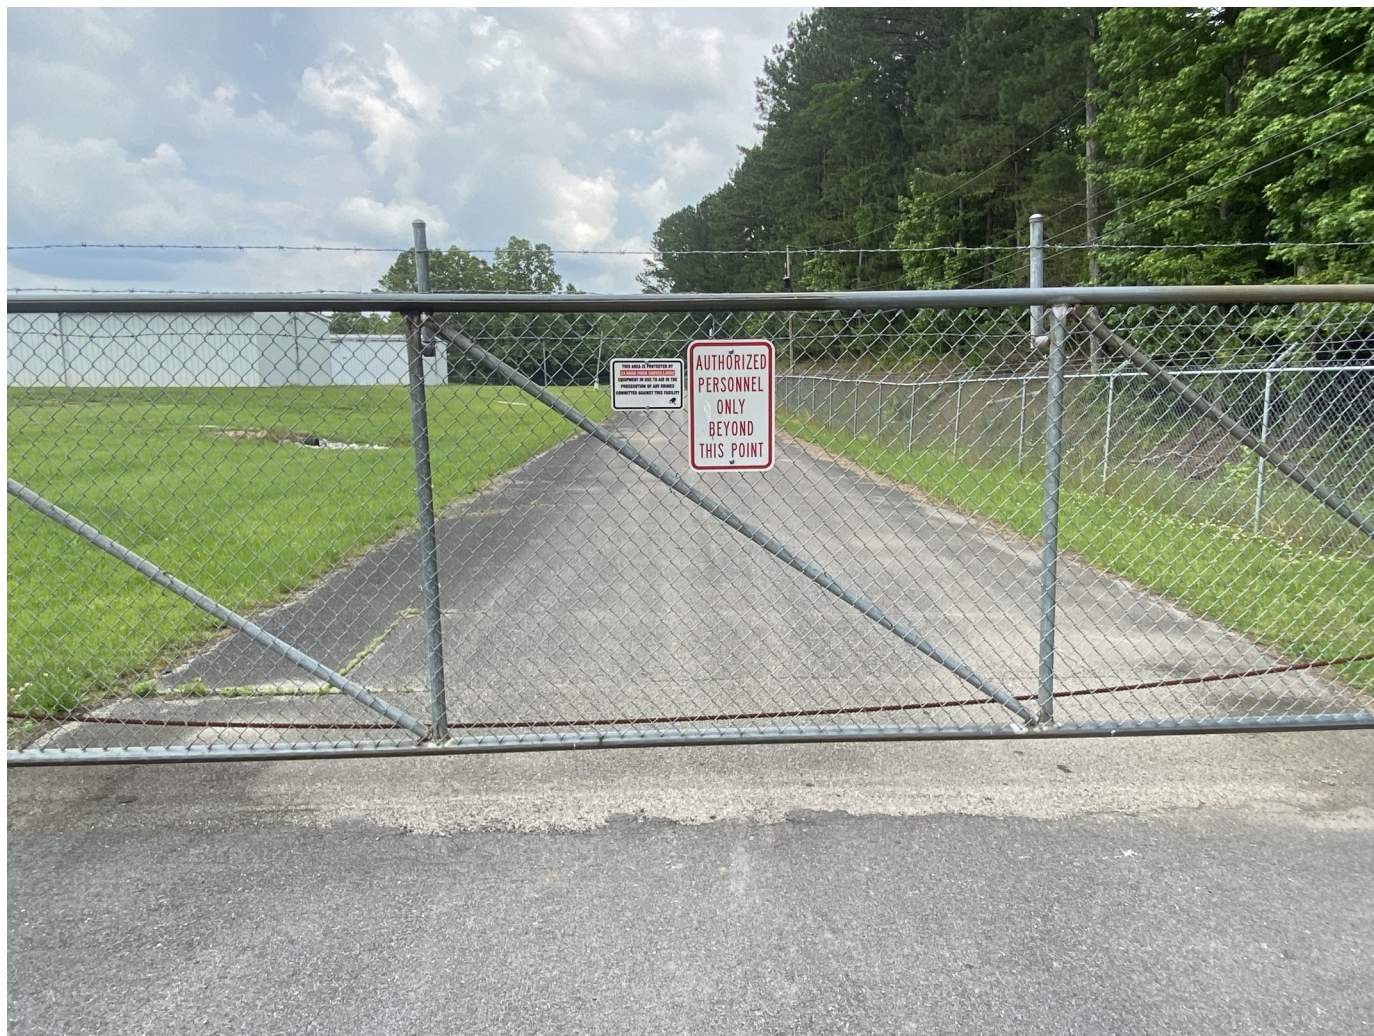
### Prohibited Activities

No prohibited activities were observed during this inspection.

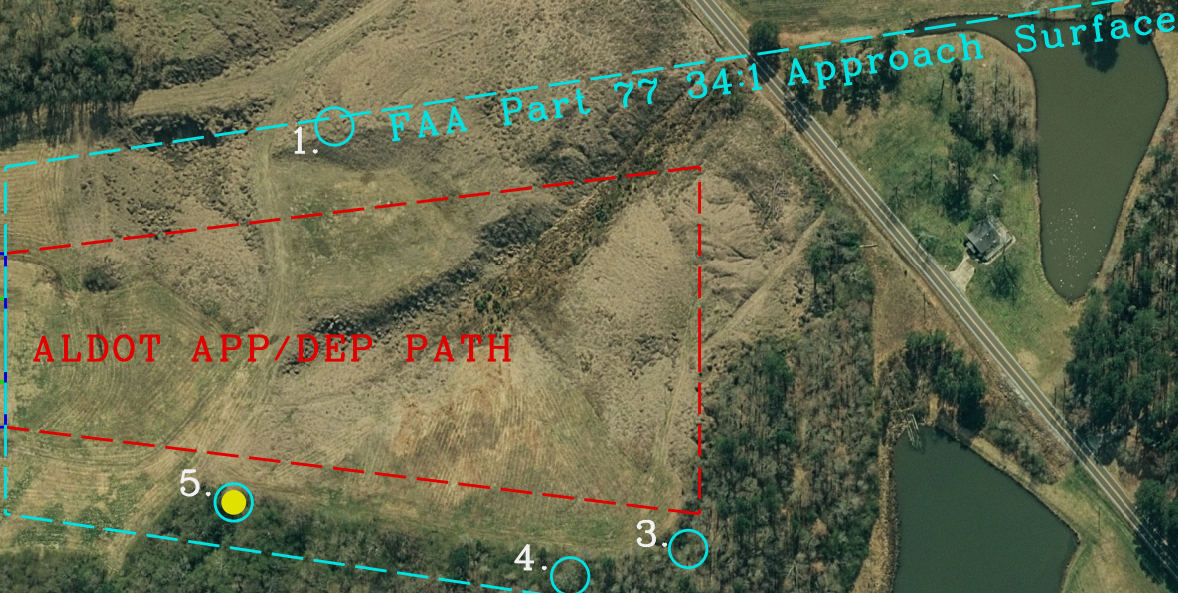
ROBBINS FIELD AIRPORT  
ONEONTA, AL  
MAY 31, 2023  
RUNWAY 6 OBSTRUCTION EVALUATION

1. Hill 30' Abv. Rwy  
703' From Rwy End  
308' Right of CL  
16:1 Obst. Clrnc

3. Tree 82' Abv. Rwy  
1,183' From Rwy End  
300' Left of CL  
11:1 Obst. Clrnc

4. Tree 91' Abv. Rwy  
1,013' From Rwy End  
108' Left of CL  
8:1 Obst. Clrnc

5. Tree 89' Abv. Rwy  
529' From Rwy End  
233' Left of CL  
3:1 Obst. Clrnc

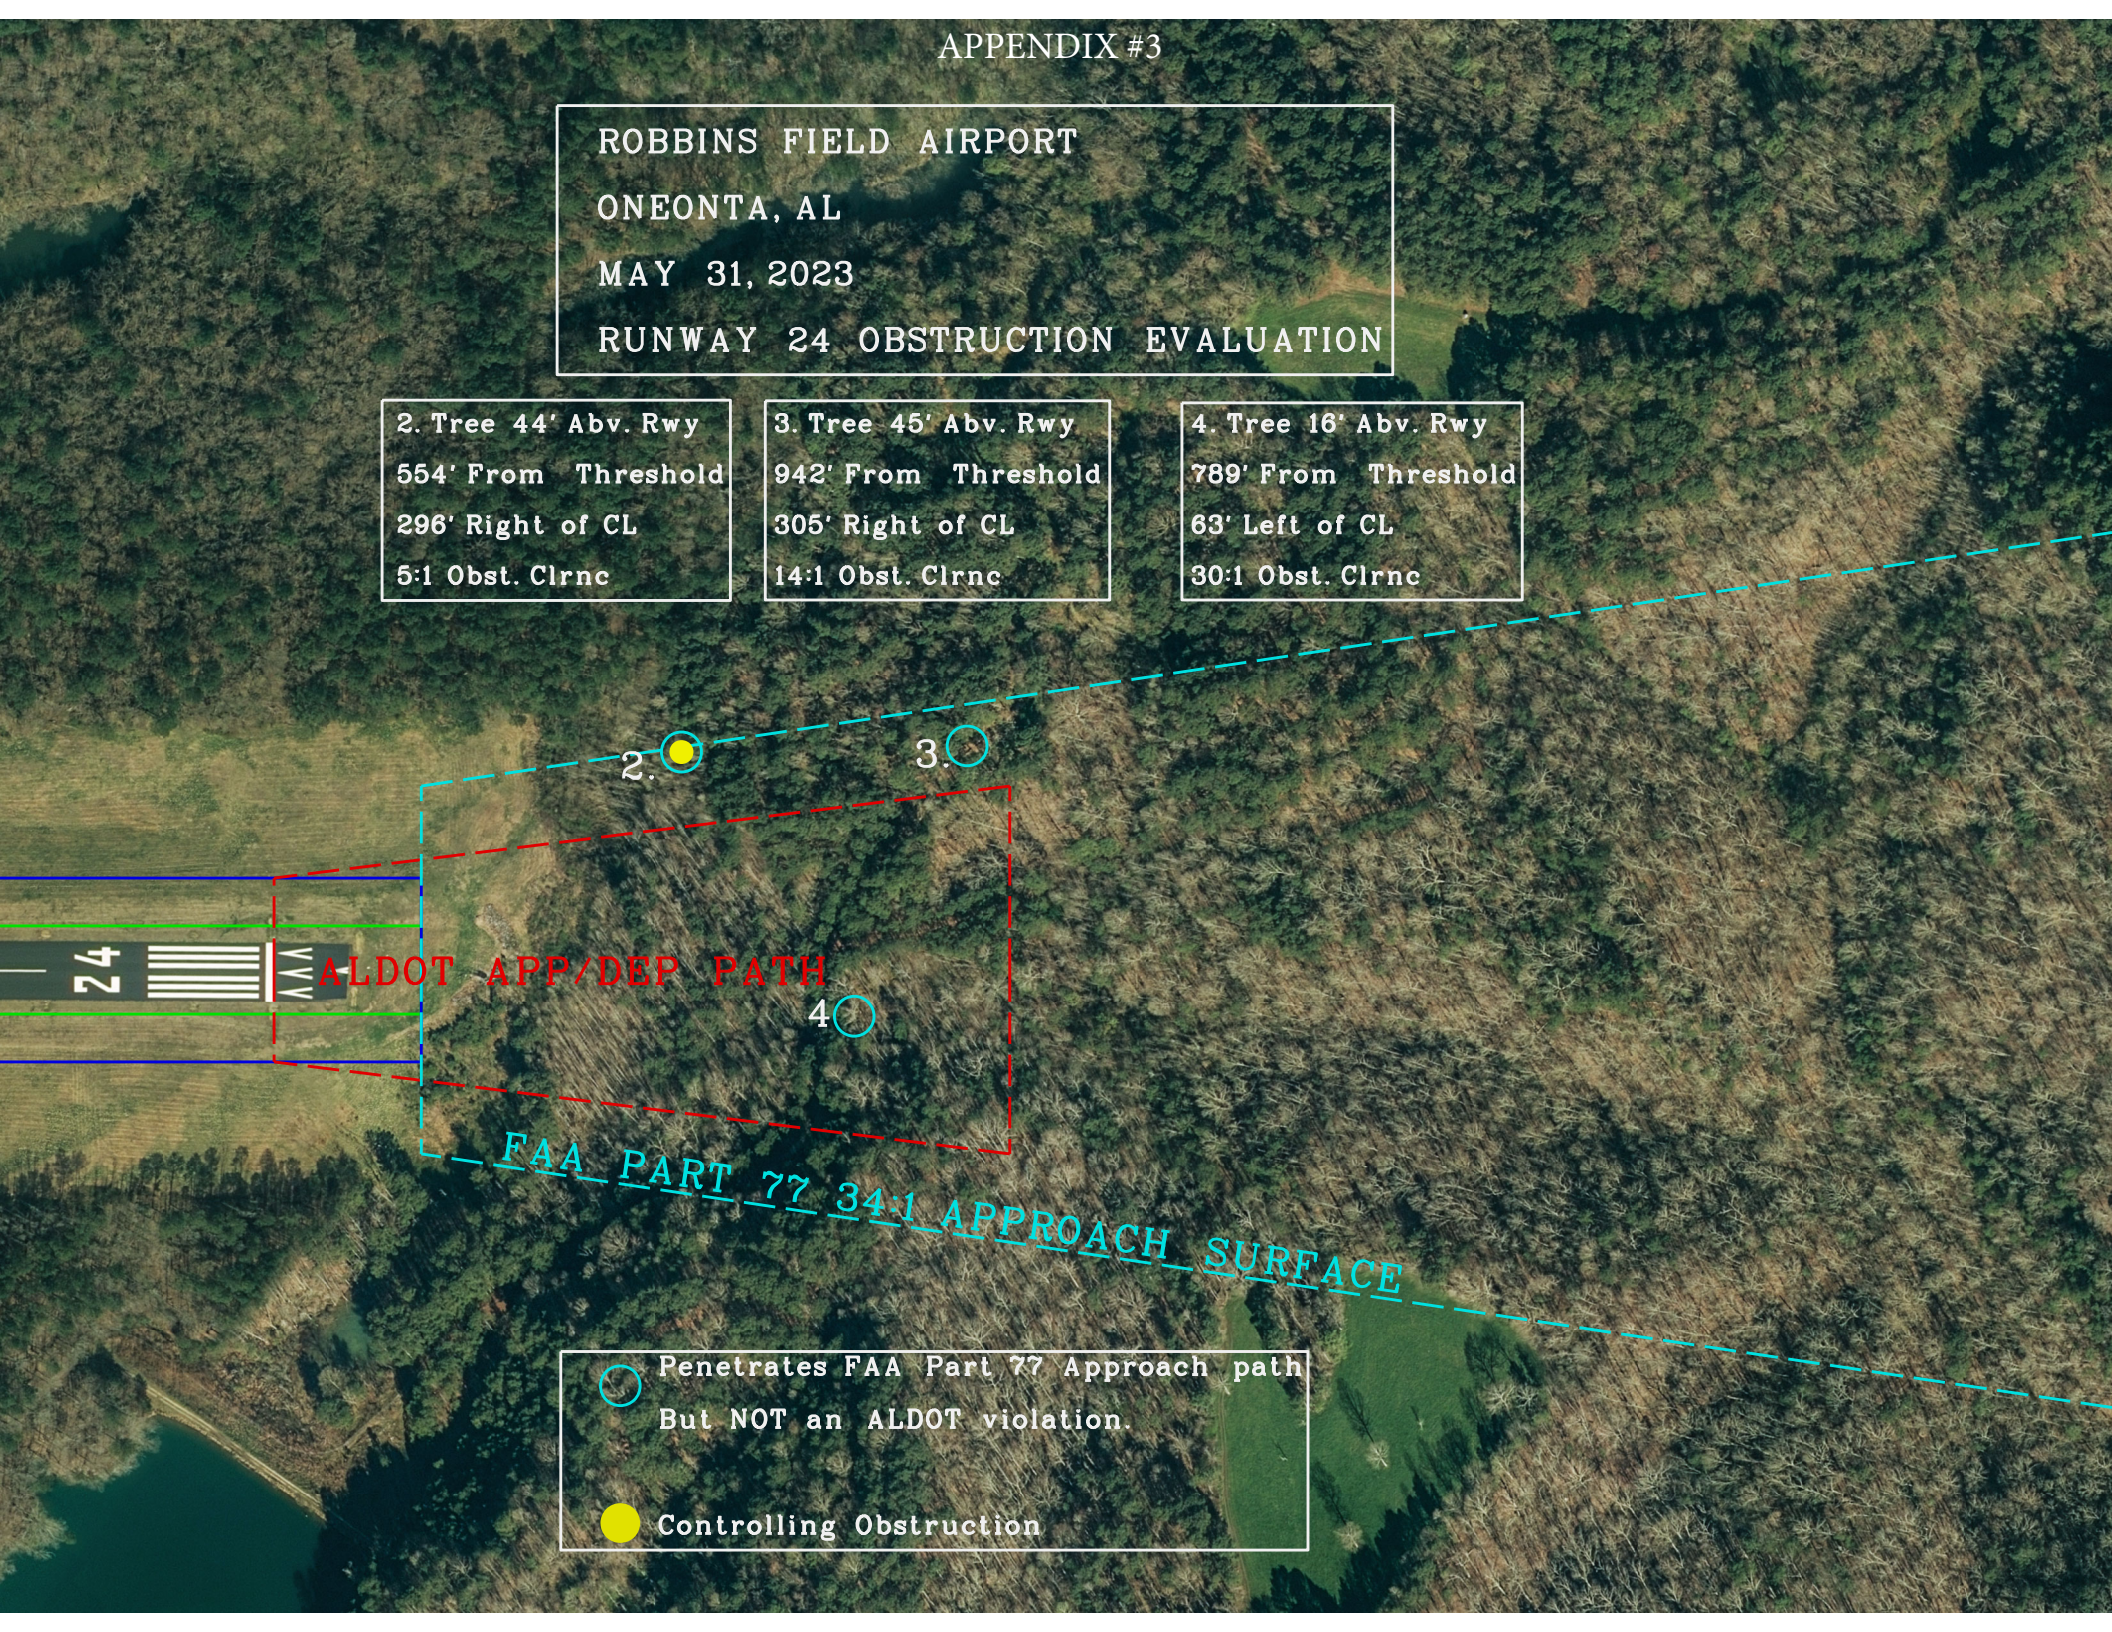
ROBBINS FIELD AIRPORT  
ONEONTA, AL  
MAY 31, 2023  
RUNWAY 24 OBSTRUCTION EVALUATION

2. Tree 44' Abv. Rwy  
554' From Threshold  
296' Right of CL  
5:1 Obst. Clrnc

3. Tree 45' Abv. Rwy  
942' From Threshold  
305' Right of CL  
14:1 Obst. Clrnc

4. Tree 16' Abv. Rwy  
789' From Threshold  
63' Left of CL  
30:1 Obst. Clrnc
