Subject: Annual Inspection Report
Stevenson/Bridgeport Municipal Airport

Annual Inspection Report Stevenson/Bridgeport Municipal Airport Stevenson, Alabama

May 22, 2007

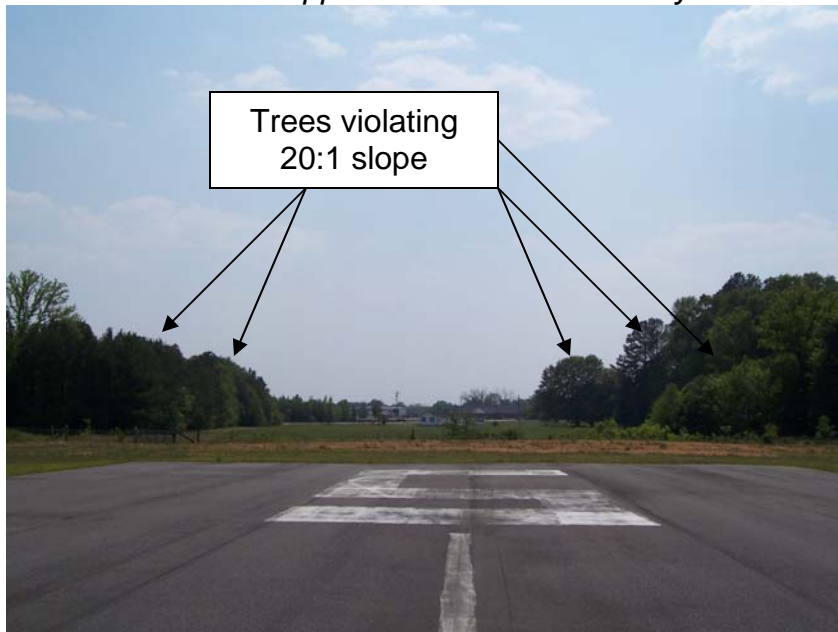
Photo 1 – Approach Violations Runway 5

- Runway 05 – The required 20:1 approach slope is violated by trees along the South side of the approach. These trees were cleared along the line of the Approach/Departure Path, but the trees have grown and now violate the required clear area.

- Runway 05 – Trees violate the required 20:1 approach slope along the North side of the approach. The required 20:1 approach slope is reduced to 1:1.
- See Appendix 2 for locations of the violations.

- The violating trees must be removed throughout the Approach/Departure Path. The tree line along the South side now violates the required approach. There are fewer trees in the Approach/Departure Path than within the Displaced Approach. The clearing of the Approach/Departure Path will enable the airport to remove the present displaced threshold and meet licensing requirements on this runway end. The required displacement to provide a clear 20:1 slope is 855 feet.

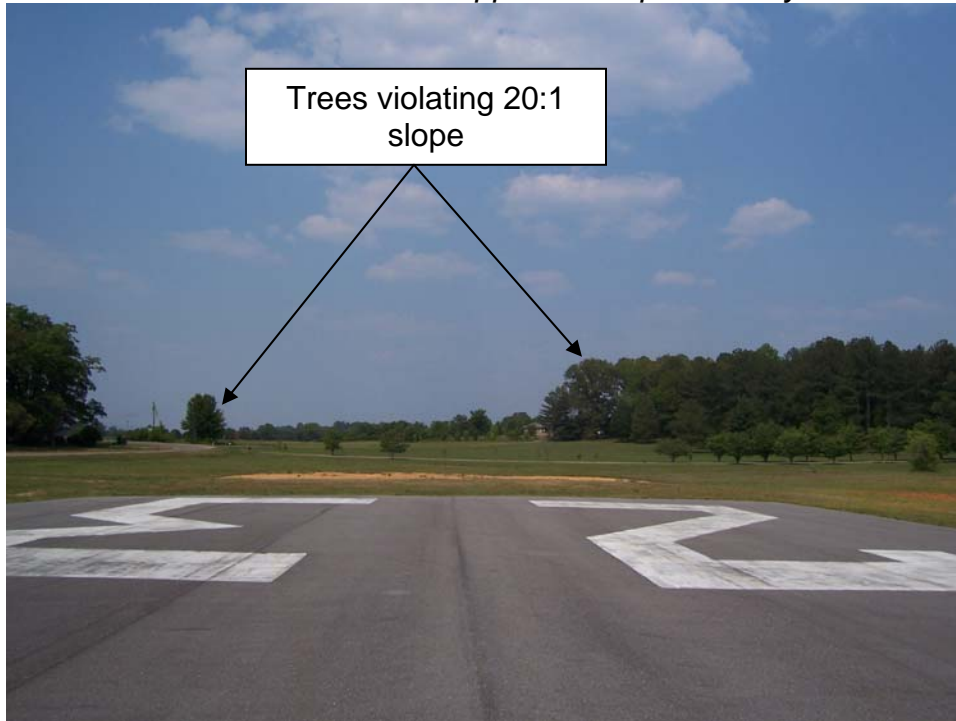
Photo 2 – Violations of approach slope Runway 23

- Runway 23 – Trees violate the required 20:1 approach slope and reduce the slope to 6:1.
- See Appendix 3 for locations of the violations.

- The trees that violate the required 20:1 approach slope must be removed from within the Approach/Departure Path.
- The present 1048 foot displacement of the runway can be reduced to a displacement of 873 feet and increase the available runway for landing from the East. The 873 foot displacement will place the end of the 1000 foot approach on the airport property line. This displacement is intended to be a temporary solution until the City can clear the trees on adjoining property that violate the licensing requirements.

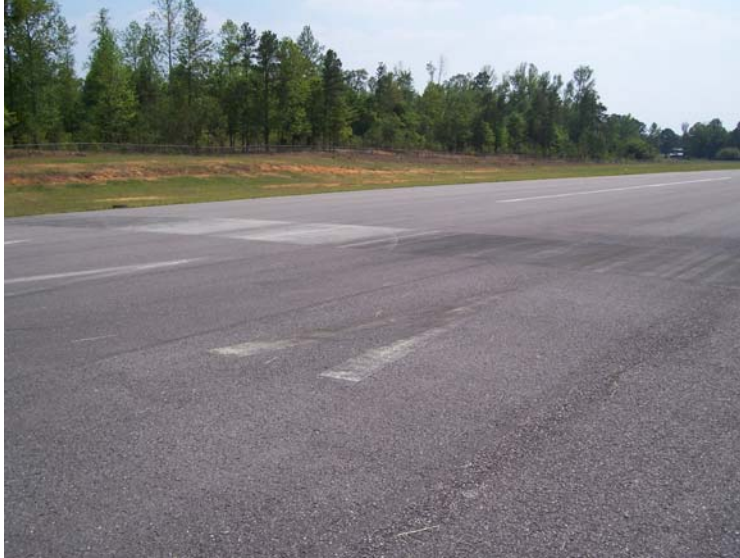
Runway 23

- The markings of Runway 04/22 are in *Good* condition with the exception of the displaced markings, which are not legible.

Photo 3 – Displacement Markings in Poor condition

- The displaced thresholds must be marked in accordance with FAA AC150/5340-1J "Standards for Airport Markings". A copy of the pertinent portions of this AC is included with this report.

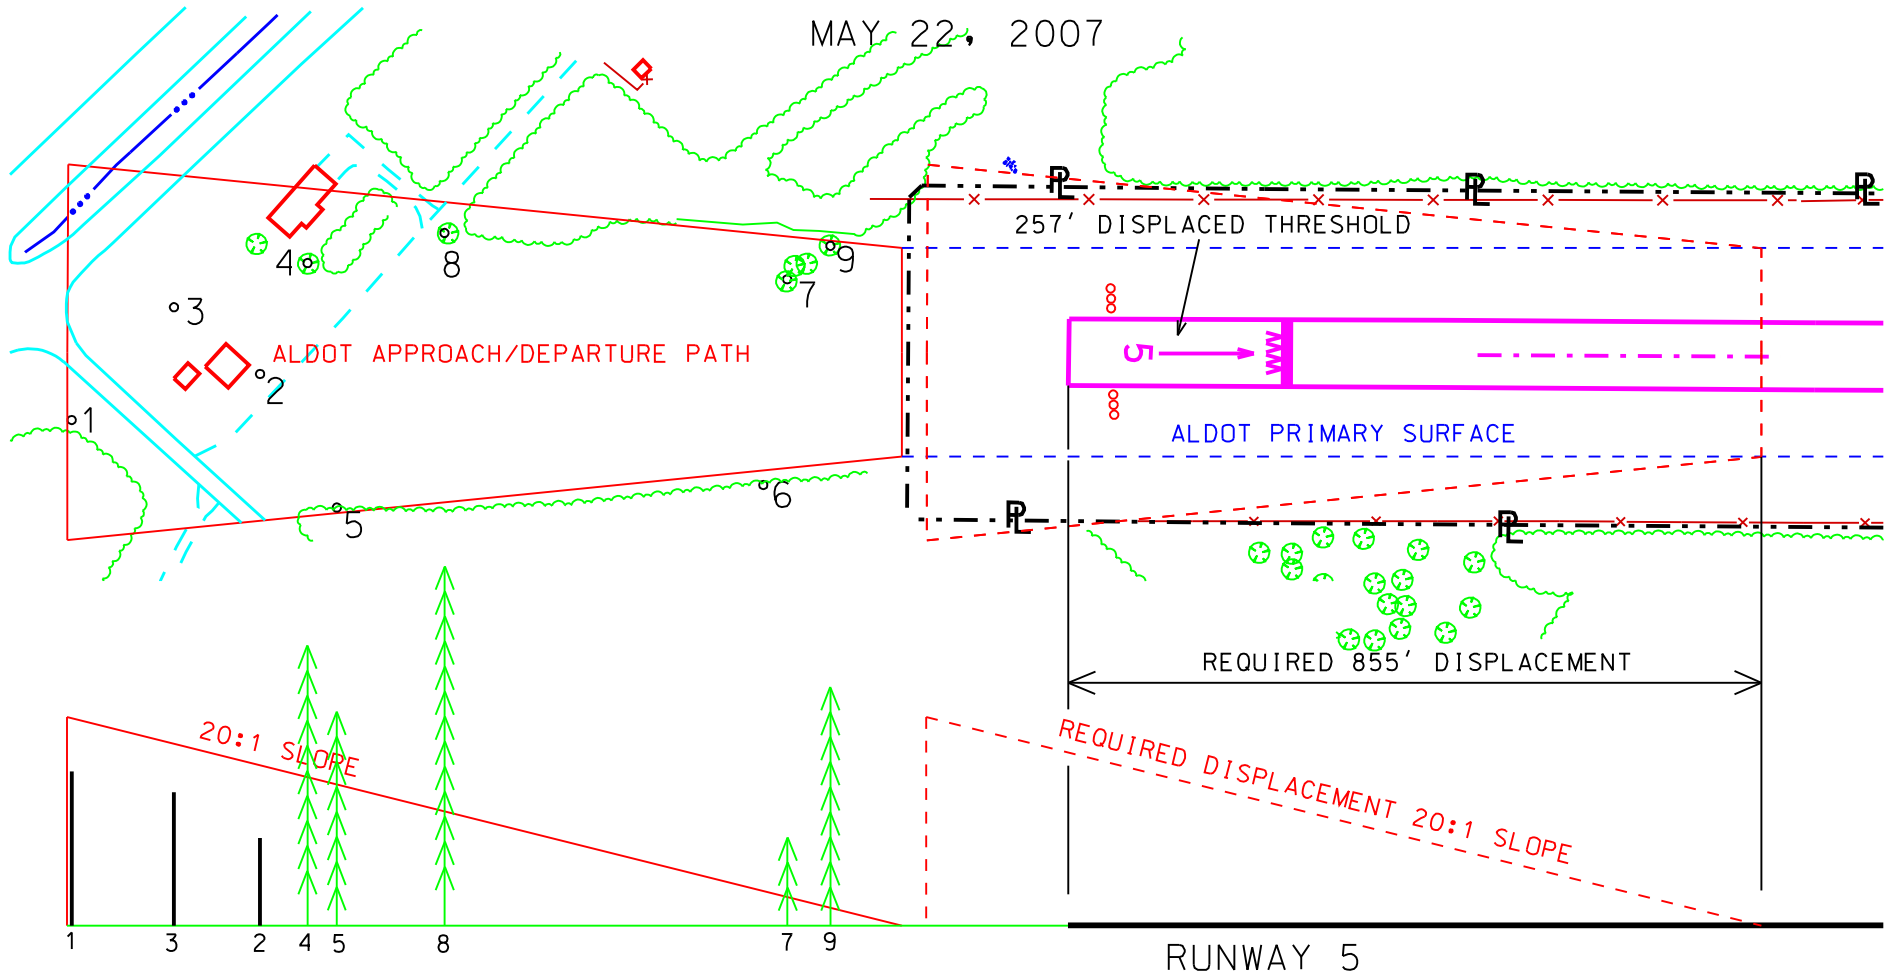
| 4. +67' TREE

912' FROM RUNWAY END
107' FROM CENTERLINE
10:1 SLOPE | 8. +86' TREE
748 FEET FROM RUNWAY END
143' FROM CENTERLINE
6:1 SLOPE |

| 5. +51' TREE LINE

757' TO 877' FROM RUNWAY END
143' FROM CENTERLINE
12:1 SLOPE | 9. +57' TREE
285' FROM RUNWAY END
128 FEET FROM CENTERLINE
1:1 SLOPE |

| 7. +21' TREE

337' FROM RUNWAY END
88' FROM CENTERLINE
6:1 SLOPE | NOTE: #8 AND #9 DELINEATE A TREE LINE |

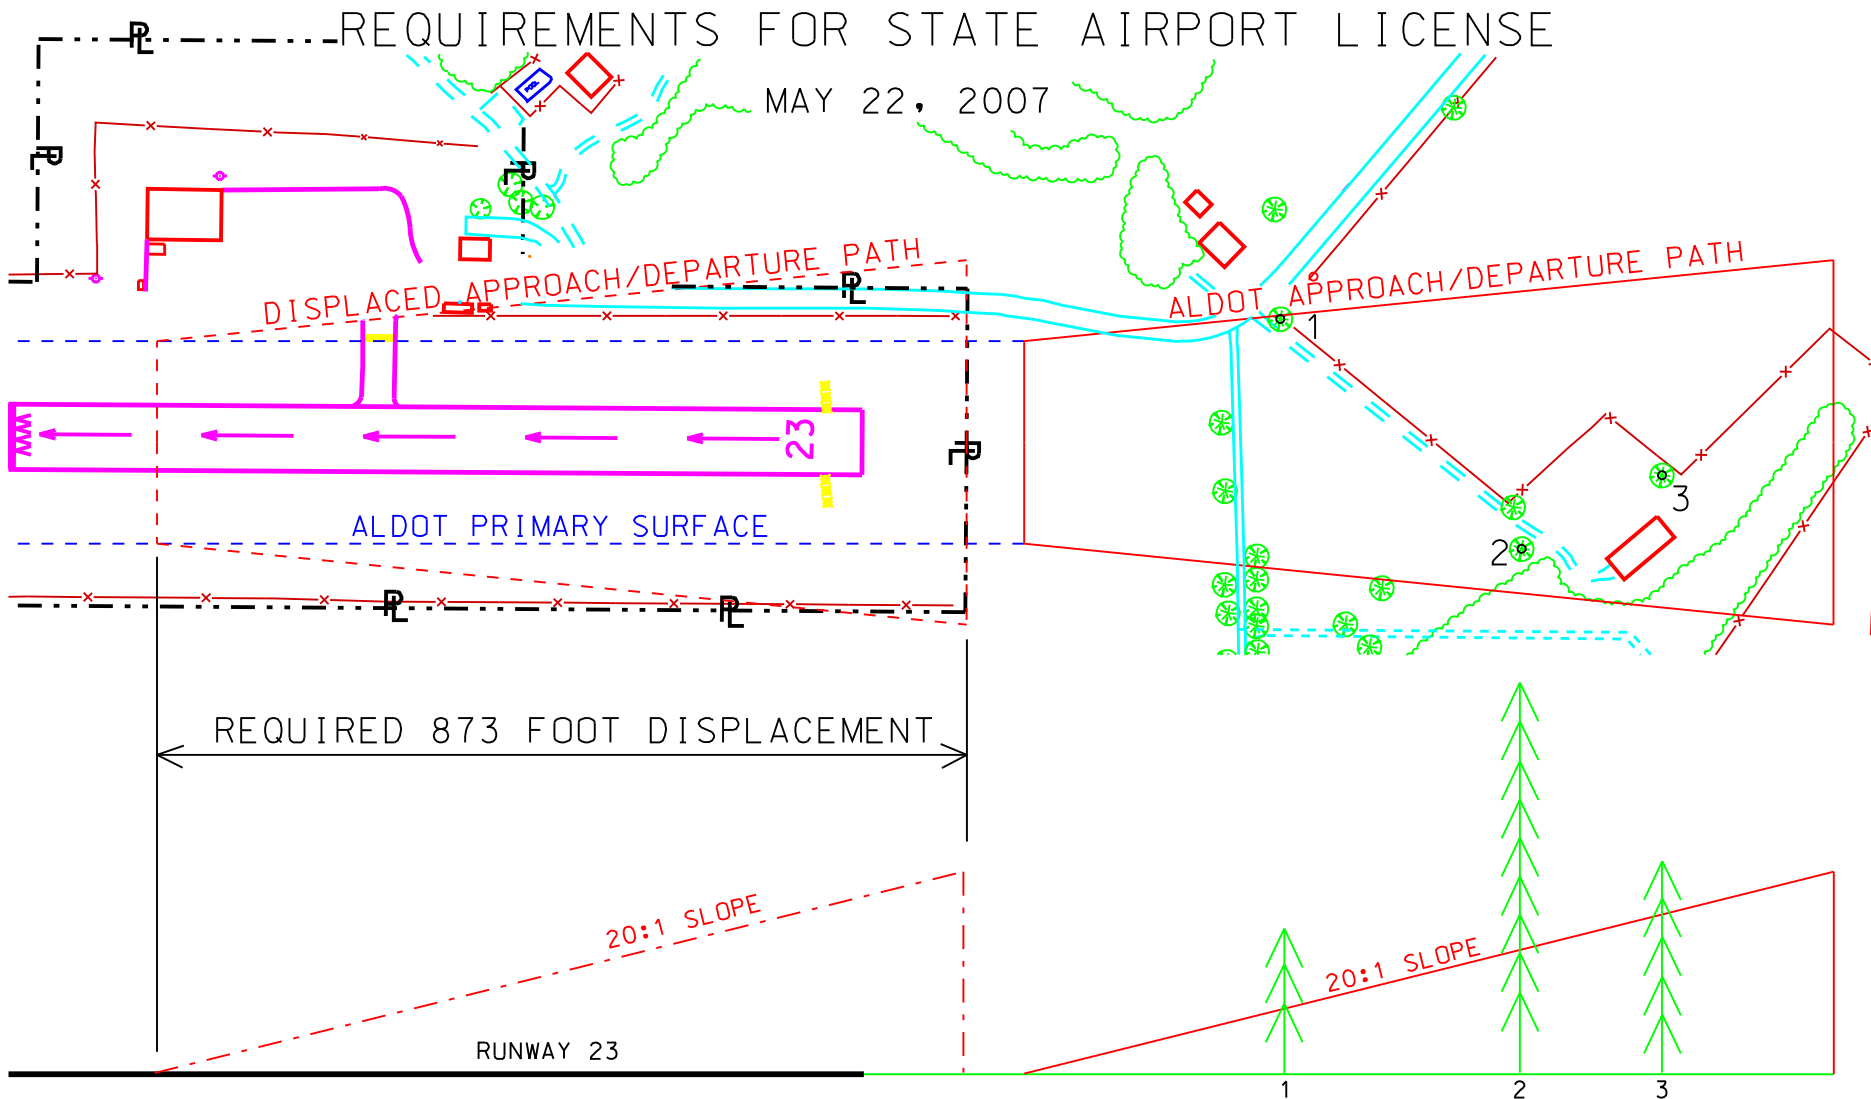
1. +36' TREE
510' FROM RUNWAY END
156' FROM CENTERLINE
8:1 SLOPE
2. +96' TREES
807' FROM RUNWAY END
137' FROM CENTERLINE
6:1 SLOPE
3. +52' TREES
989' FROM RUNWAY END
38' FROM CENTERLINE
15:1 SLOPE
