**Subject: Annual Inspection Report**  
**Pryor Field Regional Airport (DCU)**

# Annual Inspection Report

**Annual Inspection Report  
Pryor Field Regional Airport (DCU)  
Decatur, Alabama**

October 16, 2017

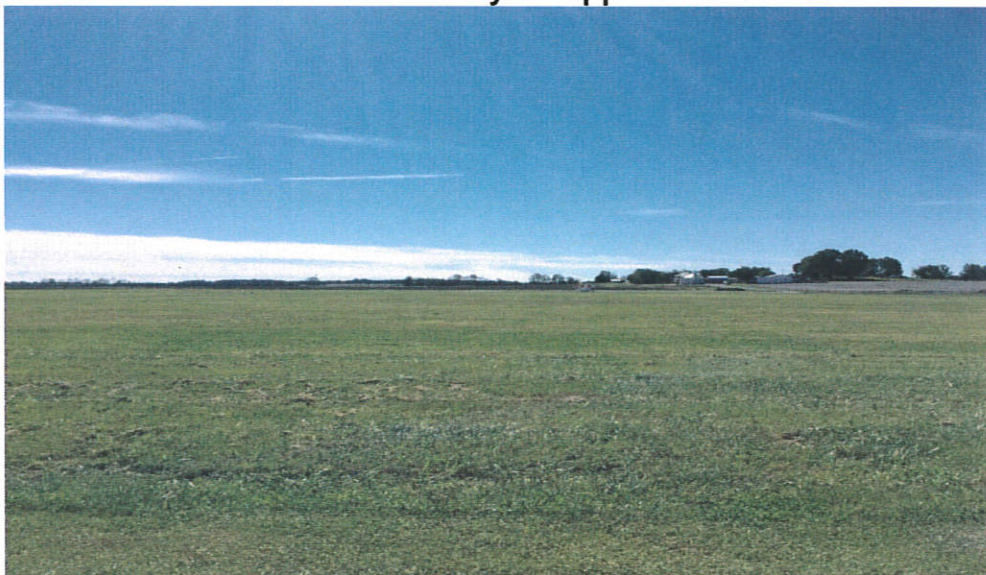
**Photo #1 – Runway 18 Approach Path**

- Runway 18 - No obstructions (See Photo #1).
- Runway 36 - No obstructions (See Photo #2).

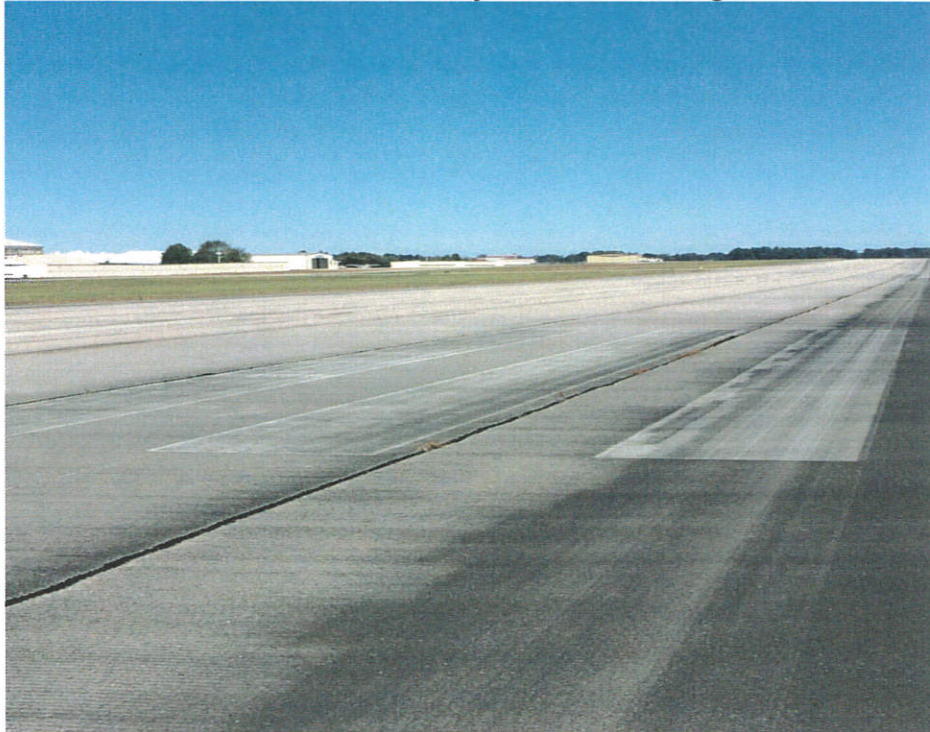
**Photo #3 – Runway 18 PIR Markings**

- The runway markings are in **FAIR** condition (See Photo #3).

- The current markings could possibly be cleaned with a water and bleach mixture followed by power washing. If the markings are unable to be cleaned, new markings should be applied in accordance with FAA AC 150/5340-1L.

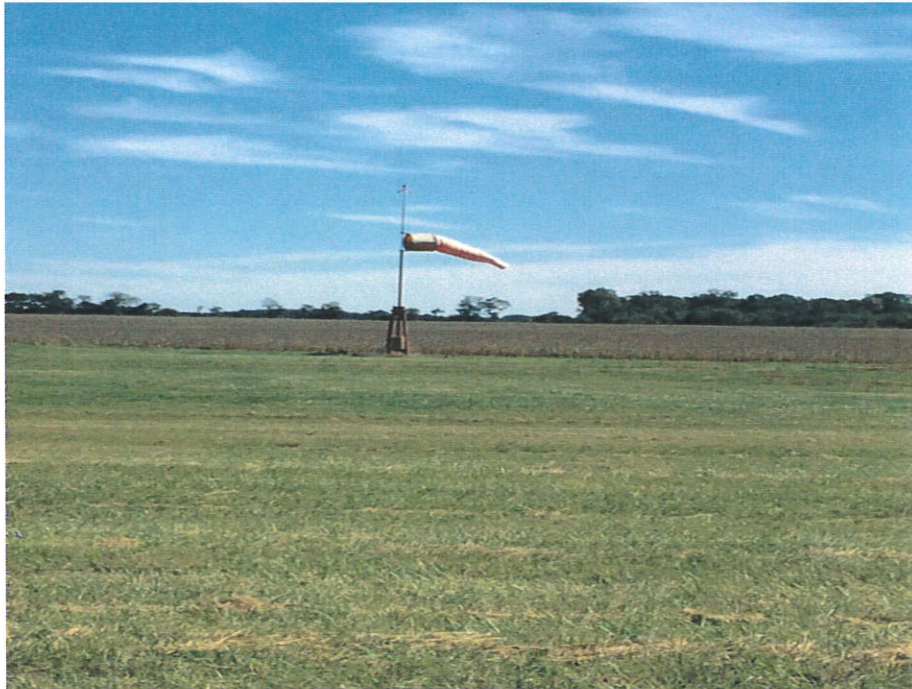
**Photo #4 – Wind Direction Indicator**

- The wind direction indicator (wind sock) is in GOOD condition (See Photo #4).

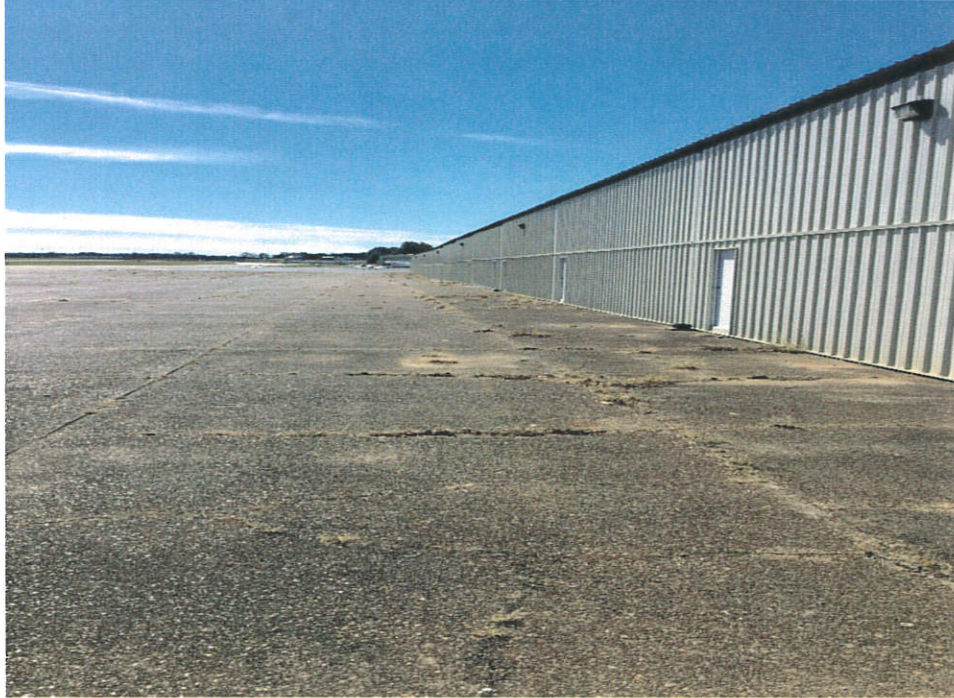
**Photo #5 – Taxilane Cracking and Vegetation**

<b>Ramp</b>	<b>GOOD</b>
<b>Taxiways</b>	<b>GOOD</b>
<b>Taxilanes</b>	<b>POOR.</b> The taxilanes are experiencing cracking, rutting, and raveling with vegetation appearing through the cracks (See Photo #5).
<b>Runway</b>	<b>GOOD</b>

- The airport should contact their airport consultant to plan future pavement rehabilitation in this area.
