**Subject: Annual Inspection Report
Eutaw Municipal Airport**

**ANNUAL INSPECTION REPORT
EUTAW MUNICIPAL AIRPORT
EUTAW, ALABAMA**

August 20, 2012

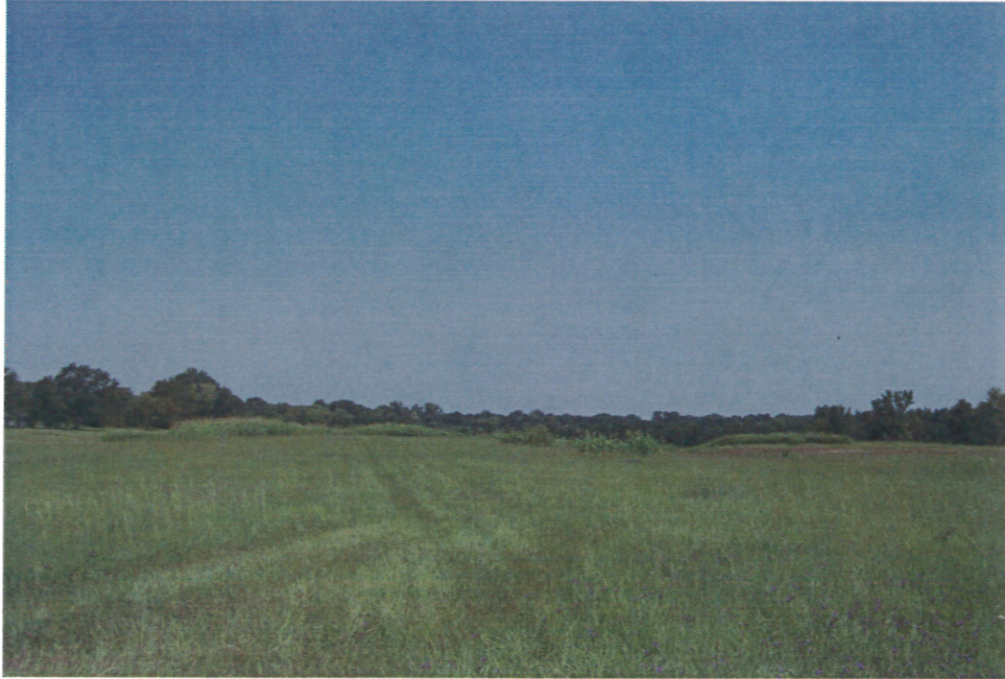
Photo 1

- ➔ The Approach/Departure Path Runway 16 is unobstructed.
- ➔ The Approach/Departure Path to Runway 34 is unobstructed.

Approach to Runway 16

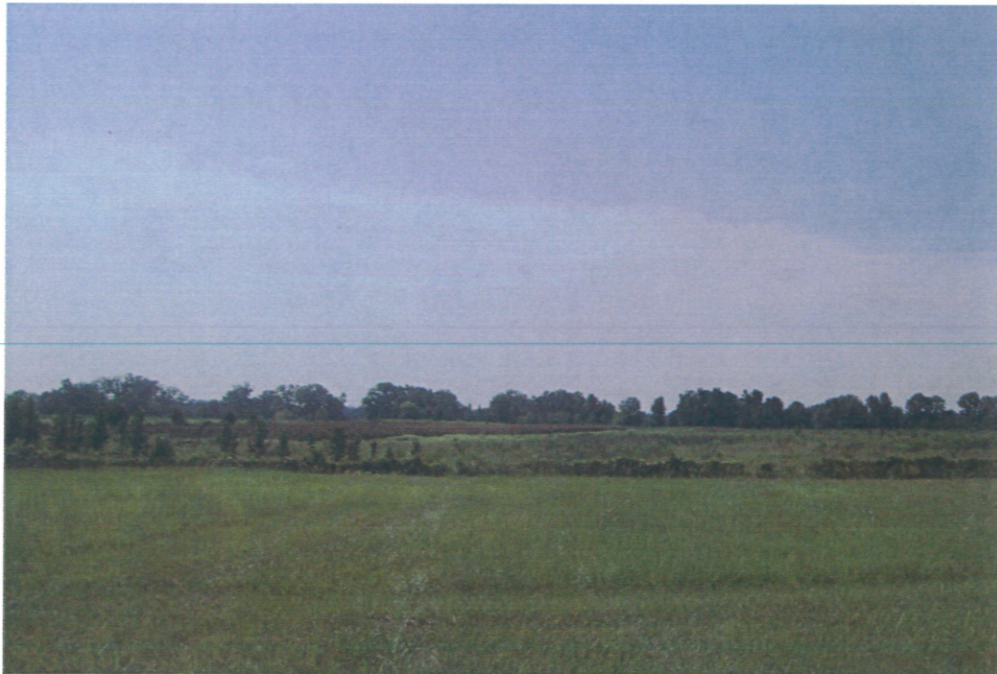
Photo 2

Approach to Runway 34

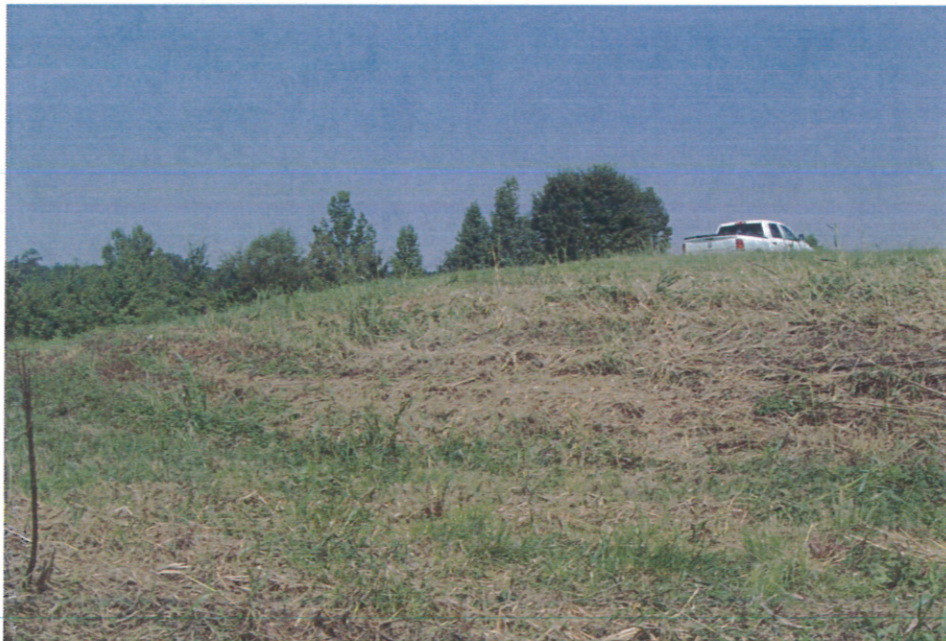
Photo 3

- ➔ Runway 34 – The ground drops at a point 104 feet past the threshold in excess of the 3% allowable grade.

View from bottom of drop adjacent to Runway 34 threshold

- ➔ Fill, compact, and grade an area 200 feet in length and 120 feet in width with no more than a 3% slope along the length.

- ➔ Displace threshold 100 feet and remark runway as displaced in accordance with FAA AC150/5340-1K "Standards for Airport Markings" and relocate the threshold lights to the displacement point.

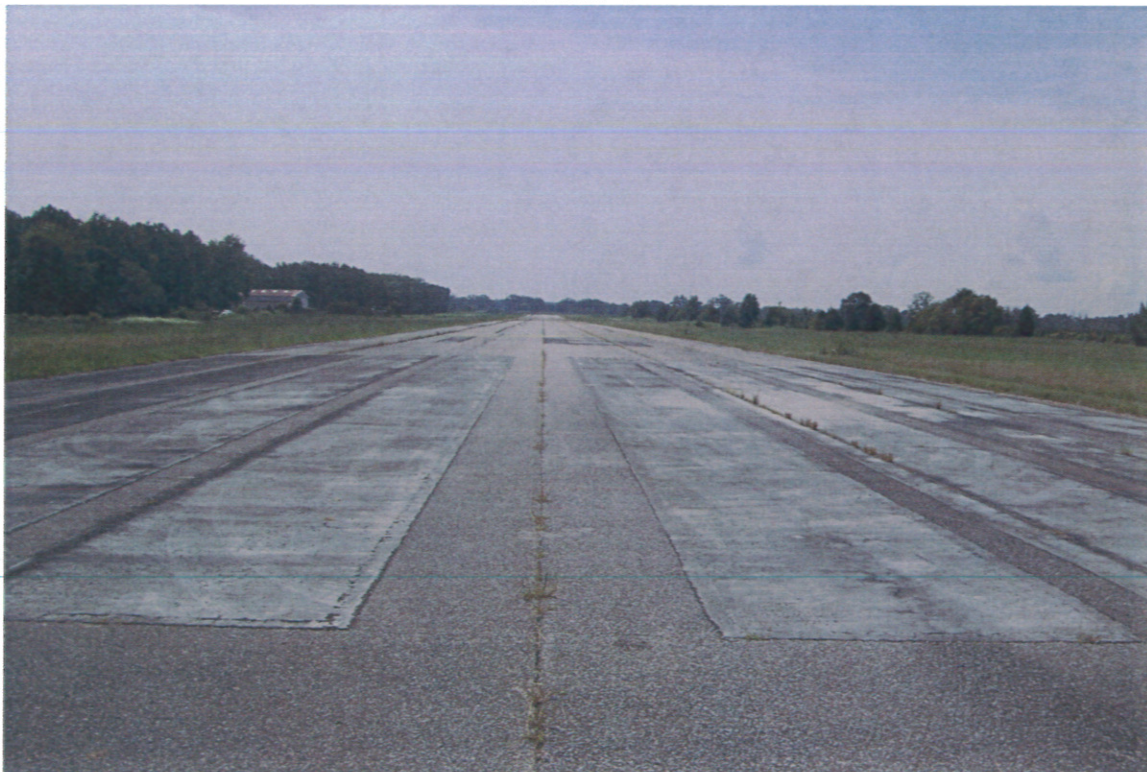
Photo 4

- The markings of Runway 16/34 are in *Poor* condition.

Runway Identifier markings of Runway 16

- Remark runway in accordance with the provisions of FAA AC150/5340-1K "Standards for Airport Markings".

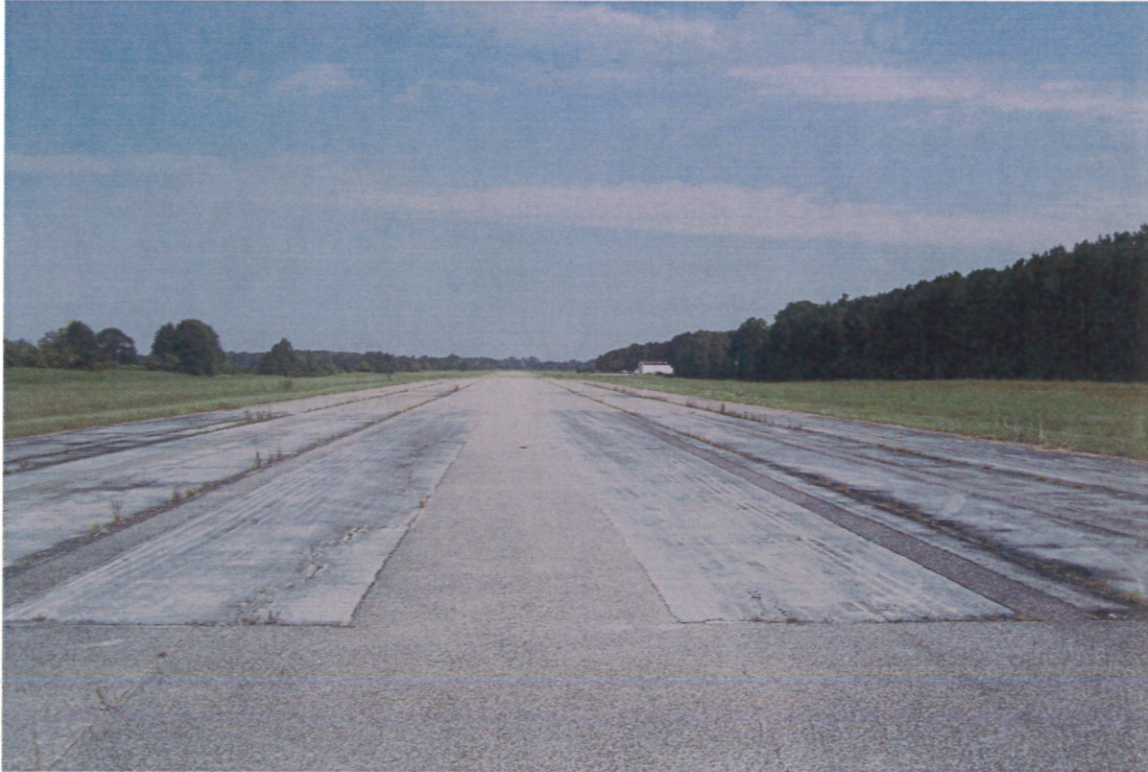
Photo 5

Runway Identifier markings of Runway 34

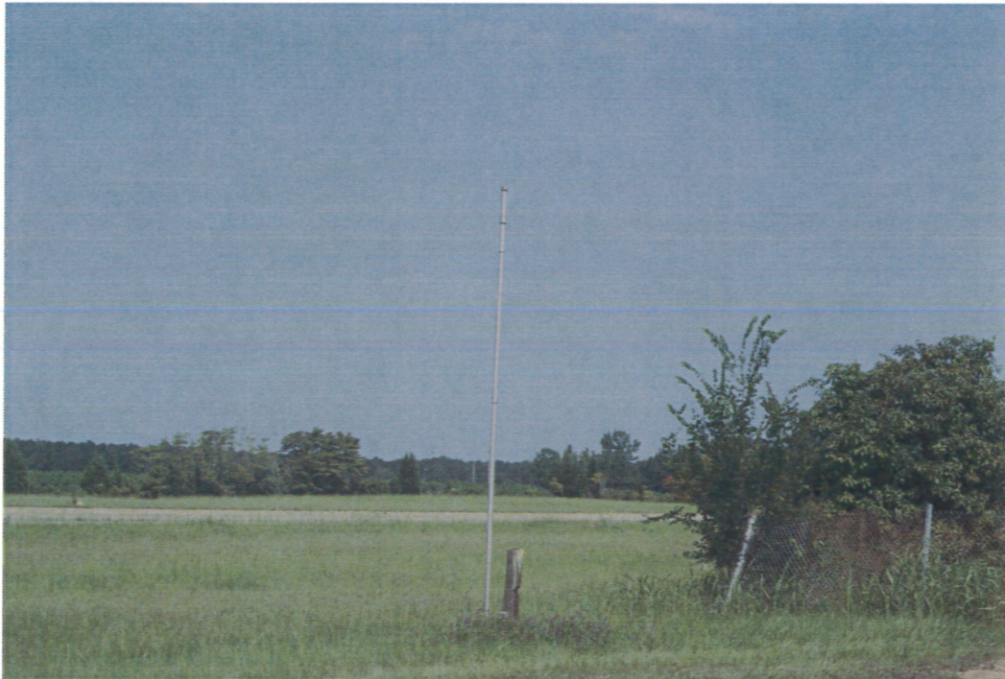
Photo 6

- The wind direction indicator was found to be missing.

Windsock mounting location

- Place a wind direction indicator as required.

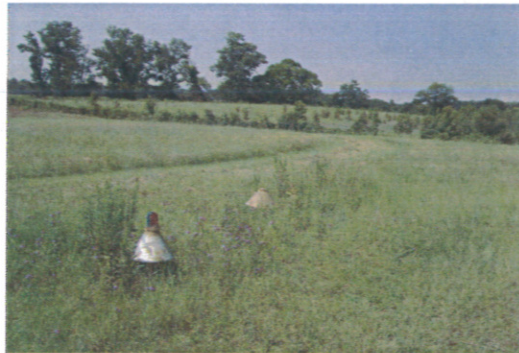
Photo 7

- ➔ The airport lighting system was inspected and found to have three runway light fixtures missing, five fixtures with missing globes and three broken mounting fixtures.
- ➔ Runway 16 has two threshold fixtures missing and one globe missing.
- ➔ Runway 34 has one threshold fixture missing and one broken.
- ➔ The runway lighting system is noted on the Airport Master Record as "Out of Service Indefinitely".
- ➔ The airport beacon is shielded from view by trees on the East side.

Threshold fixtures of Runway 34

- Close airport to night operations until lighting system is repaired.
- Replace all missing and out of service light fixtures.
- Relocate beacon to an unobstructed location.

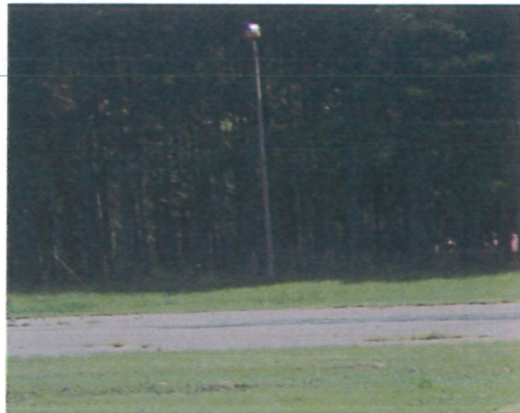
Photo 8

Airport beacon shielded by trees

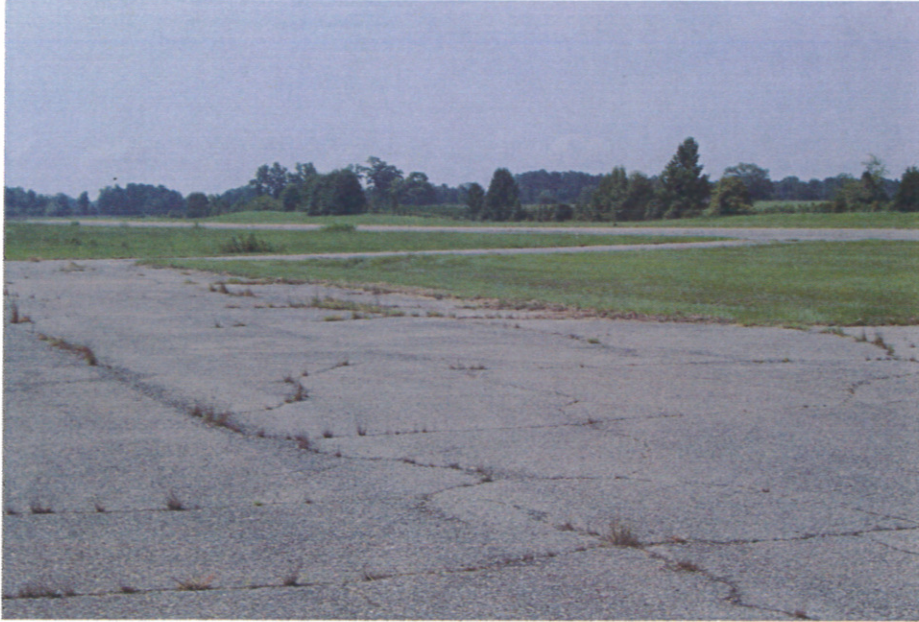
Photo 9

- The runway, taxiway and apron pavement conditions are in *Poor* condition.
- The runway has transverse cracking and longitudinal cracks with vegetation.
- The ramp and taxiways have block and alligator cracking.

Block cracking on the ramp

- The paved surfaces of the airport must be overlaid.
- The overlay should be in conjunction with a runway lengthening project to correct the Safety Area violation of Runway 34.

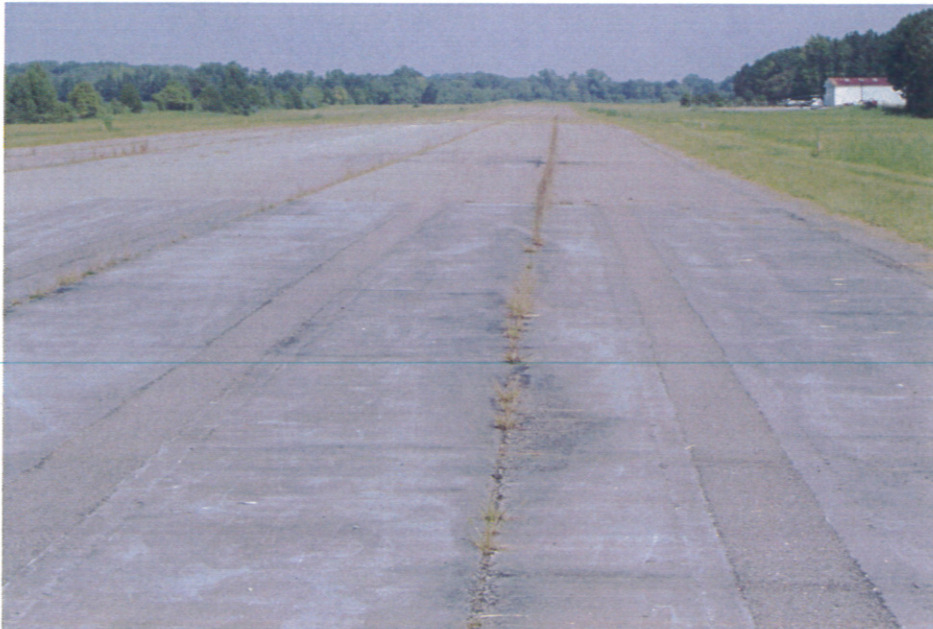
Photo 10

Block, transverse and longitudinal cracking with vegetation on the runway
