Subject: Annual Inspection Report
Northeast Alabama Regional Airport (GAD)

**Annual Inspection Report
Northeast Alabama Regional Airport (GAD)
Gadsden, Alabama**

July 30, 2019

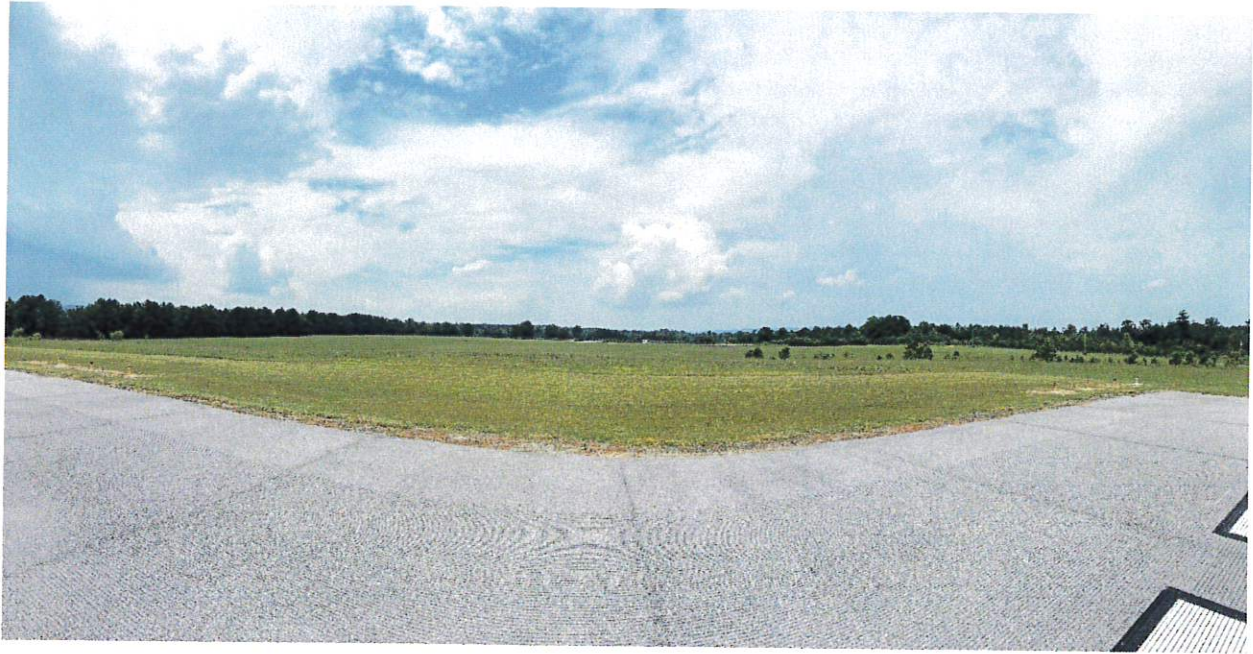
Photo #1- Runway 6 Approach Path

- Runway 06- No Obstructions (See Photo #1).
- Runway 24- No Obstructions (See Photo #2).
- Runway 18- Obstructions (See Photo #3 and Appendix 2).
- Runway 36- No Obstructions (See Photo #4).

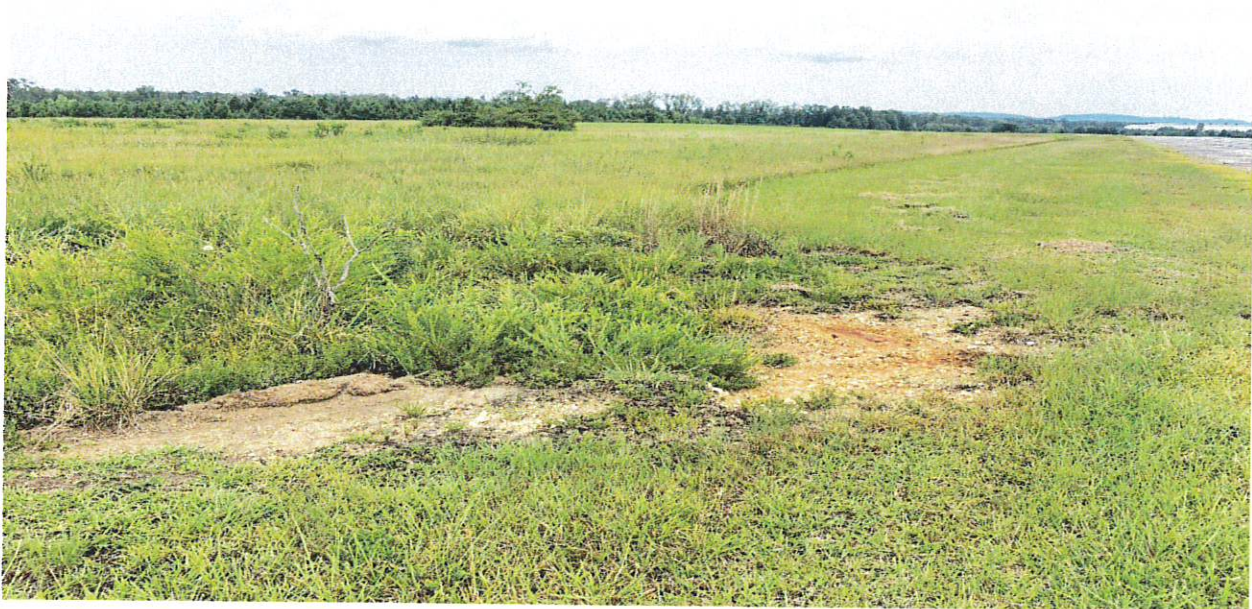
Photo #5 - Primary Surface

- Erosion occurring runway 18. (See Photo #5)
- Erosion occurring exposing electrical wiring. (See Photo #6)
- Obstructions in primary surface area (See Photo #7)

- Arrest erosion.
- Remove obstructions in primary surface.

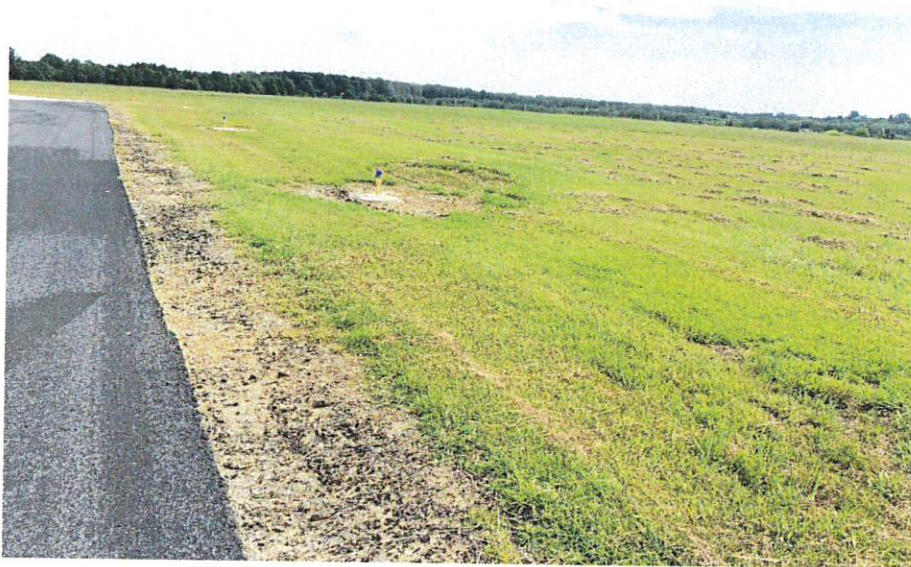
Photo #8 – Runway Safety Area

- Erosion occurring shoulder of runway 36. (See Photo #8)
- The shoulders of 18/36 are cracking and creating foreign object debris (FOD) to appear on the runway surface. (See Photo #9)

- Arrest erosion.
- Contact airport consultant to plan future shoulder repairs.

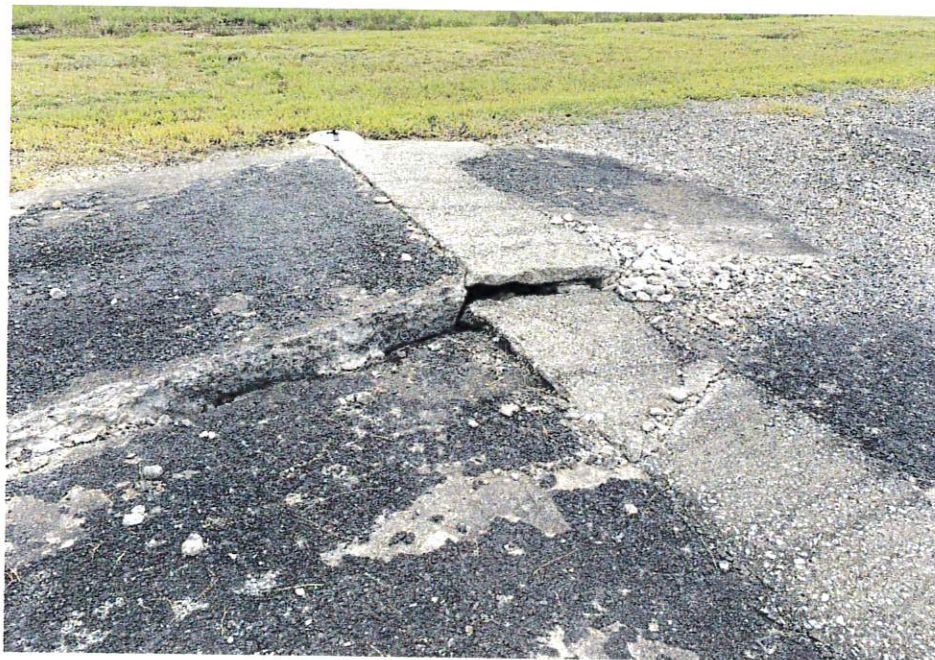
Photo #9 – Buckling RWY 18/36 Shoulder

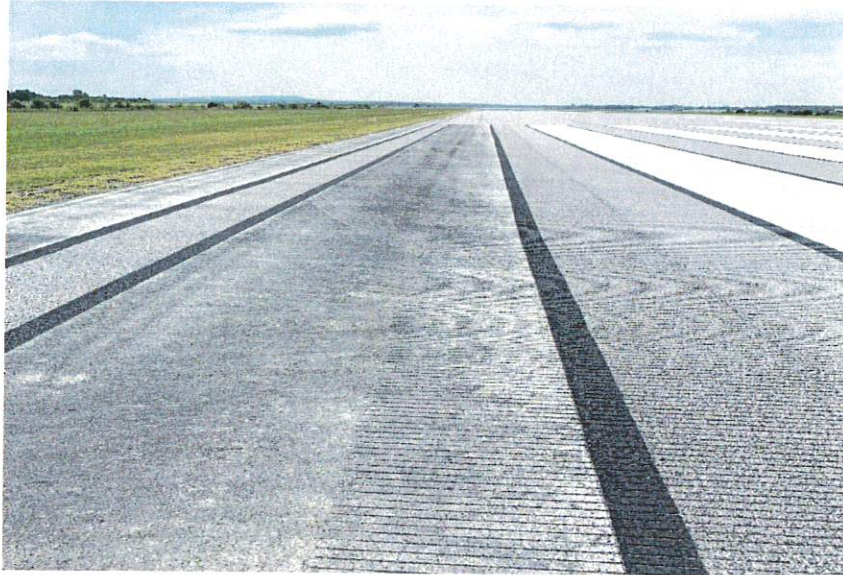
Photo #10 – Runway 6 NPI Markings

- Runway 6/24 markings are in **FAIR** condition. (See Photo #10 and #11)
- Runway 18/36 markings are in **POOR** condition. (See Photo #12 and #13)

- The current 18/36 markings could possibly be cleaned with a water and bleach mixture followed by power washing. If the markings are unable to be cleaned, new markings should be applied in accordance with FAA AC 150/5340-1M.
- The current 6/24 markings could possibly be cleaned with a water and bleach mixture followed by power washing. If the markings are unable to be cleaned, new markings should be applied in accordance with FAA AC 150/5340-1M.

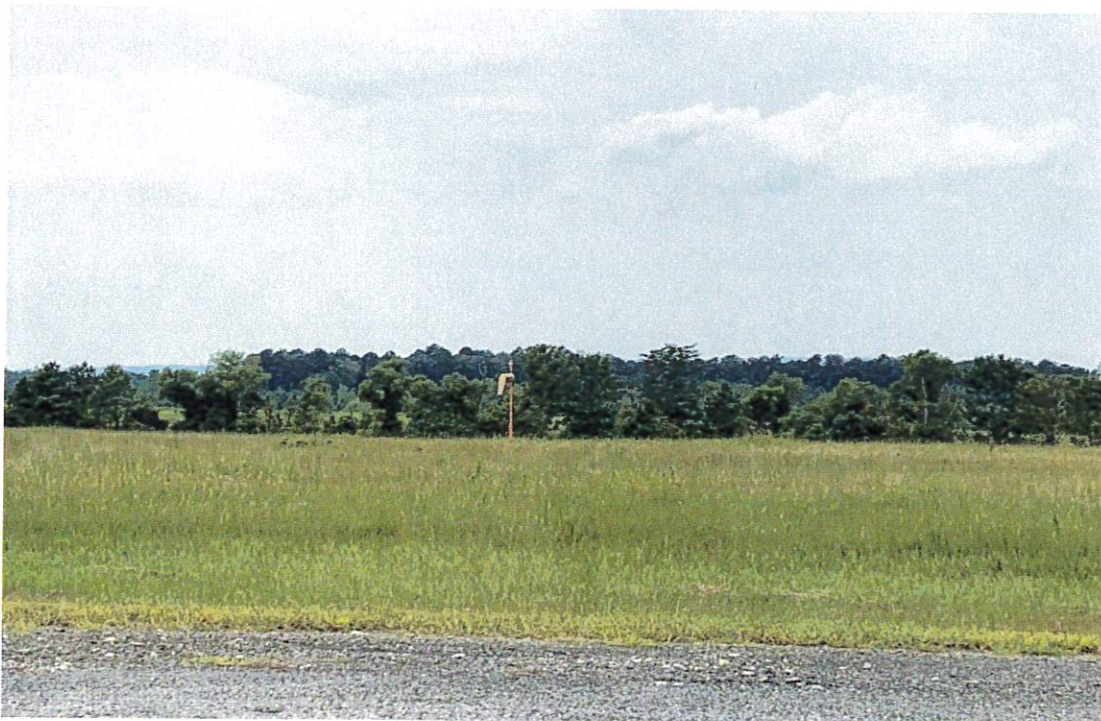
Photo #14 - Wind Direction Indicator

- The wind direction indicator (wind sock) is faded. (See Photo #14)

- Replace wind sock.

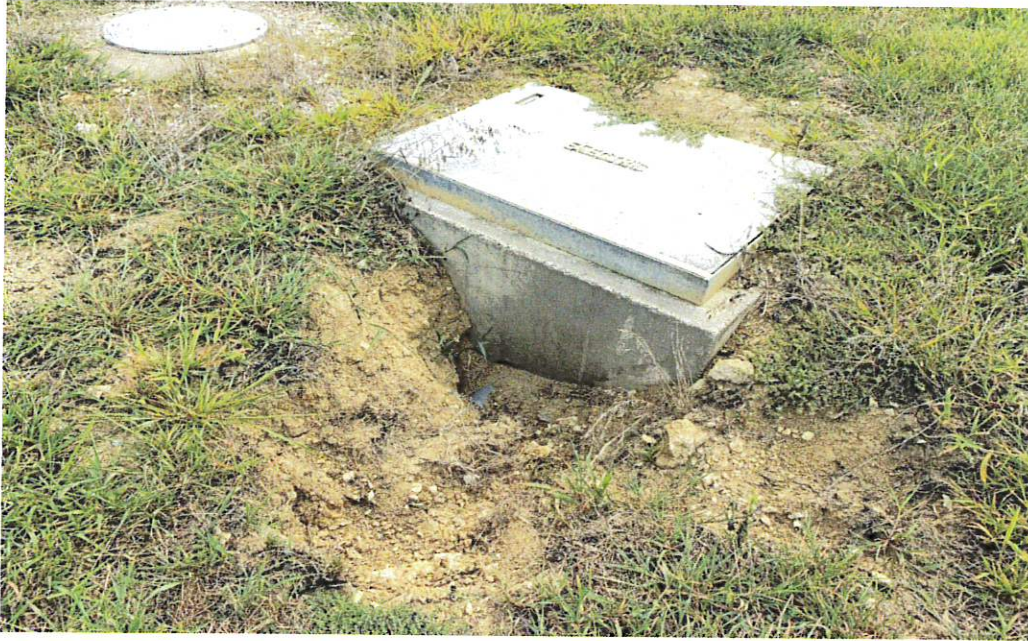
- The lighting components of 18/36 were inoperable and has no active NOTAM at the time of inspection.
- Erosion around light bases occurring. (See Photo #'s 15 and 16)

Photo #15 – Erosion Around Electrical Boxes

- Repair or replace all inoperable lighting components.
- Issue NOTAM runway 18/36 closed for night operations
- Arrest erosion around fixture bases.

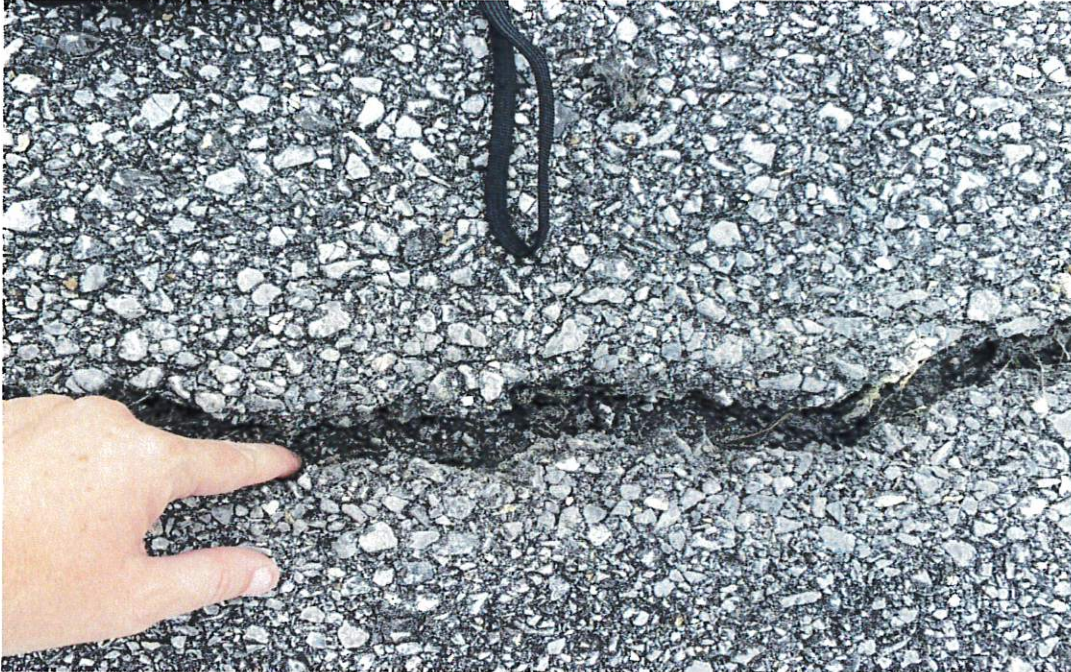
Ramp	GOOD.
Taxiways	POOR: Taxiway A has pavement buckling higher than 3 inches ~30' from AWOS station. Proceed with planned maintenance project as soon as possible. (See Photo #18)
Runway	06/24: GOOD. 18/36: FAIR. Cracking and vegetation are visible at several locations on the runway surface (See Photo #17).

Photo #17 – Runway Cracking and Vegetation

- The airport should contact their airport consultant to plan future pavement maintenance on the runway.
- The airport should proceed with pavement maintenance on the taxiways.
- The airport should periodically sweep 18/36 to eliminate FOD from the runway.
- The **Aeronautics Bureau** strongly recommends the closure of affected portion of taxiway A due to high risk to safe aircraft operations.

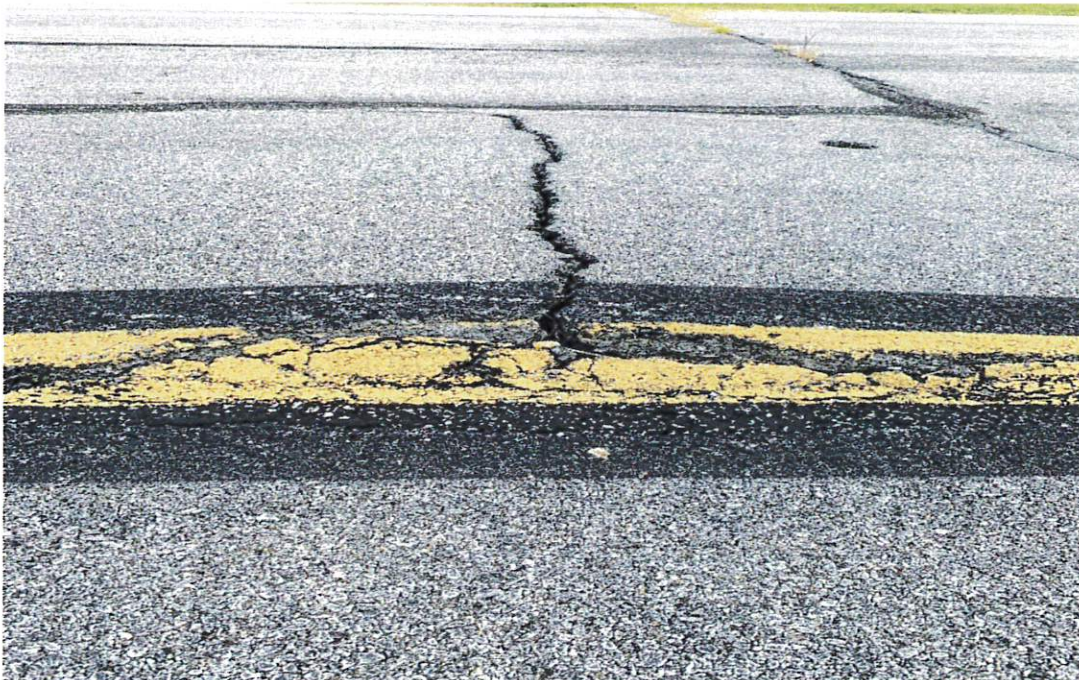
Photo #18 – Pavement Buckling Taxiway A

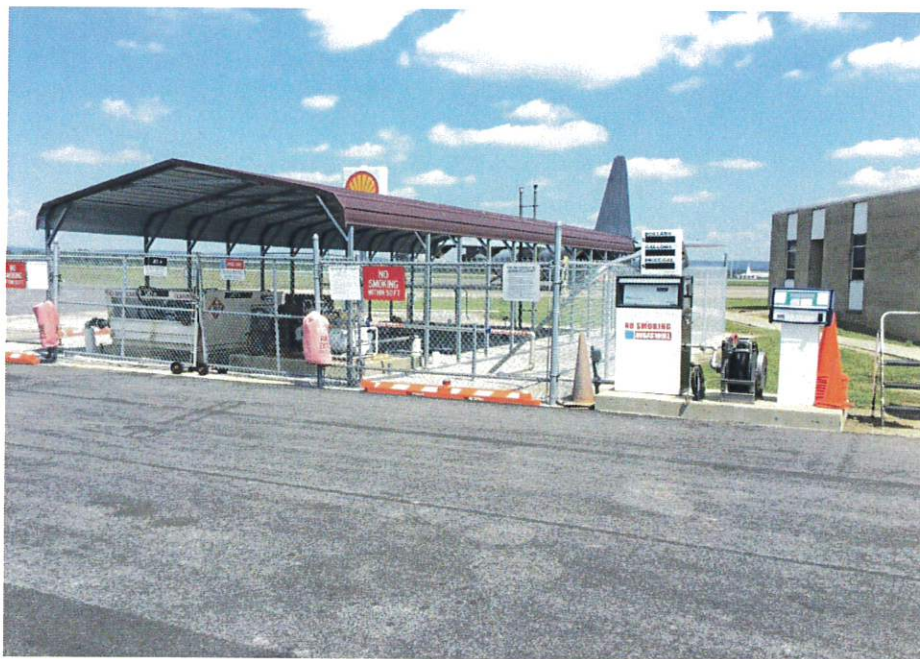
Photo #19 - AVGAS Self-Serve Fueling Area

- The fueling area meets the requirements established by the Alabama Department of Transportation Aeronautics Bureau. (See Photo #19).
- Fire Extinguisher is expired.
(See Photo # 20)

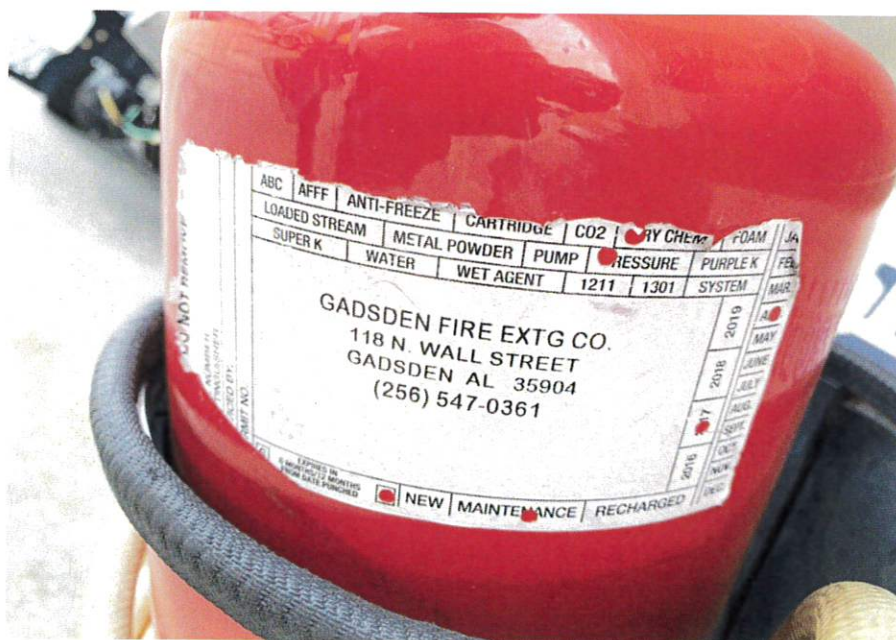
Photo #20 – Expired Fire Extinguisher

- Inspect fire extinguisher and properly note on tag.
