Subject: Annual Inspection Report
Northeast Alabama Regional Airport (GAD)

**Annual Inspection Report
Northeast Alabama Regional Airport (GAD)
Gadsden, Alabama**

May 21, 2021

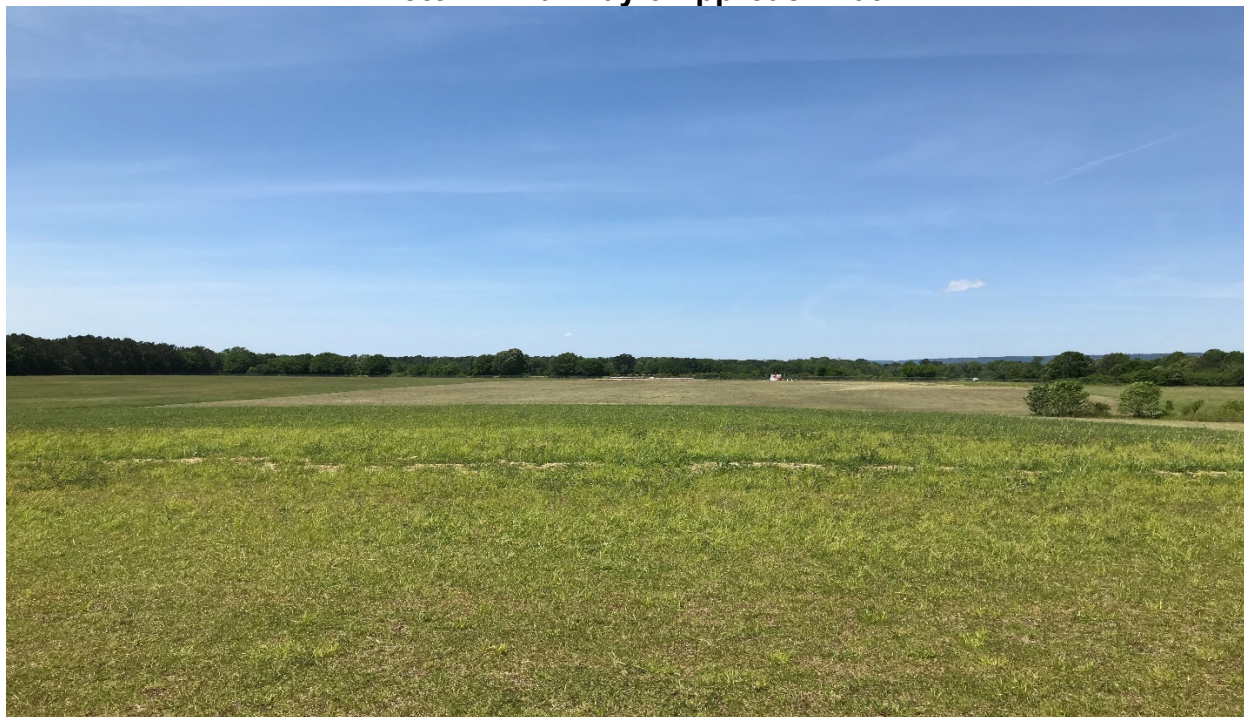
Photo #1- Runway 6 Approach Path

- Runway 06- No Obstructions (See Photo #1).
- Runway 24- No Obstructions (See Photo #2).
- Runway 18- Obstruction labeled Tree #3 violate the ALDOT 20:1 Approach/Departure Path. Obstructions labeled Tree #6, #7, and #9 will soon be violations (See Photo #3 and Appendix 2).
- Runway 36- No Obstructions (See Photo #4).

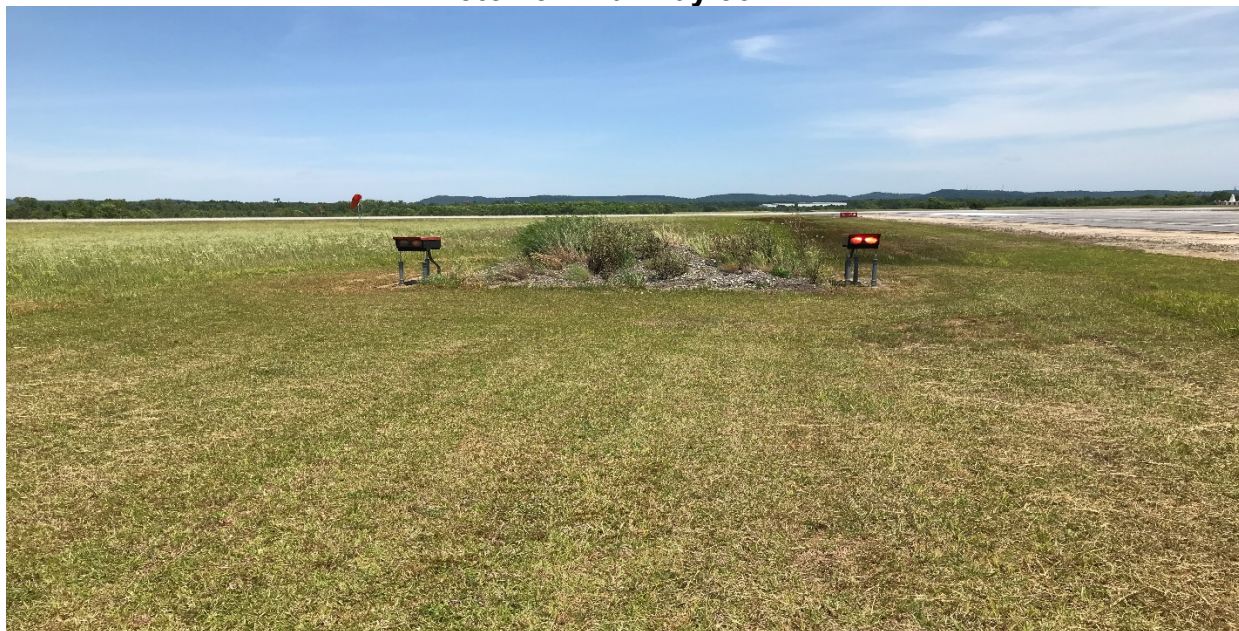
Photo #5 – Runway 36 PAPI

- A pile of gravel and debris between the PAPI boxes on Runway 36 106 feet from the Runway centerline violates the Primary Surface (See Photo #5).
- Mounds of loose debris from the shoulders of Runway 18/36 are located at multiple points along the runway (See Photo #6).
- The shoulders of Runway 18/36 are cracking and buckling, causing a foreign object debris (FOD) hazard (See Photo #7).
- A group of trees located north of the Runway 18 hold short line create a hazard by obscuring line of sight to base and final legs from the hold short position (See Photo #8)

- Remove all debris and gravel from the Primary Surface of Runway 18/36
- Continue with repair project for Runway shoulders.
- Remove trees obscuring view.

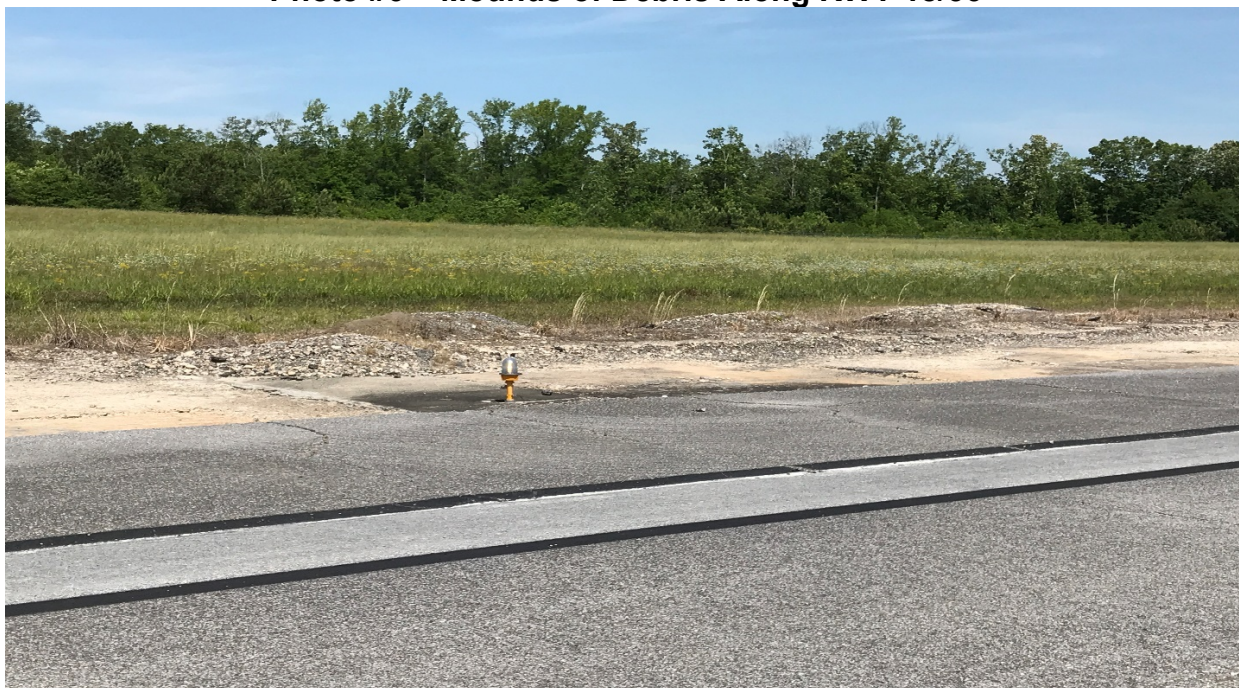
Photo #6 – Mounds of Debris Along RWY 18/36

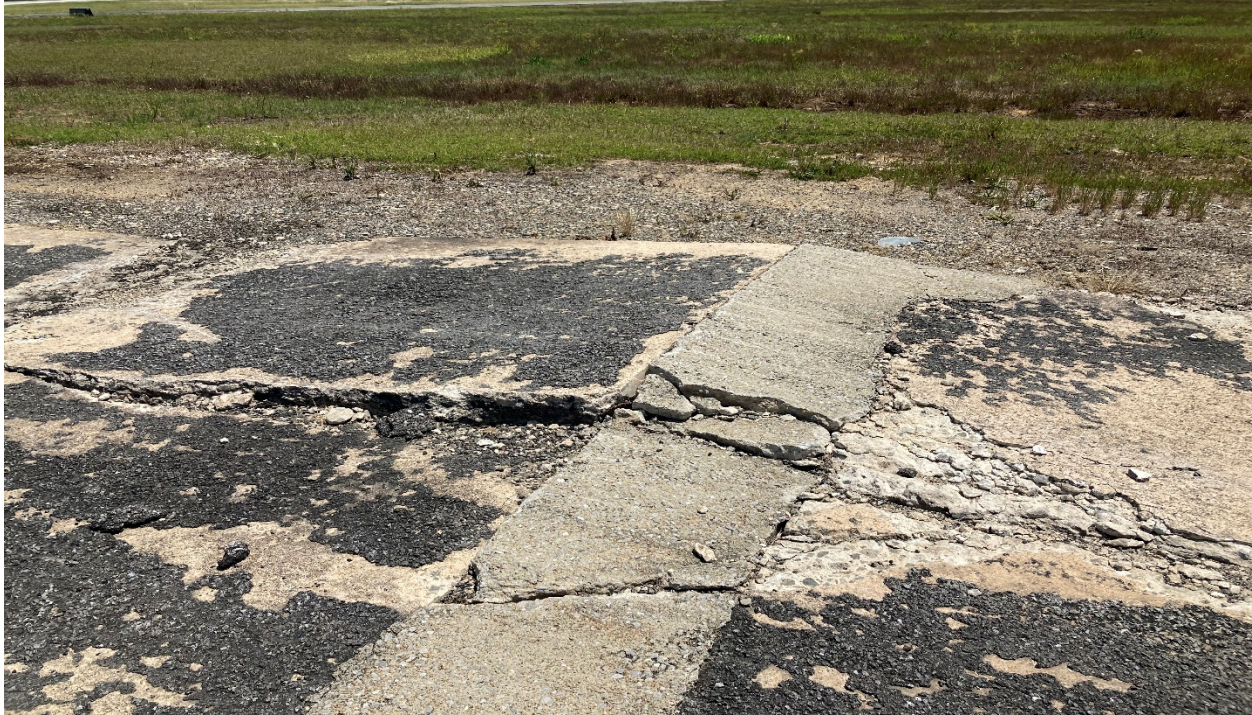
Photo #7 – Pavement Buckling RWY 18/36 Shoulder

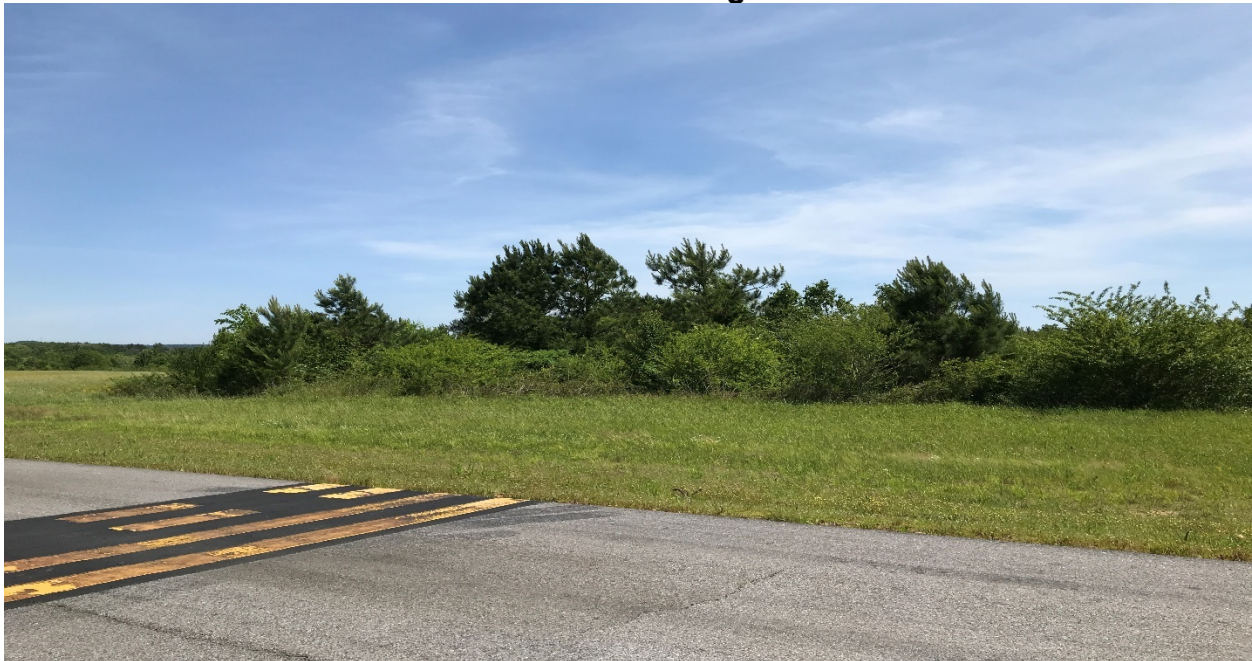
Photo #8 – Trees Obstructing View RWY 18

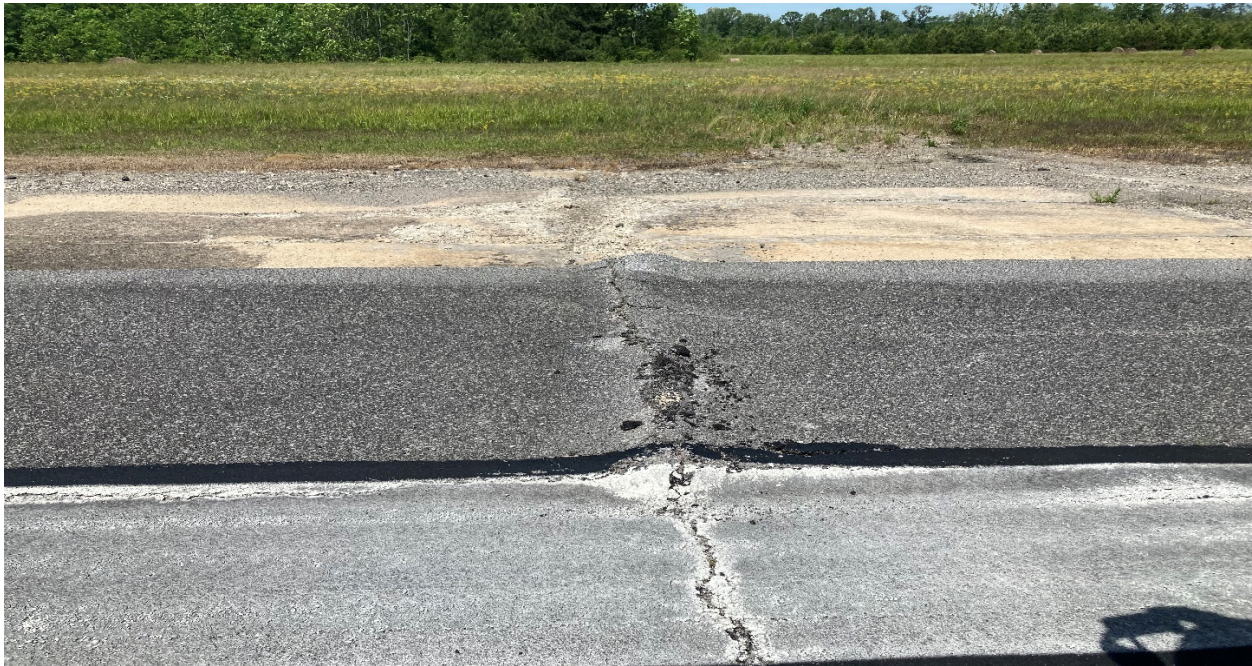
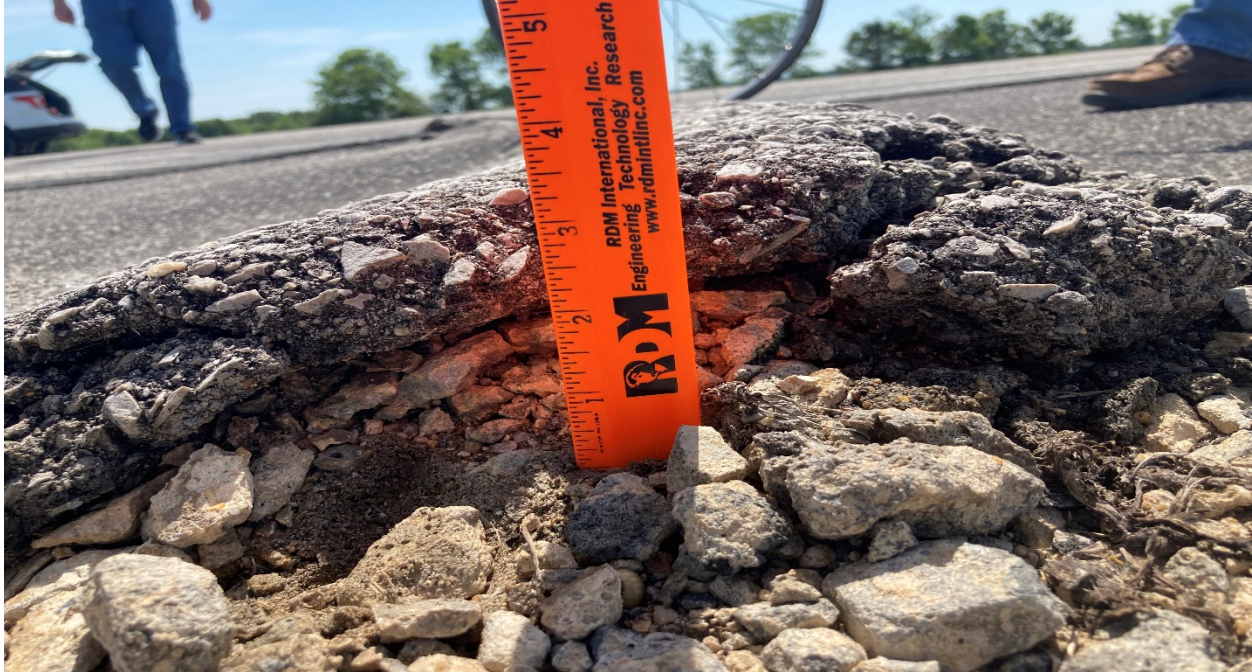
- A 4-inch-tall hazardous surface variation has formed on Runway 18/36 due to buckling of the subgrade (See Photo #9 and #10).

Photo #9 – RWY 18/36 Hazardous Surface Variation

Photo #10 – RWY 18/36 Hazardous Surface Variation

- Plan a project to repair the affected runway section.

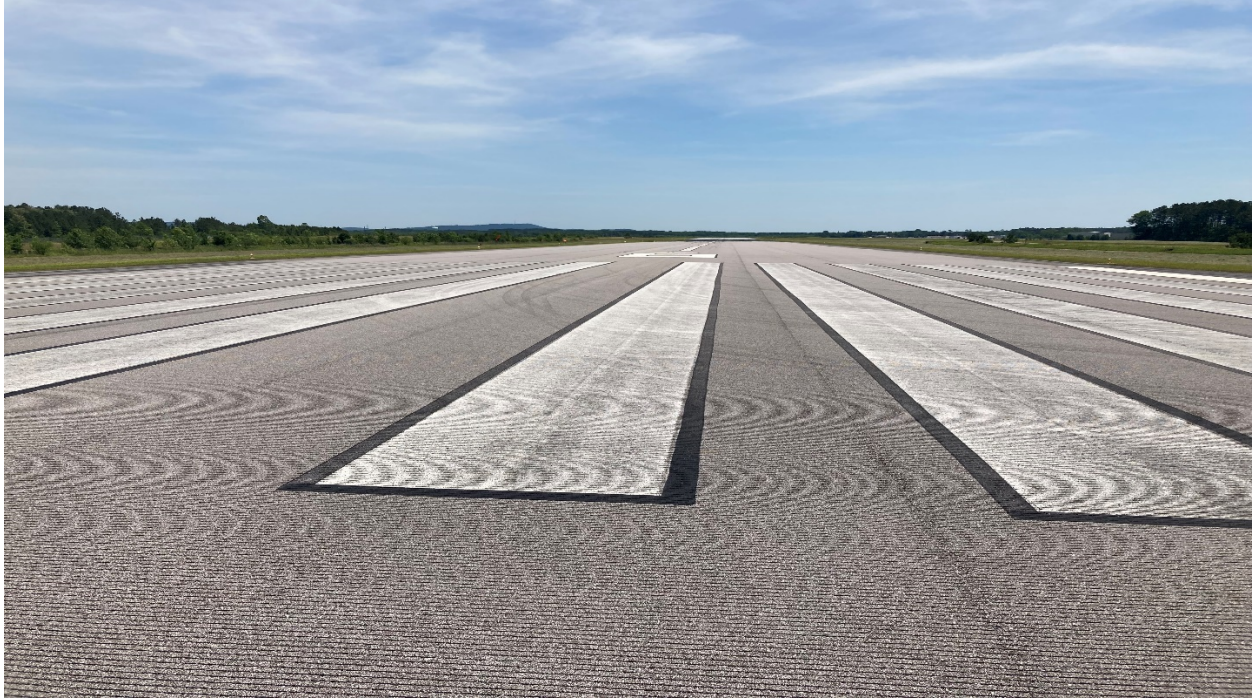
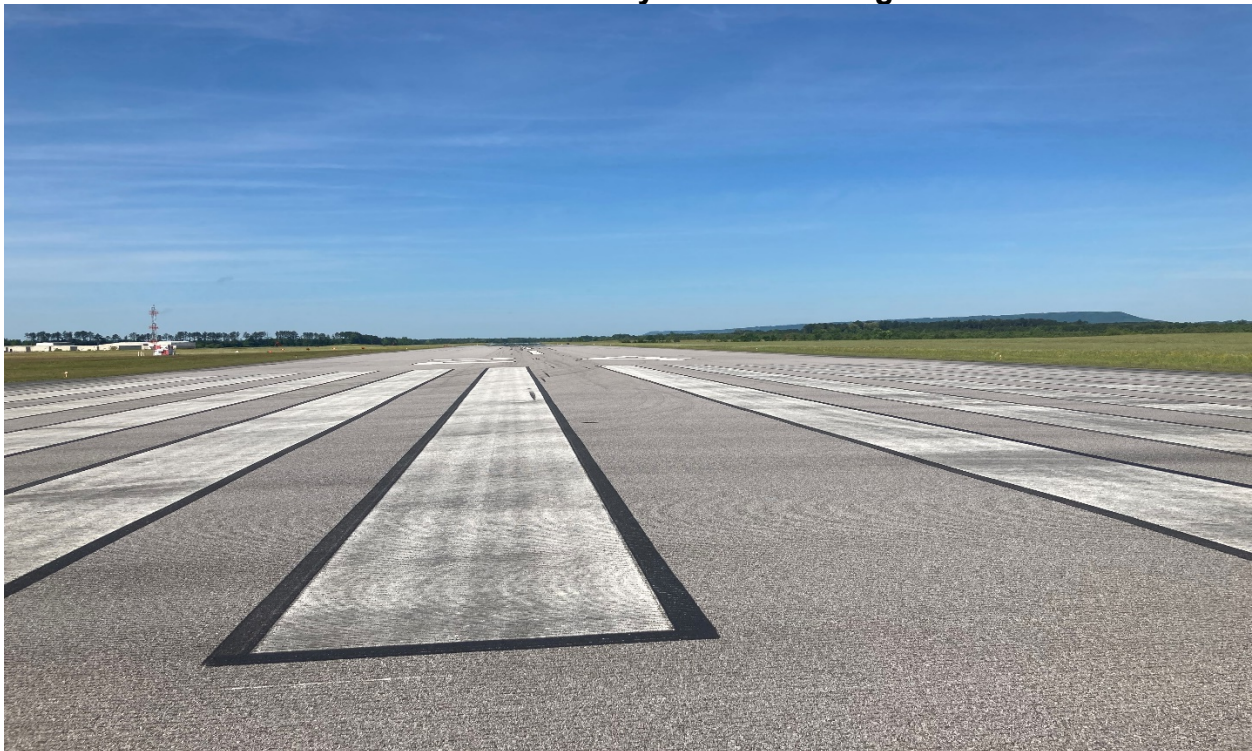
- Runway 6/24 markings are in overall **FAIR** condition due to microbial growth (See Photo #11 and #12).
- Runway 18/36 markings are in **FAIR** condition due to microbial growth (See Photo #13 and #14).

Photo #11 – Runway 6 PIR Markings

Photo #12 – Runway 24 PIR Markings

- The markings could possibly be cleaned with a water and bleach mixture followed by power washing. If the markings are unable to be cleaned, new markings should be applied in accordance with FAA AC 150/5340-1M.

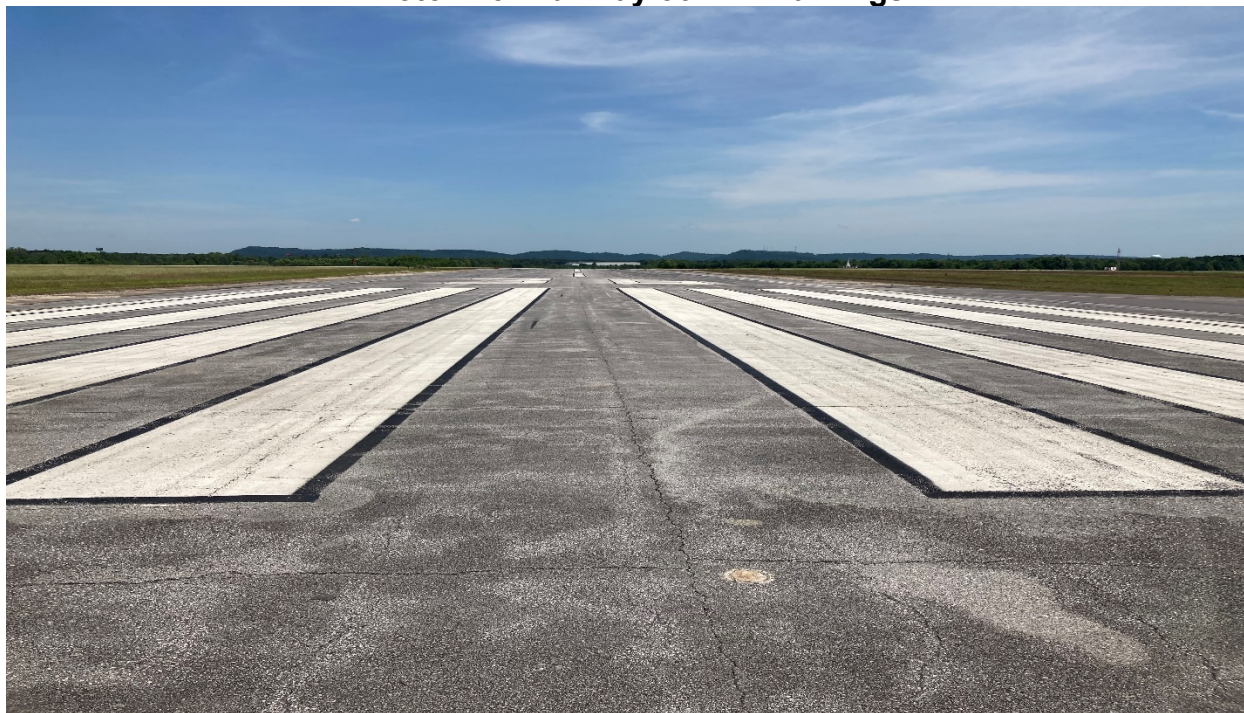
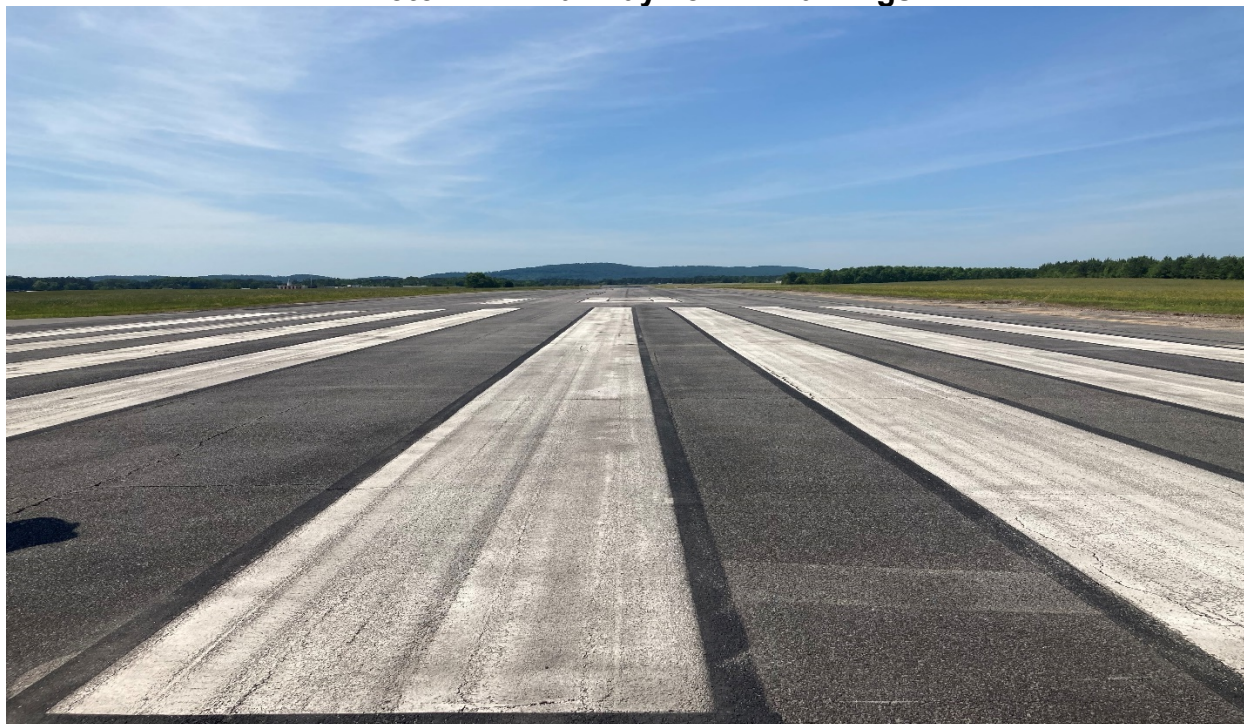
Photo #13- Runway 36 NPI Markings

Photo #14 – Runway 18 NPI Markings

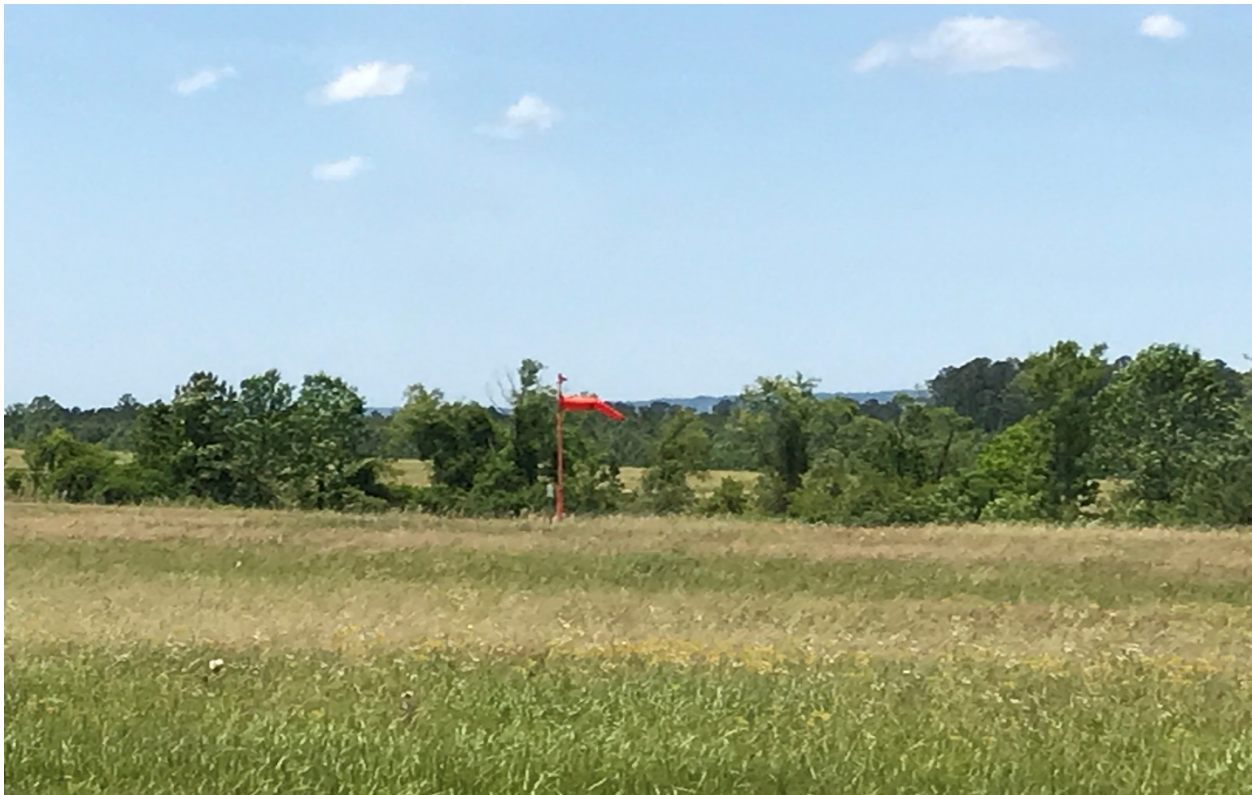
Photo #15 - Wind Direction Indicator

- The wind direction indicator (wind sock) is in **GOOD** condition (See Photo #15).

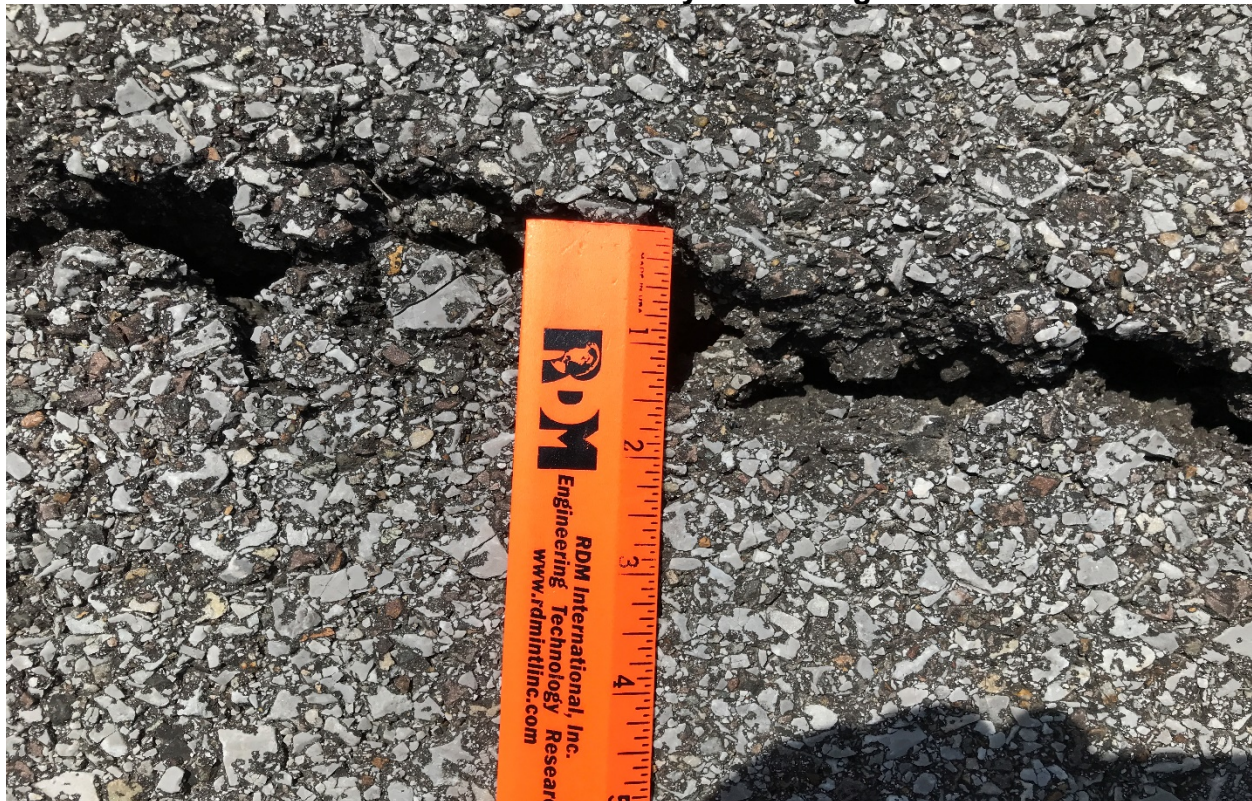
Apron	GOOD.
Taxiways	Taxiways are in overall FAIR condition.
Runway	06/24: Overall GOOD condition; however, an isolated area of the runway is experiencing severe cracking measuring 1.5 inches wide and 6 inches deep (See Photo #16). 18/36: FAIR due to longitudinal and seam cracking (See Photo #17).

Photo #16 – Runway 6 Cracking

- Proceed with planned maintenance to the affected area of Runway 6/24.
- Plan a pavement maintenance project for Runway 18/36.

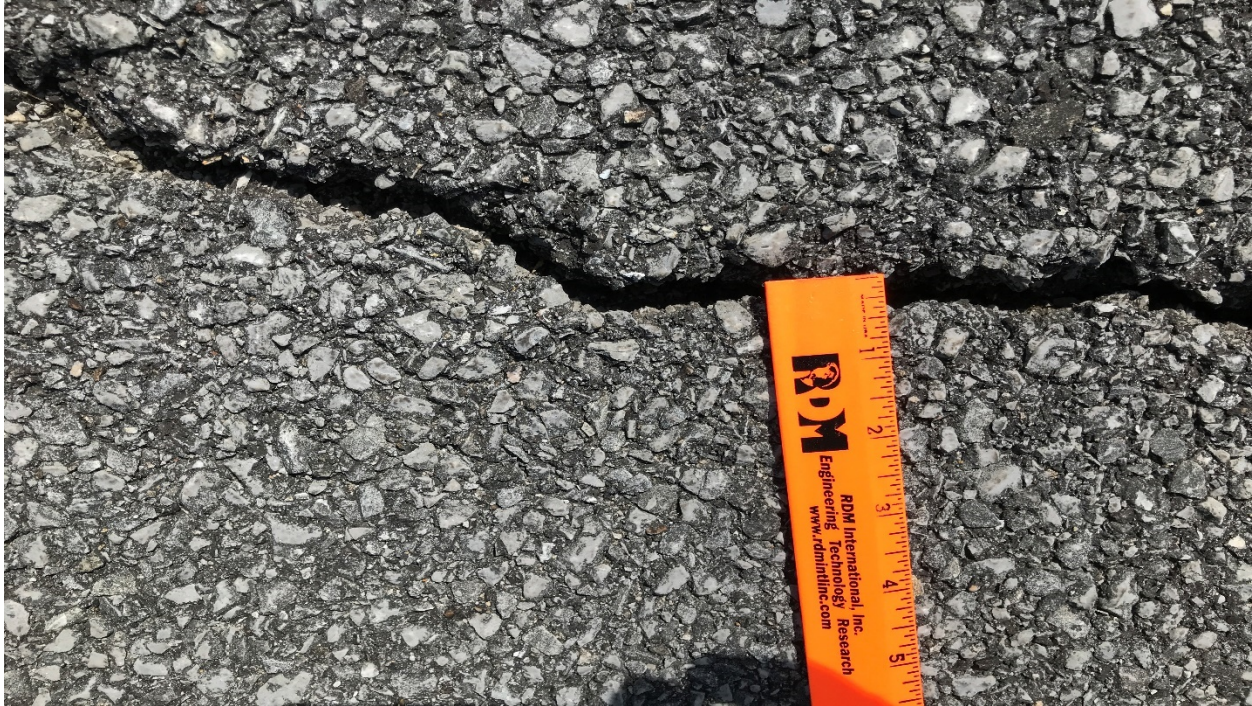
Photo #17 – Runway 18 Seam Cracking

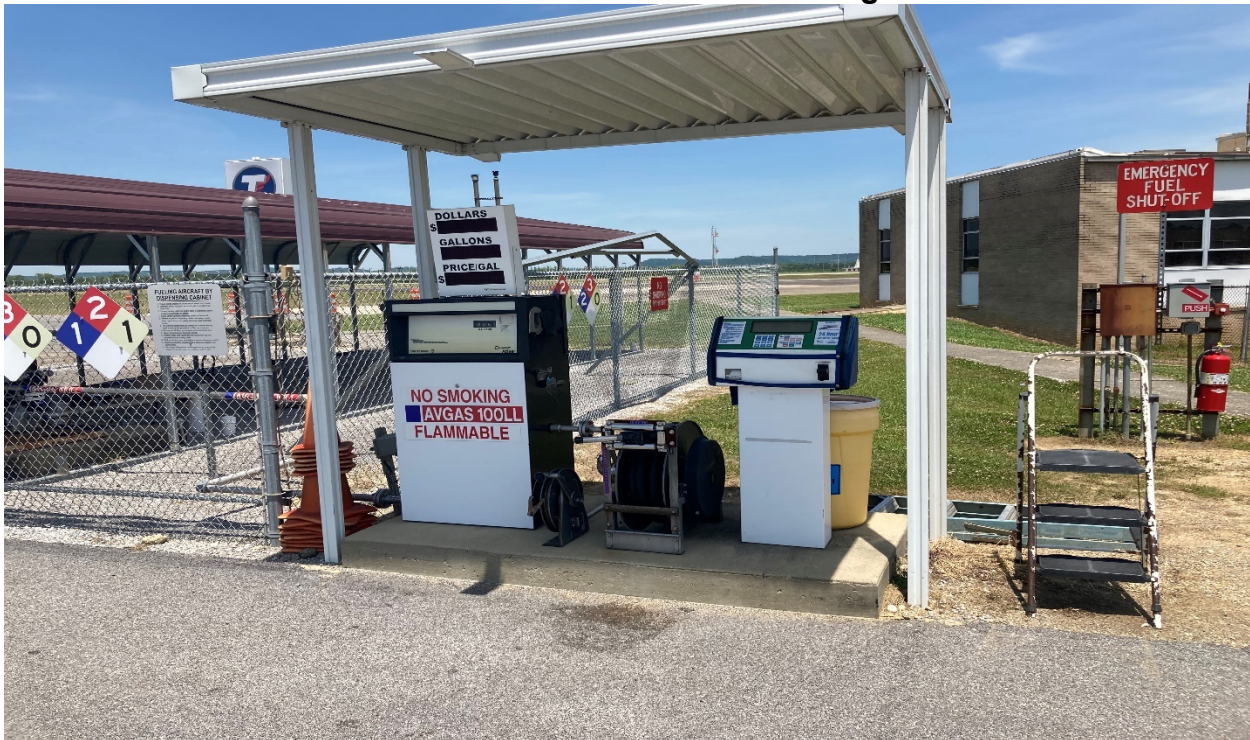
Photo #18 - AVGAS Self-Serve Fueling Area

- The fueling area meets the requirements established by the Alabama Department of Transportation Aeronautics Bureau. (See Photo #18).

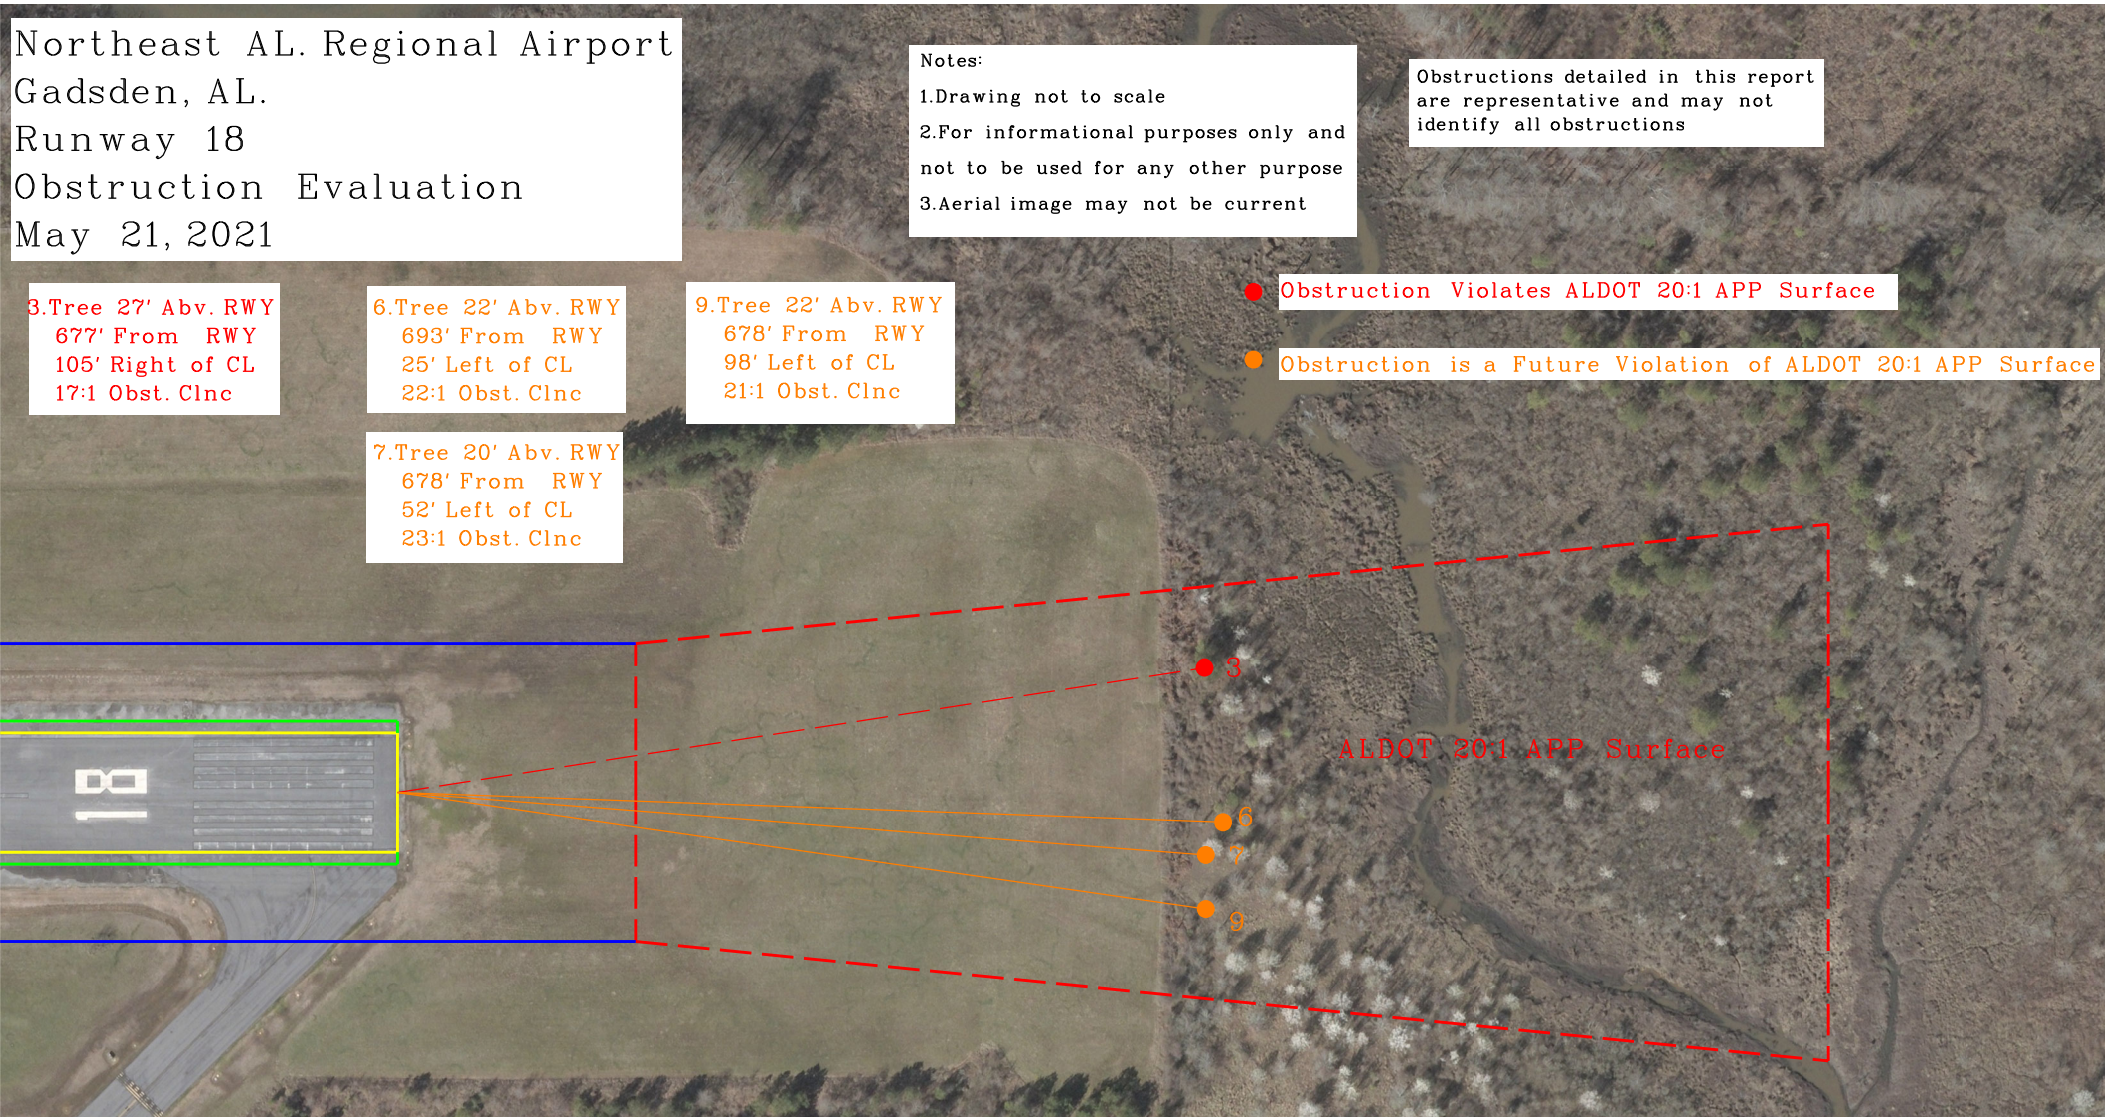
Northeast AL. Regional Airport
Gadsden, AL.
Runway 18
Obstruction Evaluation
May 21, 2021

3.Tree 27' Abv. RWY
677' From RWY
105' Right of CL
17:1 Obst. Clnc

6.Tree 22' Abv. RWY
693' From RWY
25' Left of CL
22:1 Obst. Clnc

9.Tree 22' Abv. RWY
678' From RWY
98' Left of CL
21:1 Obst. Clnc

7.Tree 20' Abv. RWY
678' From RWY
52' Left of CL
23:1 Obst. Clnc

- Remove all obstructions within the 20:1 approach and departure path.
- The obstructions detailed in the report are representative and may not include all obstructions in the approach and departure path.
