Subject: Annual Inspection Report
Mac Crenshaw Memorial Airport
Greenville, Alabama

MAC CRENSHAW MEMORIAL AIRPORT
(KPRN)
GREENVILLE, ALABAMA

**Annual Inspection Report
Mac Crenshaw Memorial Airport
Greenville, Alabama**

May 19, 2020

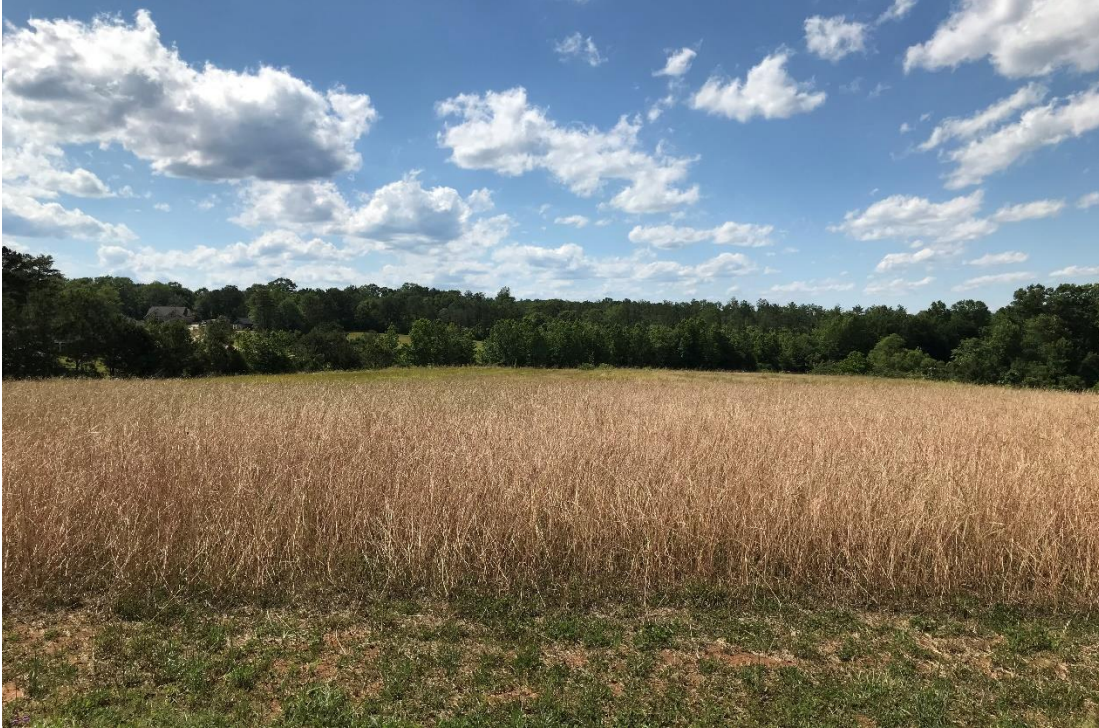
Photo # 1 – Runway 14 Approach

- Runway 14 – No obstructions (See Photo # 1)
- Runway 32 – No obstructions (See Photo # 2)

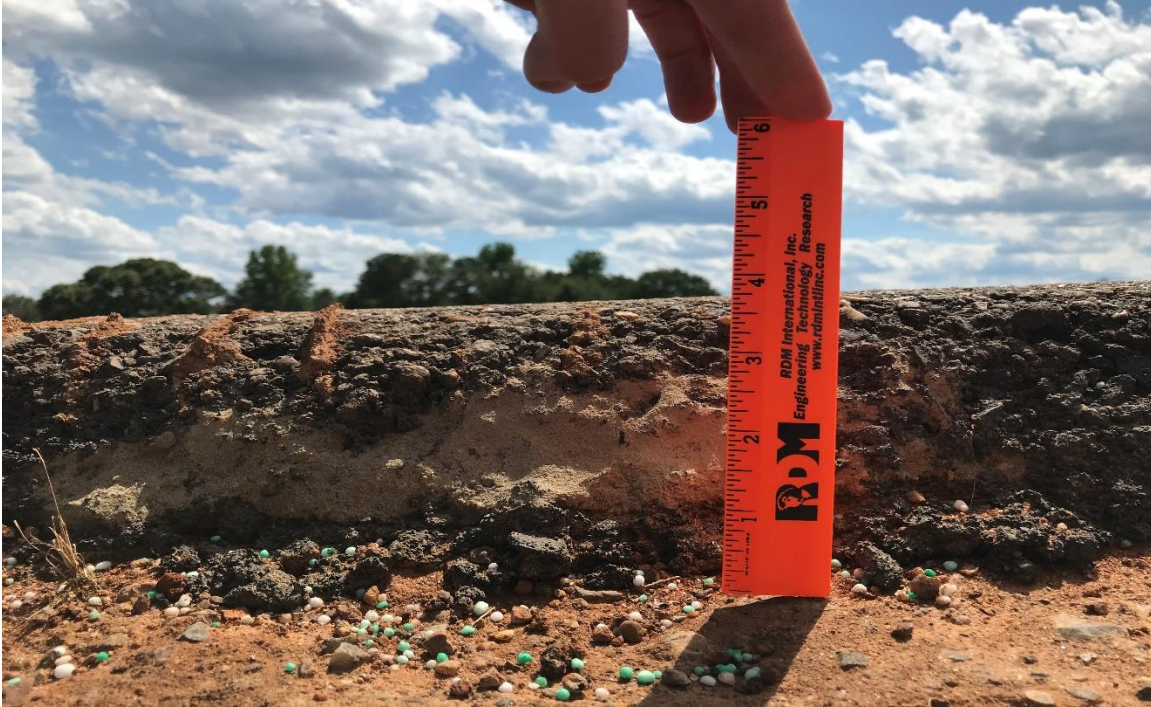
Photo # 3 – Lip of Runway Pavement

The runway lip drop-off at the old apron site was filled with asphalt and tapered, bringing the runway shoulder flush with the main pavement. The trench in the Runway Safety Area was also filled in and compacted. As a result of these corrective actions, the airport now meets the requirements for an operating license. The operating license for the airport is reissued in full effect and will be mailed to you within a few weeks

- The grade of the runway safety area **does not meet** state licensing standards.
- The lip of the runway pavement exceeds 3 inches (See Photo # 3) and there is a large rut off the approach end of Runway 14 (See Photo #4).

- The shoulder of the runway should be brought up and graded smooth so that there is a 3 inch or less drop from the lip of the pavement.
- The rut should be filled in and graded smooth.

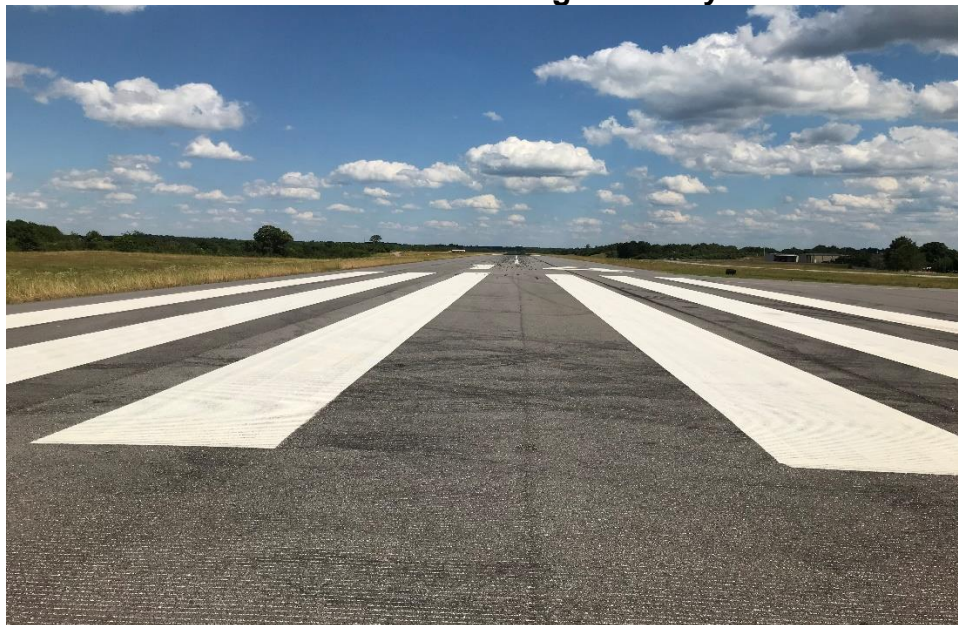
Photo # 5 – NPI Markings Runway 14

- The runway markings are in **GOOD** condition (See Photo #5).
- The taxiway markings are in **POOR** condition (See Photos #6 & #7)

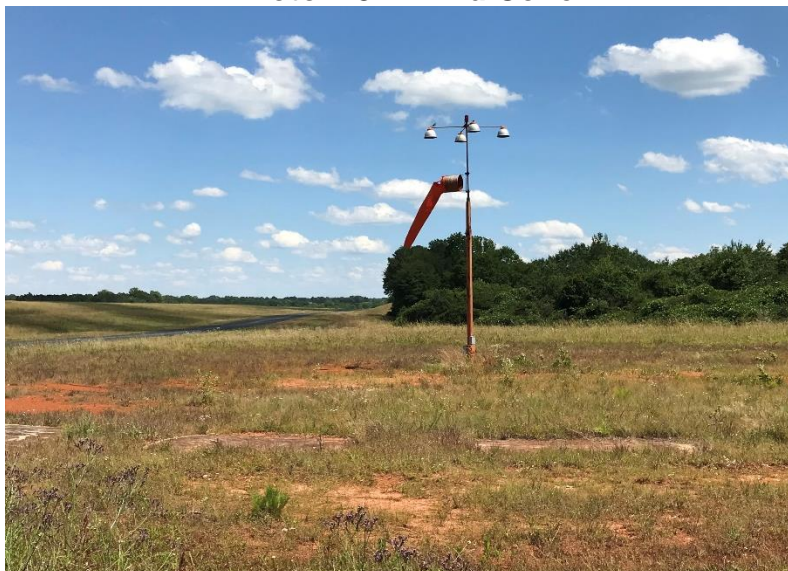
Photo # 8 – Wind Cone

- The wind direction indicator (wind cone) is torn and in **POOR** condition (See Photo #8).
- The lights on the Wind Direction Indicator assembly were unable to be tested. Wind indicator lights must be operational to be licensed for night operations.
- Segmented circle was faded and discolored.

- Replace wind cone.
- Clean and repaint segmented circle

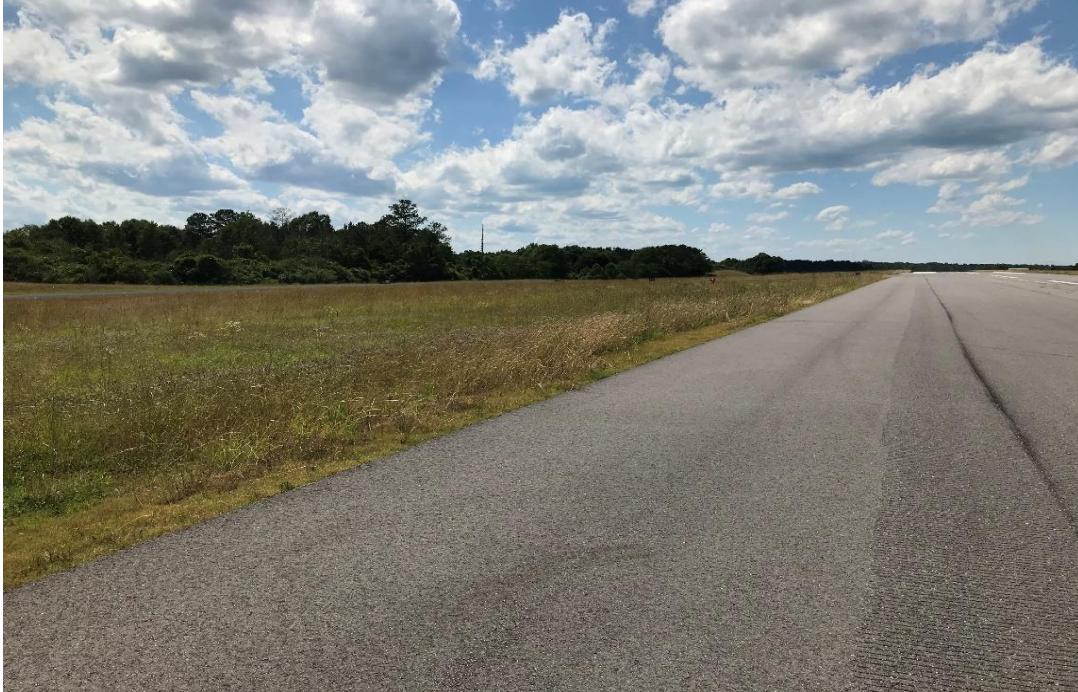
Photo #9 – Obscured RWY Edge Lights

- Runway Edge Identifier Lights and Runway Threshold Lights obscured by tall grass (See Photos #10 & #11)

- Repair/replace inoperative lights.
- Cut grass obscuring lights (See Photos #9 & #10).

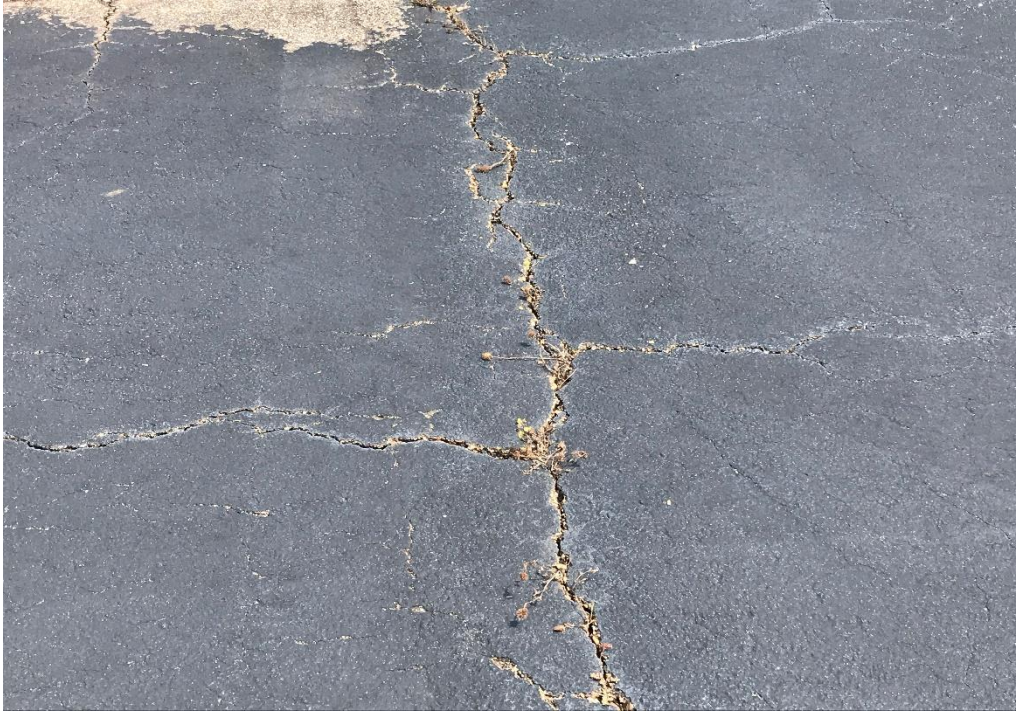
Photo # 11 – Taxiway Cracking and Raveling

- The runway surface is in **EXCELLENT** condition. All other airport pavement surfaces are in **FAIR** condition.
- Cracks of medium severity have formed throughout apron and taxiway surface and are beginning to open up. Raveling is causing foreign object debris (FOD) in areas on apron and taxiway. Vegetation can also be seen on some areas of the taxiway. (See Photo #11, #12, & #13).
- Lip of runway pavement surface exceeds three (3) inches in some areas.

- Consult with airport engineer to discuss and plan a taxiway/apron crack seal or rehabilitation project.
- Correct three (3) inch drop-off.

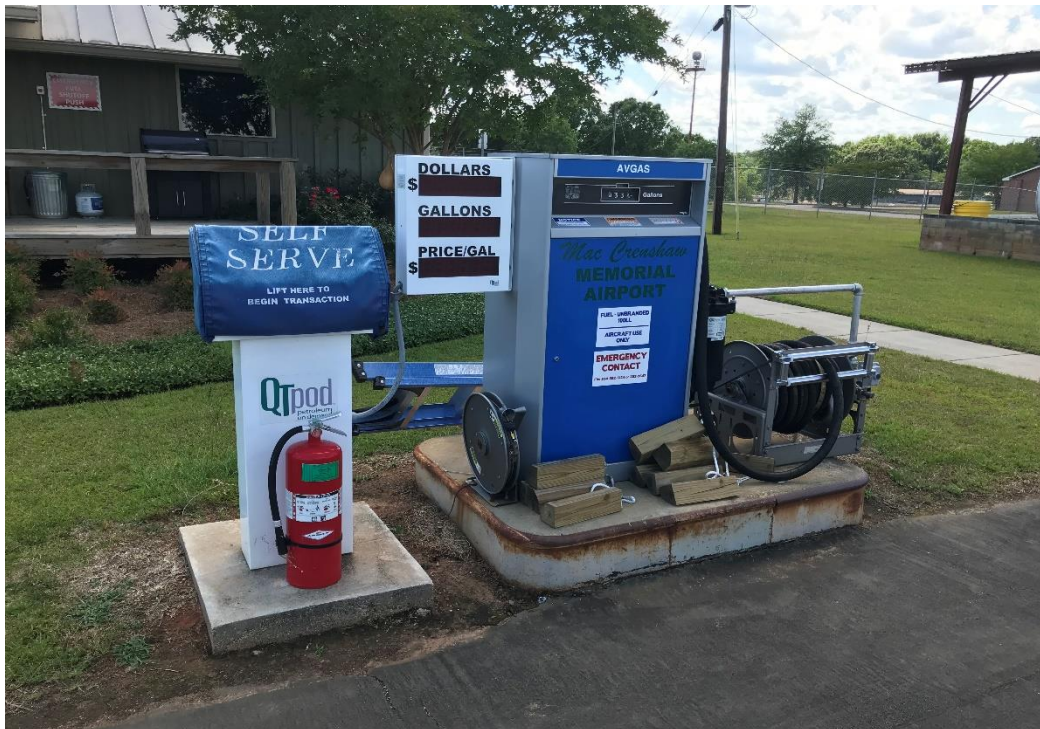
Photo # 14 – Fuel Service Area

- The fueling area **meets** the requirements established by the Alabama Department of Transportation (See Photo #14). However, the State of Alabama Department of Agriculture and Industries may have additional requirements for fueling systems that were not considered during this inspection.
