Subject: Annual Inspection Report
Grove Hill Municipal Airport

ANNUAL INSPECTION REPORT

GROVE HILL MUNICIPAL AIRPORT

GROVE HILL, ALABAMA

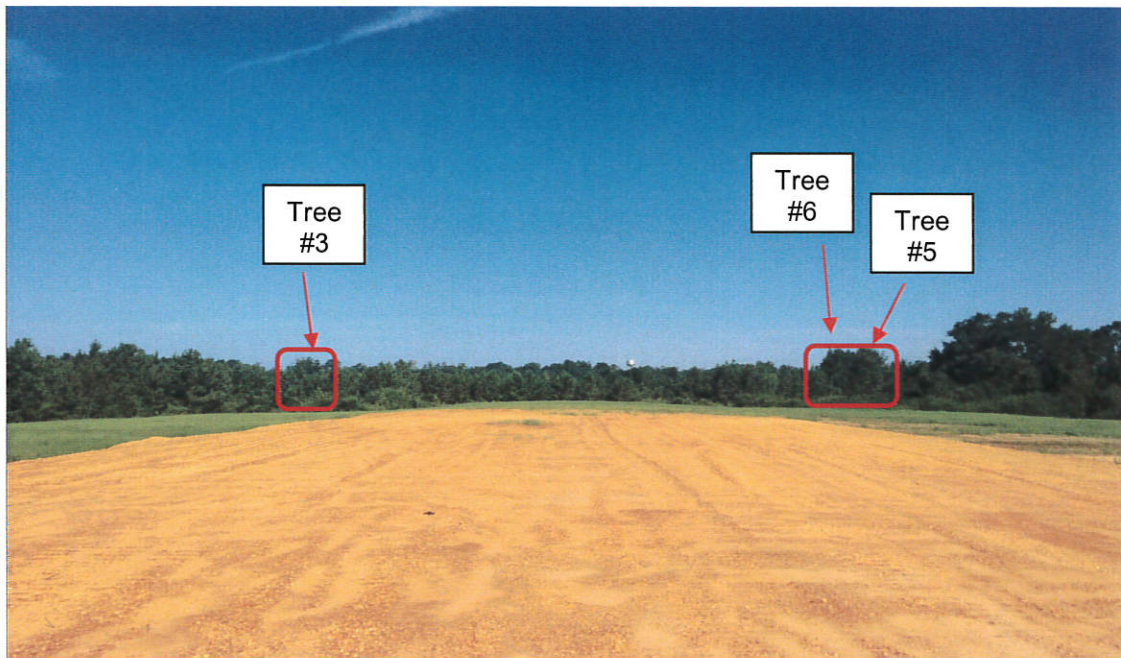
Photo # 1 – Runway 13 Obstructions

It should be noted that the violations identified in the inspection report have been re-occurring for several years and are serious safety violations. There are multiple obstructions to the Runway 13 approach. Please note that the obstructions surveyed are representative of the obstructions and are not limited to those identified in the report. The numerous depressions and erosion in the runway safety area at the end of Runway 13 presents a serious safety hazard. These items must be corrected before a license can be issued for operation. Another issue that should be addressed is the runway pavement. Though not a violation to the licensing Code of Alabama, a pavement maintenance plan should be developed to extend the useful life of the pavement. There is excessive cracking throughout the runway surface and areas that are beginning to show signs of failure.

- Runway 13 –Trees identified as Tree # 3, # 5 and # 6 obstruct the ALDOT 20:1 approach/departure path (See Photo # 1, and Appendix 2).
- Runway 31 – clear of obstructions (See Photo # 2).

- Remove all obstructions. ***It should be noted that the trees identified in this report have been cited as obstructions in past inspections.*** The obstructions are not limited to those identified in this report. We recommend that the town of Grove Hill contact a Licensed Surveyor to perform a more in-depth study to determine all obstructions.

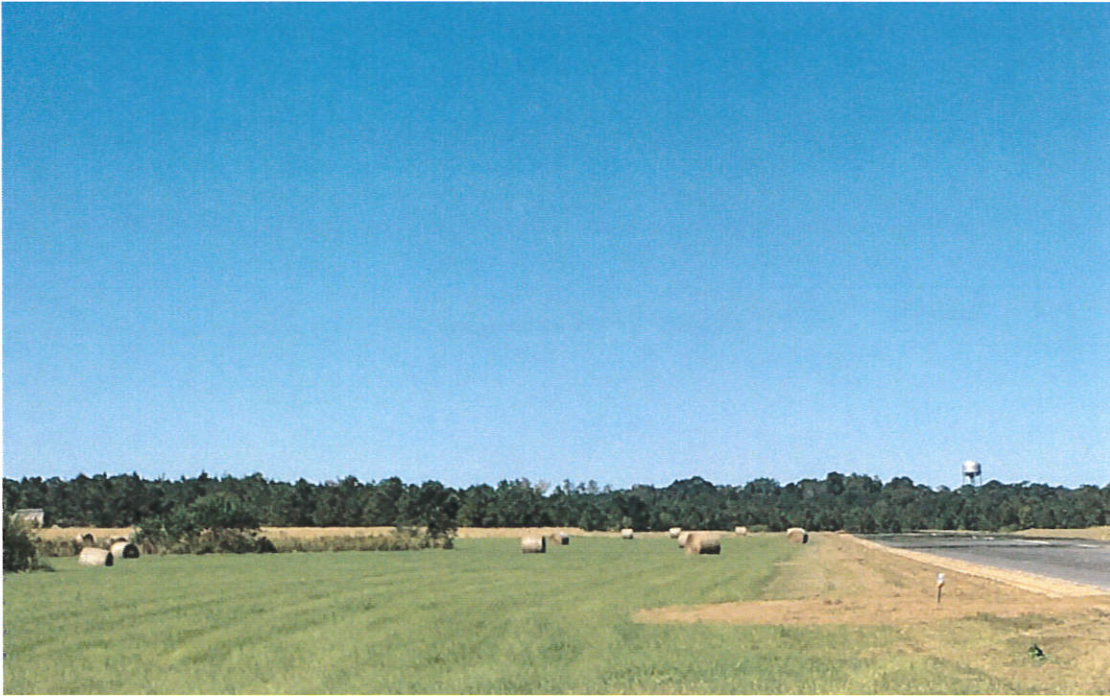
Photo # 3—Hay Bales in the Primary Surface

- The primary surface is violated by hay bales to the north and south of Runway 13/31 (See Photo # 3).

- The safety area is violated by hay bales to the north and south of Runway 13/31 (See Photo #3).
- The required safety area for a public use airport extends 200' beyond the pavement end and is 120' in width, centered on the centerline of the runway. The current runway safety area at the end of runway 13 does not meet the requirements for state licensing.

- Remove hay bales. Ensure that mowers know the limits of the Primary Surface and do not leave hay bales within those limits.

- The Runway Safety Area is 120 feet wide, centered on the runway centerline, and extends for a distance of 200 feet past the runway end. The area must be compacted and graded smooth with no ruts, humps, depressions or other potentially hazardous surface variations.
- Remove hay bales. Ensure that mowers know the limits of the Runway Safety Area and do not leave hay bales within those limits.

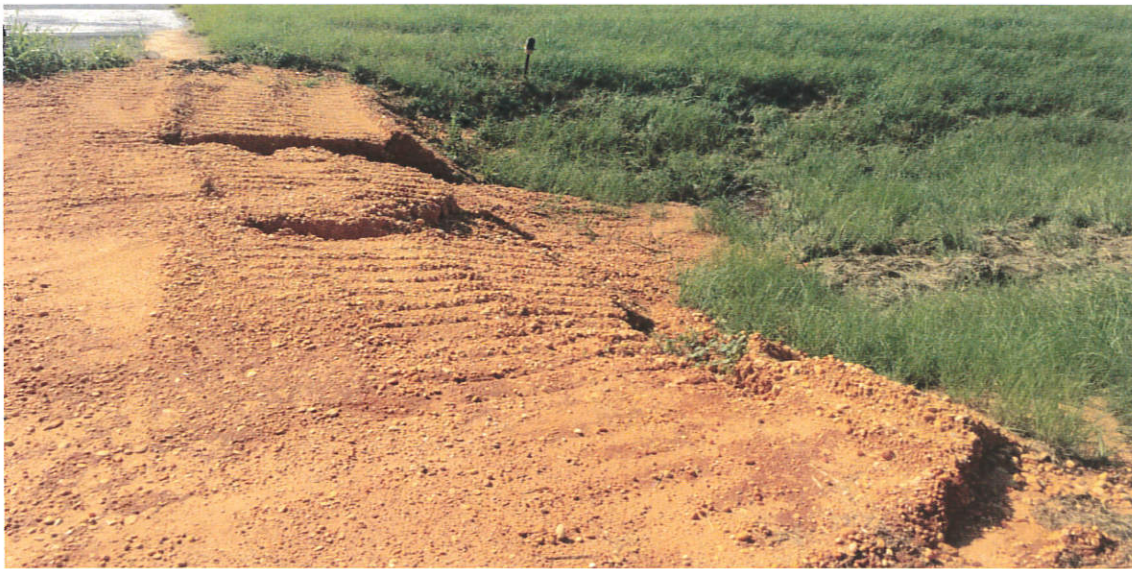
Photo # 4 – Runway 13 Safety Area

- Runway 13's safety area has numerous hazardous humps and depressions as a result of erosion (See Photo # 4).

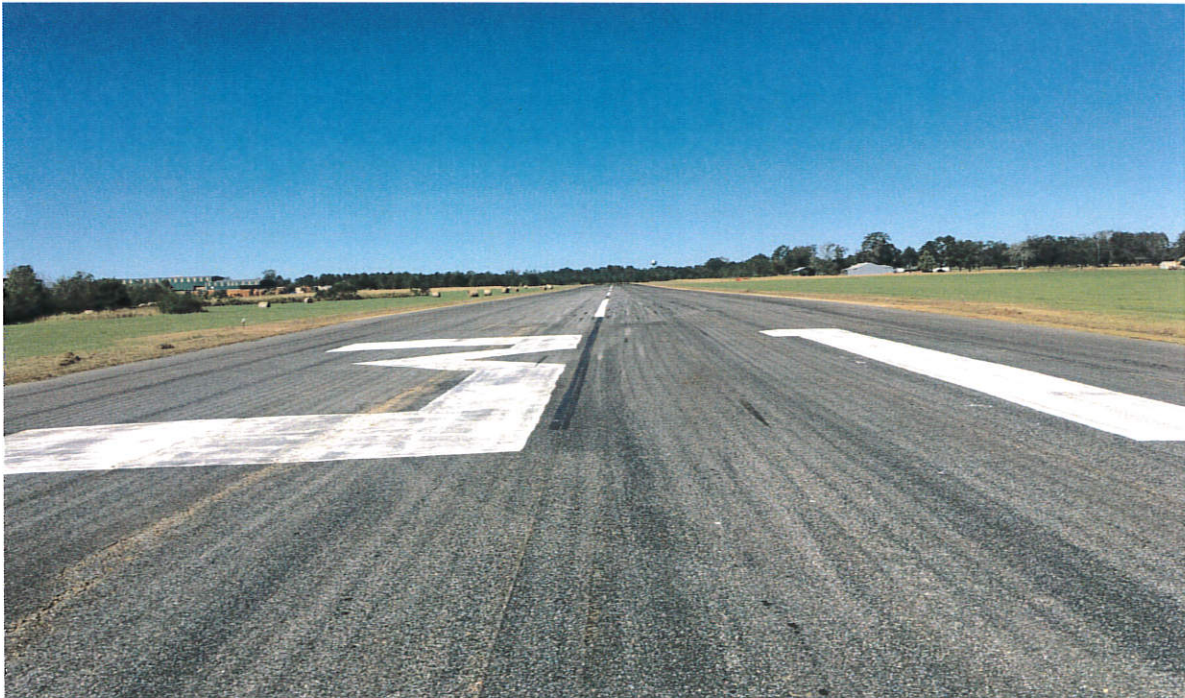
Photo # 5 – Basic Markings & Center Line Rwy 31

- The airport markings are fair condition (See Photo # 5).

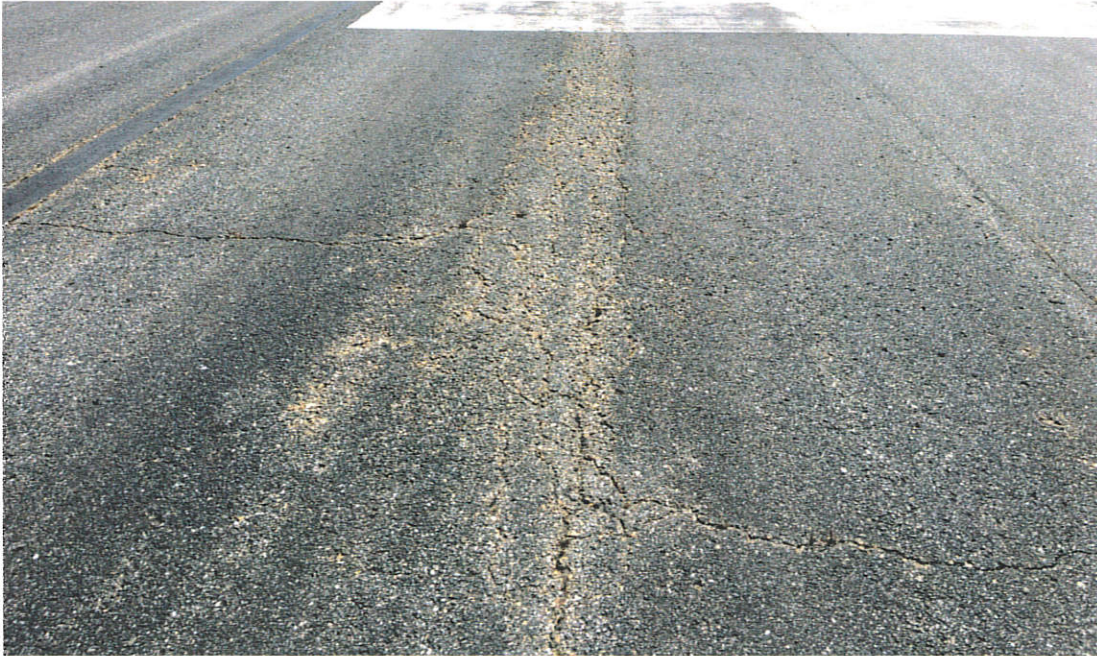
Photo # 6—Runway Conditions

- **The airport pavement surfaces are in poor condition.** All surfaces are experiencing moderate raveling with polishing and flushing. There are also areas of excessive cracking with vegetation (See Photo # 6 and Photo # 7).
- Vegetation is beginning to grow around runway edges, decreasing the width of the runway by several feet (See Photo # 8).
- Pavement is beginning to show signs of failure on the approach end of Runway 31 (See Photo #9).

- Clean and seal the cracks.
- Remove vegetation from around runway edges and runway cracks.
- **It is recommended that action be taken to ensure pavement safety standards meet the requirements of the Aeronautics Bureau.** Pavement failure will result in the immediate closure of the airfield by personnel of the Alabama Department of Transportation Aeronautics Bureau.
