Subject: Annual Inspection Report
Guntersville Municipal – Joe Starnes Field (8A1)

ANNUAL INSPECTION REPORT

Guntersville Municipal – Joe Starnes Field (8A1)
Guntersville, Alabama

March 27, 2019

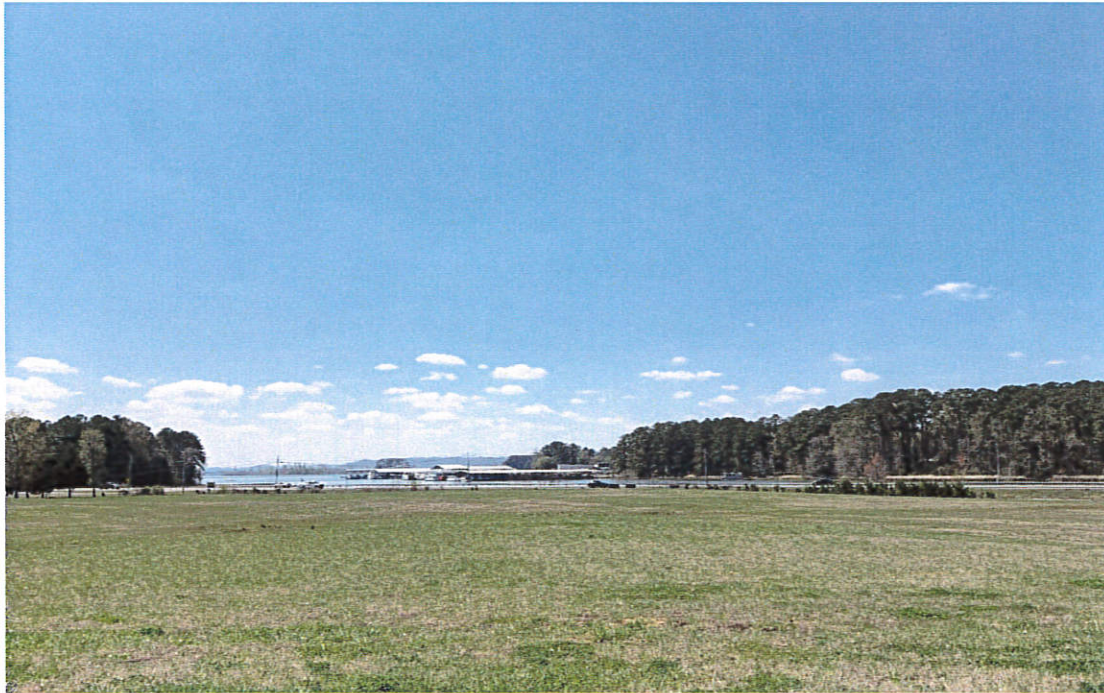
Photo #1 – Runway 07 Approach

- Runway 07 – No obstructions (See Photo #1).
- Runway 25 – No obstructions (See Photo #2). However, growth at the end of the primary surface will become obstructions if not removed as soon as possible.

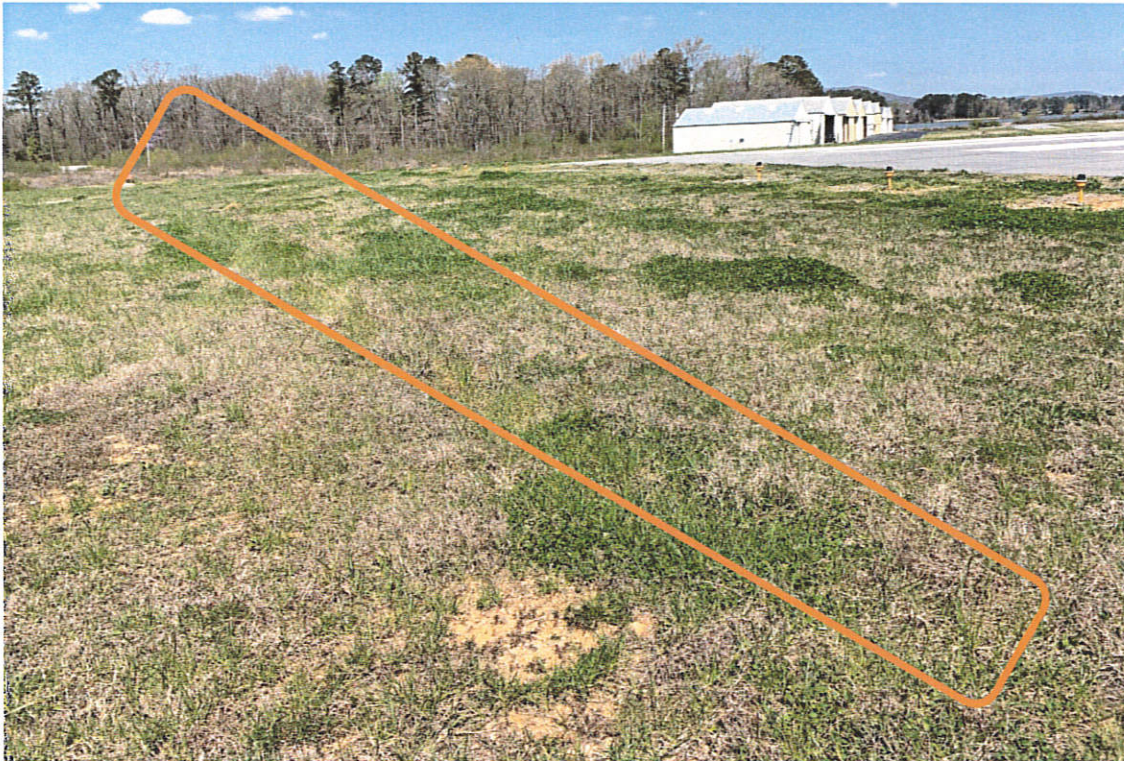
Photo #3 –Runway Safety Area

- The runway safety area meets state requirements (See Photo #3). However, there is an area at the approach end of runway 7 where the dirt covering the electrical trench has settled.

- Correct settling of dirt in the safety area.

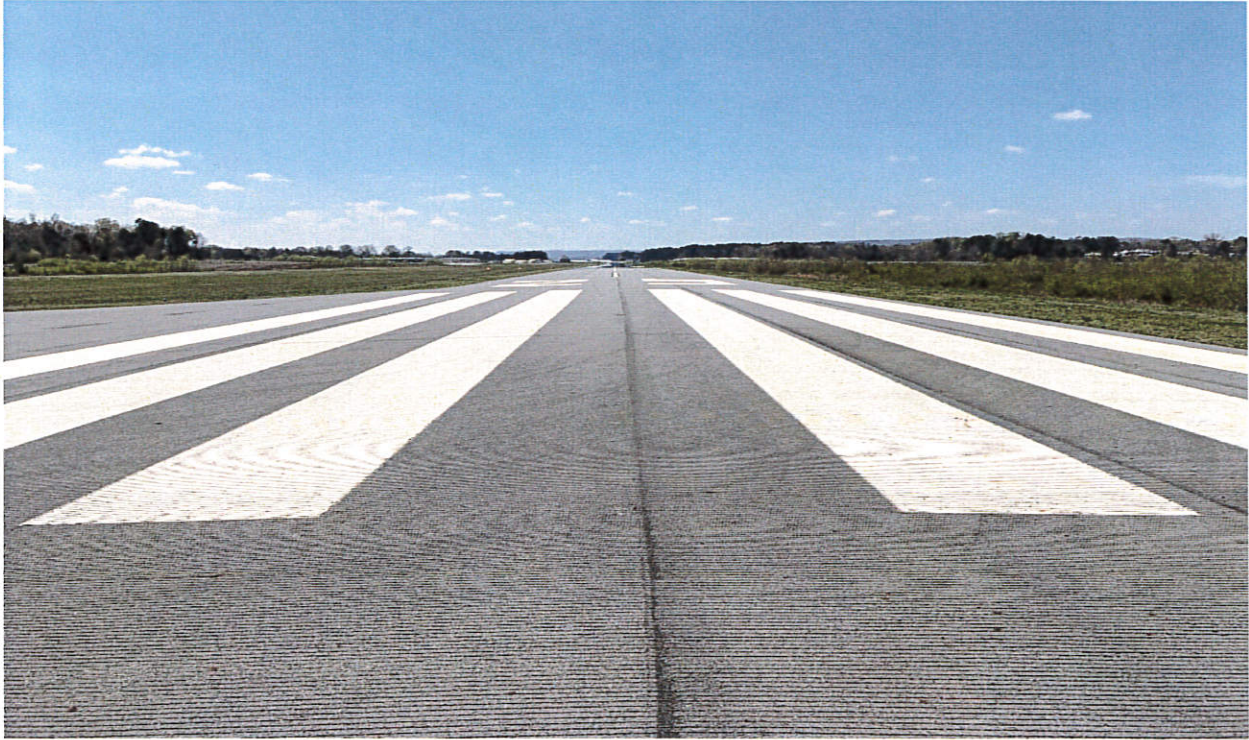
Photo #4 – Runway 25 NPI Markings

- The airport markings are in **GOOD** condition (See Photo #4).

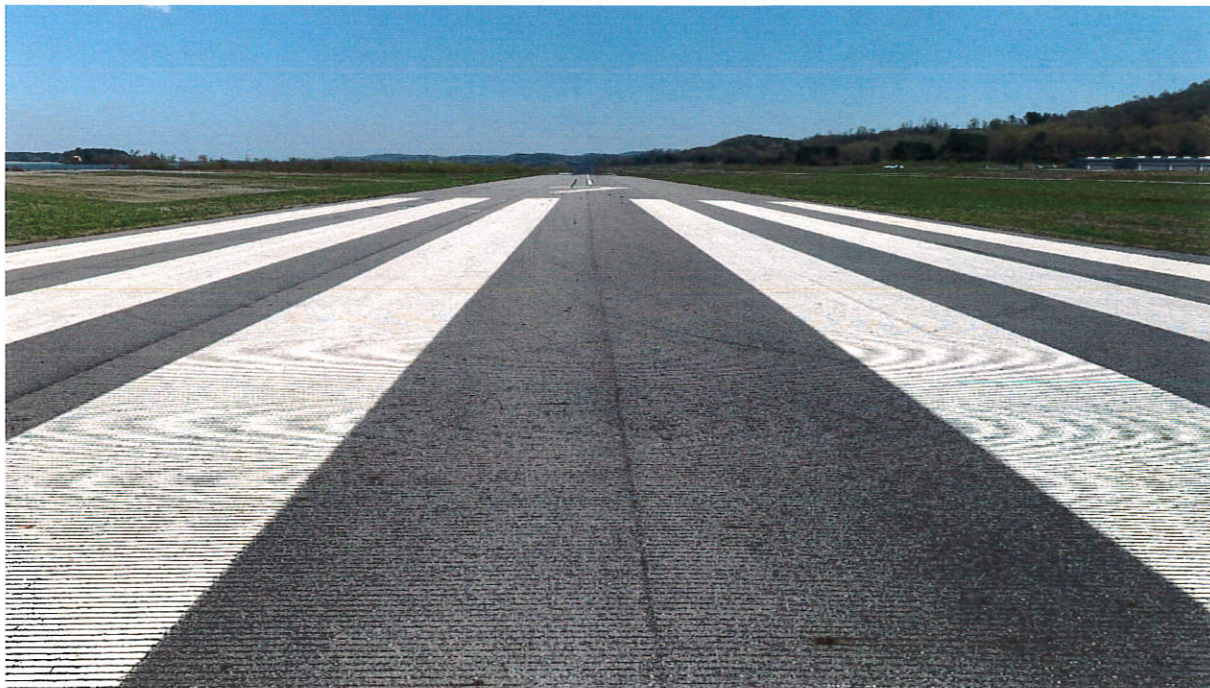
Photo #5 – Runway 7

Ramp	GOOD.
Taxiways	GOOD.
Runway	GOOD. (See Photo #5)
