**Subject: Annual Inspection Report
Headland Municipal Airport**

ANNUAL INSPECTION REPORT

HEADLAND MUNICIPAL AIRPORT

HEADLAND, ALABAMA

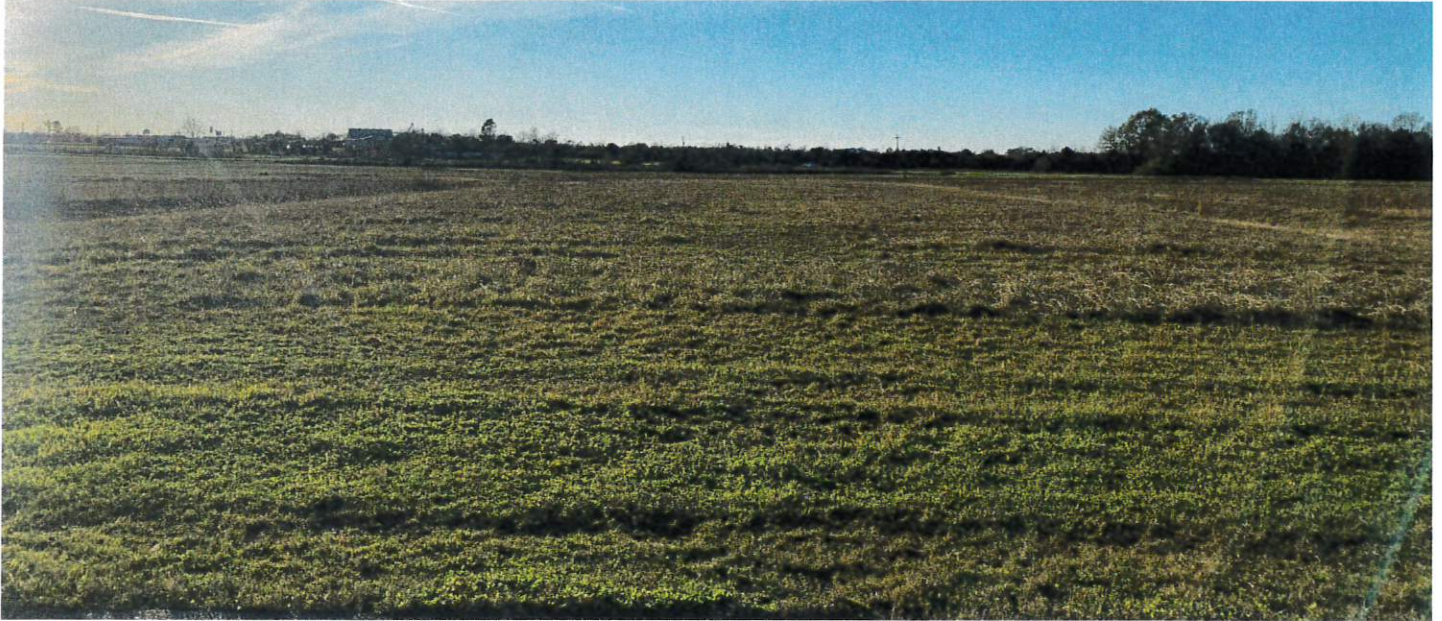
Photo #1 – Runway 9 Approach

- Runway 09 – No obstructions (See Photo # 1).
- Runway 27 – No obstructions. However, 3 trees were identified and have the possibility of becoming obstruction in the near future. (See Photo # 2).
- Runway 17 – No obstructions (See Photo # 3).
- Runway 35 – No obstructions (See Photo # 4).

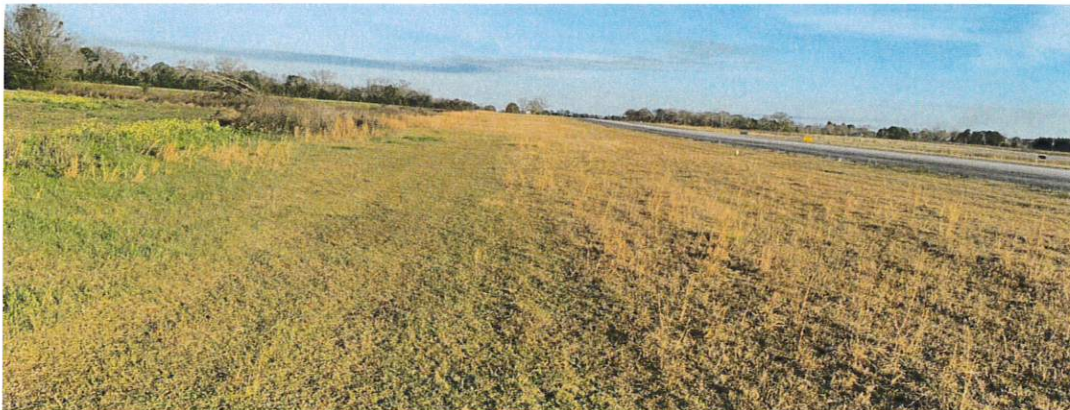
Photo #5 – Primary Surface RWY 09/27

- The Primary Surface for Runway 09/27 **meets** state licensing standards (See Photo #5).
- Primary Surface for Runway 17/35 **meets** state licensing standards (See Photo #6).

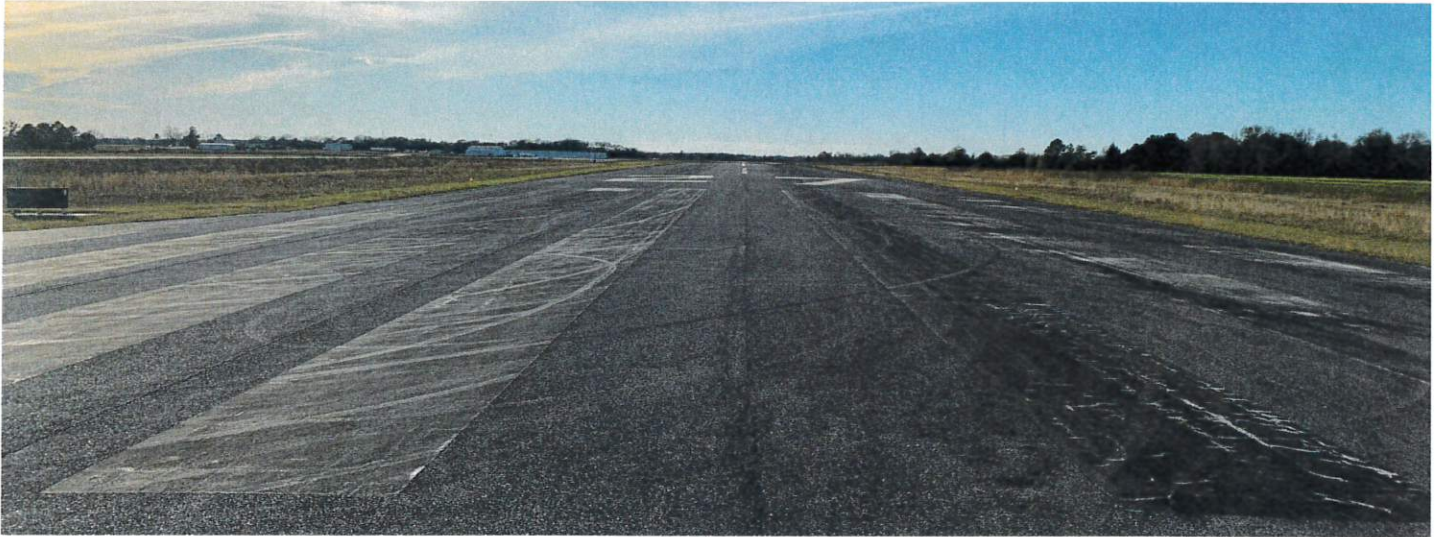
Photo #7 – NPI Markings Rwy 27

- The non-precision runway markings for runway 9/27 are in POOR condition; beginning to fade due to algae growth and weathering (See Photo #7).
- The turf markings for runway 17/35 are in GOOD condition. The runway threshold markers on Runway 17/35 are faded (See Photo #8).

- Clean Runway 9/27 markings or replace markings in accordance with FAA AC 150/5340-1M if they cannot be cleaned.
- Repaint Runway 17/35 threshold markers.

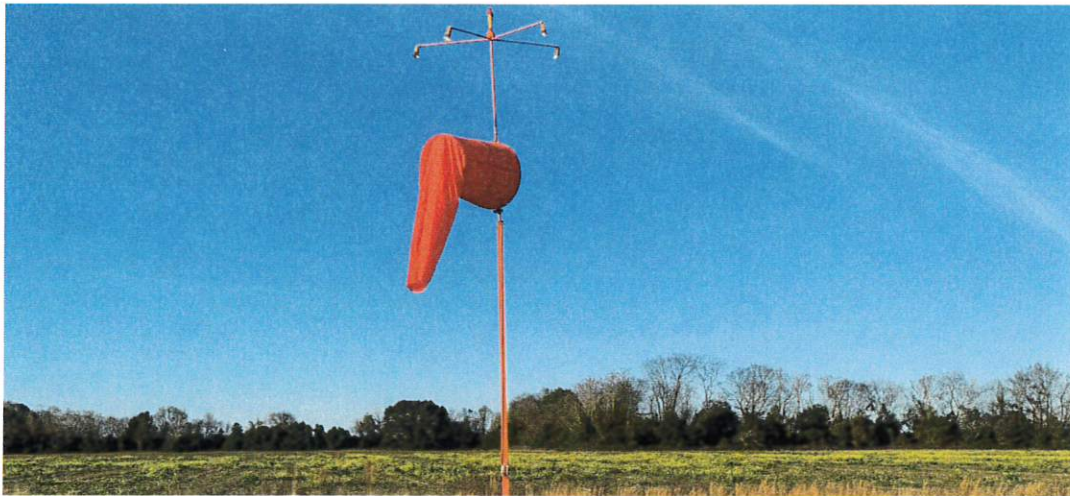
Photo #9 – Wind Cone

- The wind cone is operational and in **GOOD** condition. The segmented circle is in **GOOD** condition but needs to be repainted. (See Photo #9 and #10).

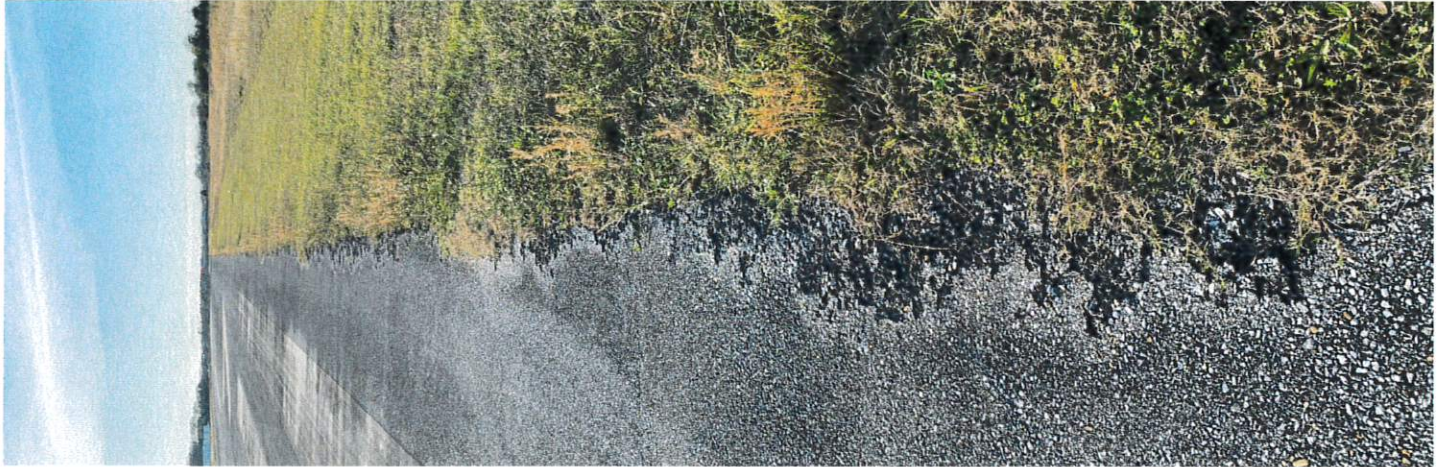
Photo #11 -- Runway Edge Raveling

- The runway surfaces are in **FAIR** condition. Runway paving joints are beginning to open and ravel. Foreign object debris (FOD) from raveling is collecting near the edges of pavement. (See Photo #11)
- Taxiway and Apron surfaces are in **GOOD** condition. (See Photo #12)
- The turf surfaces are in **GOOD** condition. (See Photo #13)

- Contact airport consultant to plan a runway rehabilitation project.

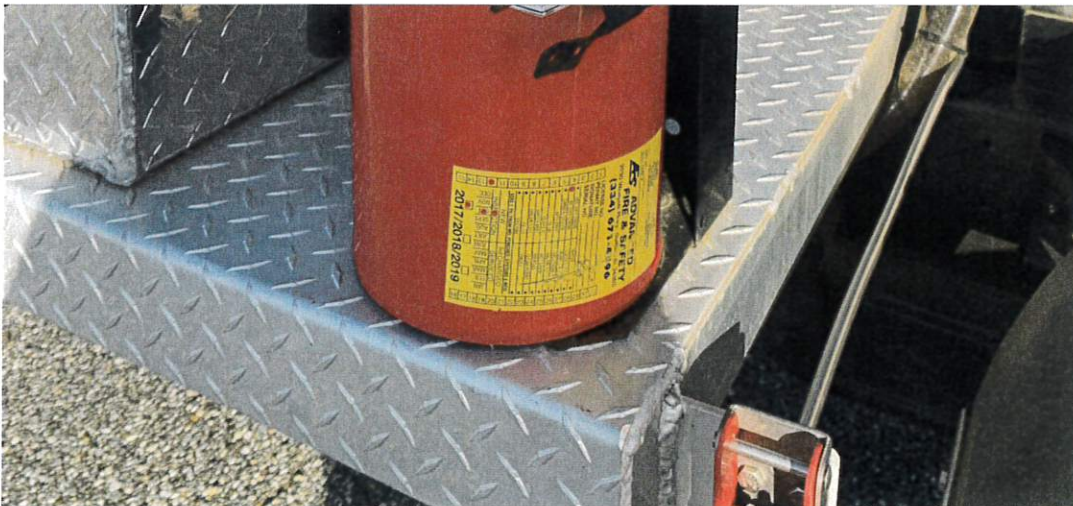
Photo #14 – Fueling Area

- The fueling area meets the requirements established by the Alabama Department of Transportation. However, the State of Alabama Department of Agriculture and Industries may have additional requirements for fueling systems that were not considered during this inspection (See Photo #14).

- Have fuel truck fire extinguishers inspected or replaced.
