**Subject: Annual Inspection Report  
Jackson Municipal Airport**

**Annual Inspection Report  
Jackson Municipal Airport  
Jackson, Alabama**

March 20, 2020

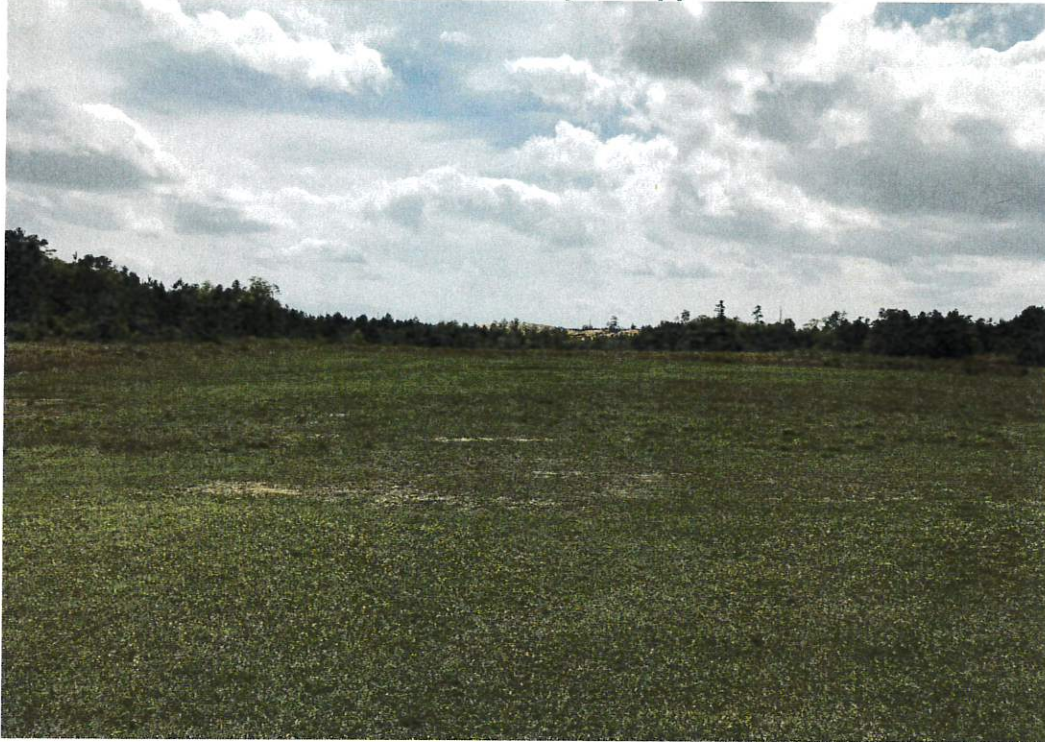
**Photo # 1 – Runway 01 Approach**

- Runway 01 – No Obstructions (See Photo #1).
- Runway 19 – Trees identified as #1 and #2 obstruct the required 20:1 approach/departure path (See Photo # 2).

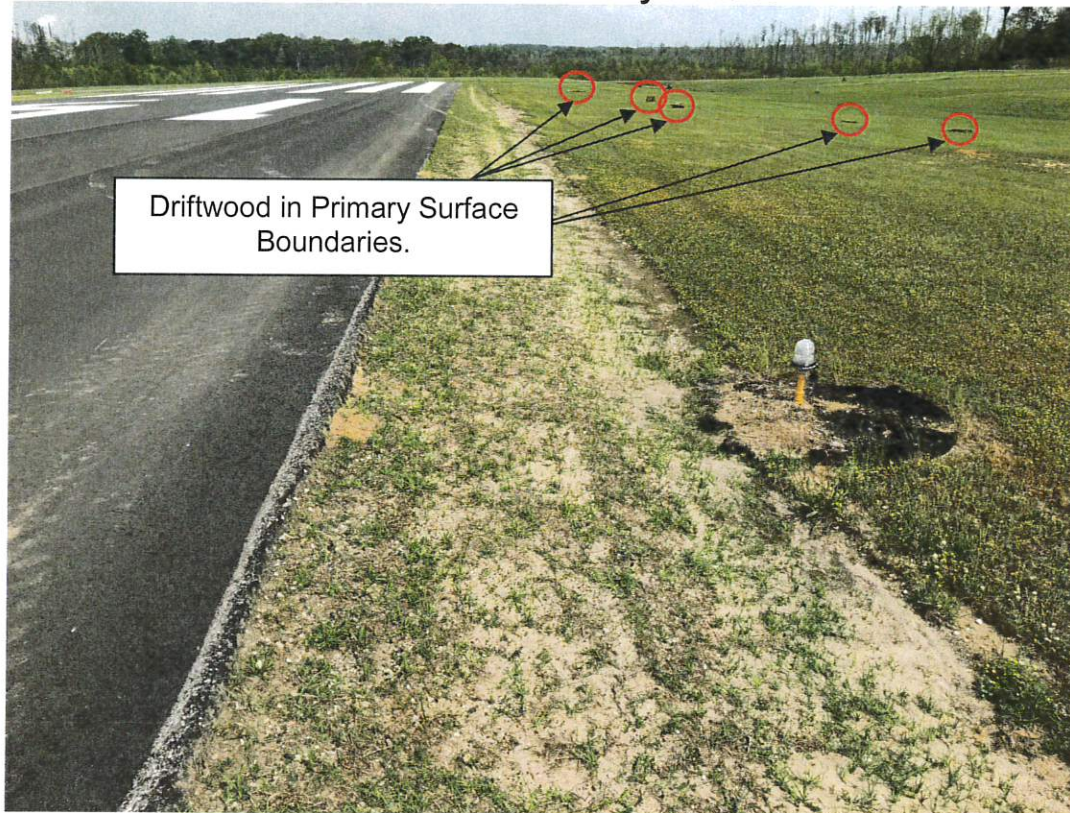
Photo # 3 – Primary Surface

- The Primary Surface meets state licensing requirements, however, some driftwood has been deposited into the boundaries of the Primary Surface by floodwaters (See Photo #3).

- Remove driftwood.

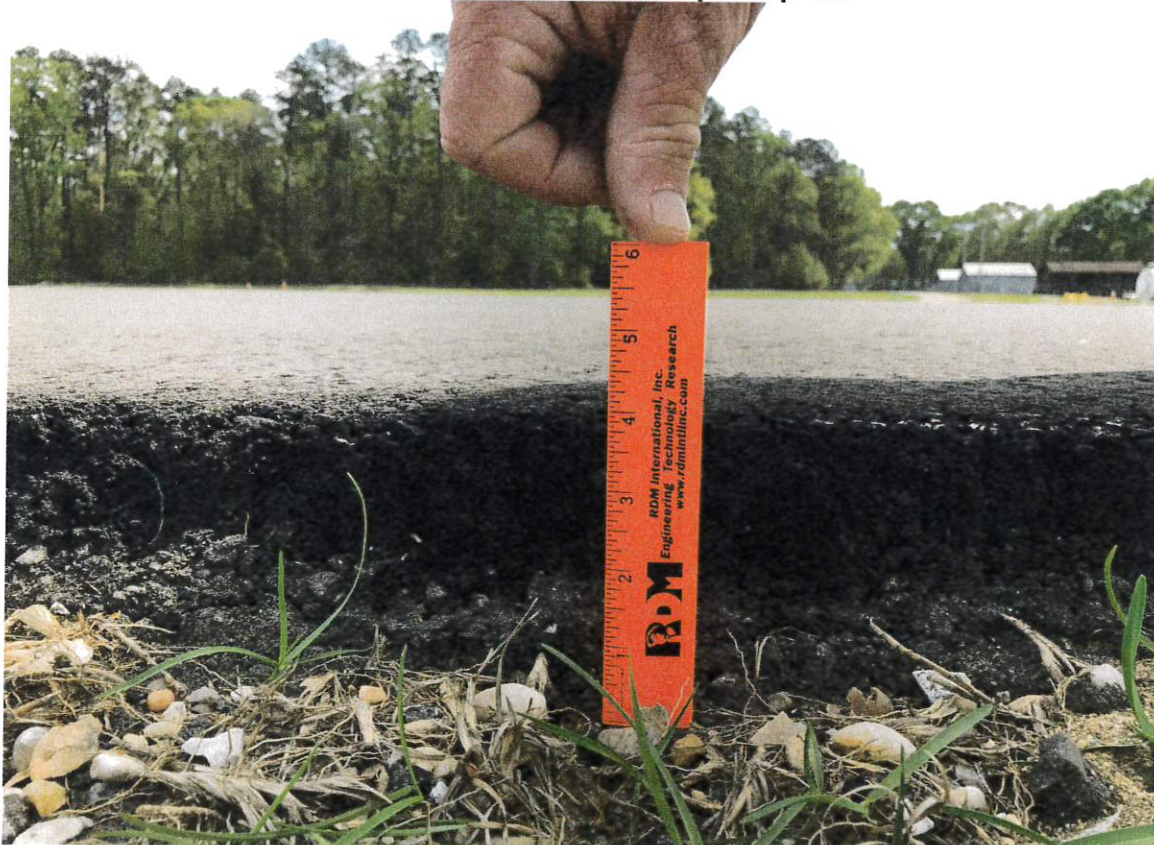
**Photo # 4 — Pavement Lip Drop-off**

- Lip of runway pavement in many areas along runway shoulder exceed the maximum allowable drop of (3) inches (See Photo # 4).
- There are ruts along both sides of the runway that exceed the maximum allowable depth of (3) inches (See Photo #5).
- Sections of the grade next to runway pavement edge exceed a rise of (3) inches. (See Photo #6).
- Slope of grade adjacent to runway exceeds (3) percent.

- The grade adjacent to the runway has been brought up and compacted smooth, **correcting safety deficiencies**. However, based upon our Runway Safety Area (RSA) inspection, it is recommended that an RSA grading project be planned for the near future, to meet current FAA design standards found in FAA AC150/5300-13A.

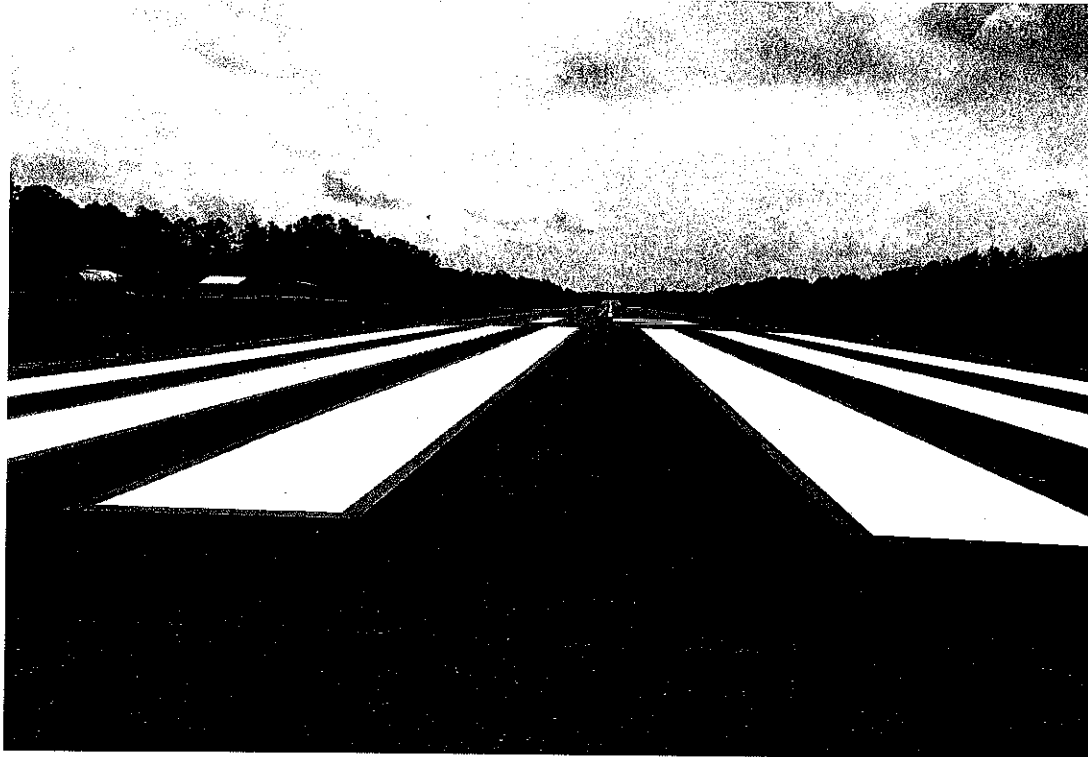
Photo # 7 – NPI Markings RWY 19

- The airport markings are in GOOD condition (See Photo #7).

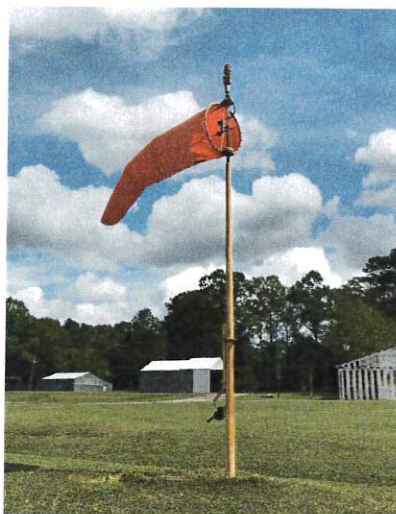
**Photo #8 – Wind Direction Indicator**

- The wind direction indicator (wind cone) is operational and in **GOOD** condition (See Photo #8).

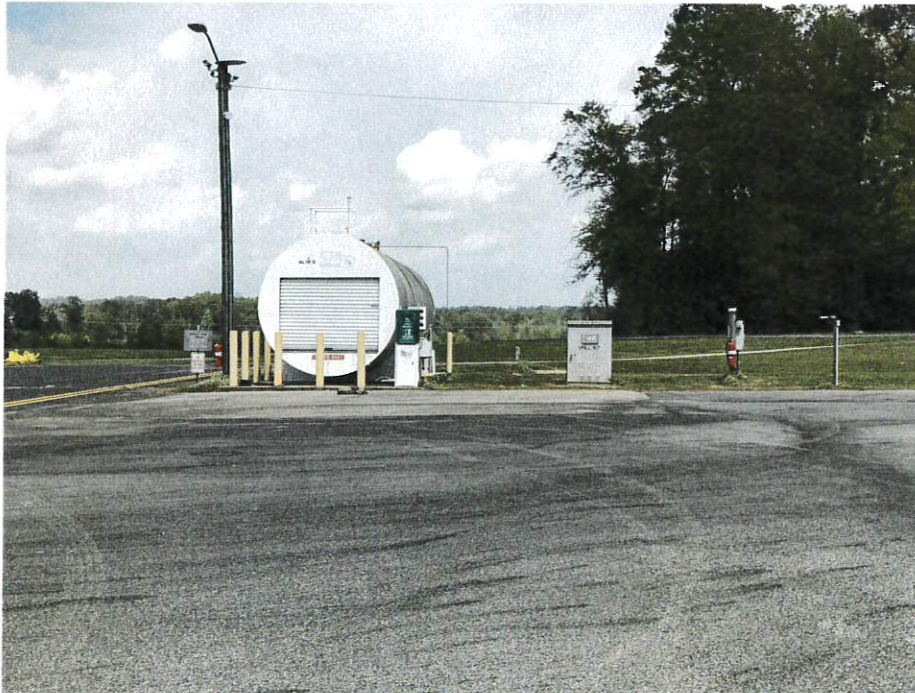
**Photo # 9 – Fuel Service Area**

- The fueling area **meets** the requirements established by the Alabama Department of Transportation. However, the State of Alabama Department of Agriculture and Industries may have additional requirements for fueling systems that were not considered during this inspection (See Photo # 9).

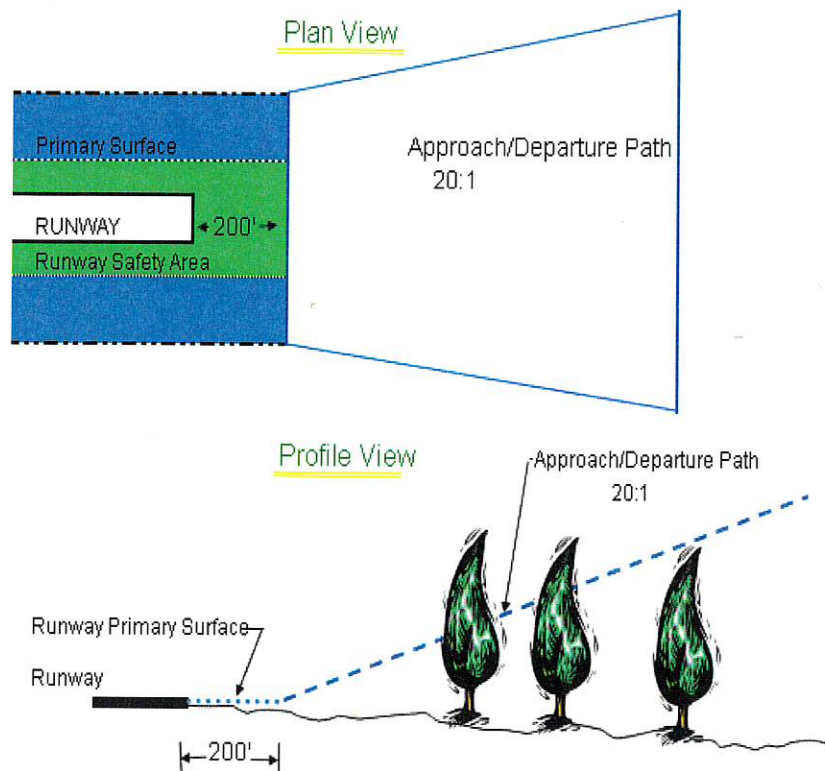
*Jackson Municipal Airport (4R3)  
RWY 19 20:1 App/Dep Path  
March 20, 2020*

| 1. Tree 18' Abv. RWY End | 2. Tree 19' Abv. RWY End |
| 505' From RWY End | 510' From RWY End |
| 37' Right of Cntln. | 14' Left of Cntln. |
| 16:1 Obst. Cline. | 16:1 Obst. Cline. |

- Remove all obstructions. The obstructions are not limited to those identified in this report.
