**Subject: Re-Inspection Report
Robbins Field (20A)**

**Subject: Annual Inspection Report
Robbins Field (20A)**

**Annual Inspection Report
Robbins Field (20A)
Oneonta, Alabama**

July 13, 2020

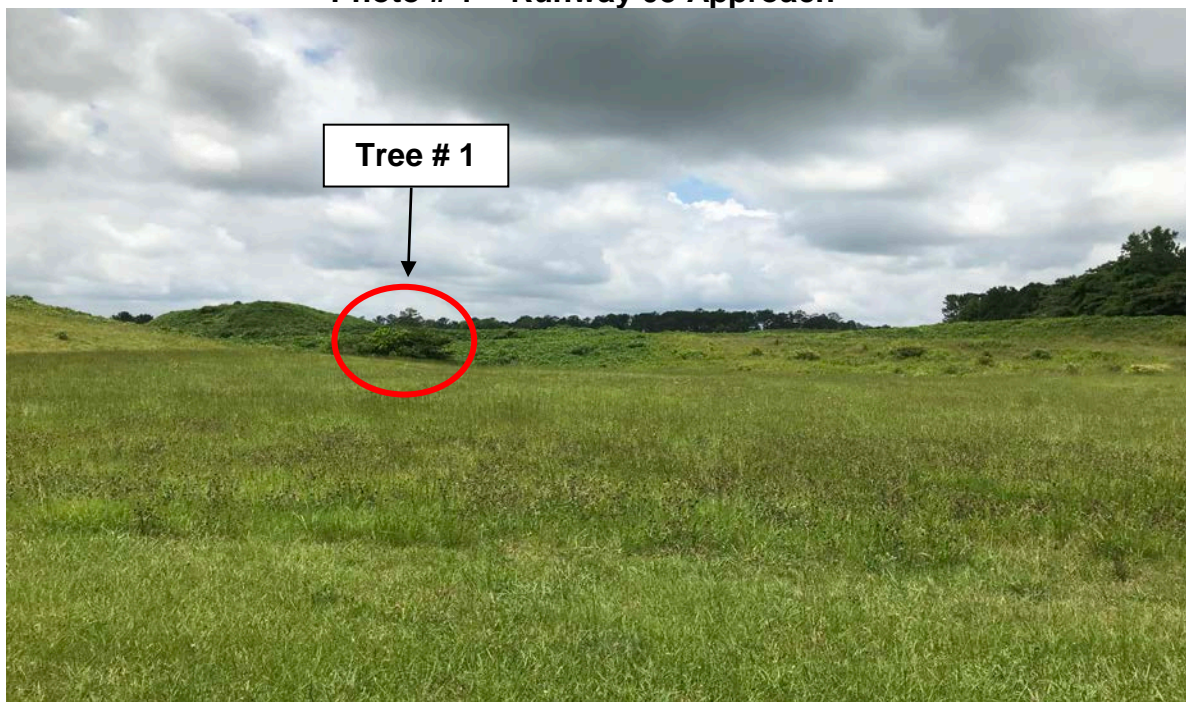
Photo # 1 – Runway 05 Approach

- Runway 05 – Brush labeled #1 obstructs the required 20:1 approach/departure path (See Photo #1 and Appendix 2).
- Runway 23 – Tree labeled #1 obstructs the required 20:1 approach/departure path. Trees labeled #3, #4, #5, and #6 will be obstructions soon if not removed (See Photo #2 and Appendix 3).

- Remove all obstructions to the required 20:1 approach/departure paths.

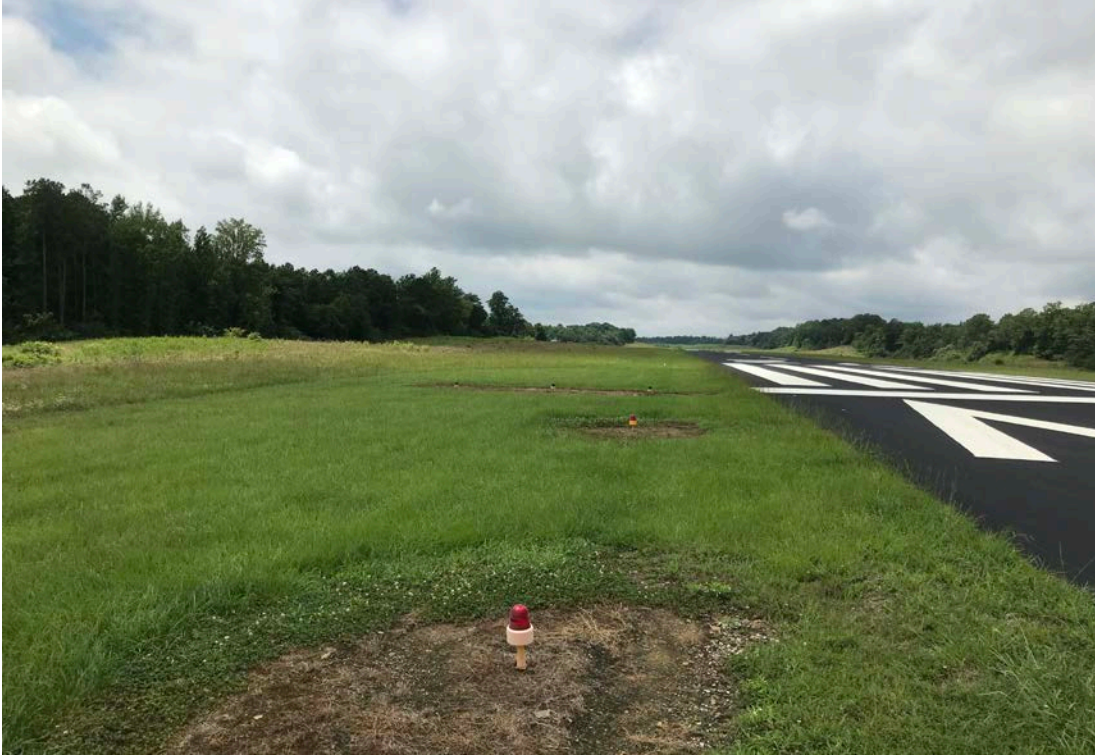
Photo #3—Primary Surface and RSA

- The primary surface **meets** state licensing requirements (See Photo #3).

- The grade of the runway safety area **meets** state licensing requirements (See Photo #3).

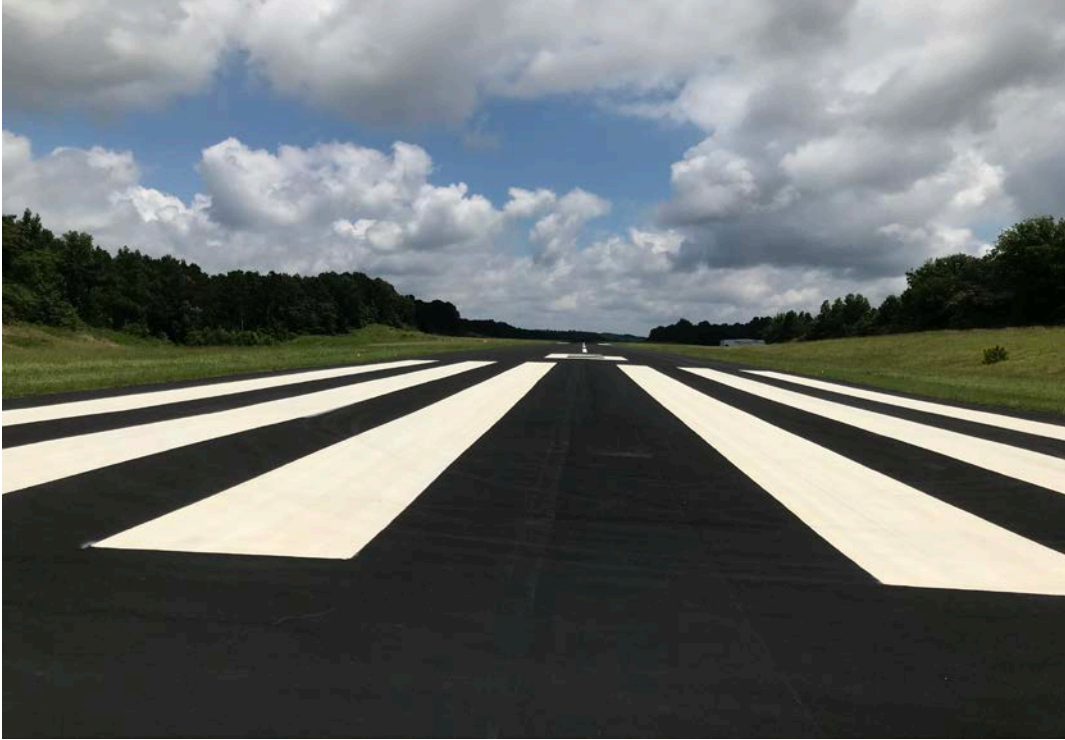
Photo #4 – Markings Runway 05

- The runway markings are in GOOD condition (See Photo #4).

- The Runway pavement is in **EXCELLENT** condition due to the recent overlay (See Photo #4).
- The Apron corrective work was not completed in a thorough manner, therefore resulting in relatively poor results.

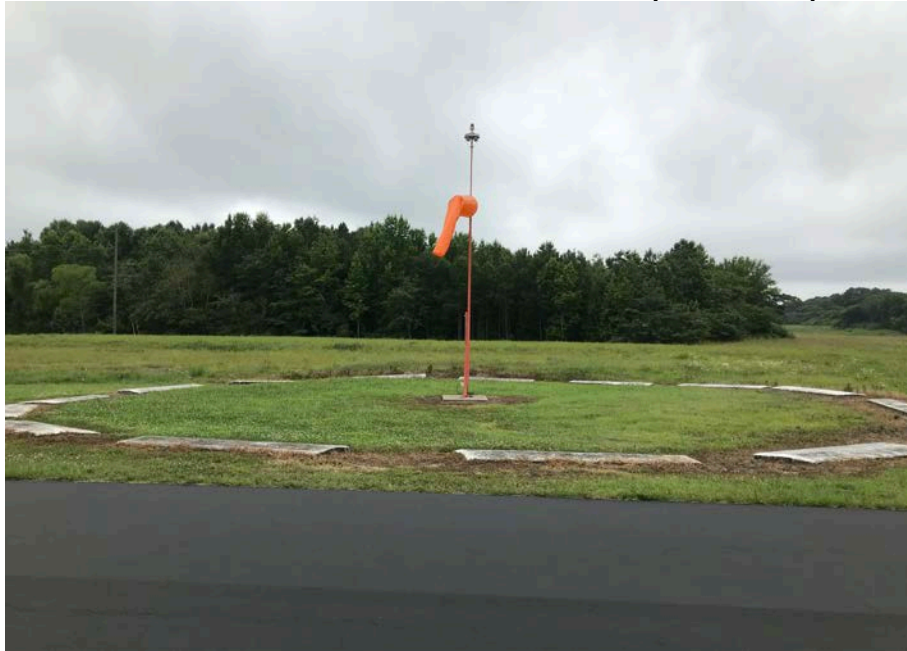
Photo #5—Wind Direction Indicator (Windsock)

- The wind direction indicator (wind cone) is operational and in **GOOD** condition (See Photo #5).
- The functionality of the wind direction indicator lighting was not inspected due to the inaccessibility of the system's photo cell; however, all fixtures appeared in good shape with no broken globes or fixtures.
- Segmented circle is faded.

- Paint segmented circle white in accordance with FAA AC 150/5340-5D

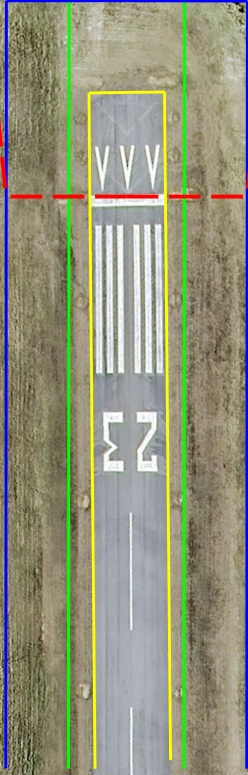
Oneonta-Robbins Field *Runway 23 20:1 Obstructions* *July 13, 2020*

- 1. Tree 47' abv. RWY End 2. Tree 22' abv. RWY End 4. Tree 21' abv. RWY End 5. Tree 19' abv. RWY End 6. Tree 14' abv. RWY End
605' From RWY End 342' From RWY End 338' From RWY End 298' From RWY End 250' From RWY End
206' Right of Cntln. 92' Right of Cntln. 16' Right of Cntln. 25' Left of Cntln. 155' Left of Cntln.
Obst. Clnc. 15:1 Obst. Clnc. 20:1 Obst. Clnc. 2:1 Obst. Clnc. 21:1 Obst. Clnc. 25:1

VIOLATION
