**Subject: Annual Inspection Report
Ozark Airport—Blackwell Field**

ANNUAL INSPECTION REPORT

OZARK (BLACKWELL FIELD) MUNICIPAL AIRPORT

**Annual Inspection Report
Ozark Airport—Blackwell Field
Ozark, Alabama**

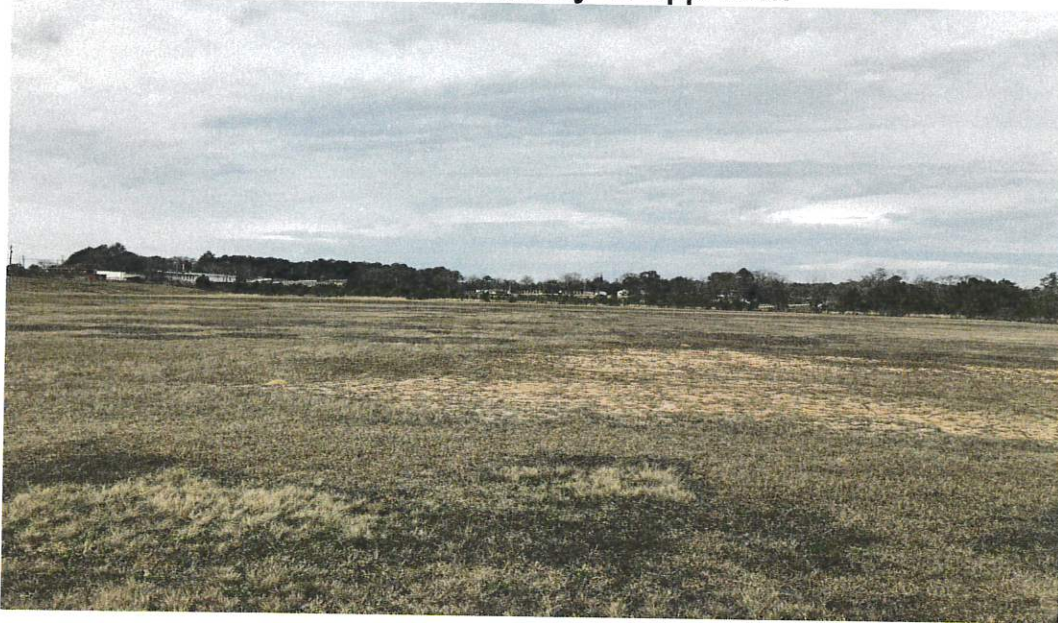
Photo # 1 – Runway 13 Approach

- Runway 13 – No obstructions (See Photo #1).
- Runway 31 – Trees identified as #1, #2, #3, #4, and #12 are obstructions to the Required 20:1 Approach/Departure Path. (See Photo #2, Appendix 2).

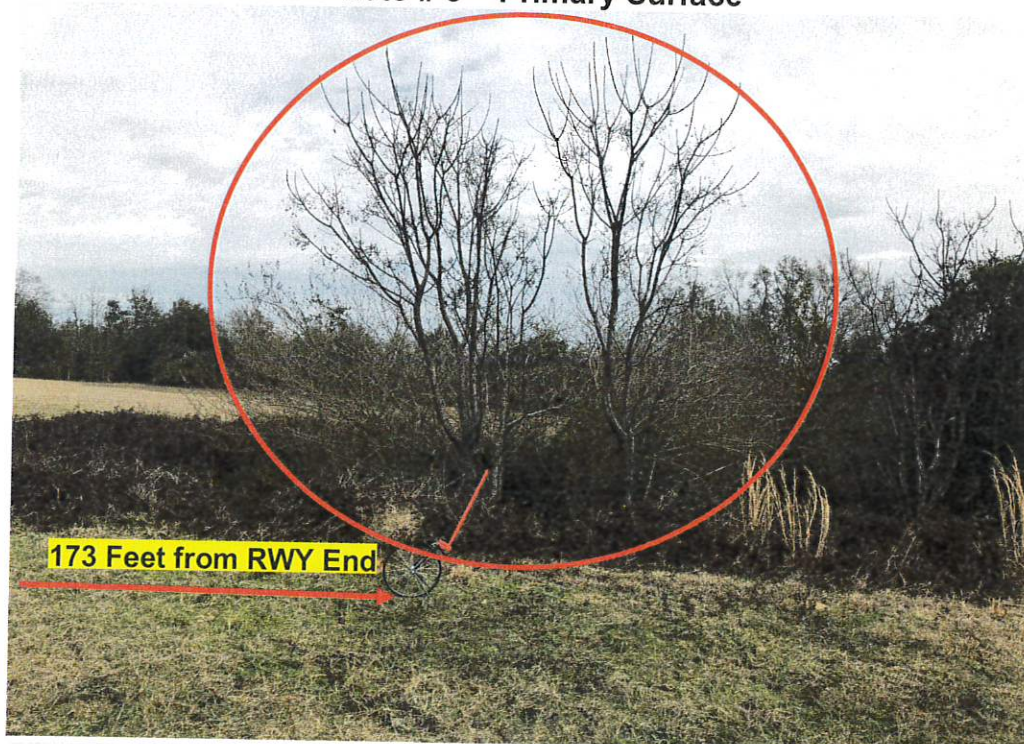
Photo # 3 – Primary Surface

- **Violation:** There are two close-in obstructions on the approach end of RWY 31 that violate the Primary Surface (See Photo #3 and Appendix 2).
- **Maintenance:** Remove vegetation from area of gravel in Primary Surface near RWY 31 Approach End (See Photo #4).

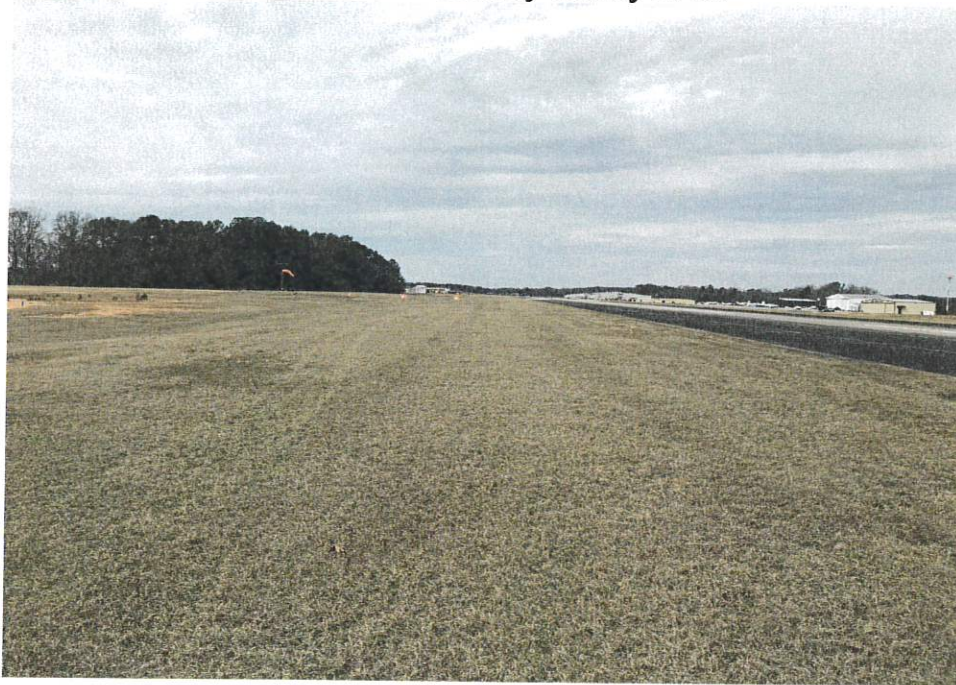
Photo #5—Runway Safety Area

- The runway safety area meets the state licensing standards (See Photo #5).

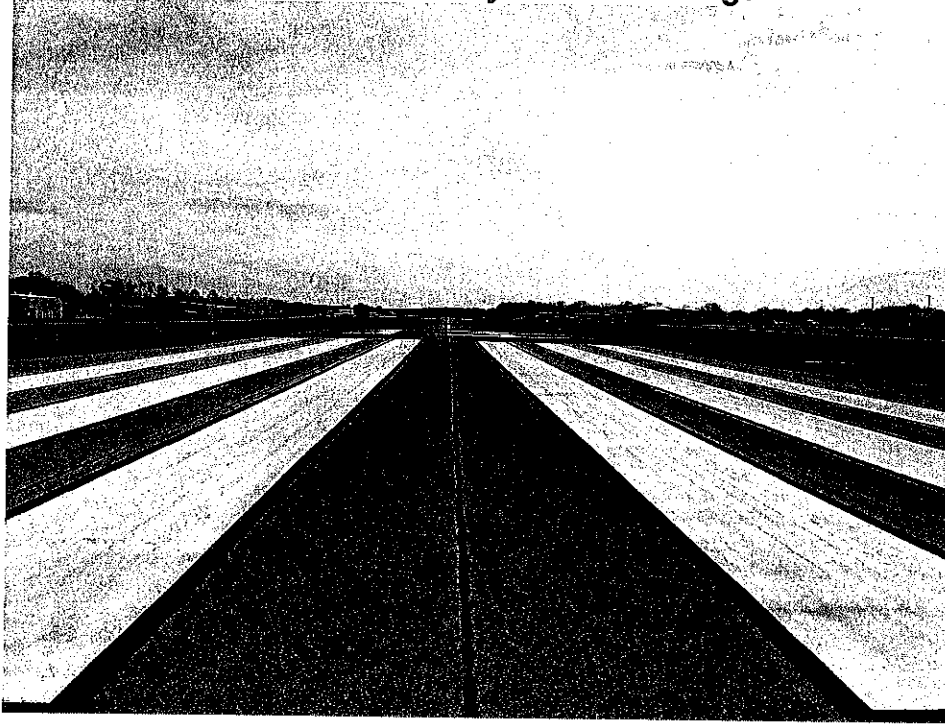
Photo #6 – Runway 13 NPI Markings

- The runway markings are in **GOOD** condition, although some of the paint is beginning to flake up (See Photo #6).
- The taxiway and apron markings are in **GOOD** to **FAIR** condition, with some fading.

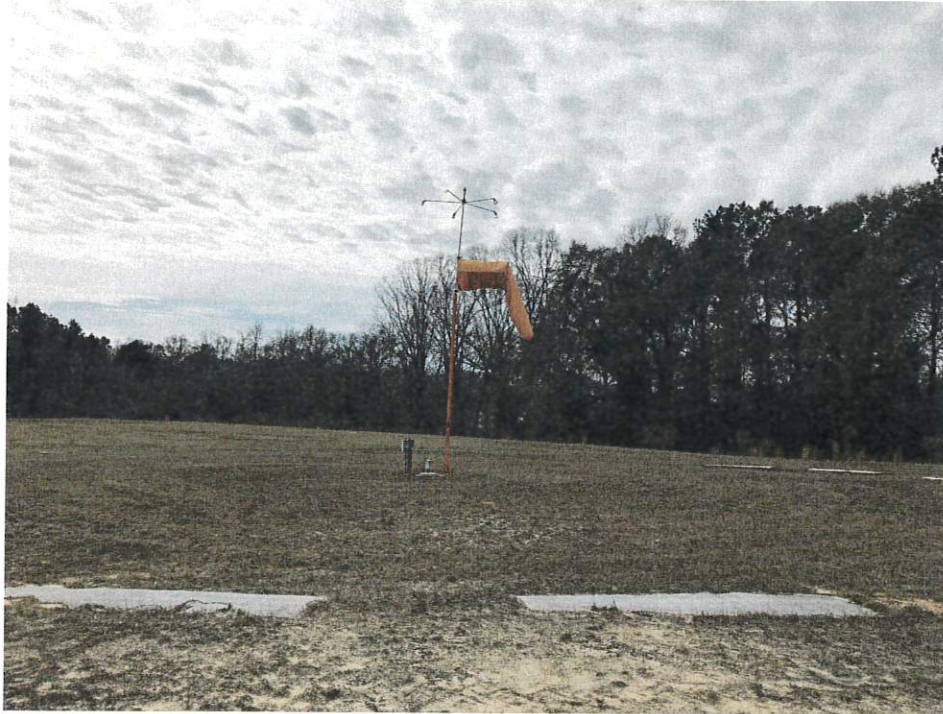
Photo #7 – Wind Cone

- The wind direction indicator (wind cone) is in **FAIR** condition due to microbial growth (See Photo #7).
- Segmented circle has completely faded.

- Re-paint segmented circle white. It should be noted that the airport has re-painting on schedule.

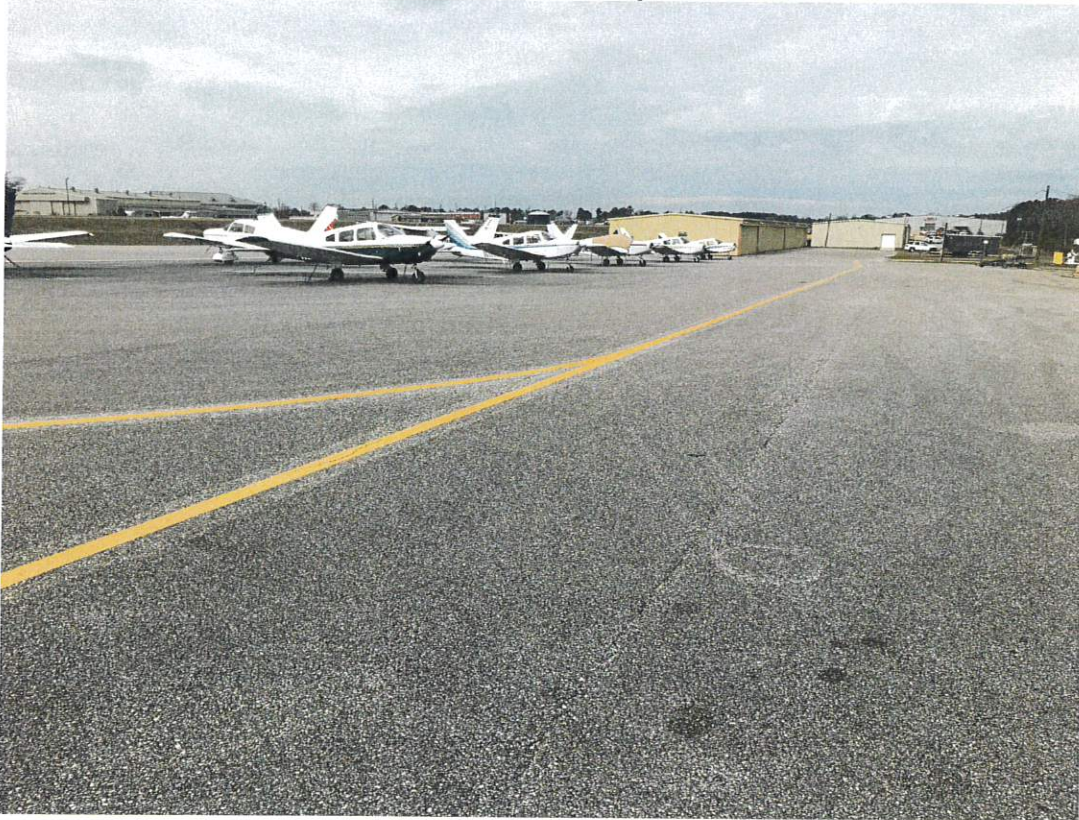
Photo #8—Old Apron

- The runway and the newer south-side apron and taxiway are in **GOOD** condition with some light weathering (See Photo #6). The crack-seals on the runway are holding up well.
- The older north-side apron and taxiways are in **FAIR** condition due to moderate polishing and thermal cracking (See Photo #8).

- Plan a future pavement maintenance project for the older north-side apron and taxiways.

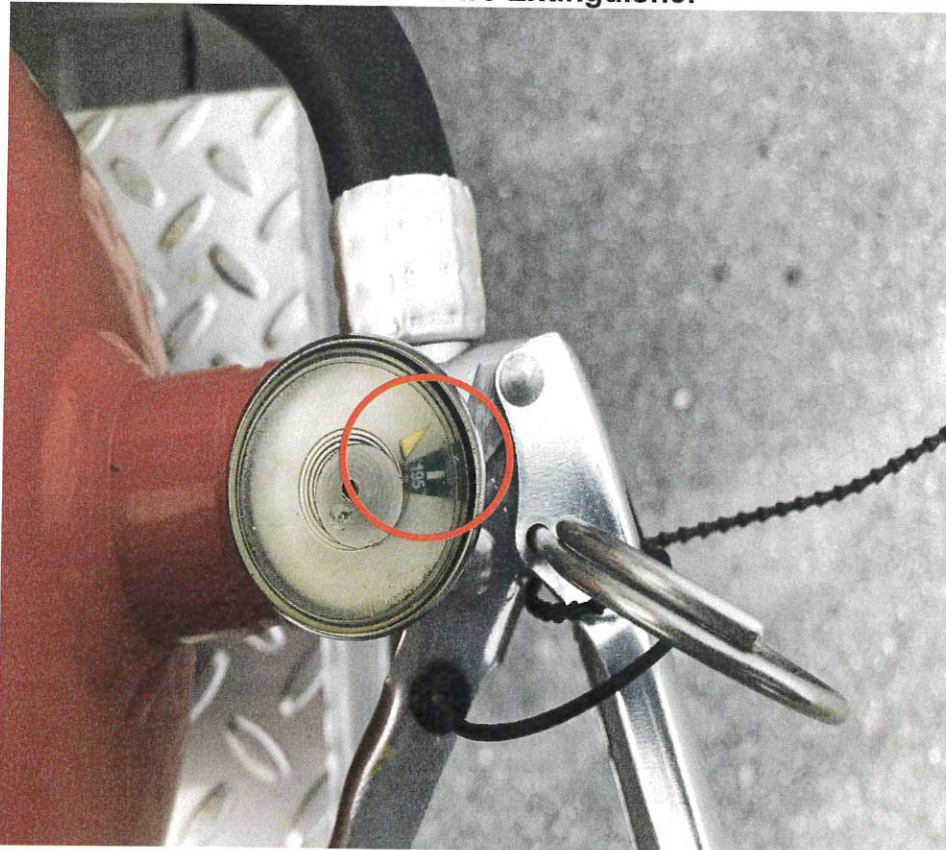
Photo #9 – Fire Extinguisher

- The fueling area **meets** the requirements established by the Alabama Department of Transportation. However, the State of Alabama Department of Agriculture and Industries may have additional requirements for fueling systems that were not considered during this inspection.
- Jet-A Self-Serve fueling area is currently shut down by the airport for maintenance and improvements.
- One of the fire extinguishers on the AVGAS (100LL) truck was not fully charged (See Photo #9).

- Have fire extinguisher re-charged or replaced.

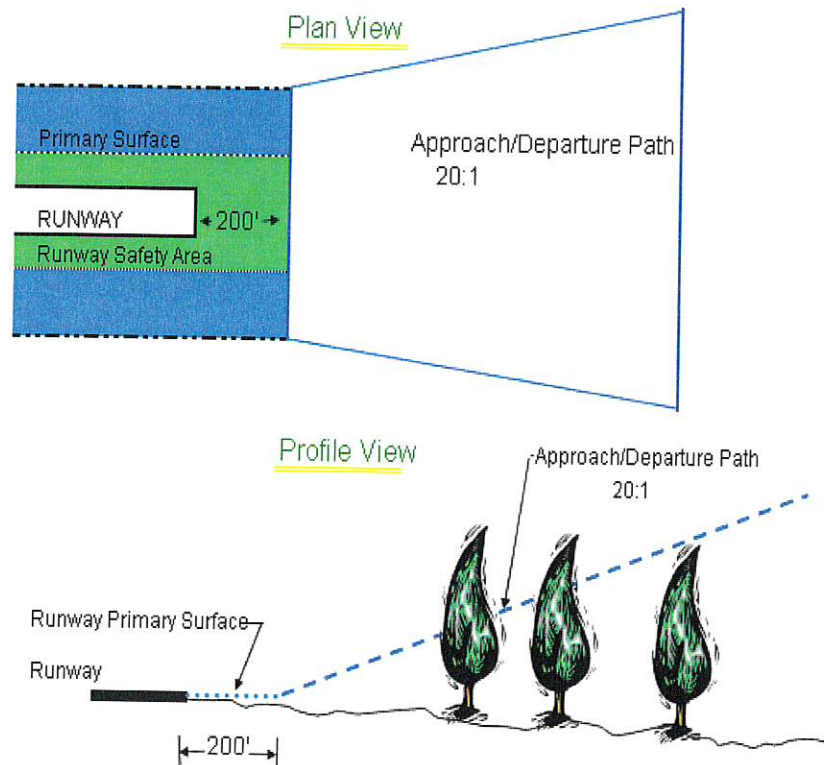
Ozark-Blackwell Field
Ozark, AL
February 4, 2021
Obstruction Evaluation
Runway 31

1. Tree 15' Abv. RWY
 173' From RWY End.
 102' Right of Cntln.
 Close-In Obst. (0:1)

2. Tree 13' Abv. RWY
 212' From RWY End.
 85' Right of Cntln.
 Close-In Obst. (0:1)

3. Tree 11' Abv. RWY
 251' From RWY End.
 83' Right of Cntln.
 4:1 Obst. Clnc.

4. Tree 12' Abv. RWY
 297' From RWY End.
 75' Right of Cntln.
 8:1 Obst. Clnc.

12. Tree 5' Abv. RWY
 286' From RWY End.
 80' Left of Cntln.
 17:1 Obst. Clnc.

- Remove all obstructions to the Required 20:1 ALDOT Approach & Departure Path.
