Subject: Annual Inspection Report
Prattville Municipal (Grouby Field) Airport

**Annual Inspection Report
Prattville (Grouby Field) Municipal Airport
Prattville, Alabama**

November 16, 2020

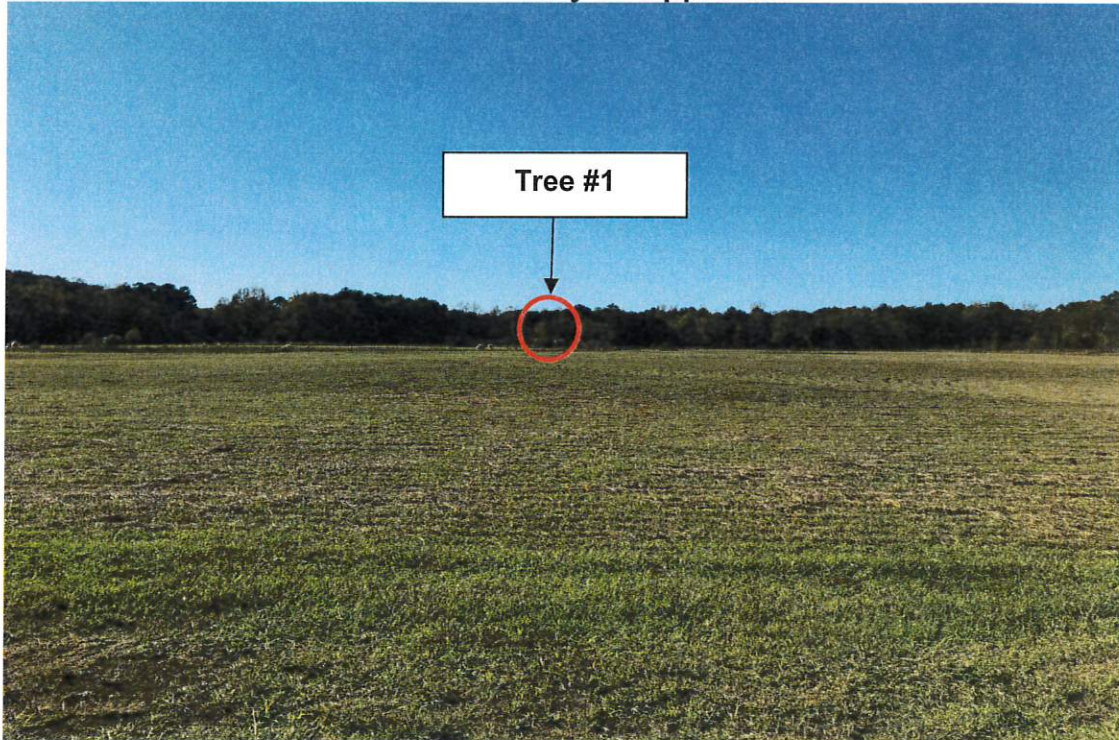
Photo # 1 – Rwy 09 Approach

- Runway 09 – Tree identified as Tree #1 obstructs the required 20:1 approach and departure path (Photo # 1).
- Runway 27 – Tree identified as Tree #1 obstructs the required 20:1 approach and departure path (Photo # 2).

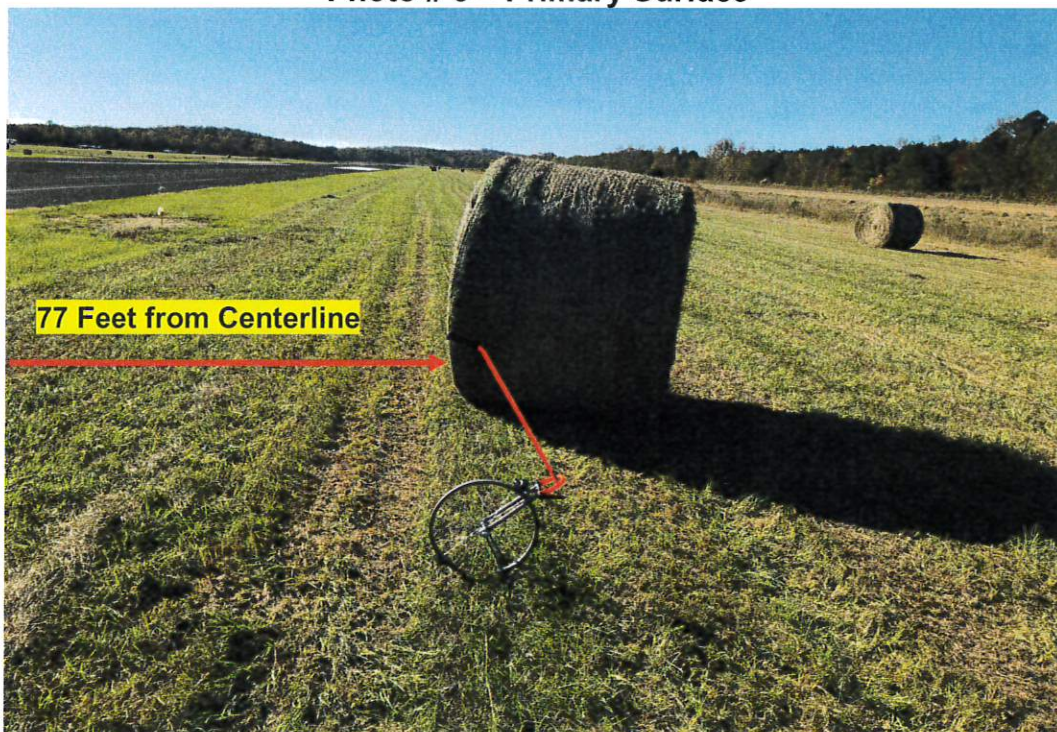
Photo # 3 – Primary Surface

- Hay bales violate the Primary Surface at 77 feet and 102 feet from runway centerline (Photo # 3).

- Remove hay bales from all airport imaginary surfaces. Ensure that

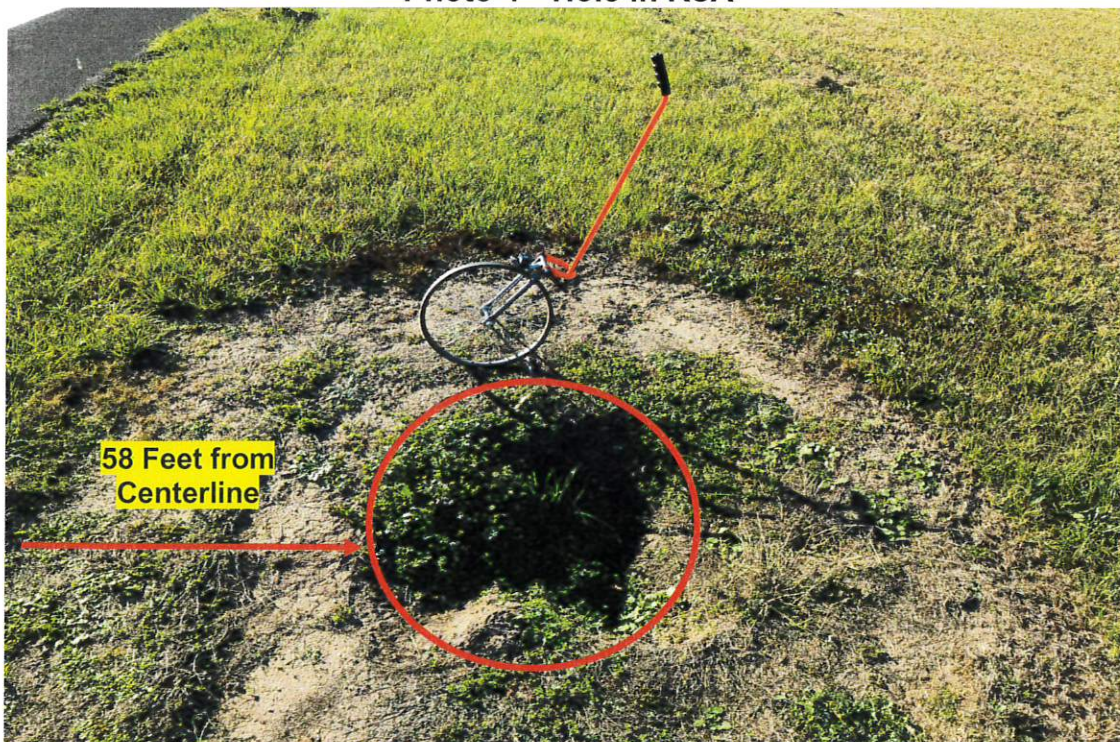
Photo 4—Hole in RSA

- There is an 8-inch (+/-) deep hole in the Runway Safety Area (RSA). It is located 58 feet left of the runway centerline, near the approach end of Runway 09 (See Photo #4).

- Fill in hole and compact smooth so that there are no hazardous depressions, humps, bumps, or surface variations.

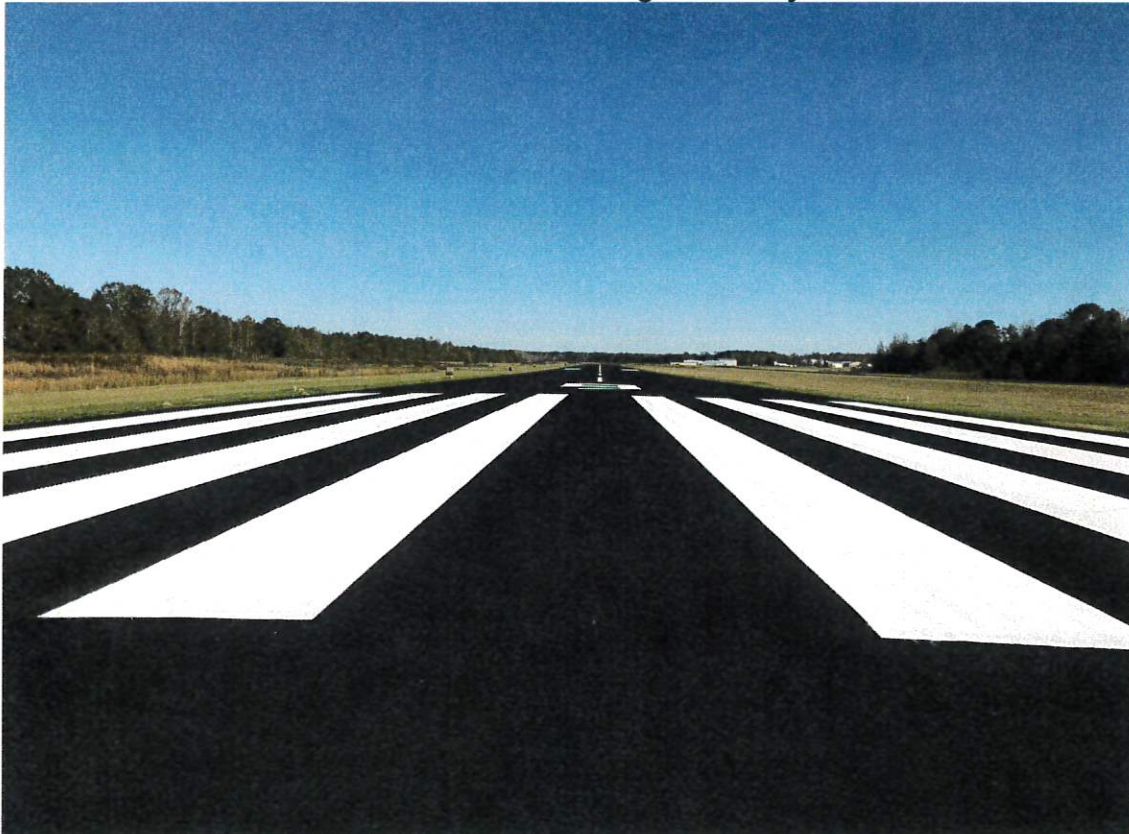
Photo # 5 – NPI Markings Runway 09

- Airport markings are in **GOOD** condition (Photo # 5).

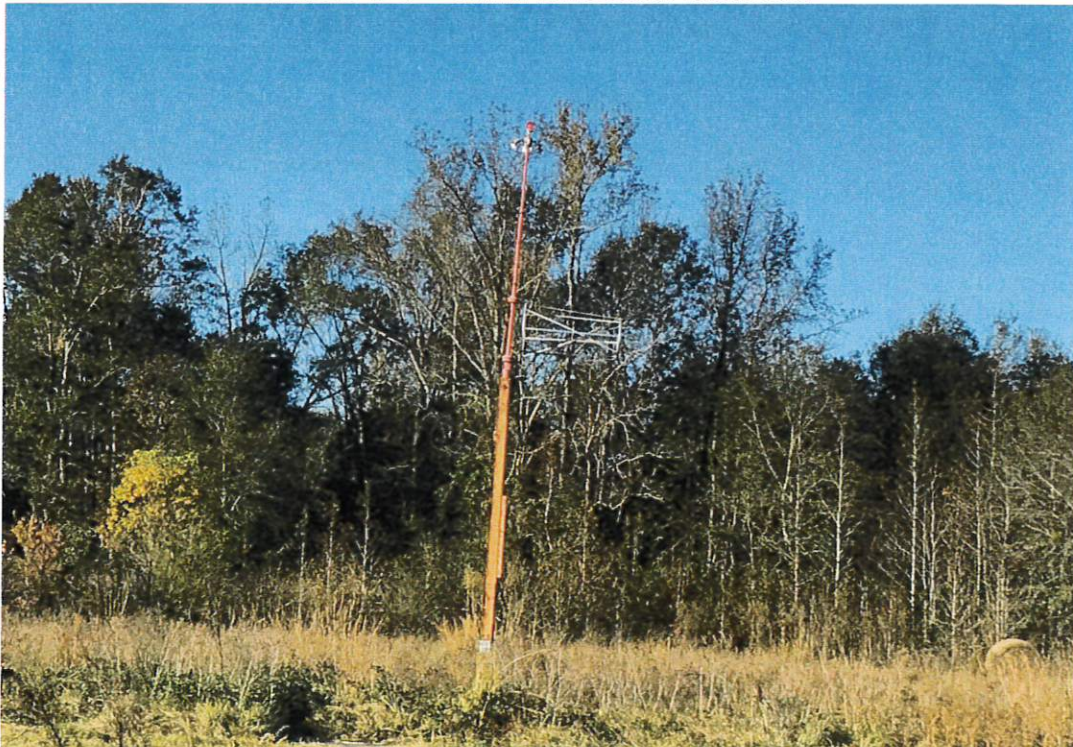
Photo # 6 – Wind Direction Indicator

- The wind direction indicator (windsock) is missing due to the effects of Hurricane Zeta (Photo # 6).

- Replace torn wind direction indicator (wind cone). **It should be noted that airport had a new windsock on order at time of inspection.*

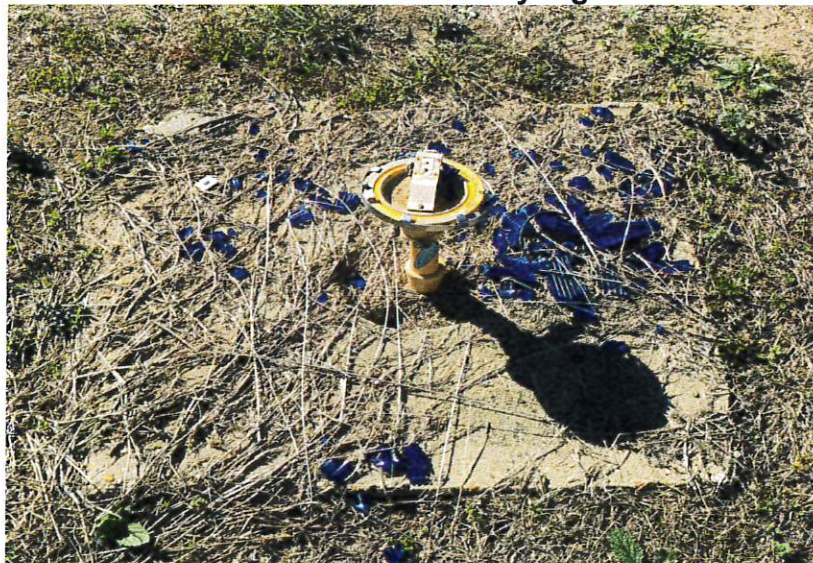
Photo # 7 – Broken Taxiway Light Globe

- Ant beds and/or dirt build up are noticeable in several light globes.
- The results of the lighting system inspection is as follows:

Threshold Lights –	2 inoperative; 1 broken fixture
Taxiway Lights –	20 inoperative; 1 broken globe
Runway Lights –	8 inoperative; 1 broken globe
PAPI's –	Rwy 9 u/s
REIL's –	Operative

- Replace/repair inoperative lights.
- Ensure that light globes are clean and easily visible.

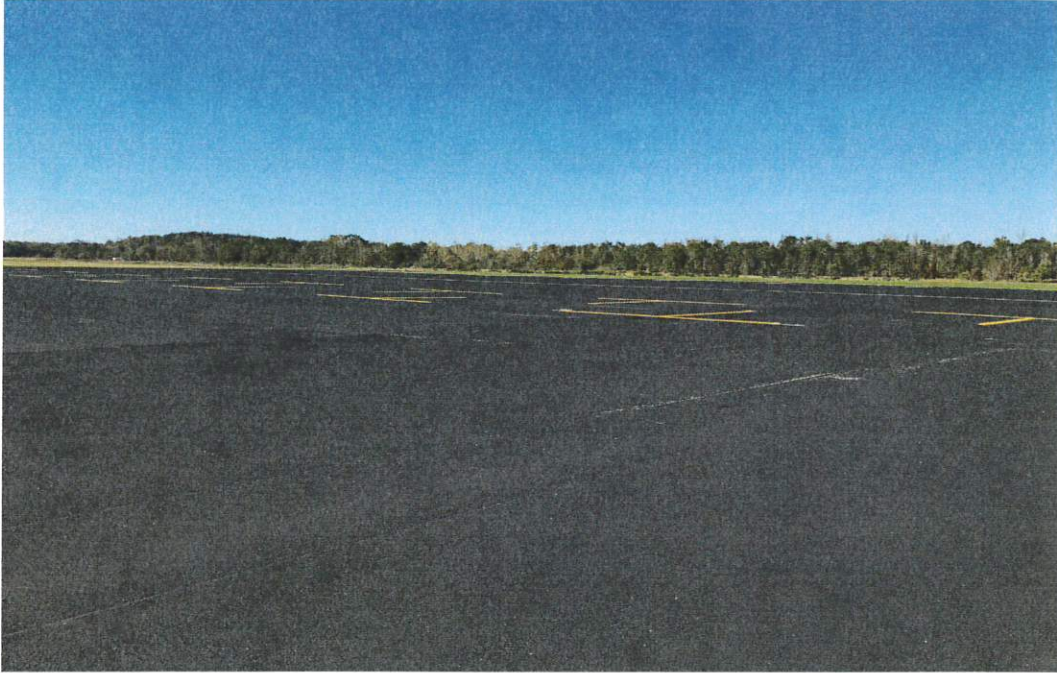
Photo #8—Revitalized Aircraft Parking Apron

- The runway and taxiway surfaces are in **EXCELLENT** condition, along with the west half of the aircraft parking apron (See Photos # 5 and # 8). The east half of the aircraft parking apron is in **FAIR** condition, with thermal cracking. The taxi-lanes are in **POOR** condition with moderate to severe cracking and raveling (See Photo # 9).

- Plan pavement rehabilitation plan for taxi-lanes.
- Proceed with second half of apron rehabilitation project listed on the airport's Capital Improvement Plan (CIP).

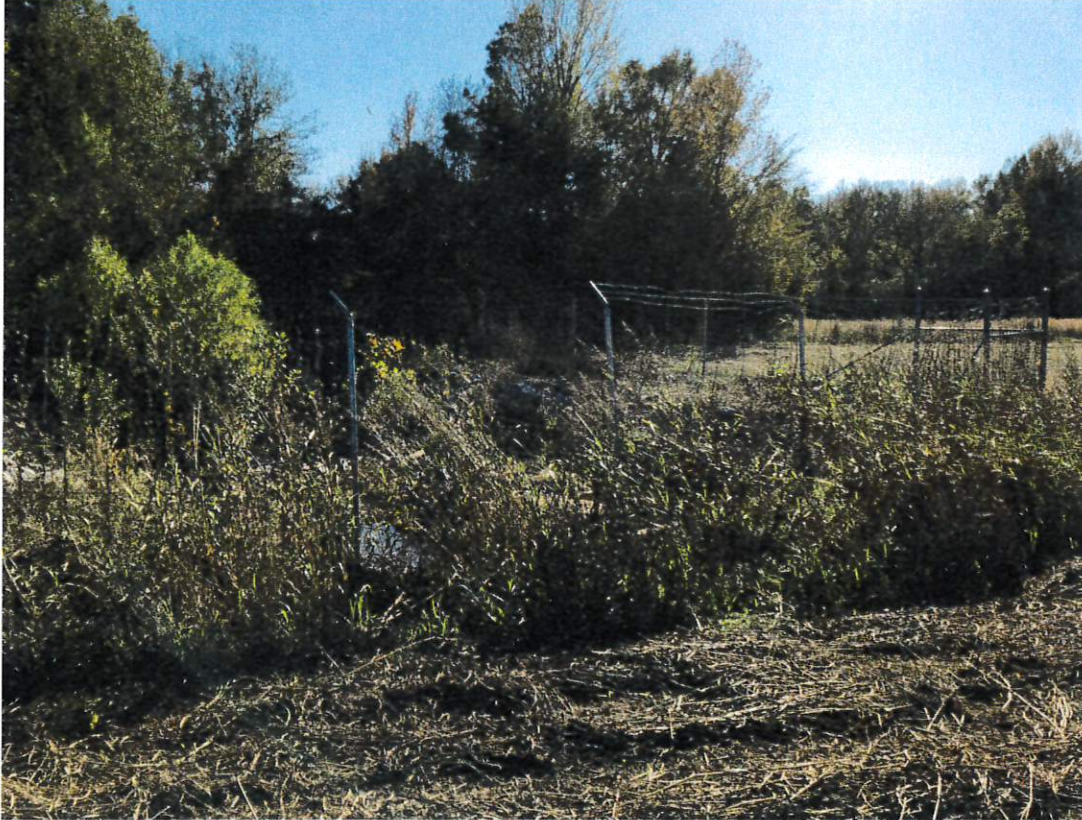
Photo # 10 – Damaged Wildlife Fencing

- No prohibited activities were observed during the inspection, however, there did appear to be a portion of wildlife fencing that was damaged on the southwest side of the airport (See Photo # 10).

- Repair damaged wildlife fence.
