Subject: Annual Inspection Report
Reeves Airport (41A)

**Annual Inspection Report
Reeves Airport (41A)
Tallassee, Alabama**

June 23, 2017

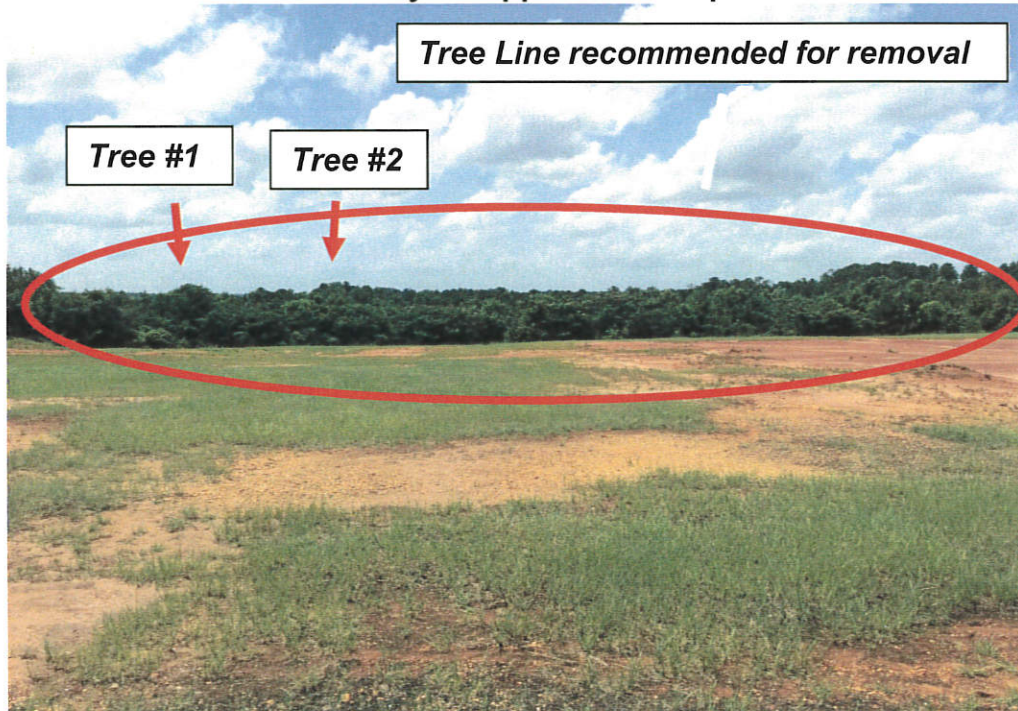
Photo #1 – Runway 13 Approach & Departure Path

- Runway 13 – **VIOLATION**. Several trees in the tree line are obstructions to the ALDOT 20:1 Approach and Departure Path (See Photo #1 and Appendix #3).
- Runway 31 – No obstructions (See Photo #2).

- Remove all obstructions to the ALDOT 20:1 Approach and Departure Path.
- The obstructions detailed in this report are representative, and may not include all obstructions. It is highly recommended all vegetation in the Approach and Departure Path be removed to prevent other trees from becoming obstructions in the future.

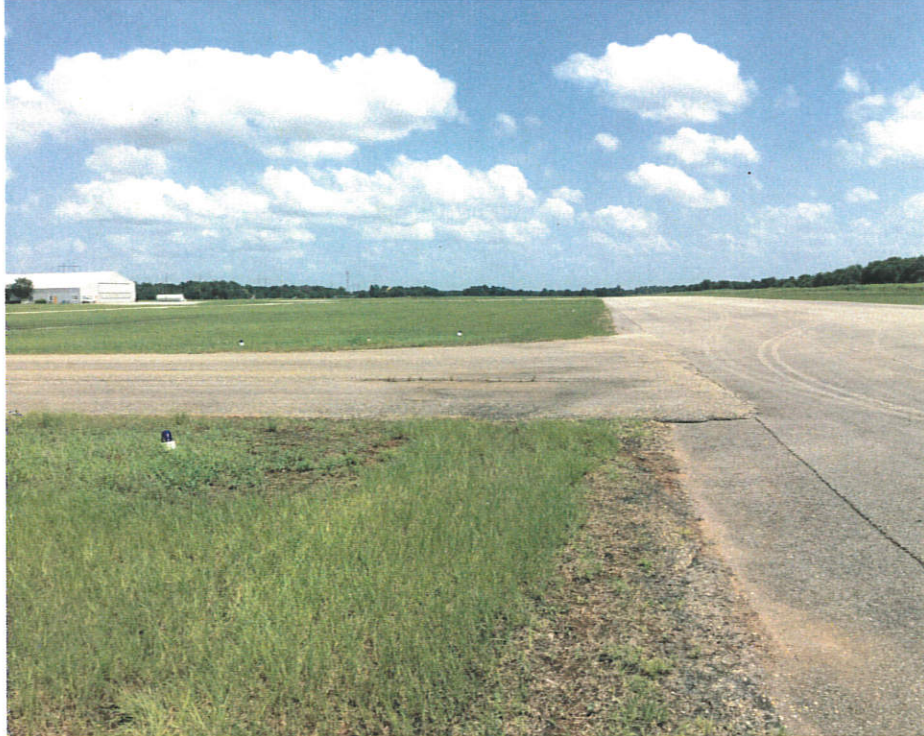
Photo #3 – Primary Surface and Runway Safety Area

- The primary surface meets state licensing requirements (See Photo #3).

- The runway safety area meets state requirements (See Photo #3).

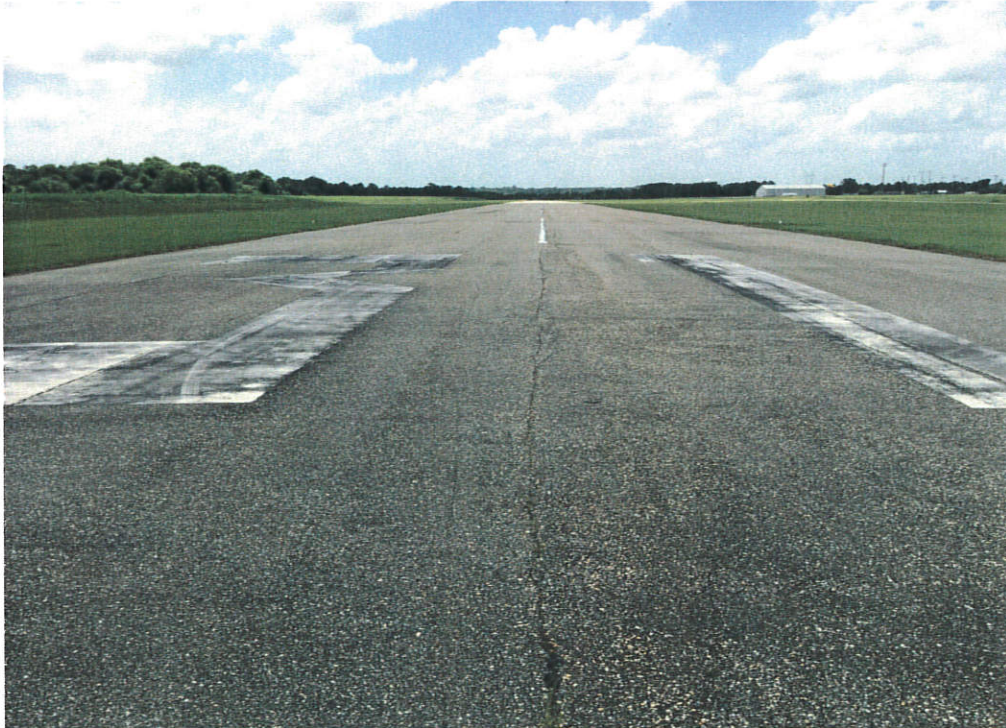
Photo #4 – Runway 31 NSTD Markings

- The runway markings are in **POOR** condition (See Photo #4).
- The taxiway markings are in **POOR** condition (See Photo #5).

- The runway markings could possibly be cleaned with a water and bleach mixture followed by power washing. If the markings are unable to be cleaned, new markings should be applied in accordance with FAA AC 150/5340-1L.
- The taxiway markings should be re-applied in accordance with FAA AC 150/5340-1L.

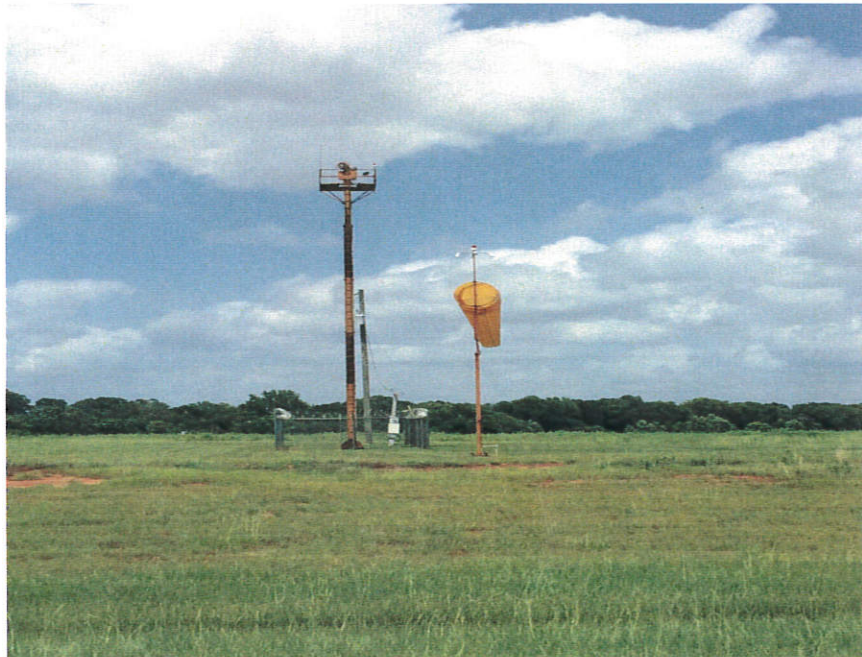
Photo #6 – Wind Direction Indicator

- The wind direction indicator (wind cone) is in **GOOD** condition. However, airport lighting could not be verified operable (See Photo #6).

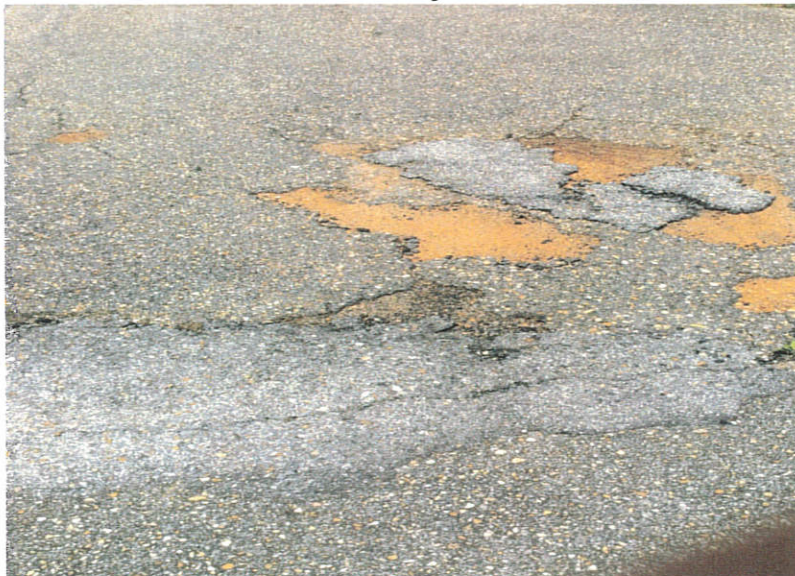
Photo #7 – Taxiway Deterioration

Ramp	FAIR. The ramp is experience cracking with vegetation appearing at various locations on the ramp.
Taxiway - VIOLATION	POOR. The taxiway is experiencing severe cracking with extensive raveling and flushing. Vegetation is growing through current cracks and creating moderate levels of foreign object debris (FOD). Pot holes are also visible at several locations on the taxiway. Pot holes are a hazard to aircraft due to the possibility of loss of control, and should be filled immediately (See Photo #7).
Runway - VIOLATION	POOR. Cracking and raveling visible on the surface. A 13 x 10 piece of asphalt is absent at the approach end of runway 13. Due to the missing section, the runway distance is not accurate to pilots in the airport facility directory (AFD). The runway should be repaired, or the runway be displaced (See Photo #8).

- All foreign object debris must be cleared from the taxiway. The localized areas of damage may be able to be patched. If the areas are too extensive, reconstruction may be required. Some cracks may be able to be cleaned and sealed, this will reduce moisture penetration and prevent further subgrade weakening. All potholes must be filled immediately.
- The missing asphalt from the approach end of 13 must be repaired. If the asphalt is unable to be repaired, the runway length must be reduced, as the current published length is not usable to aircraft. Please contact the Aeronautics Bureau for more information.

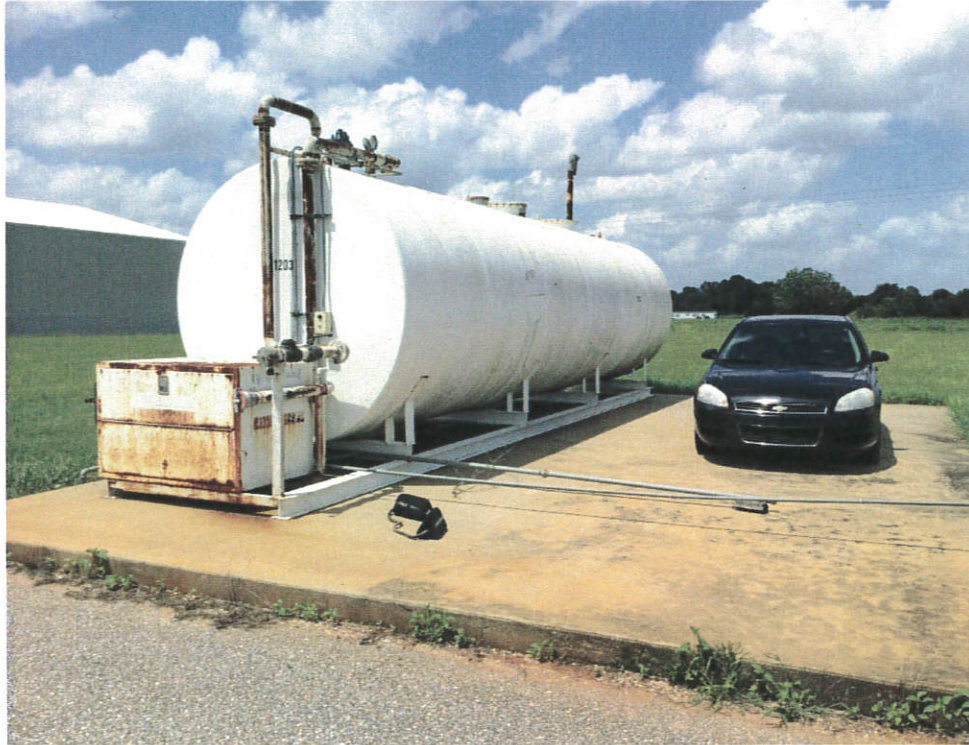
Photo #9 – Prohibited Activity

- A vehicle was observed parked near the unused AVGAS pump. The vehicle is non-aeronautical and is prohibited (See Photo #9).

- Remove vehicle. Ensure all non-aeronautical related vehicles remain off airport property.

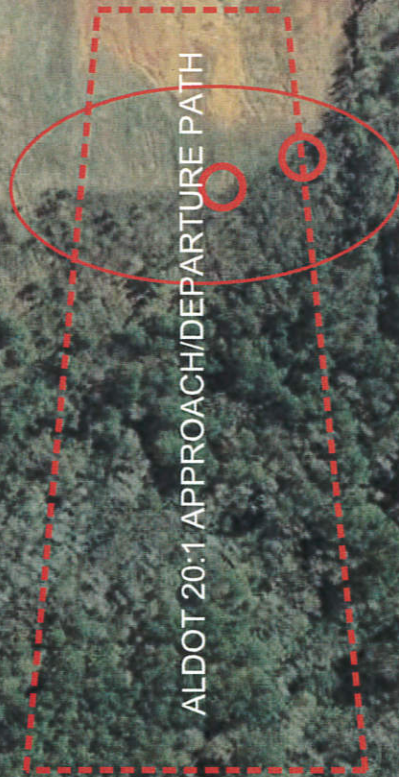
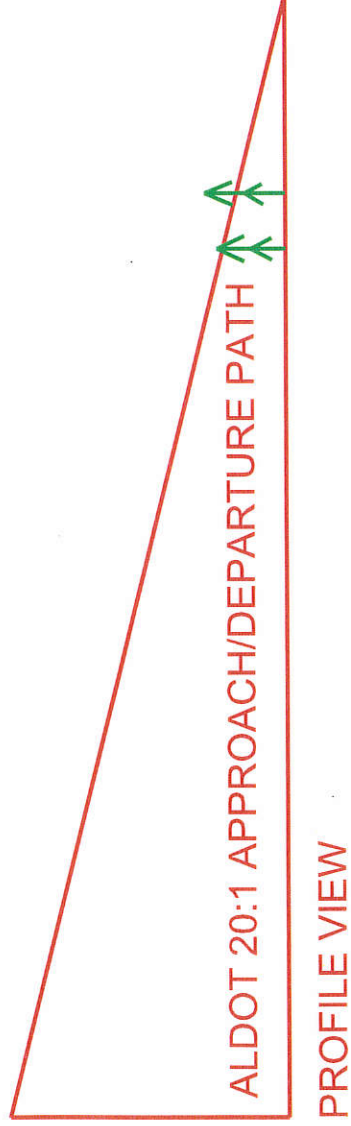
REEVES AIRPORT RUNWAY 13

OBSTRUCTIONS:

1. 16' TREE
387' FROM RUNWAY END
142' RIGHT OF CENTERLINE
11:1
2. 17' TREE
531' FROM RUNWAY END
96' RIGHT OF CENTERLINE
19:1
