Subject: Annual Inspection Report
Troy Municipal Airport at N. Kenneth Campbell Field

AUGUST 21, 2019

ANNUAL INSPECTION REPORT

TROY MUNICIPAL AIRPORT AT N. KENNETH CAMPBELL FIELD

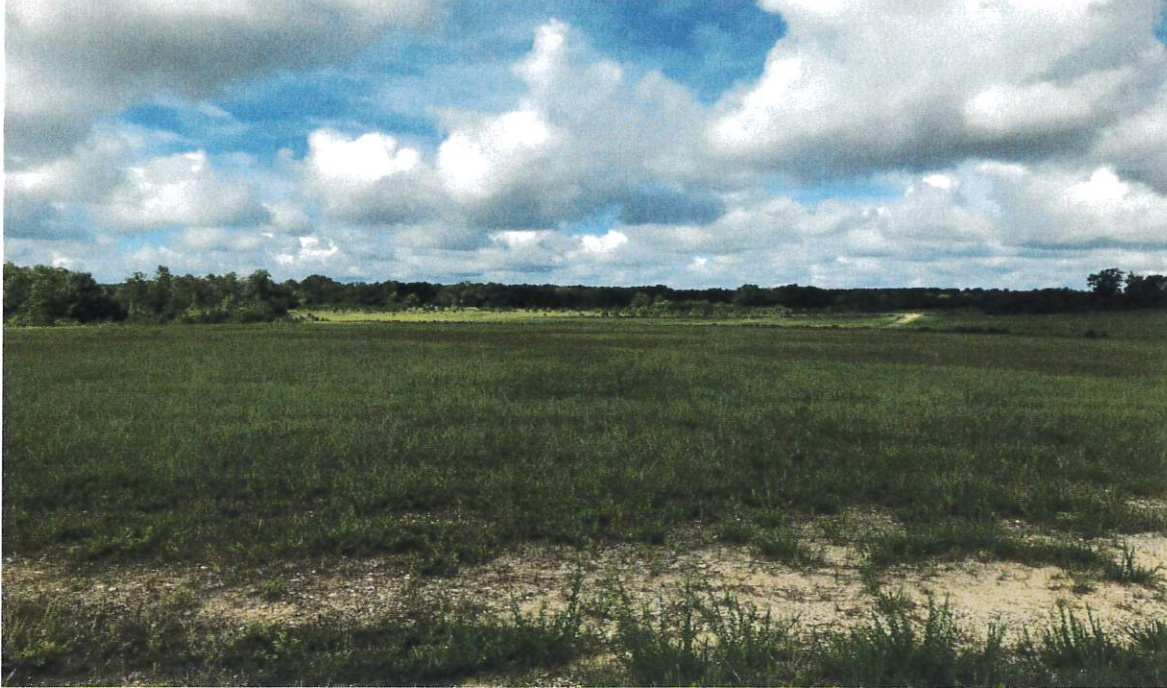
Photo #1 – Runway 7 Approach

- Runway 07 – No obstructions to ALDOT 20:1 surface (See Photo # 1).
- Runway 25 – No obstructions to ALDOT 20:1 surface, however, a tree should be removed before it becomes an obstruction (See Photo # 2).
- Runway 14 – No obstructions to ALDOT 20:1 surface (See Photo # 3).
- Runway 32 – No obstructions to ALDOT 20:1 surface, however, trees labeled #2, #3, and #4 fall within an FAA surface and should be removed (See Photo # 4).

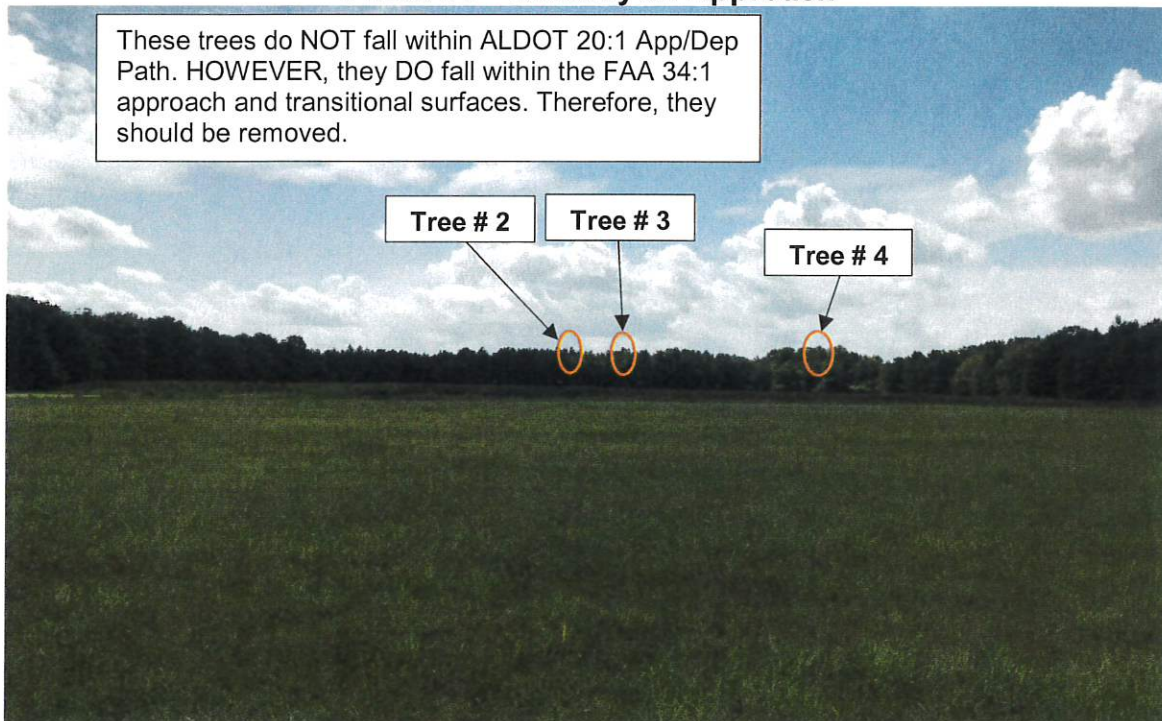
Photo #4 – Runway 32 Approach

- 2. Tree 75 Feet Adv Rwy End
1316 Feet From Rwy End
43 Feet Right of Rwy Cntr.
141 Obstacle Clearance
• While object does NOT violate ALDOT
app/dep. path, object DOES violate FAA
surface and removals recommended.

- 3. Tree 69 Feet Adv Rwy End
1236 Feet From Rwy End
27 Feet Left of Rwy Cntr.
151 Obstacle Clearance
• While object does NOT violate ALDOT
app/dep. path, object DOES violate FAA
surface and removals recommended.

- 4. Tree 75 Feet Adv Rwy End
1205 Feet From Rwy End
27 Feet Left of Cntr.
131 Obstacle Clearance
• While object does NOT violate ALDOT
app/dep. path, object DOES violate FAA
surface and removals recommended.

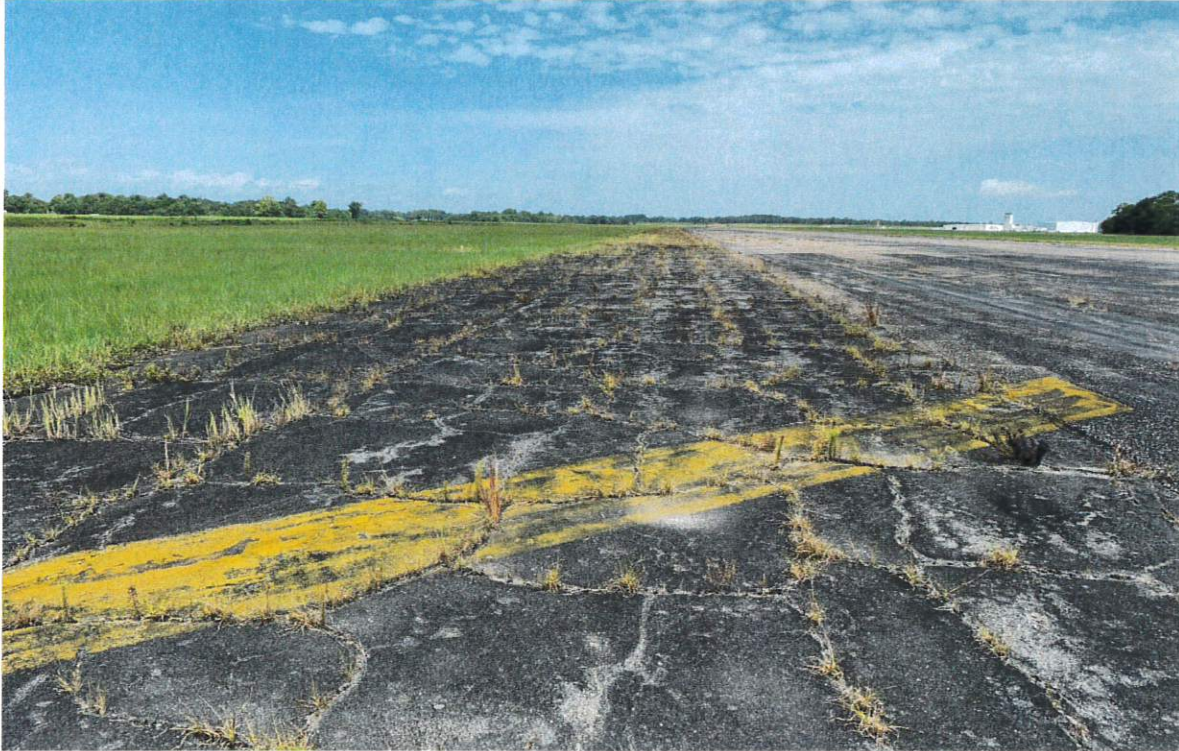
Photo #5 – 32/14 Primary Surface/Safety Area

- The primary surface meets state requirements. The runway shoulder markings are not required; however, they are recommended to better delineate the unusable portion of pavement. These markings extend into the primary surface and are severely faded. (See Photo # 5)

- The runway safety area meets state requirements. However, there is a large amount of block cracking and vegetation growing through the cracks. Again, it was noted that the runway shoulder markings are severely faded (See Photos # 5 & 6).

- The runway shoulder markings should be replaced in accordance with AC 150/5340-1M

- Remove vegetation and seal cracks.
- Replace runway shoulder markings in accordance with AC 150/5340-1M.

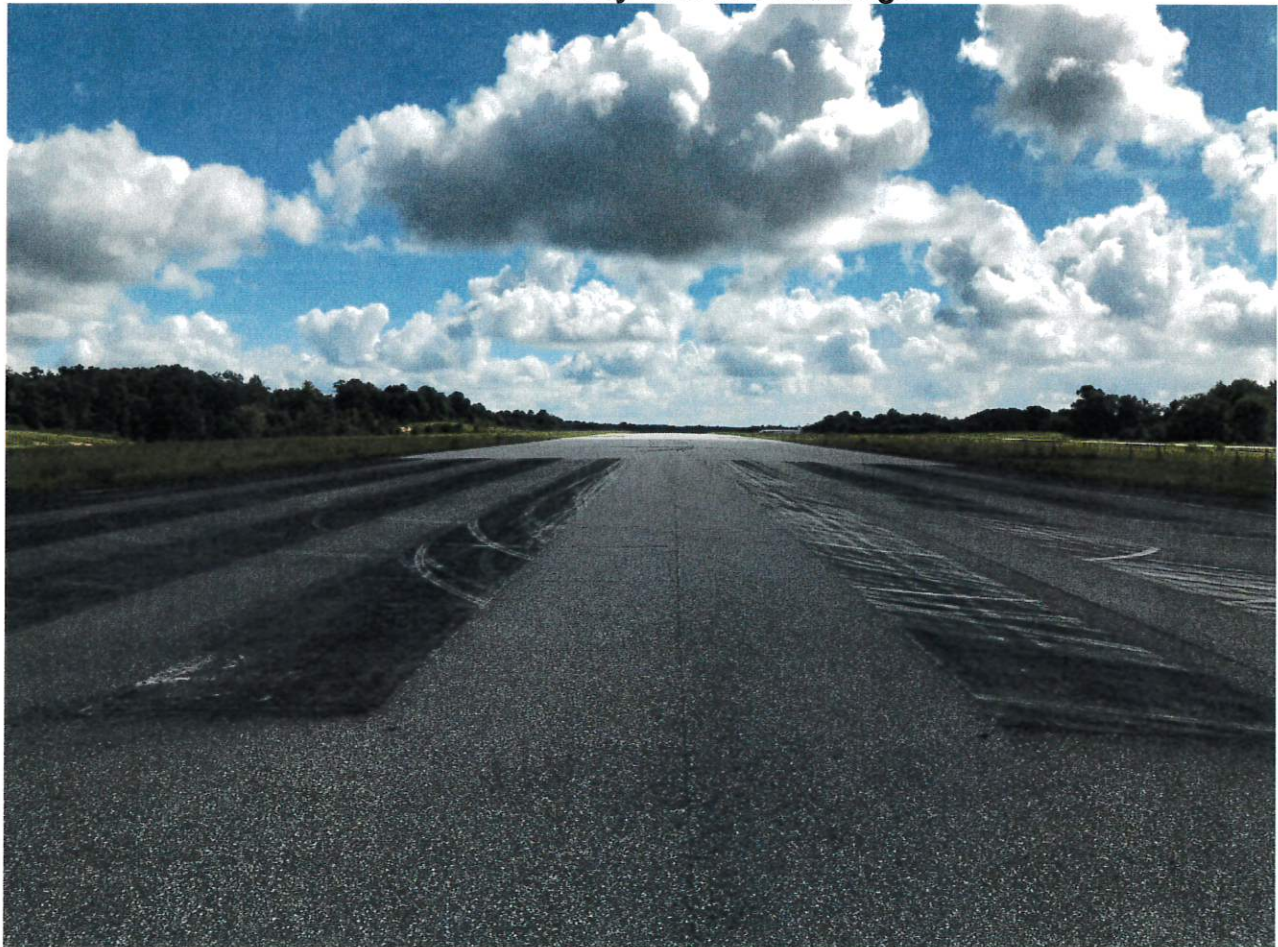
Photo #7 – Runway 7/25 NPI Markings

- The markings for runway 7/25 are in FAIR condition but are fading (See Photo # 7).
- Runway 14/32 markings are in POOR condition (See Photo # 8).
- Parallel Taxiway markings for Runway 7/25 are in POOR condition and faded due to algae growth. Taxiway markings joining Runway 25 and yellow arrowheads are in POOR condition (See Photo # 9).
- Parallel Taxiway markings for Runway 14/32 are in FAIR condition.

- Clean markings with use of pressure washer. If unable to clean, remark all runways/taxiways in accordance with FAA AC 150/5340-1M.

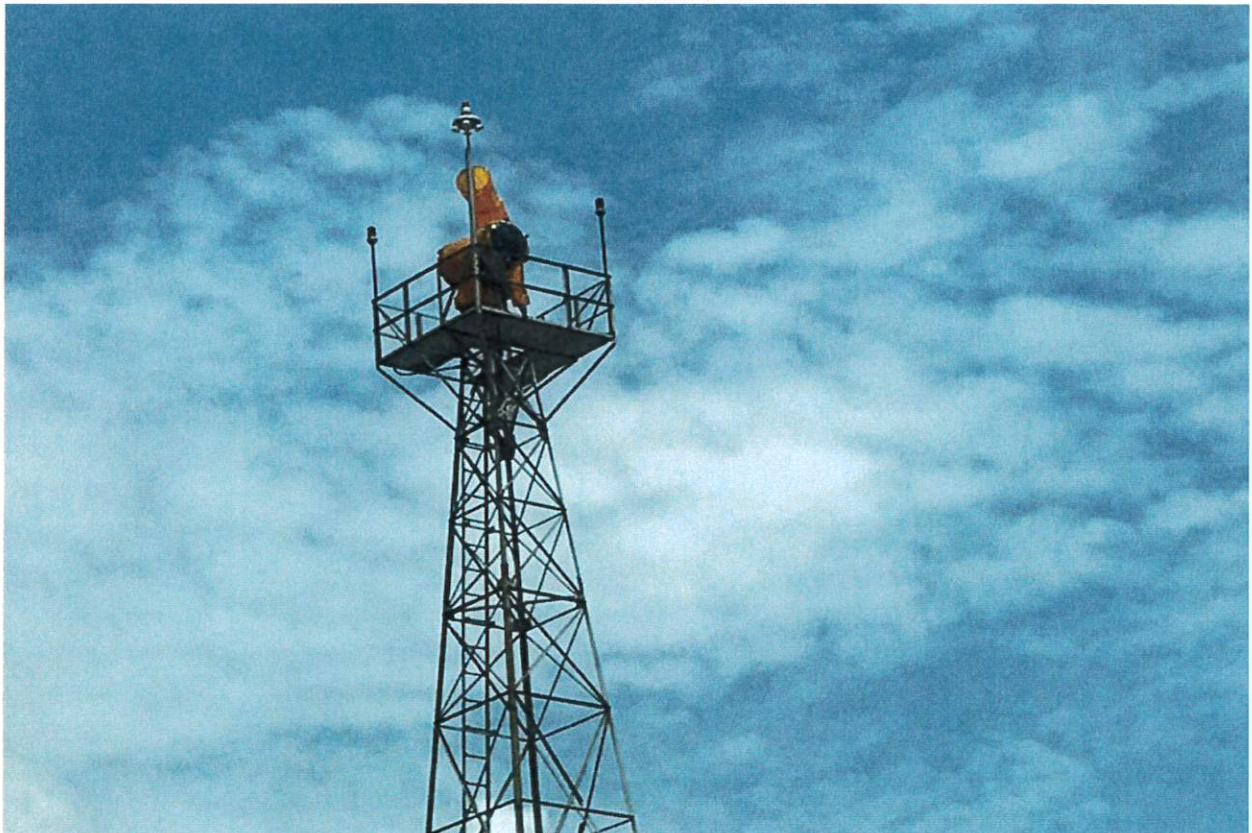
Photo #10 – Wind Cone

- The wind direction indicator (wind cone) is operational and the fabric is in good condition but is becoming faded (See Photo # 10).

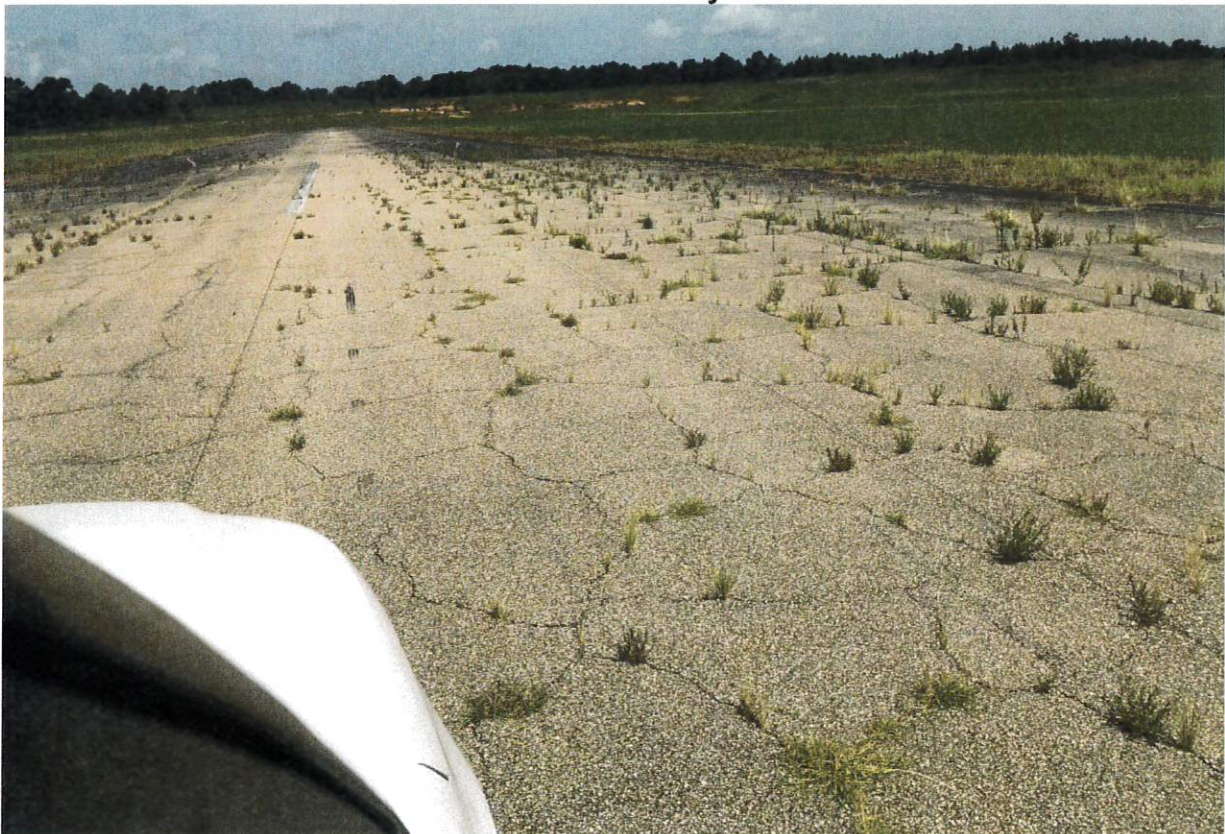
Photo #11 – Runway 14/32

- Runway 7/25 and the parallel taxiway are in FAIR condition with slight joint cracking.
- Runway 14/32 is in extremely POOR condition due to widespread block and joint cracking, raveling, and vegetation. The parallel taxiway is in POOR condition with widespread, severe block cracking with vegetation growing from the cracks (See Photos # 11 & # 12).

- Airport should contact their consultant promptly to plan a pavement rehabilitation project for Runway 14/32 and the corresponding taxiway before pavement becomes irreparable or poses major safety issues.
- All vegetation on runway and taxiways should be eradicated.

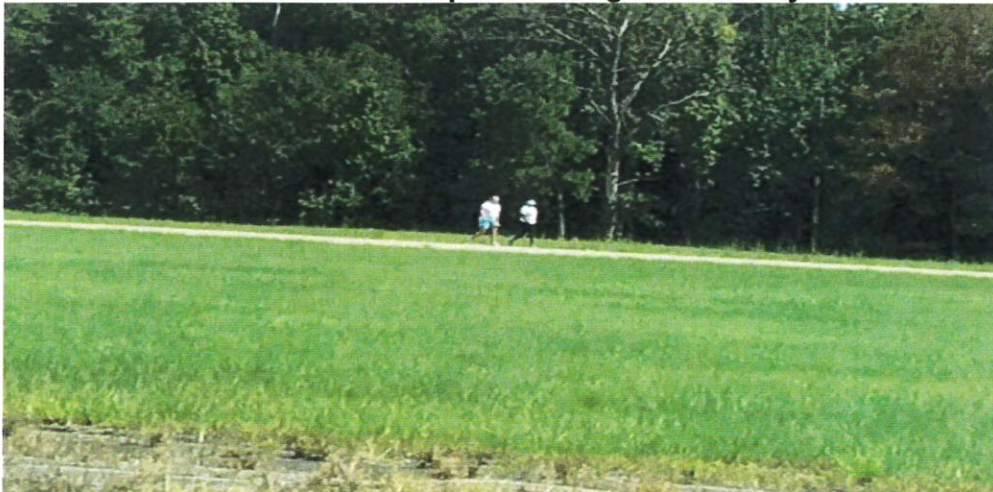
Photo #13 – People Walking on Taxiway

- Two people were spotted walking for recreational/exercise purposes on the parallel taxiway to Runway 14/32 (See Photo # 13).

- Prohibit non-aeronautical activity in aircraft operations area and within the boundaries of imaginary surfaces.
