Alabama Statewide Airport Pavement Management Program Update

Carl Folsom Airport (14J)

Final Report

February 2022

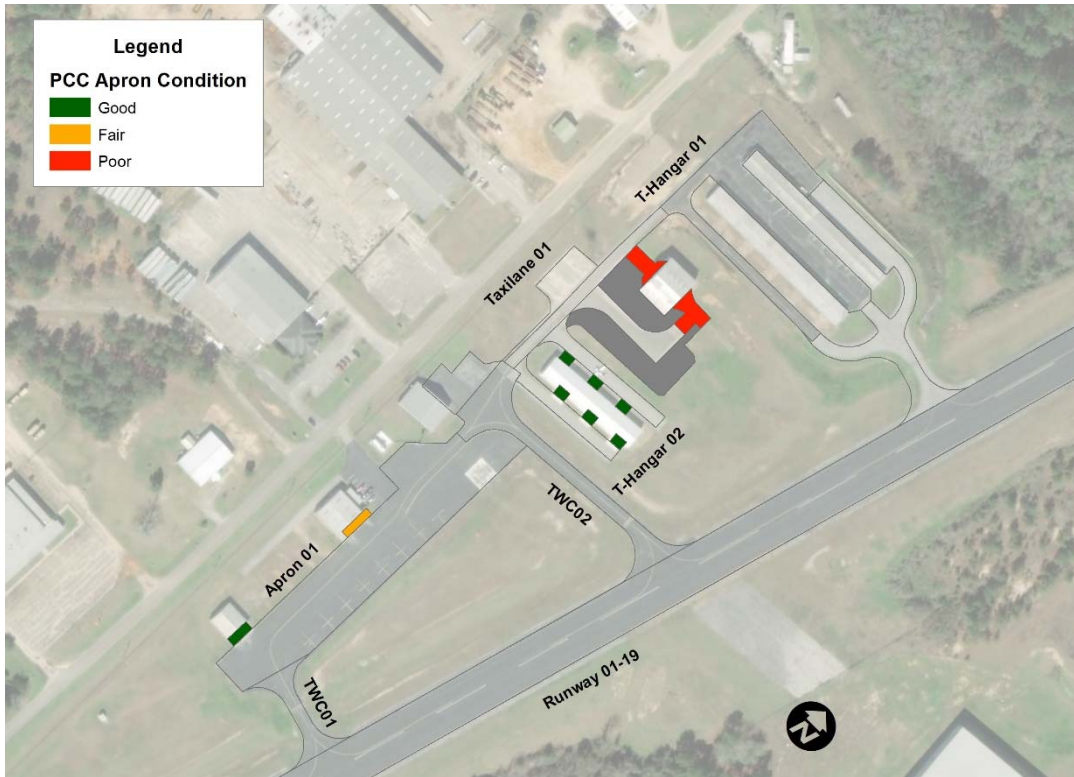
Figure 3.4: PCC Apron Condition Rating.

As stated earlier, the project scope did not include a detailed pavement condition survey for any Portland Cement Concrete (PCC) aprons. For these pavements, a rating of “Good”, “Fair”, or “Poor” was assigned based on the overall pavement condition. Figure 3.4 shows the condition of the PCC aprons at 14J.

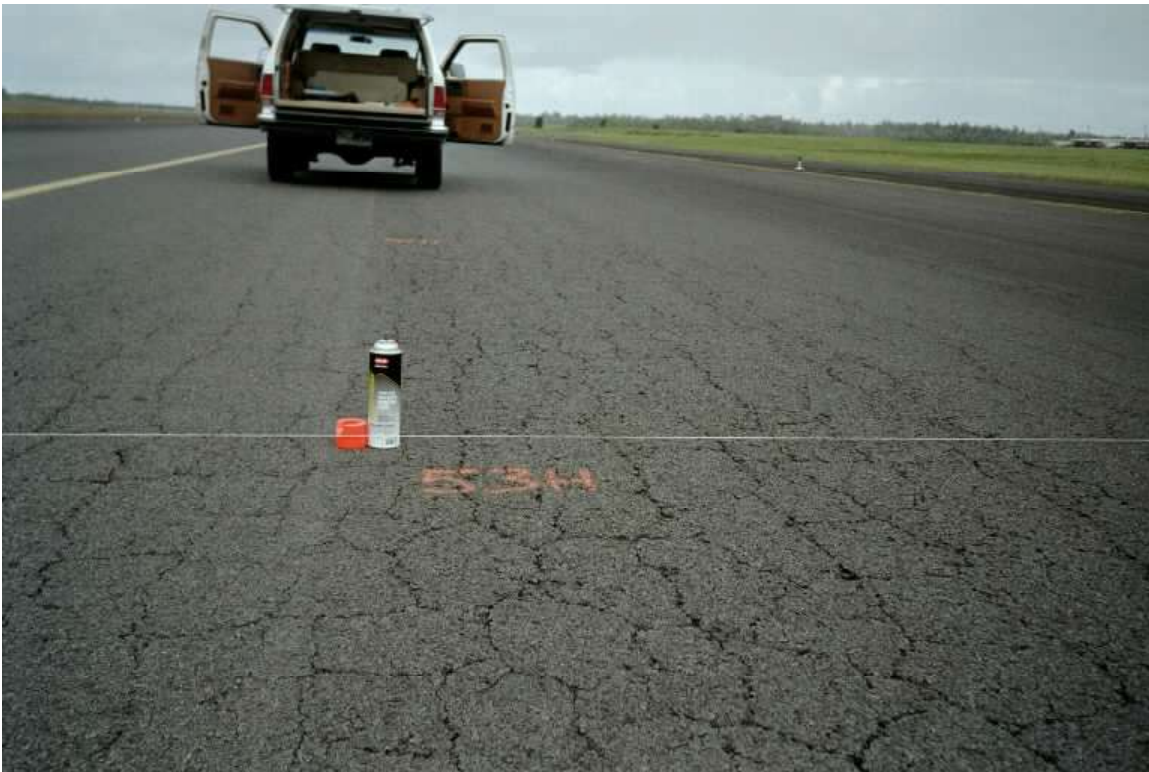
Figure C.9: AC Rutting.

A rut is a surface depression in the wheel path; however, in many instances ruts are noticeable only after a rainfall, when the wheel paths are filled with water. Pavement uplift may occur along the sides of the rut. Rutting stems from a permanent deformation in any of the pavement layers or sub-grade, usually caused by consolidation or lateral movement of the materials due to traffic loads. Significant rutting can lead to major structural failure of the pavement.

- ◆ Low - No action;
- ◆ Medium - patch and/or overlay;
- ◆ High - patch and/or overlay.

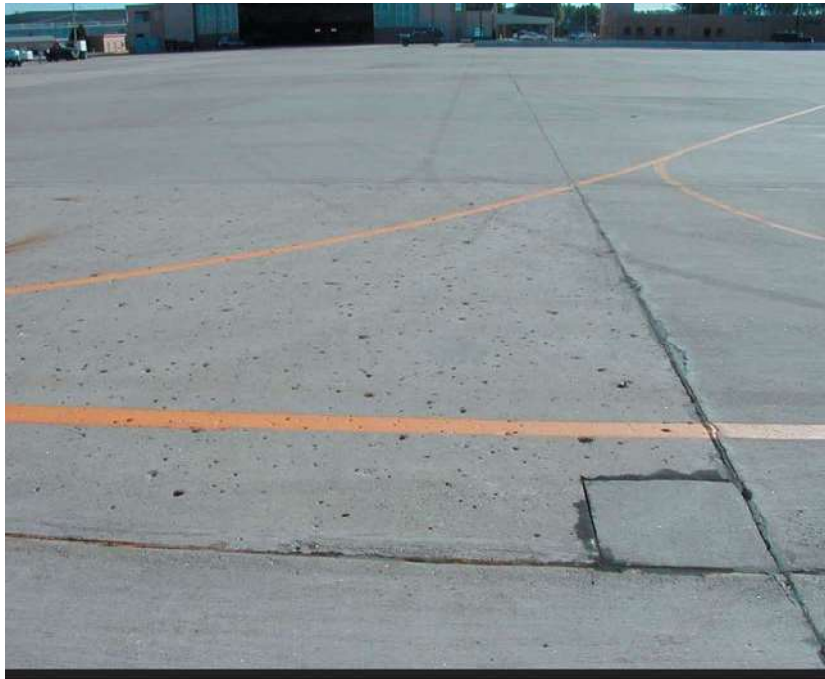
Figure C.16: Popouts.

No degrees of severity are defined for popouts. However, popouts must be extensive before they are counted as a distress; i.e., average popout density must exceed approximately three popouts per square yard over the entire slab area.
