Alabama Statewide Airport Pavement Management Program Update

**Evergreen Regional – Middleton
Field (GZH)**

Final Report

Evergeen Regional Airport – Middleton Field, Evergreen (GZH)

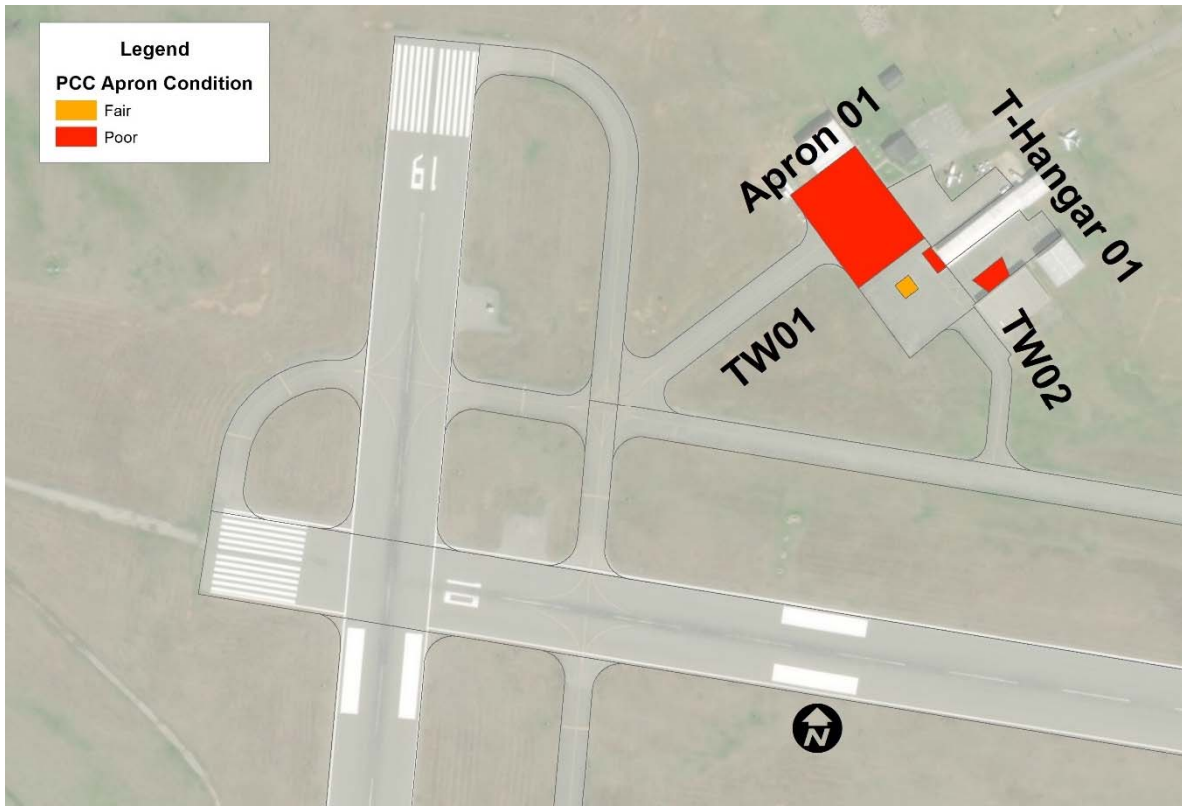
Figure 3.4: PCC Apron Condition Rating.

As stated earlier, the project scope did not include a detailed pavement condition survey for any Portland Cement Concrete (PCC) aprons. For these pavements, a rating of “Good”, “Fair”, or “Poor” was assigned based on the overall pavement condition. Figure 3.4 shows the condition of the PCC aprons at GZH.

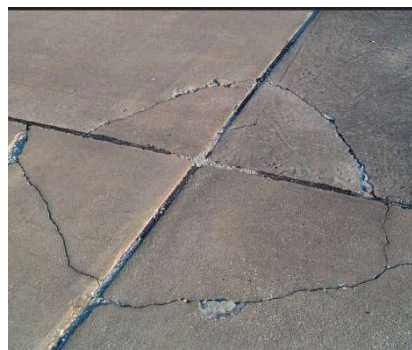
Figure C.11: PCC Corner Break.

A corner break is a crack that intersects the joints at a distance less than or equal to one-half the slab length on both sides, measured from the corner of the slab. For example, a slab with dimensions of 25 by 25 feet that has a crack intersecting the joint 5 feet from the corner on one side and 17 feet on the other side is not considered a corner break; it is a diagonal crack. However, a crack that intersects 7 feet on one side and 10 feet on the other is considered a corner break. A corner break differs from a corner spall in that the crack extends vertically through the entire slab thickness, while a corner spall intersects the joint at an angle. Load repetition combined with loss of support and curling stresses usually causes corner breaks.

- ◆ Low - No action or seal cracks;
- ◆ Medium - seal cracks;
- ◆ High - seal cracks, apply a full or replace the slab.

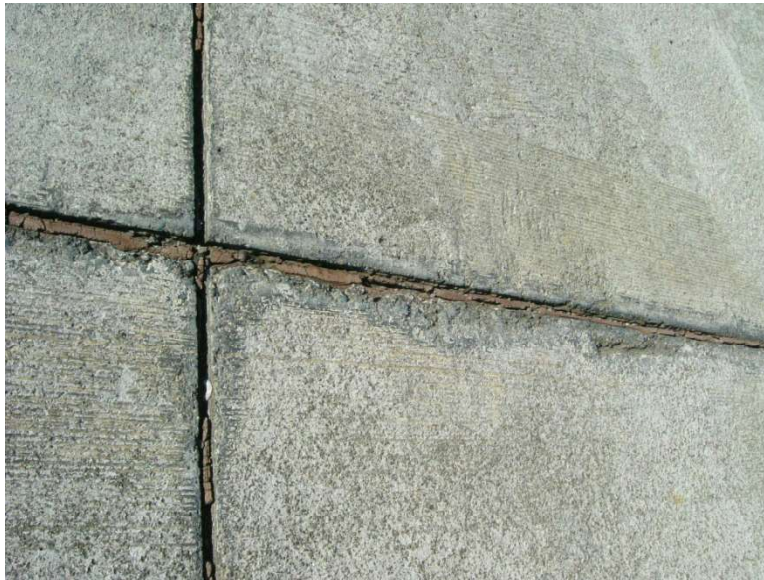
Figure C.13: PCC Joint Seal Damage.

Joint seal damage is any condition, which enables soil or rocks to accumulate in the joints or allow significant infiltration of water. Accumulation of incompressible materials in the joint prevents the slab from expanding and may result in buckling, shattering, or spalling. Pliable joint filler bonded to the edges of the slabs protects joints from the accumulation of materials and also prevents water from seeping down and softening the foundation supporting the slab. Typical types of joint seal damage are: 1) stripping the joint sealant; 2) extrusion of joint sealant; 3) weed growth; 4) hardening of the filler; 5) loss of bond to the slab edges; and 6) lack or absence of sealant in the joint.

- ◆ Low - No action;
- ◆ Medium - seal joints;
- ◆ High - seal joints.

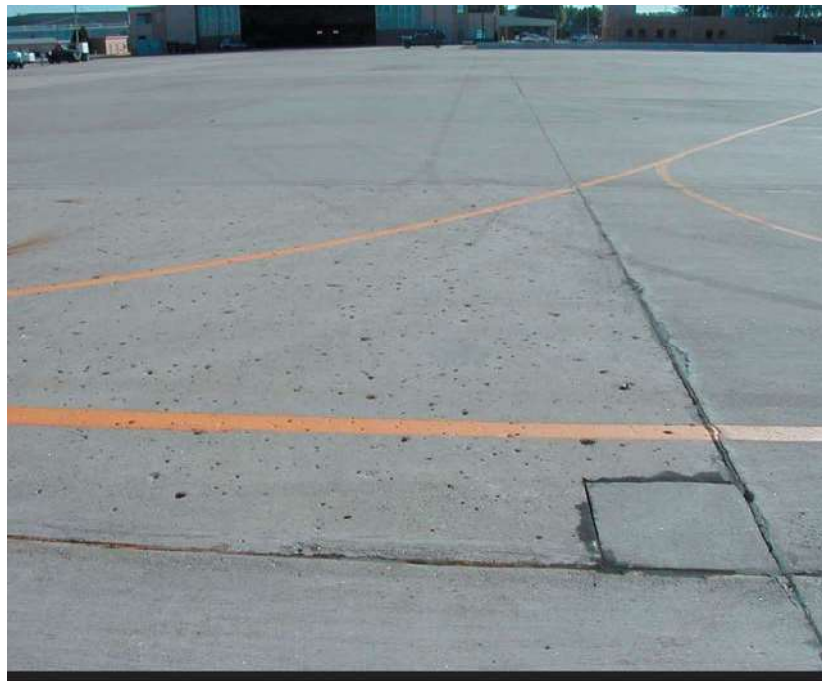
Figure C.16: Popouts.

No degrees of severity are defined for popouts. However, popouts must be extensive before they are counted as a distress; i.e., average popout density must exceed approximately three popouts per square yard over the entire slab area.
