# Alabama Statewide Airport Pavement Management Program Update

Vaiden Field (A08)

Final Report

February 2022

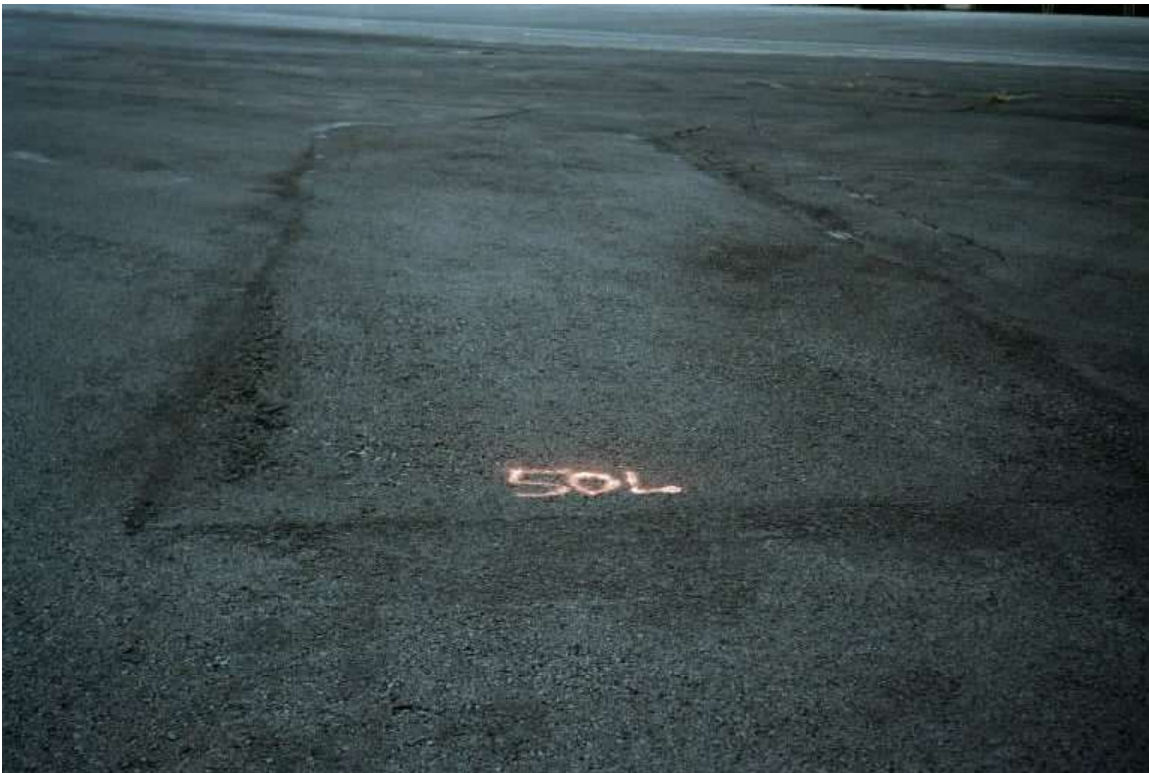
**Figure C.7 Asphalt Patching**

**Repair patching and utility cut patching is considered a defect, regardless of how well it performs or was constructed**

- ◆ **Low-** No action
- ◆ **Medium-** seal cracks, repair the distresses in the patch or replace the patch
- ◆ **High-** replace the patch

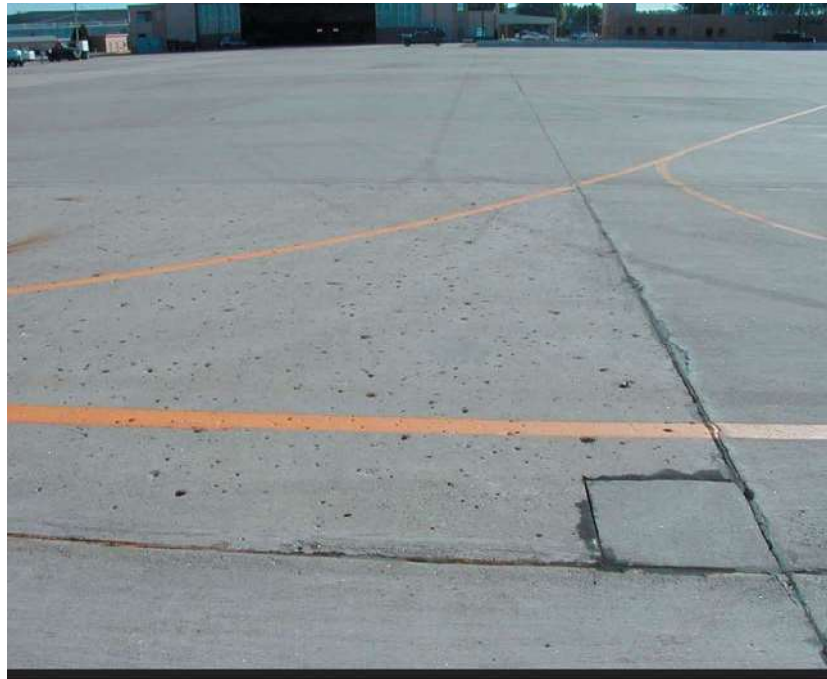
**Figure C.16 Popouts**

No degrees of severity are defined for popouts. **However, popouts must be extensive before they are counted as distress, i.e., average popout density must exceed approximately three popouts per square yard over the entire slab area**
