Alabama Statewide Airport Pavement Management Program Update

Prattville – Grouby Field (1A9)

Final Report

February 2022

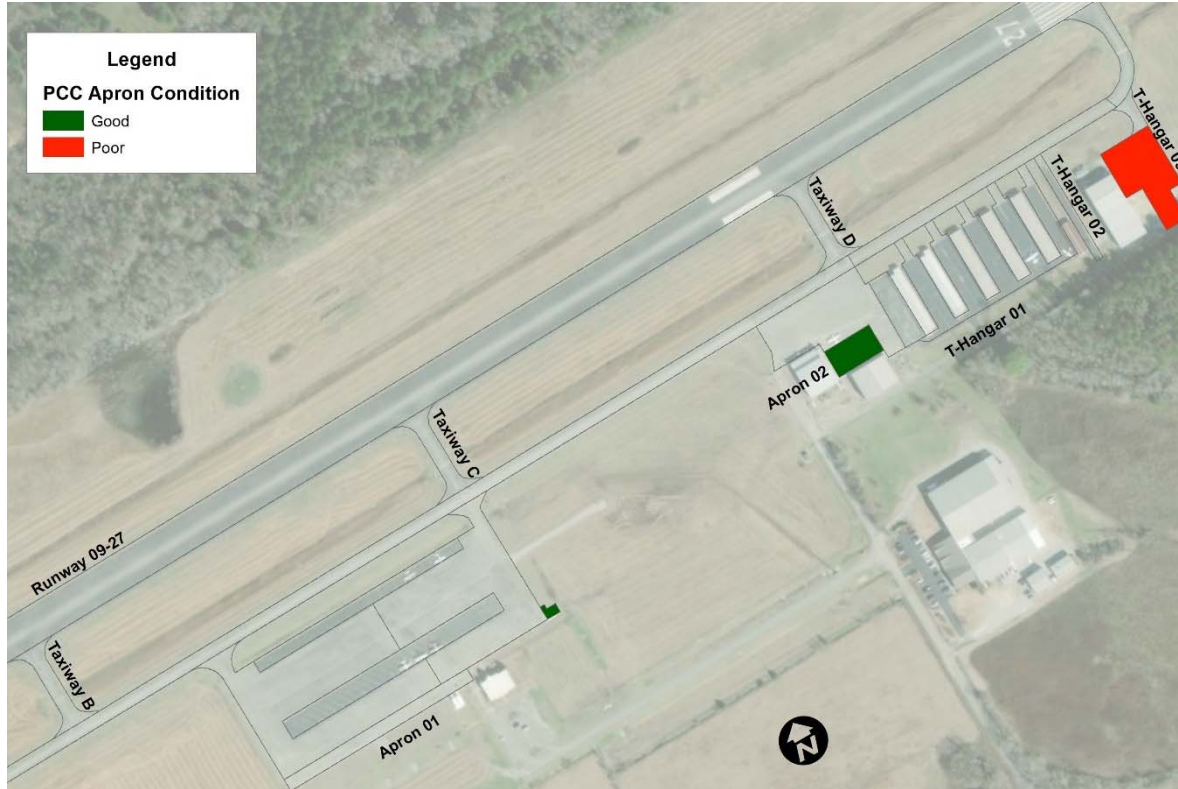
Figure 3.4: PCC Apron Condition Rating.

As stated earlier, the project scope did not include a detailed pavement condition survey for any Portland Cement Concrete (PCC) aprons. For these pavements, a rating of “Good”, “Fair”, or “Poor” was assigned based on the overall pavement condition. Figure 3.4 shows the condition of the PCC aprons at 1A9.
