**Subject: Corrective Actions Completed  
Bill Pugh Field Airport (M22)**

**Subject: Annual Inspection Report  
Bill Pugh Field Airport (M22)**

**Annual Inspection Report  
Bill Pugh Field Airport (M22)  
Russellville, Alabama**

January 20, 2021

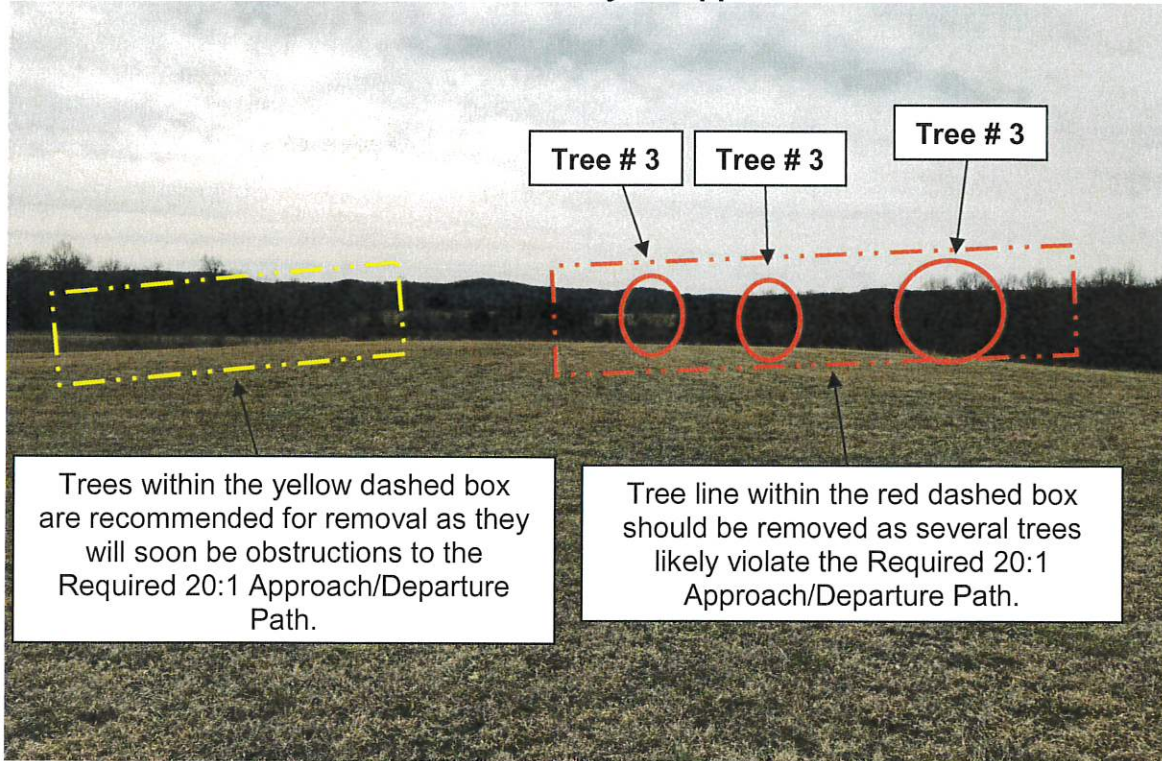
Photo #1 – Runway 02 Approach

- Runway 02 – Trees identified as #3, #5, and #6 are obstructing the Required 20:1 Approach/Departure Path (See Photo #1, Appendix #2). It is recommended that other trees identified in Photo #1 be removed before they become obstructions.
- Runway 20 – No obstructions (See Photo # 2)

- Remove all obstructions to the Required 20:1 Approach/Departure Path.
- Obstructions identified in this report are representative and may not include all obstructions. **It is the airport sponsor's responsibility to identify and remove ALL obstructions to the Required 20:1 Approach/Departure Path.**

- Remove line of trees in Approach/Departure Path before they become obstructions.

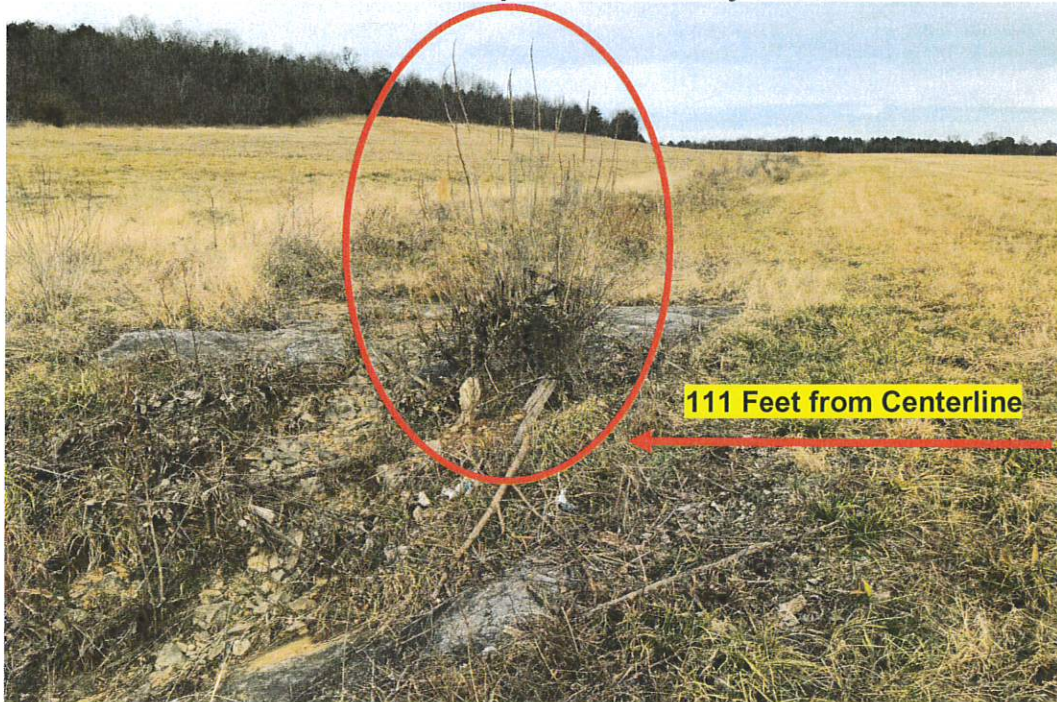
**Photo #3 – Stump within Primary Surface**

- A tree and brush are obstructing the outer limits of the Primary Surface at 111 feet to 120 feet from the runway centerline on the west side of Runway 02/20 (See Photos #3 and #4).

- The Primary Surface is an object free area and all vegetation within its boundaries should be removed.
- The Primary Surface vegetation has been noted in previous reports and should be permanently eradicated this time.

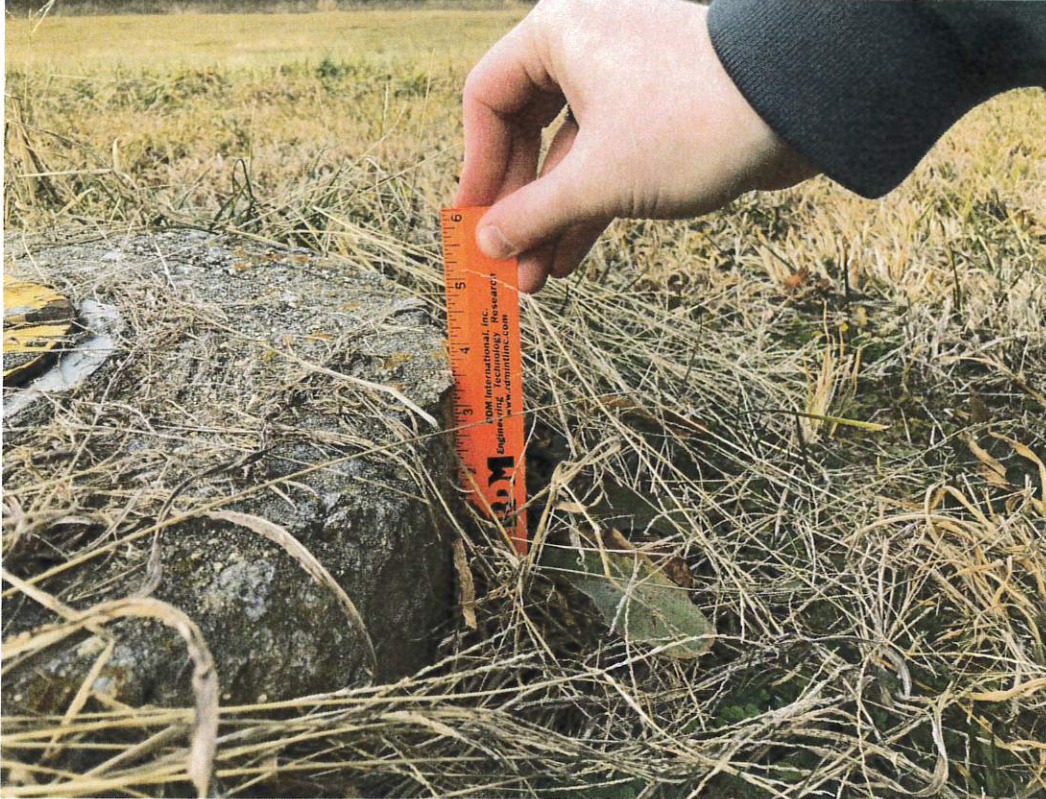
Photo #5— Runway Light Base

- There is one (1) light base on the west side of the runway within the Runway Safety Area which partially exceeds 3 inches in height (See Photo #5).

- Bring grade up around light base.

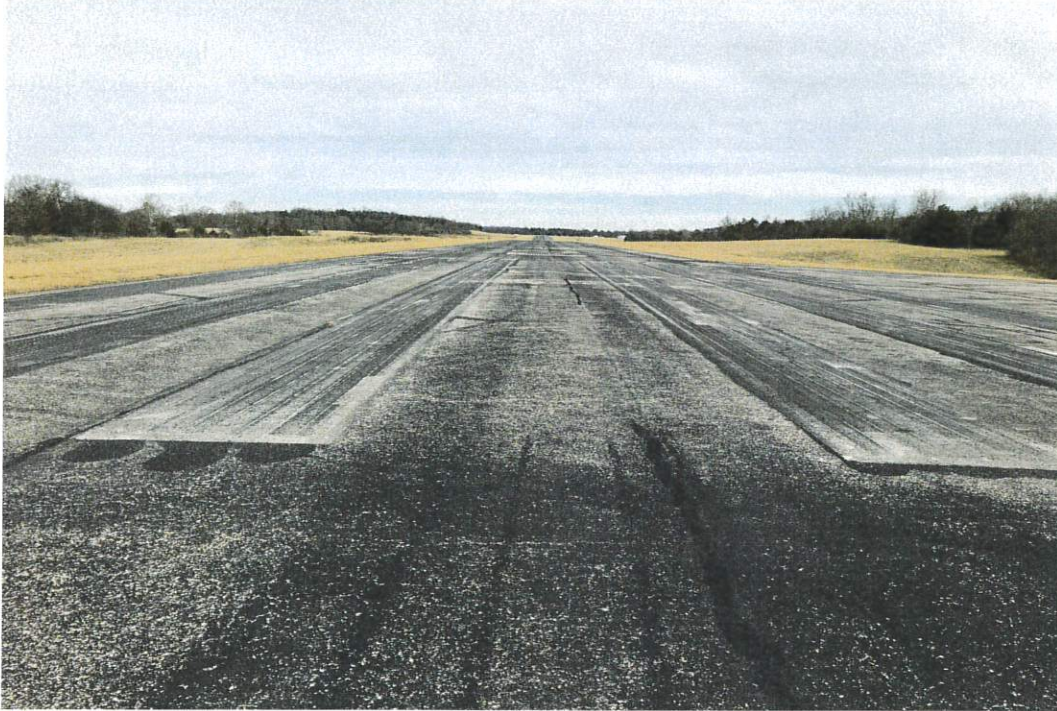
Photo #6 – NP Markings Runway 2

- The runway markings are **POOR** condition (See Photo #6).
- The apron and taxiway markings are in **FAIR** condition.

- Clean runway markings or re-apply in accordance to FAA AC 150/5340-1M.

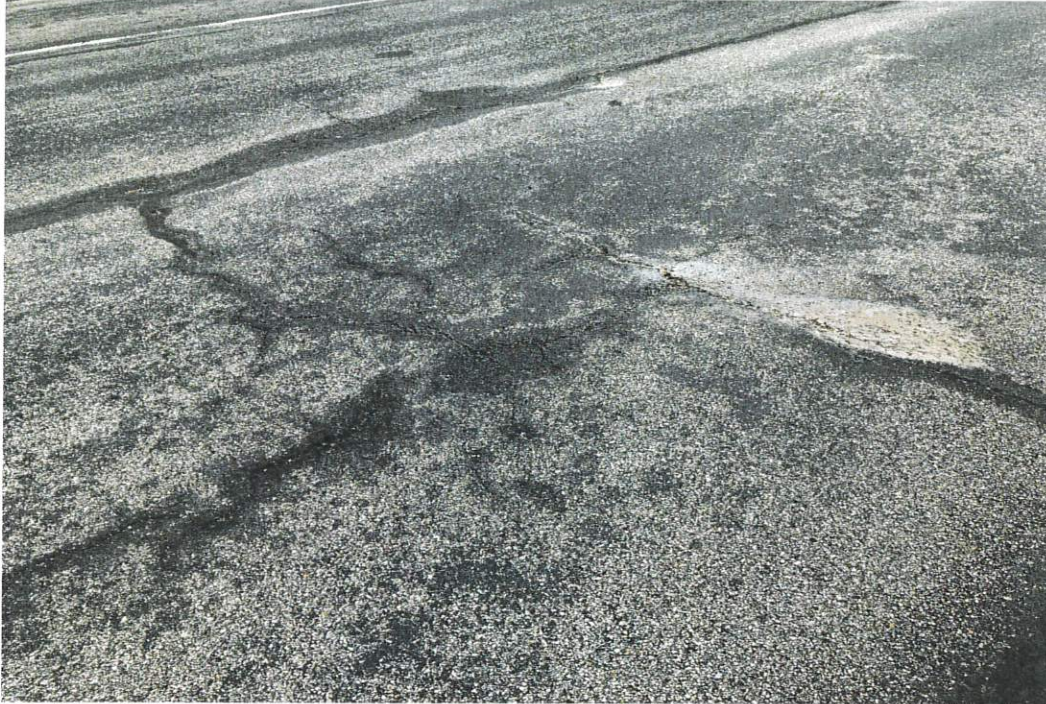
**Photo #7 – Runway Surface**

- The Runway is in ***FAIR*** condition, with moderate levels of weathering, thermal cracking, and joint cracking (See Photo #7).
- The Apron is in ***GOOD*** condition.
- The taxiways are in ***FAIR*** condition with moderate cracking. Taxi-lanes near the hangars are in ***POOR*** condition with moderate alligator cracking, raveling, and vegetation growth (See Photo #8).

- Airport sponsor should continue to plan a pavement rehabilitation project for the future.

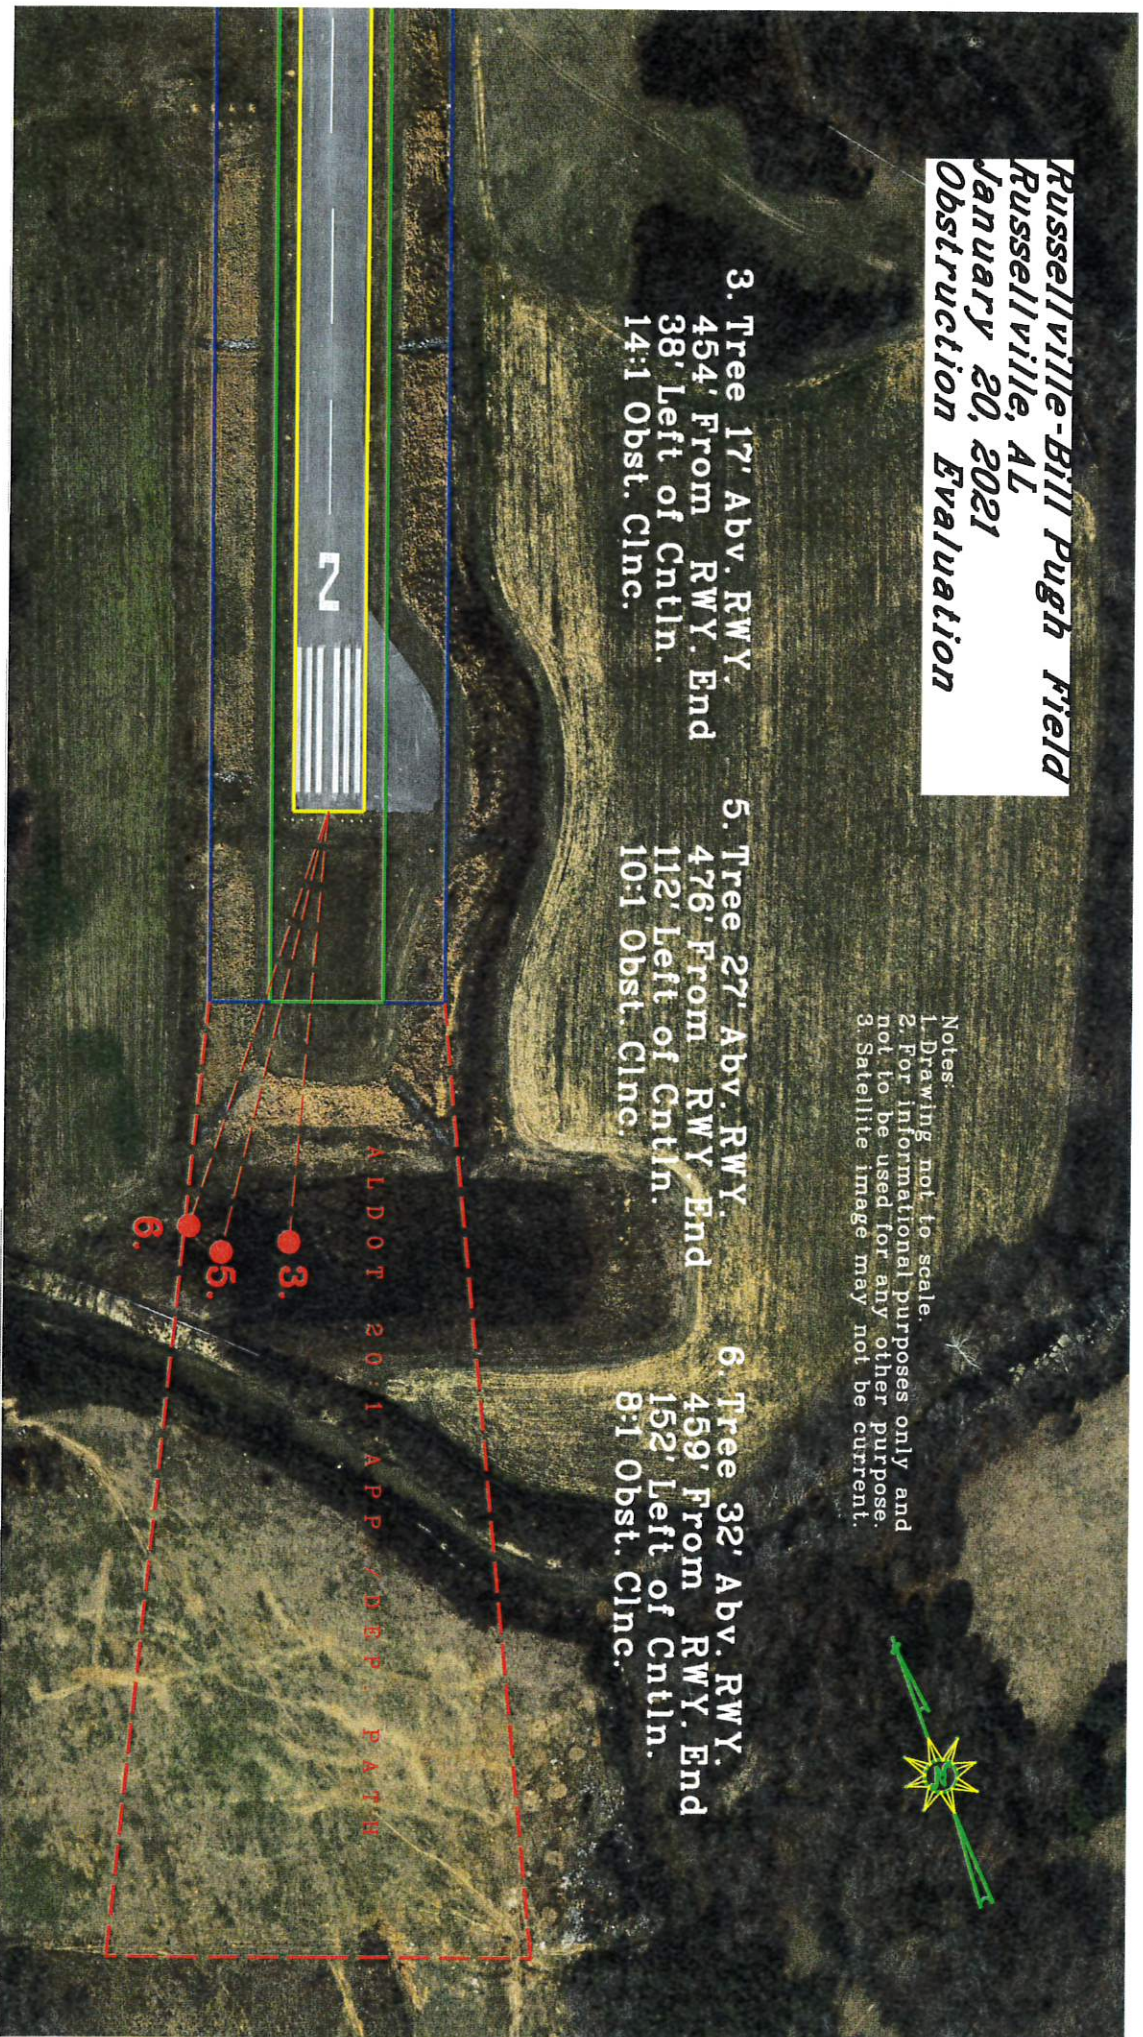
**Russellville-Bill Pugh Field**  
**Russellville, AL**  
**January 30, 2021**  
**Obstruction Evaluation**

3. Tree 17' Abv. RWY.  
 454' From RWY. End  
 38' Left of Cntln.  
 14:1 Obst. Clnc.

5. Tree 27' Abv. RWY.  
 476' From RWY. End  
 112' Left of Cntln.  
 10:1 Obst. Clnc.

6. Tree 32' Abv. RWY.  
 459' From RWY. End  
 152' Left of Cntln.  
 8:1 Obst. Clnc.
