**Subject: Annual Inspection Report**  
**George Downer Field Airport**

**December 21, 2023**

## **ANNUAL INSPECTION REPORT**

**GEORGE DOWNER FIELD AIRPORT  
ALICEVILLE, ALABAMA**

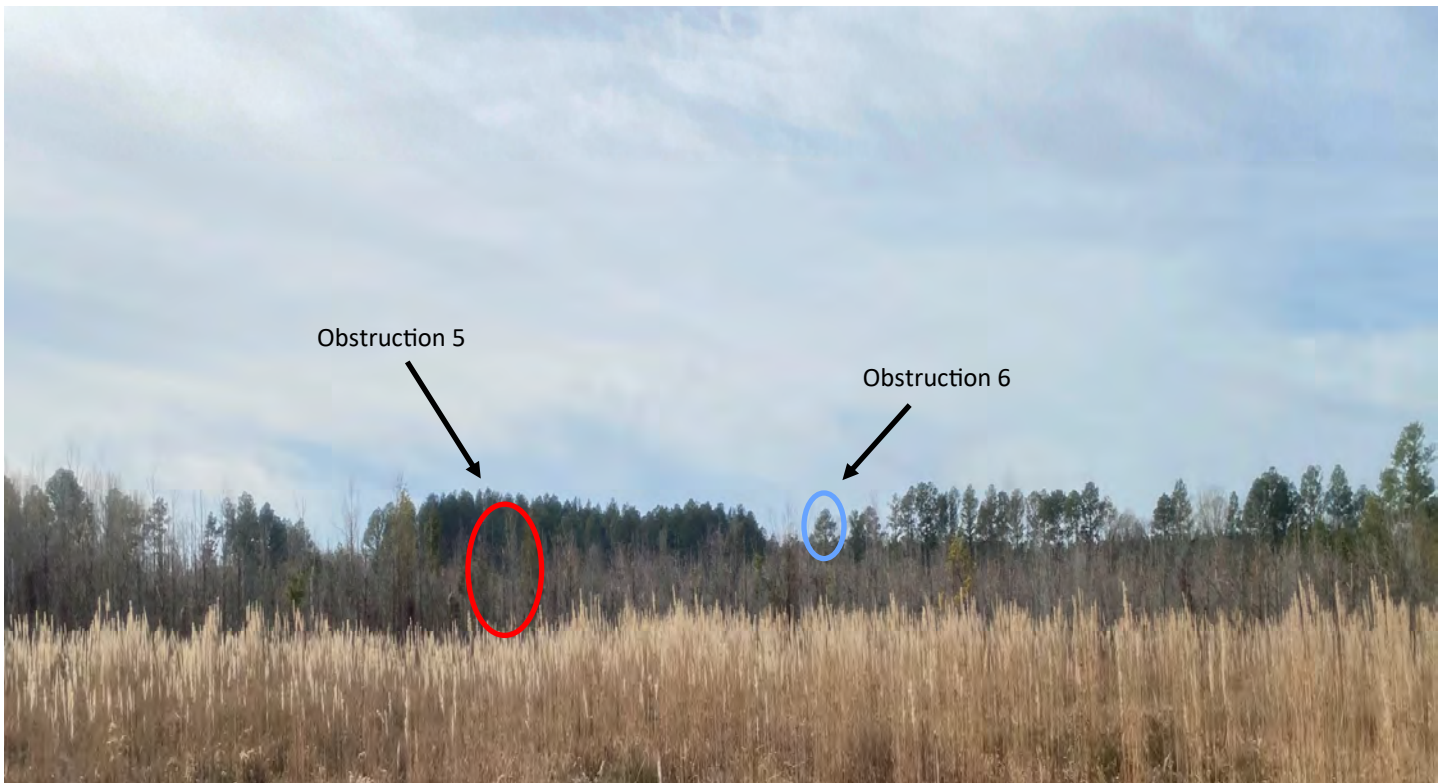
### Approach and Departure Paths—RUNWAY 6

Obstructions were located in the ALDOT Approach/Departure Path of Runway 6. The tree identified as Obstruction 5 is an ALDOT Approach/Departure Path Violation. The tree identified as Obstruction 6 is a FAA Part 77 Approach Surface Violation. See Appendix #2.

5. Tree 30' Above Runway End  
733' From RWY End  
104' Right of CL  
17:1 Obstruction Clearance

6. Tree 99' Above RWY End  
1,923' From RWY End  
23' Left of CL  
17:1 Obstruction Clearance

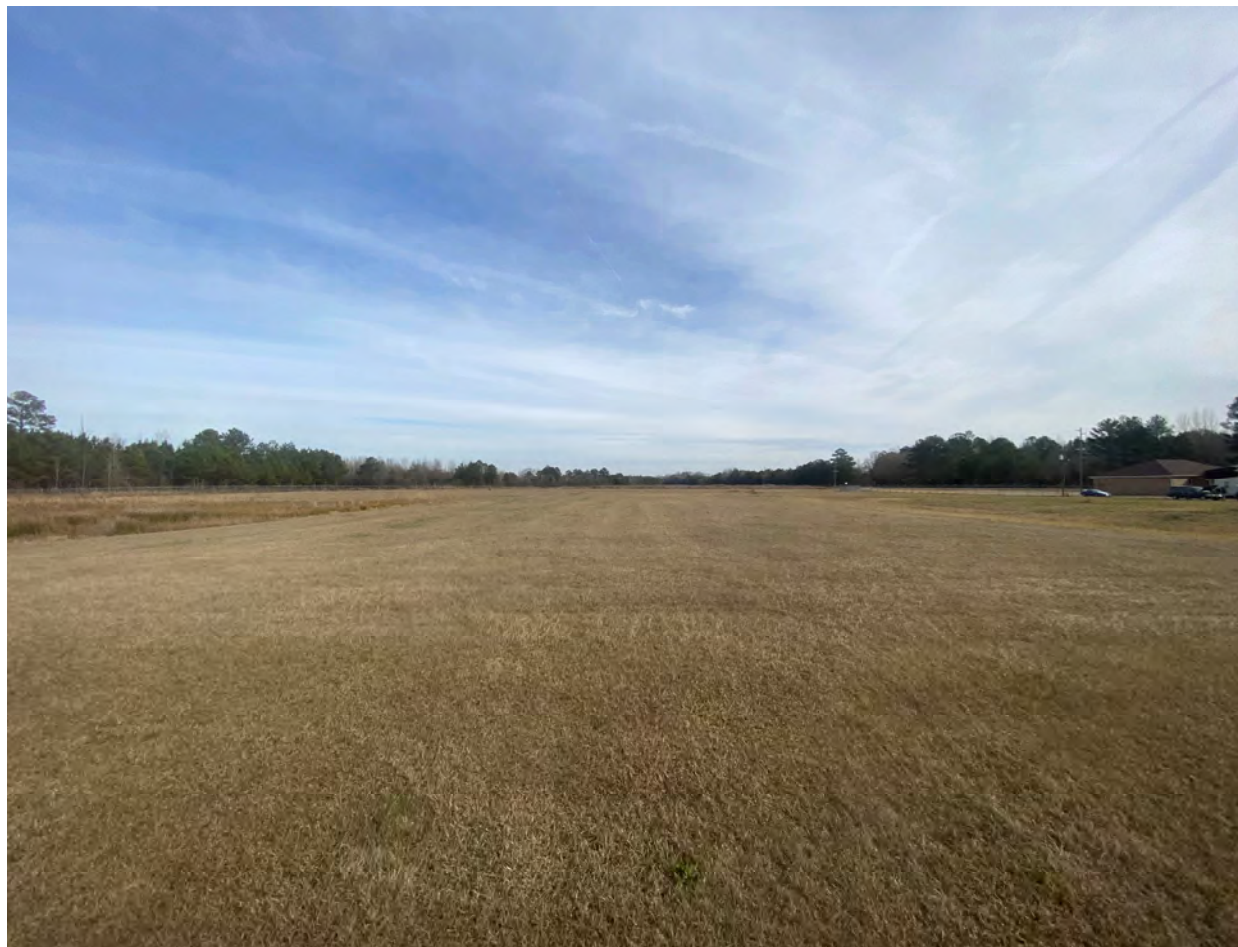
### Approach and Departure Paths—RUNWAY 24

There were no obstructions in the ALDOT Approach and Departure path.

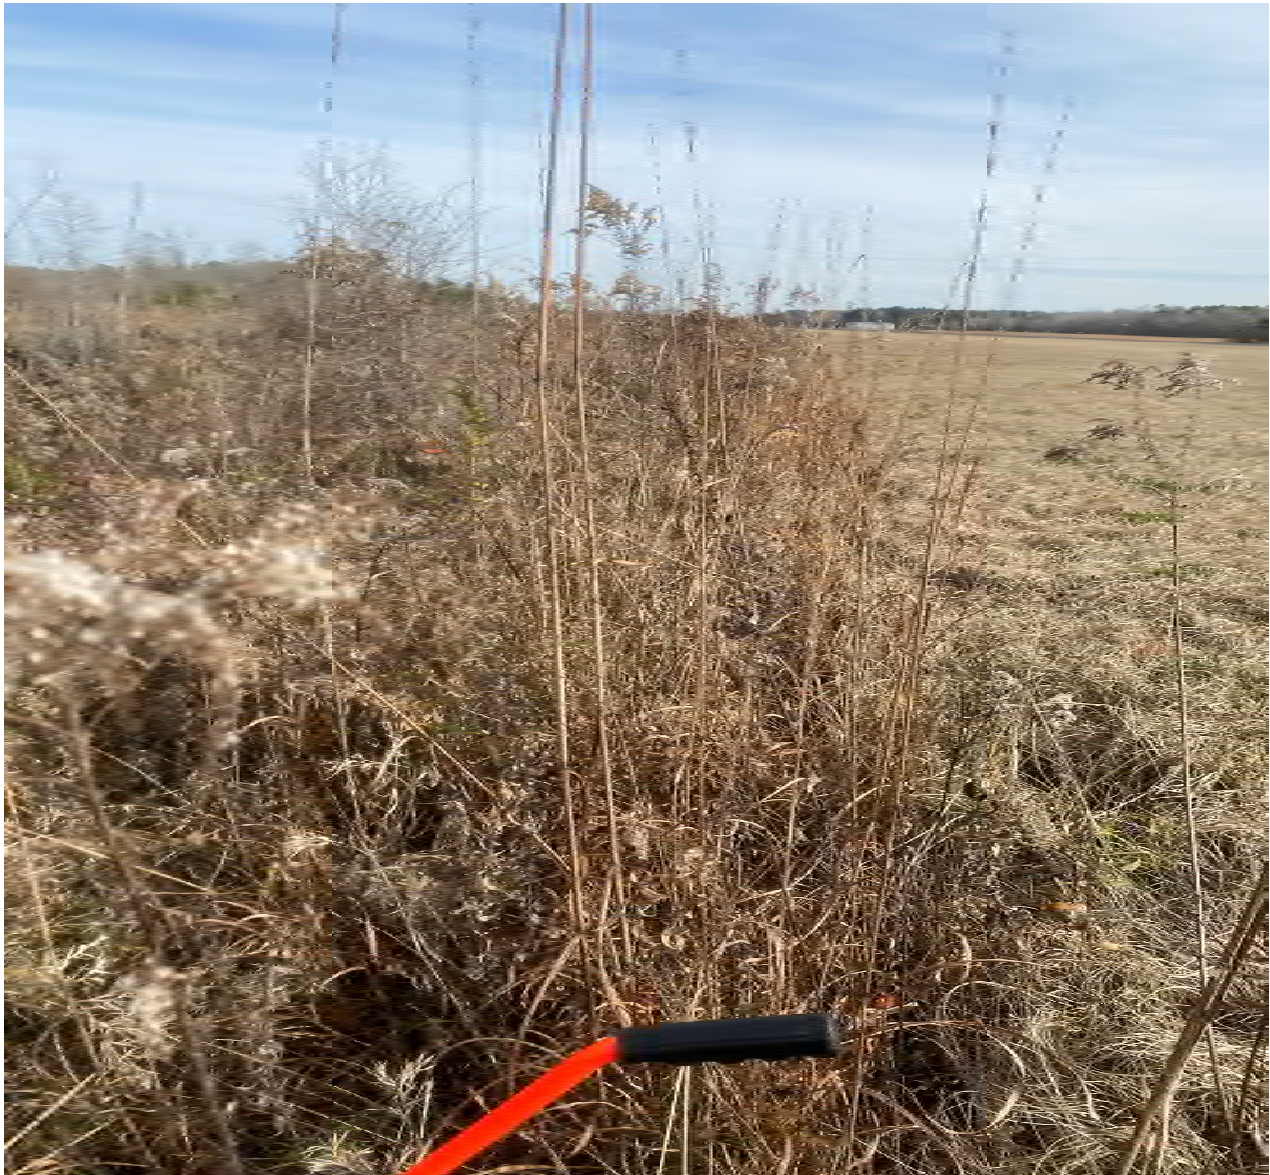
### Primary Surface

Primary Surface **MEETS** state licensing standards.

**Maintenance**: Tall grass and small trees are beginning to encroach on the Primary Surface near the Runway 6 end. Please clear the Primary Surface in that area to ensure that it meets Primary Surface Requirements.

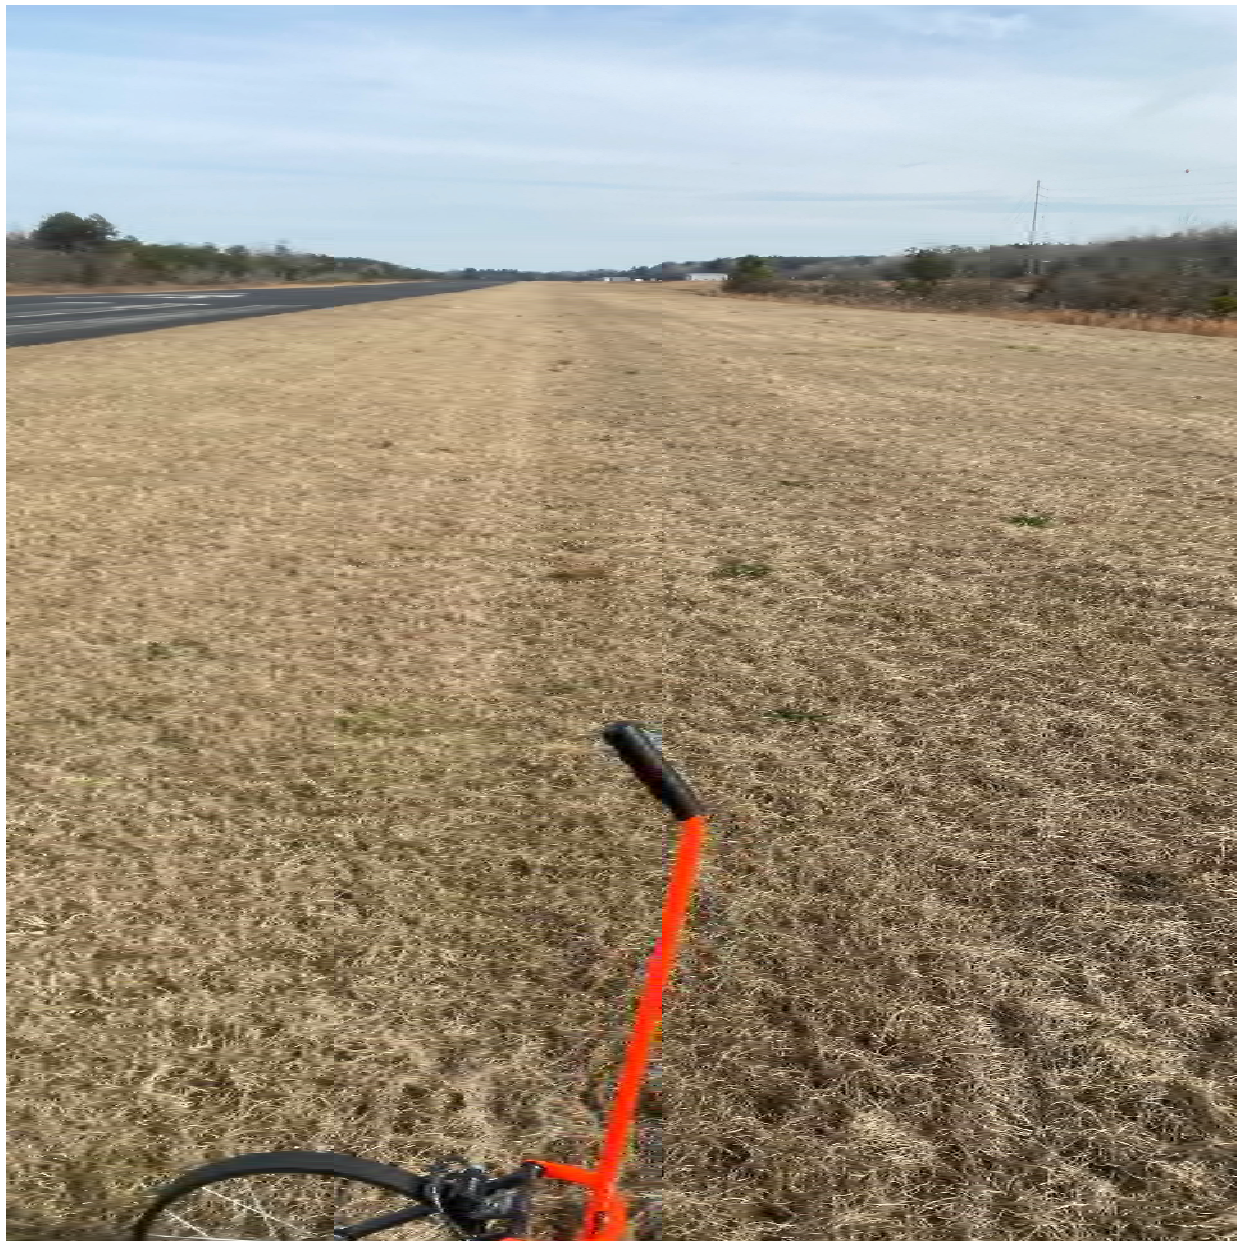
### Runway Safety Area

Runway Safety Area **MEETS** state licensing standards.

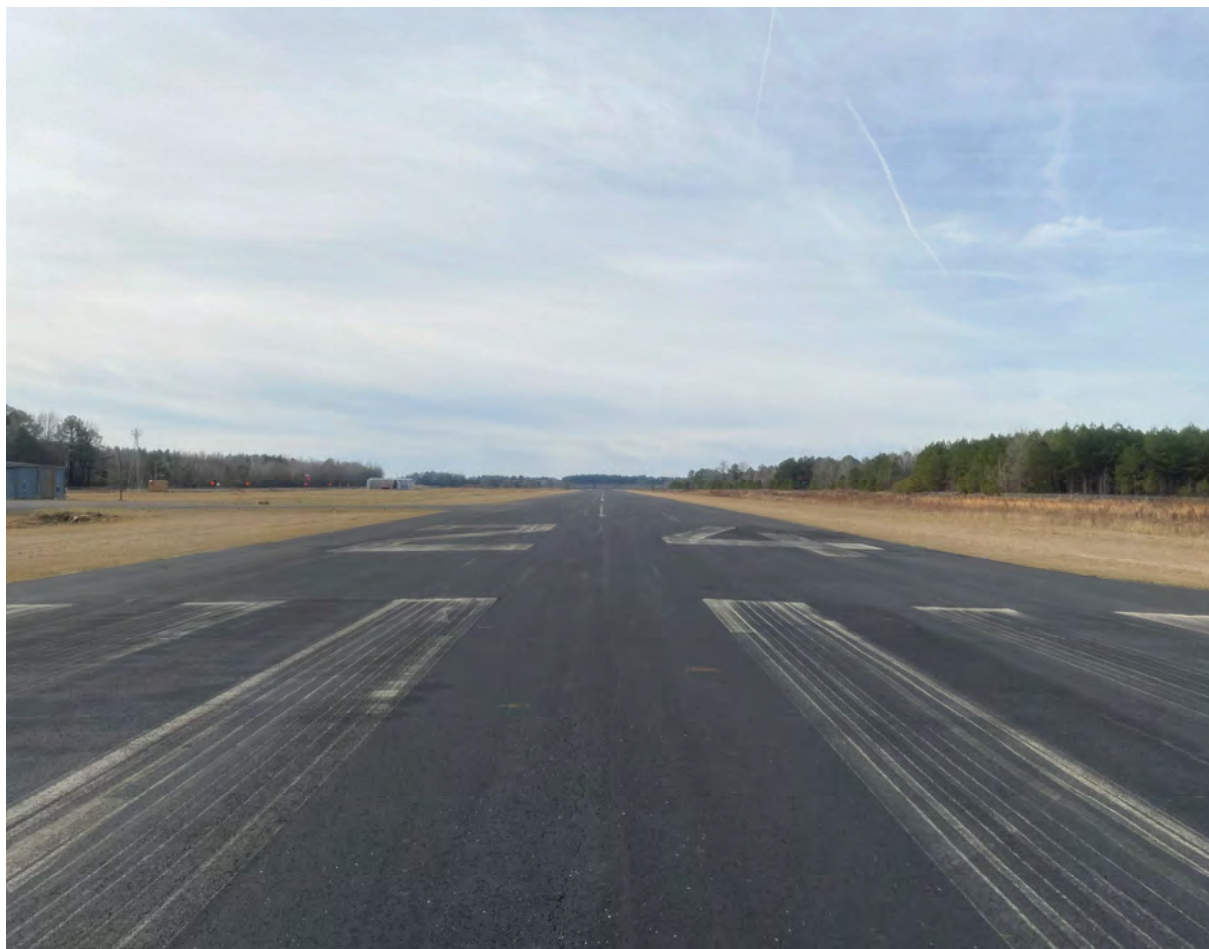
### Airport Markings—Runway

Runway markings are in **POOR** condition.

**Maintenance:** Runway markings should be reapplied so that they are visible.

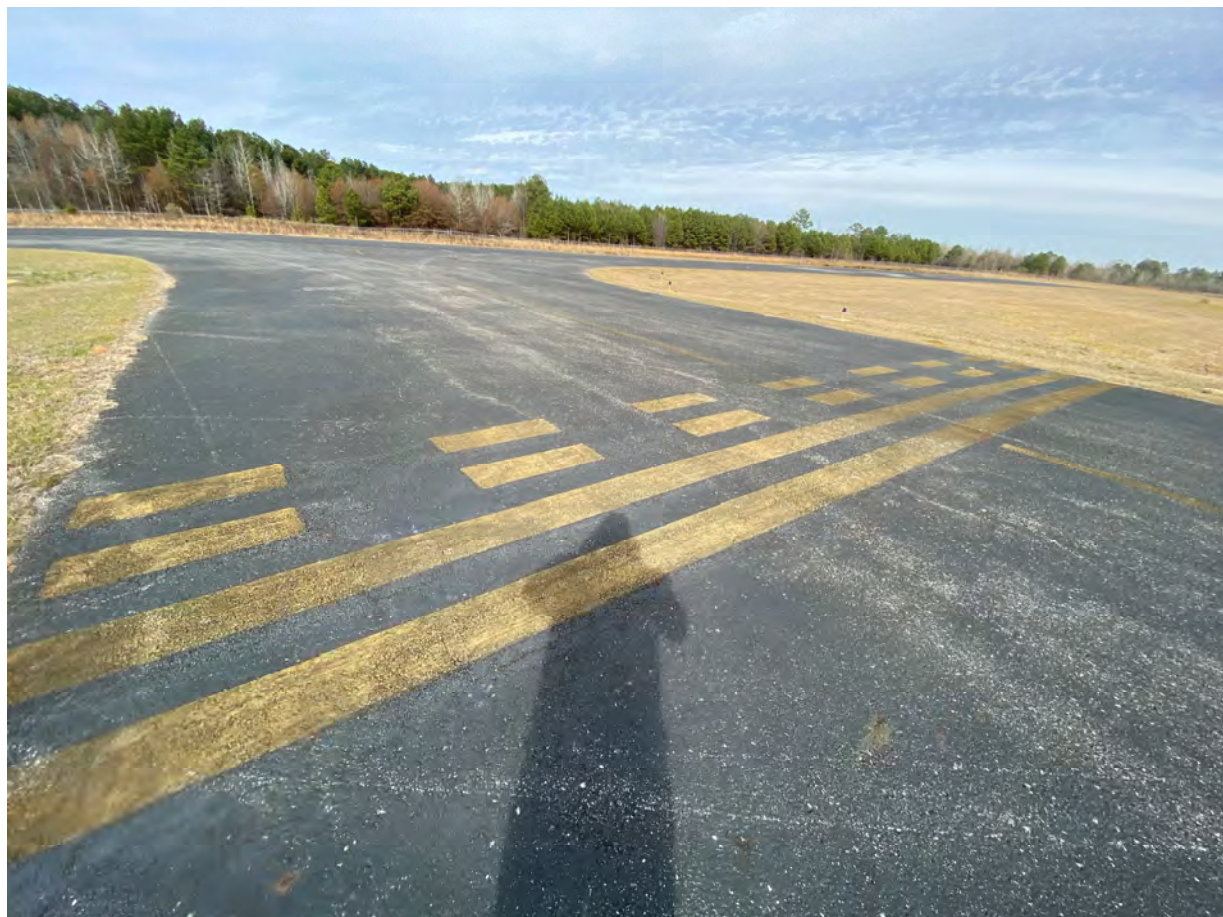
### Airport Markings—Taxiway

Taxiway markings are in **FAIR** condition.

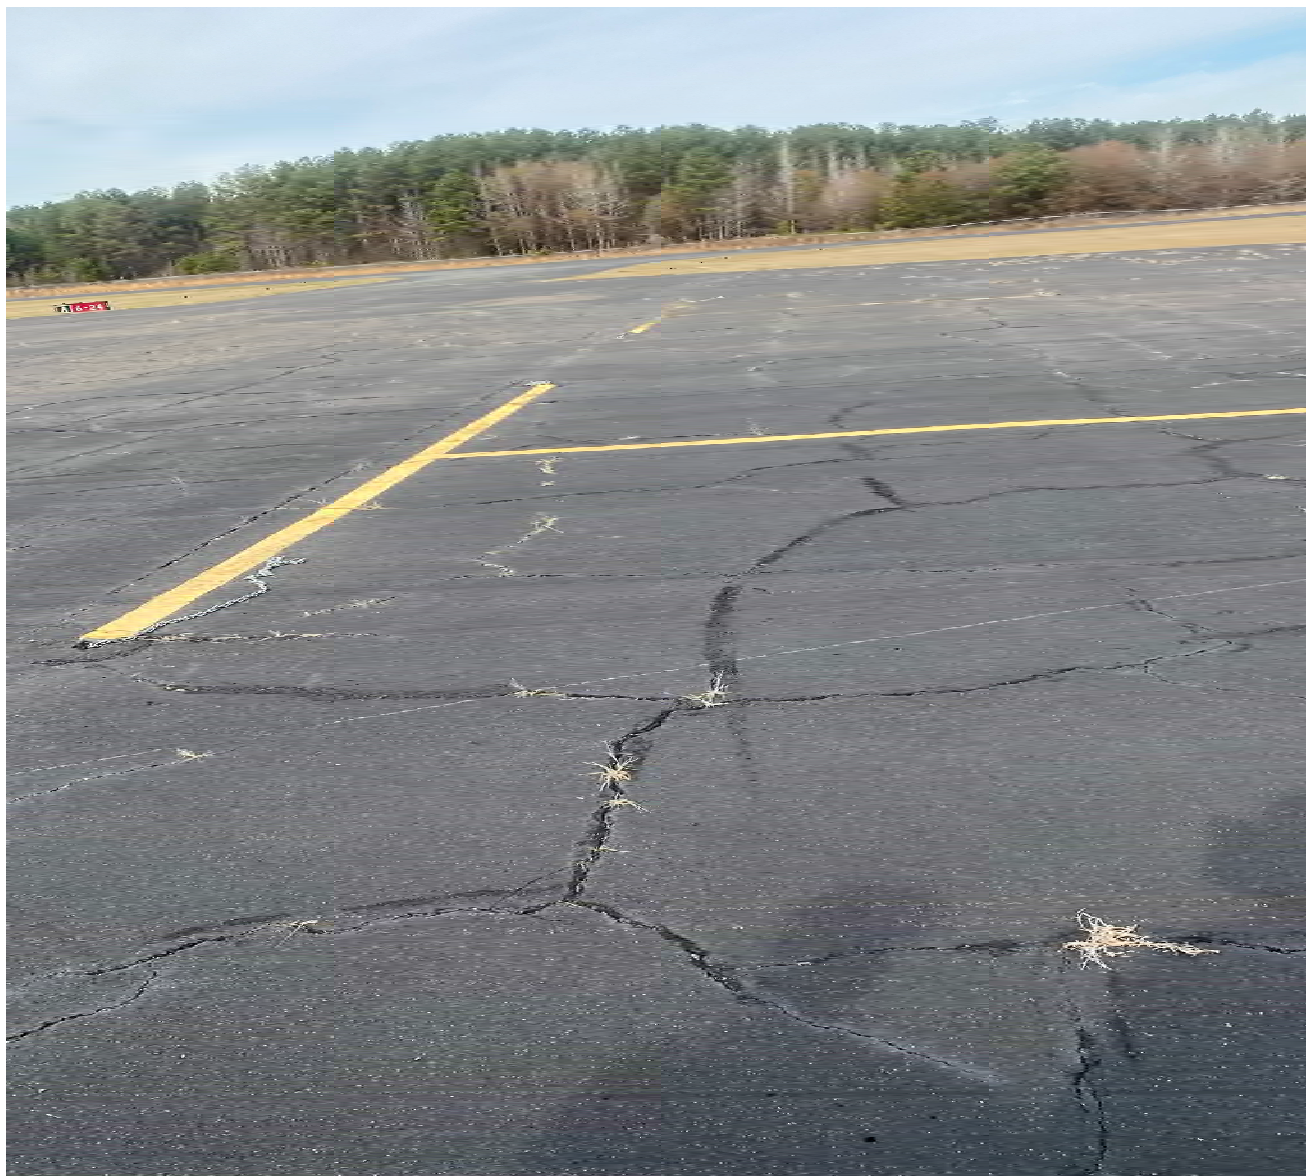
### Airport Markings—Apron

Apron markings are in **FAIR** condition.

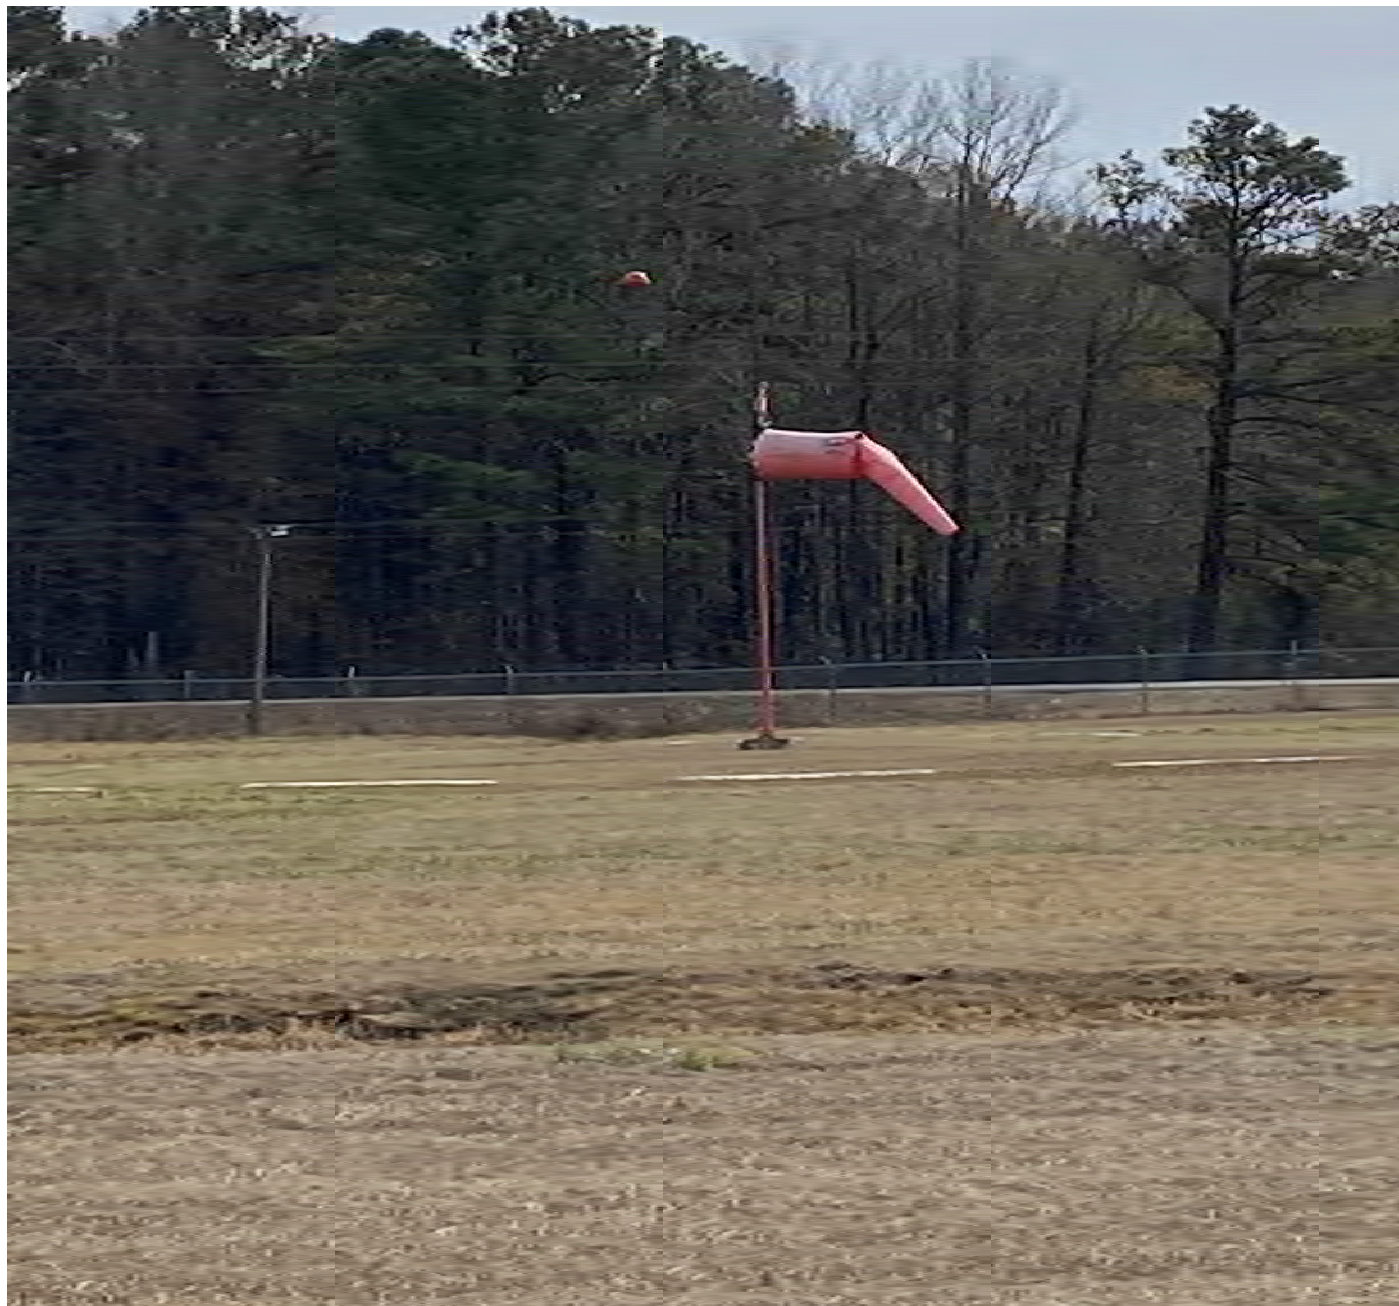
### Wind Direction Indicator

Wind direction indicator is in **FAIR** condition.

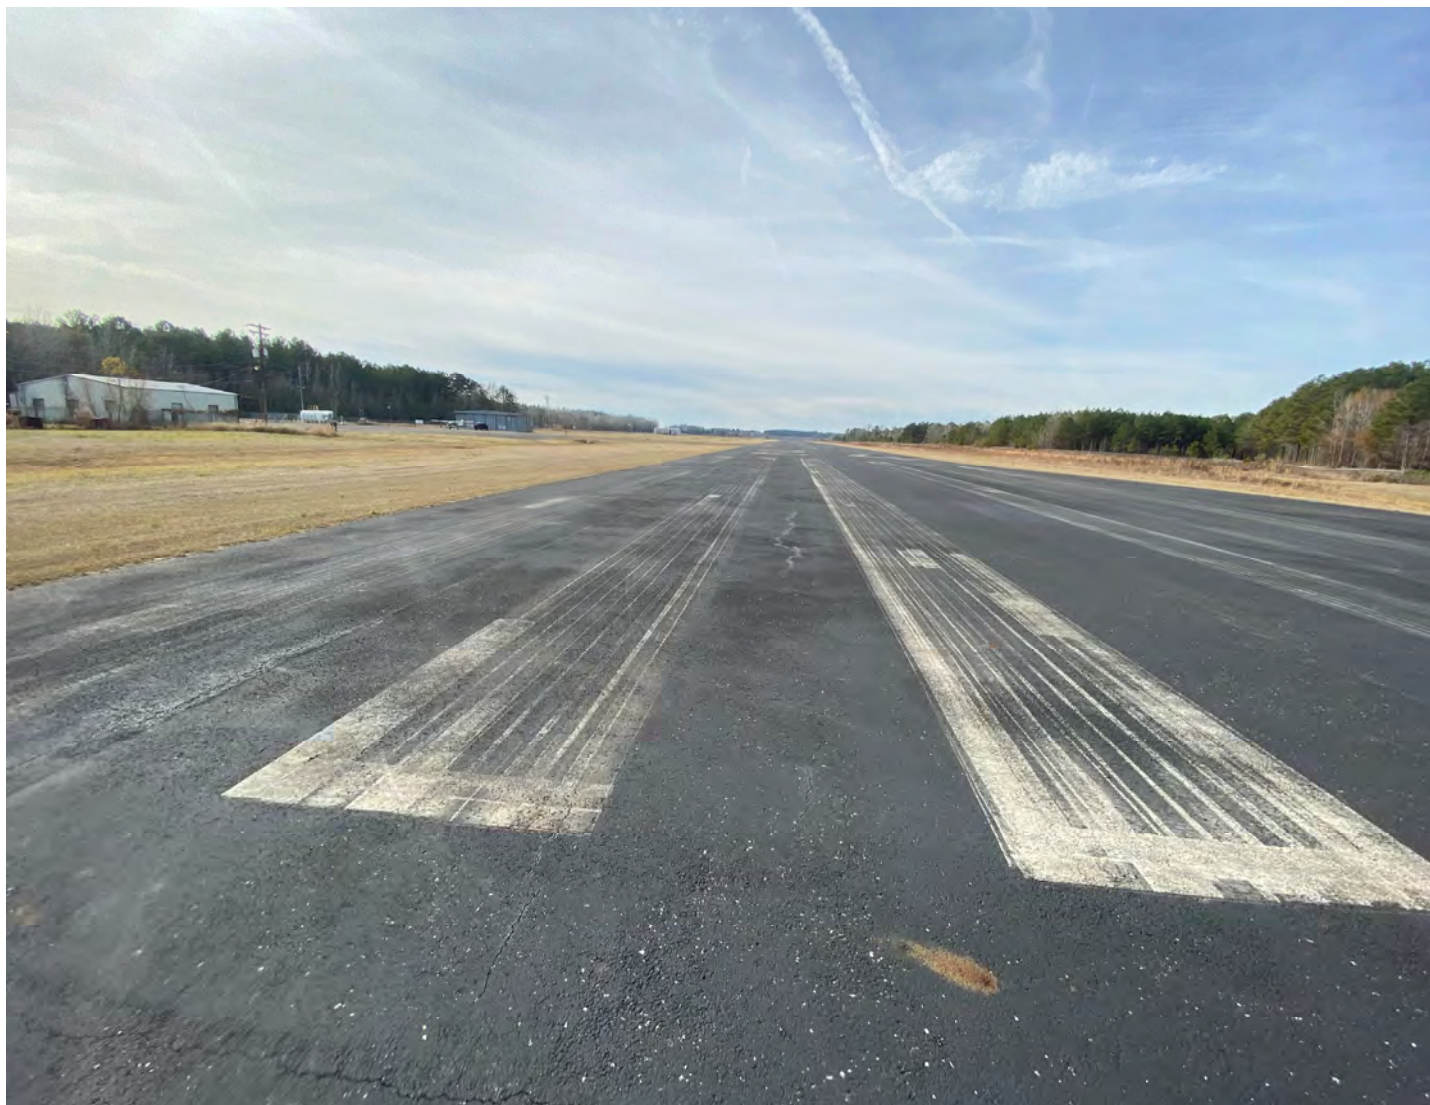
### Runway, Taxiway and Apron Conditions—RUNWAY

Runway surface is in **FAIR** condition.

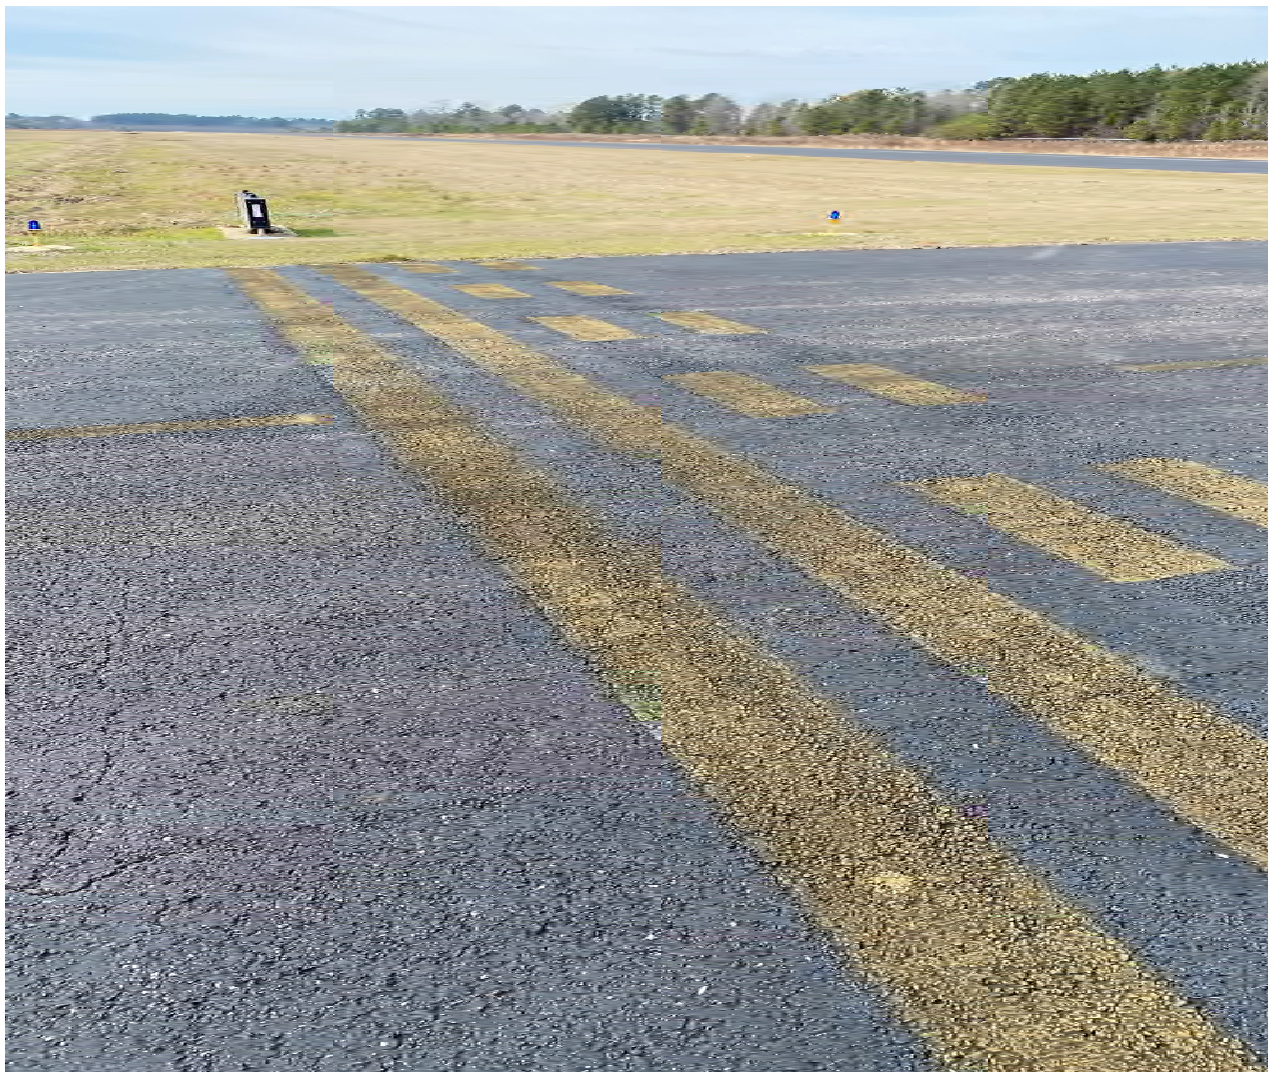
### Runway, Taxiway and Apron Conditions—TAXIWAY

Taxiway surface is in **FAIR** condition.

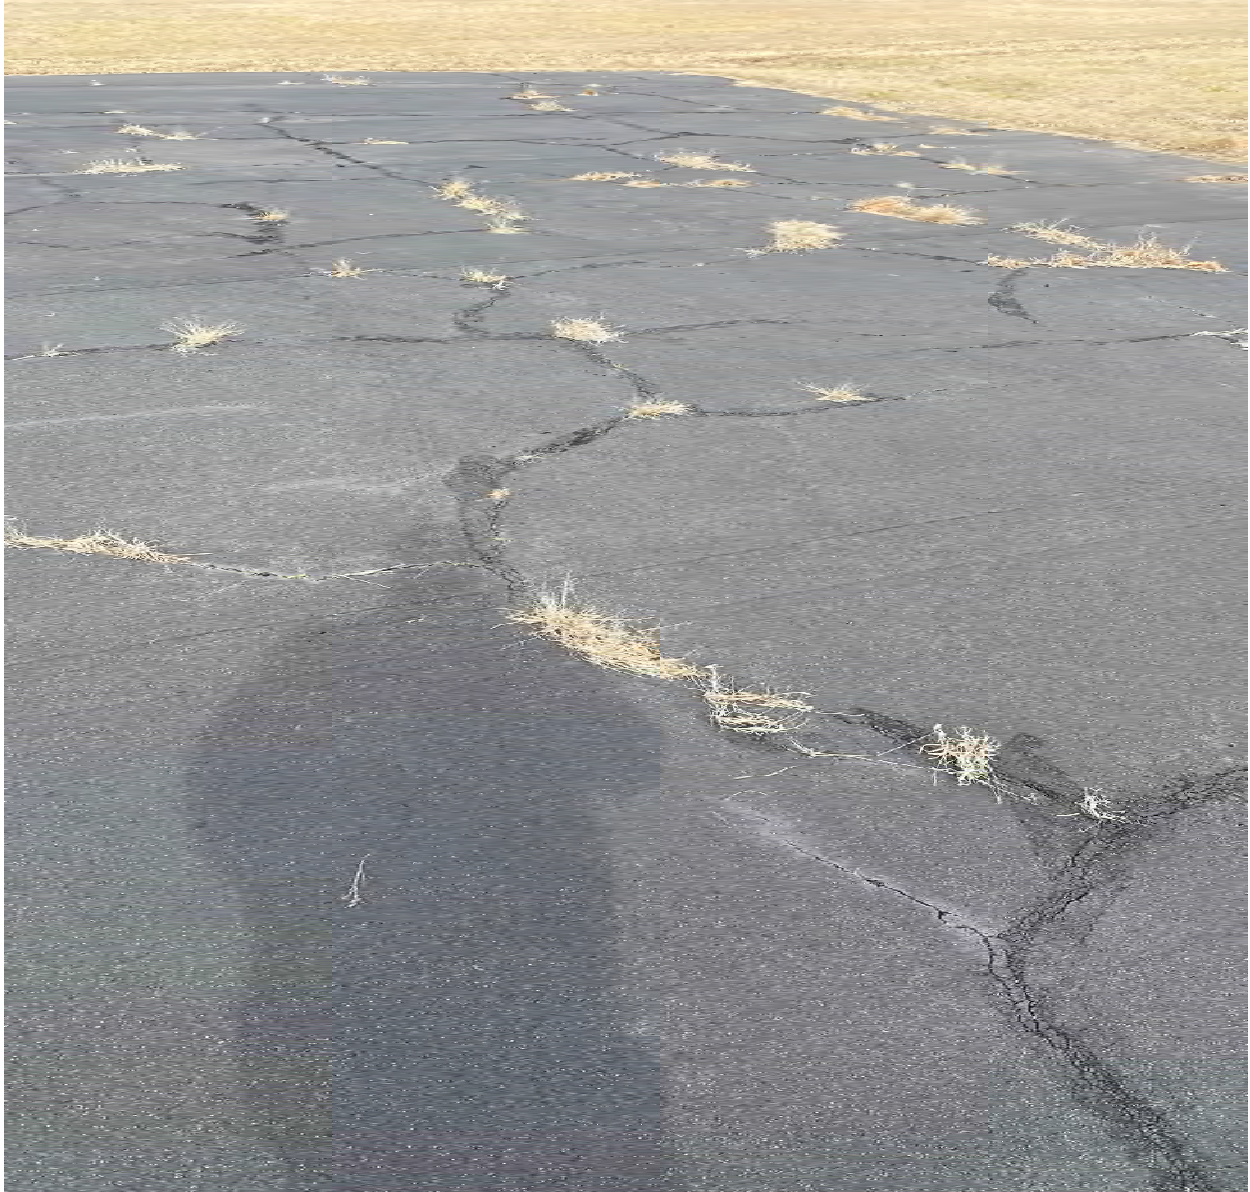
### Runway, Taxiway and Apron Conditions—APRON

Apron surface is in **POOR** condition.

**Maintenance:** Ensure apron is cleaned of all vegetation.

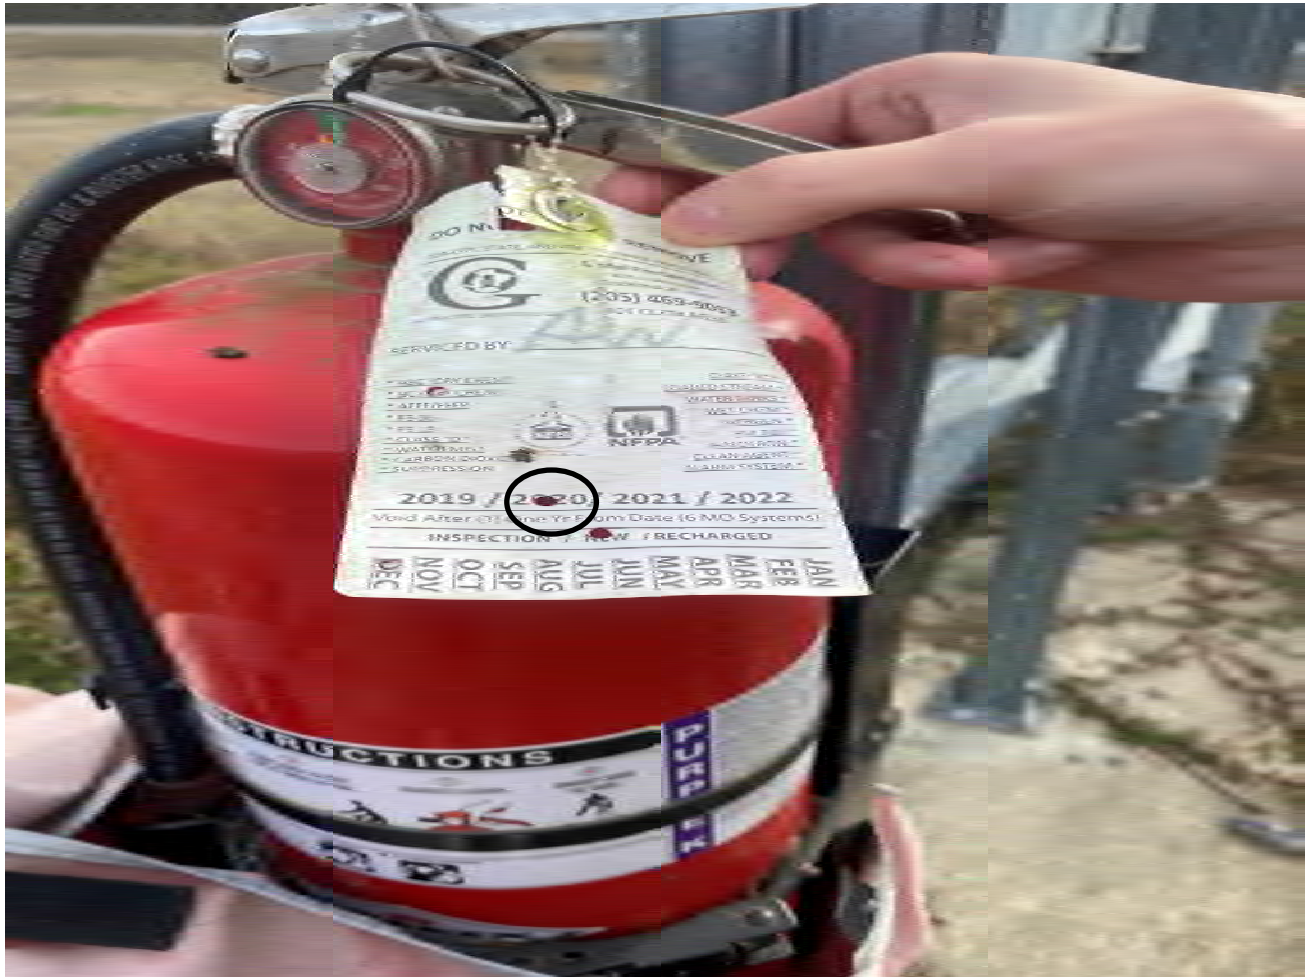
### Fueling Area Requirements

Fueling area **DOES NOT MEET** state licensing standards.

**Violation:** Ensure fire extinguishers are inspected regularly and approved for use.

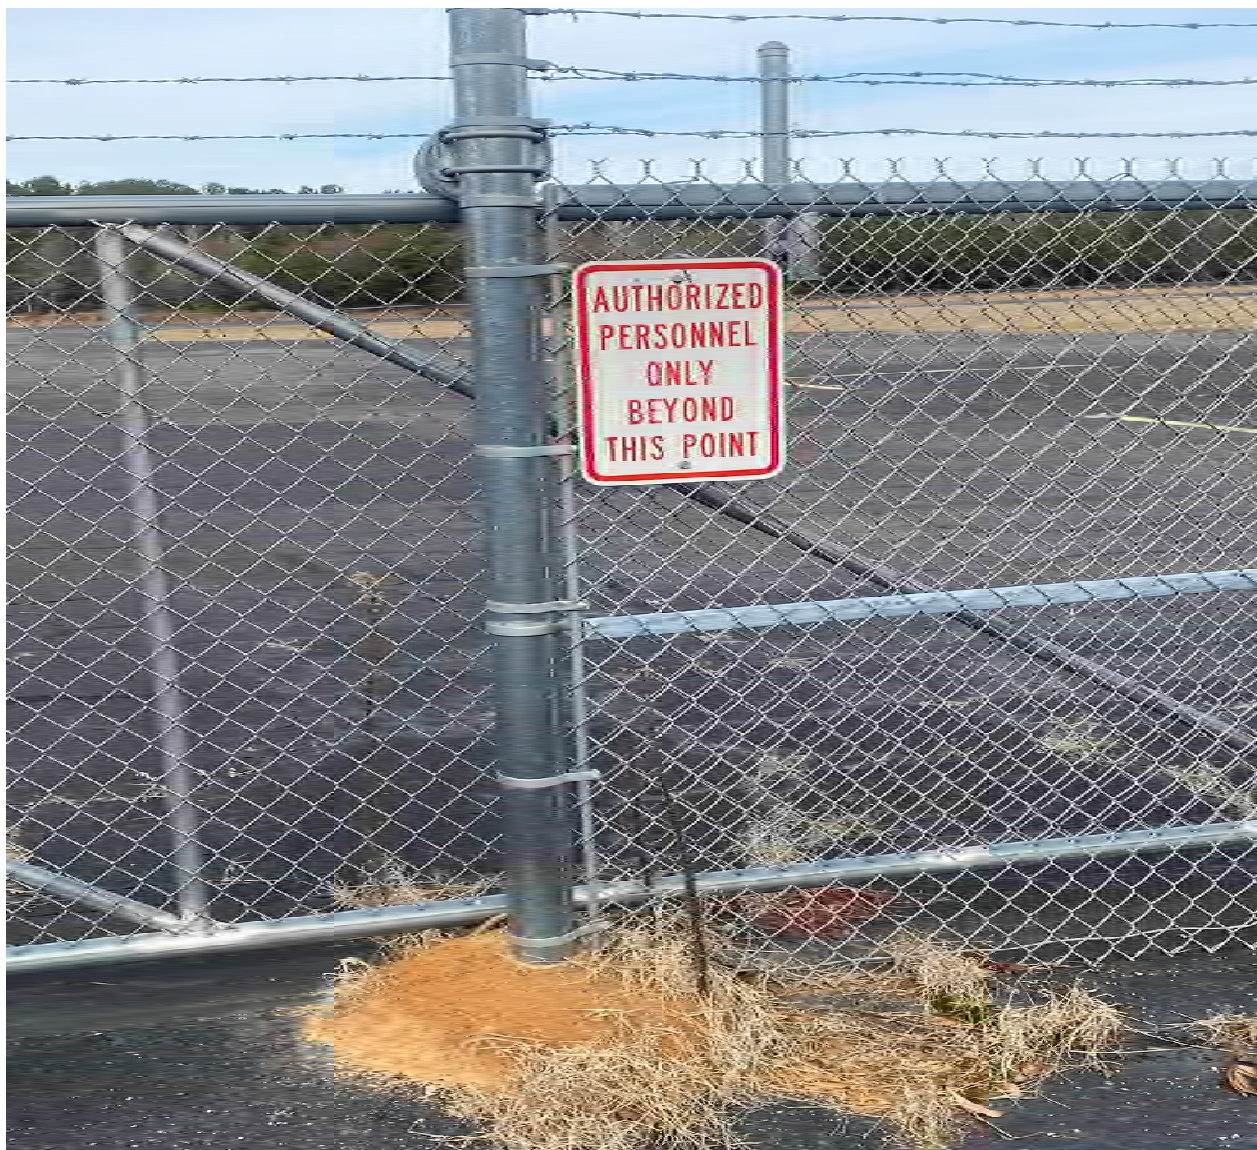
### Prohibited Activities

No prohibited activities were observed during this inspection. All gates were locked and airfield access was secure.

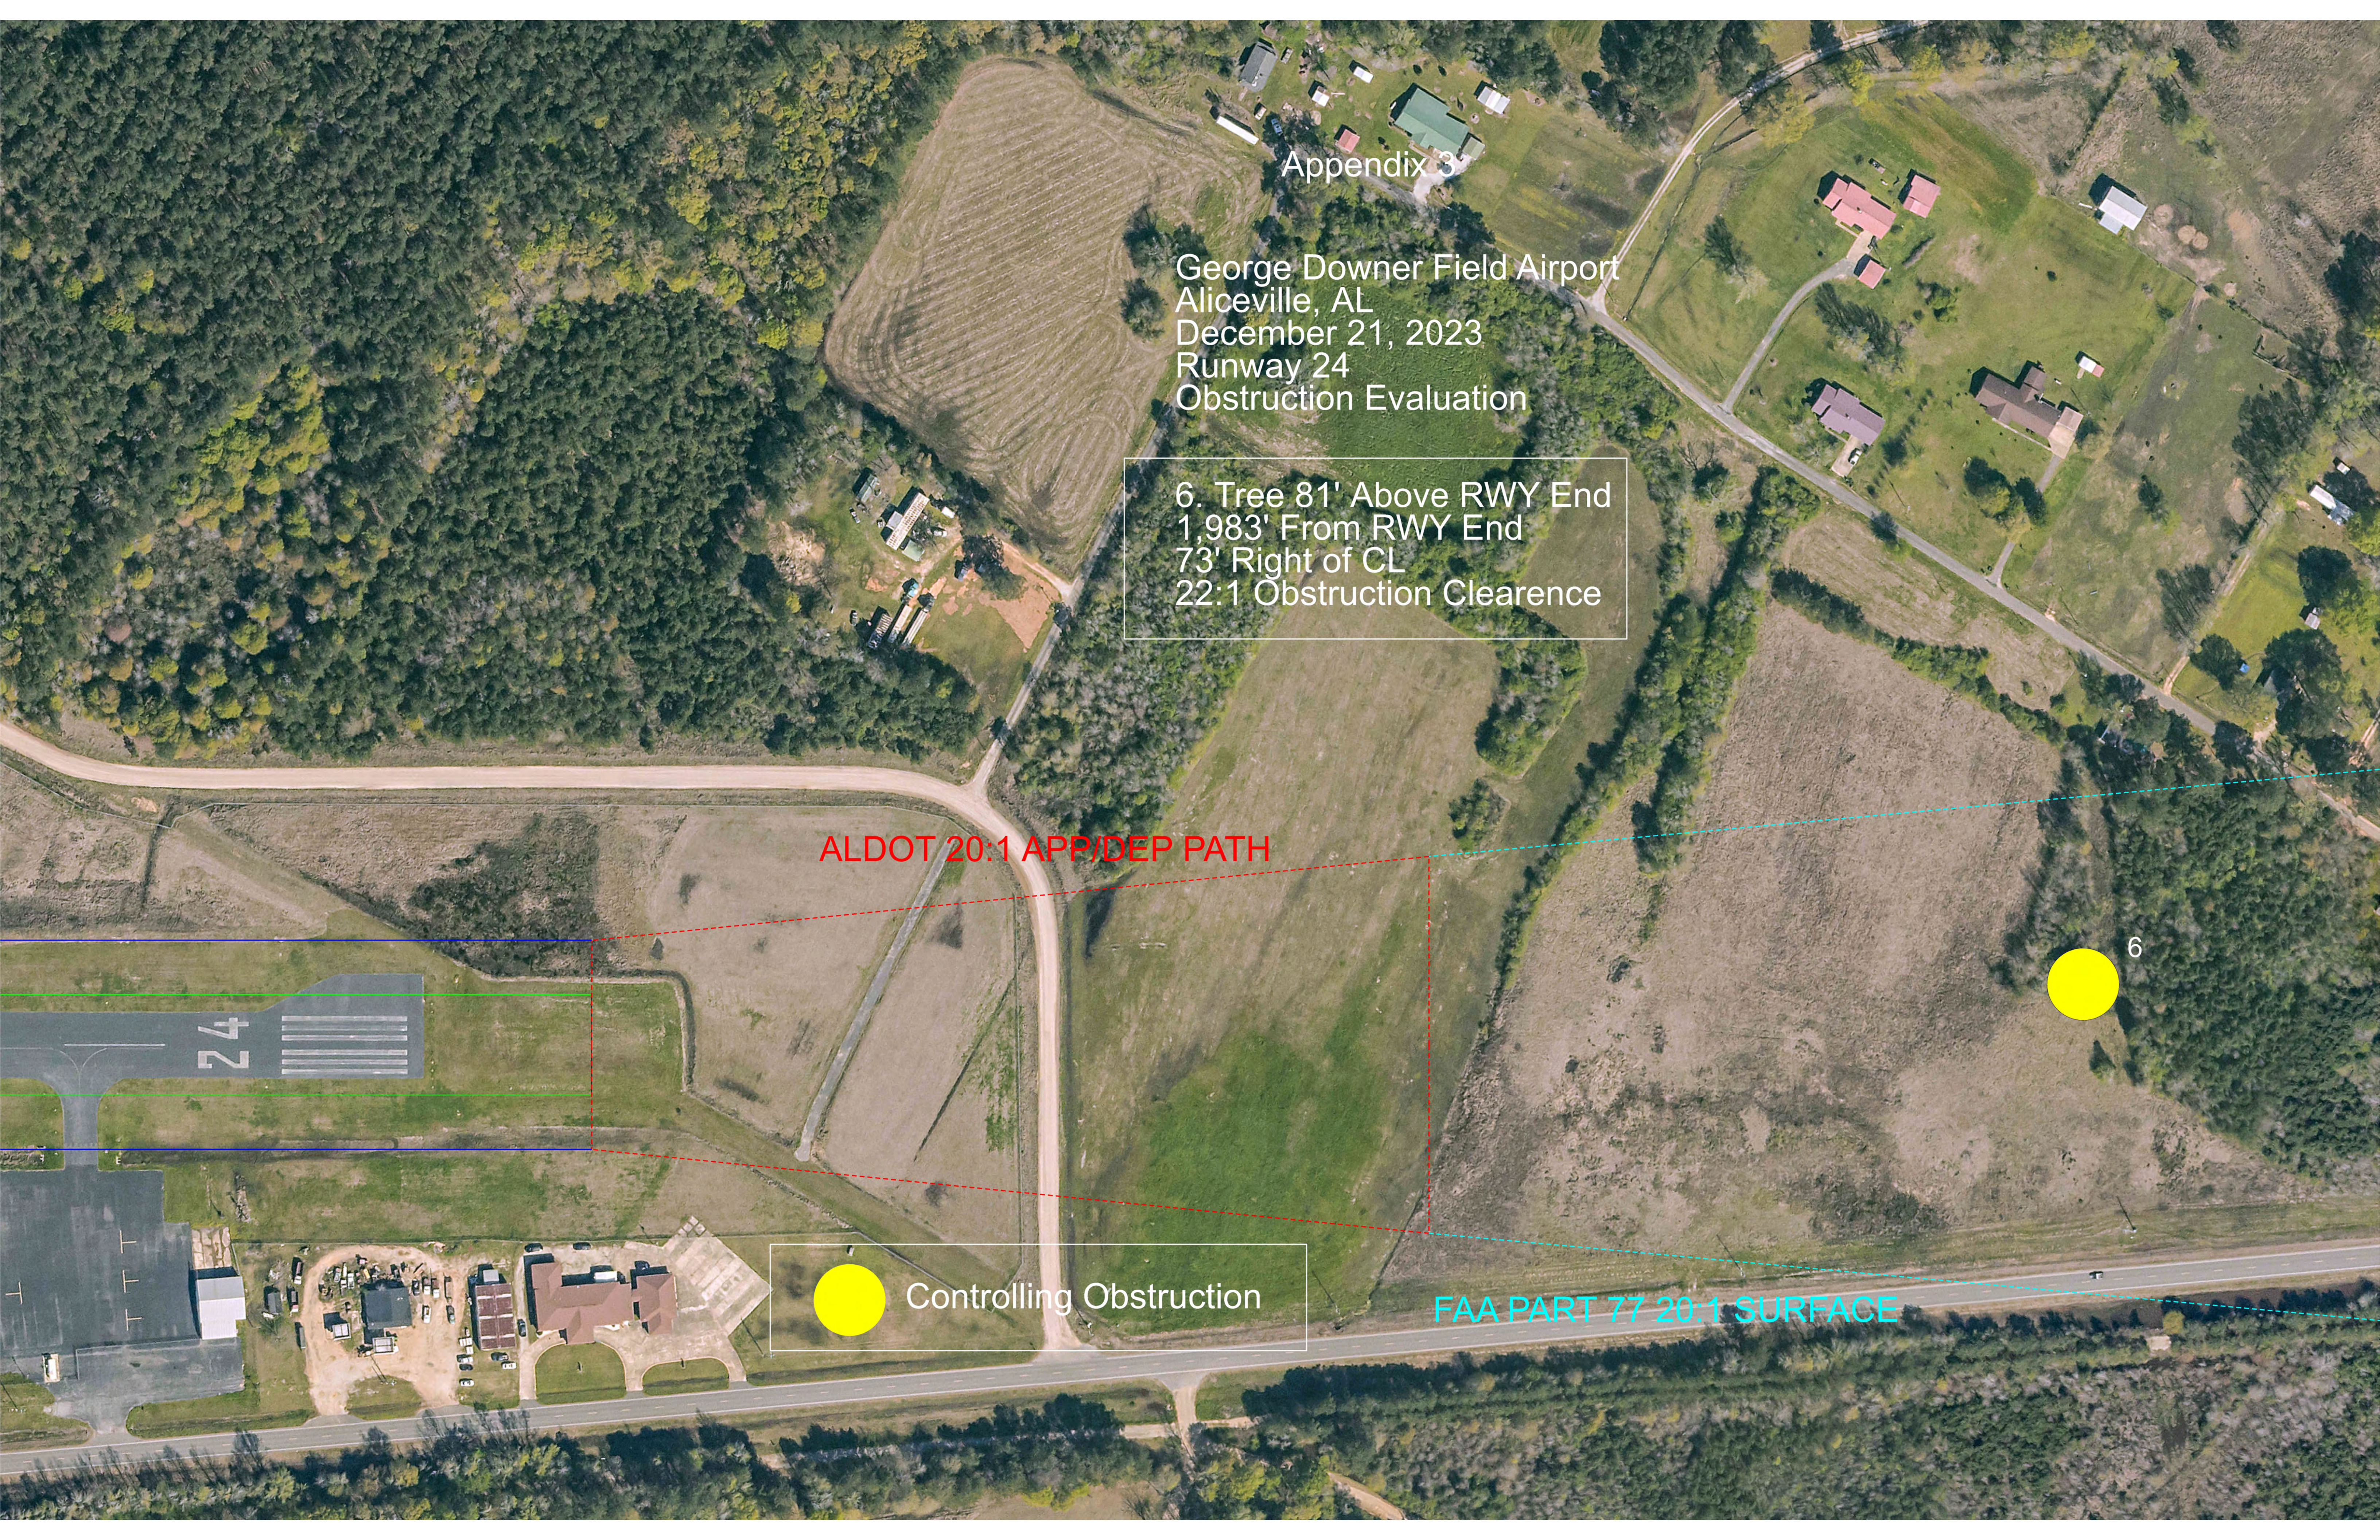
Appendix 3

6. Tree 81' Above RWY End  
1,983' From RWY End  
73' Right of CL  
22:1 Obstruction Clearance
