**Subject: Annual Inspection Report
Courtland Airport (9A4)**

**Annual Inspection Report
Courtland Airport (9A4)
Courtland, Alabama**

October 5, 2021

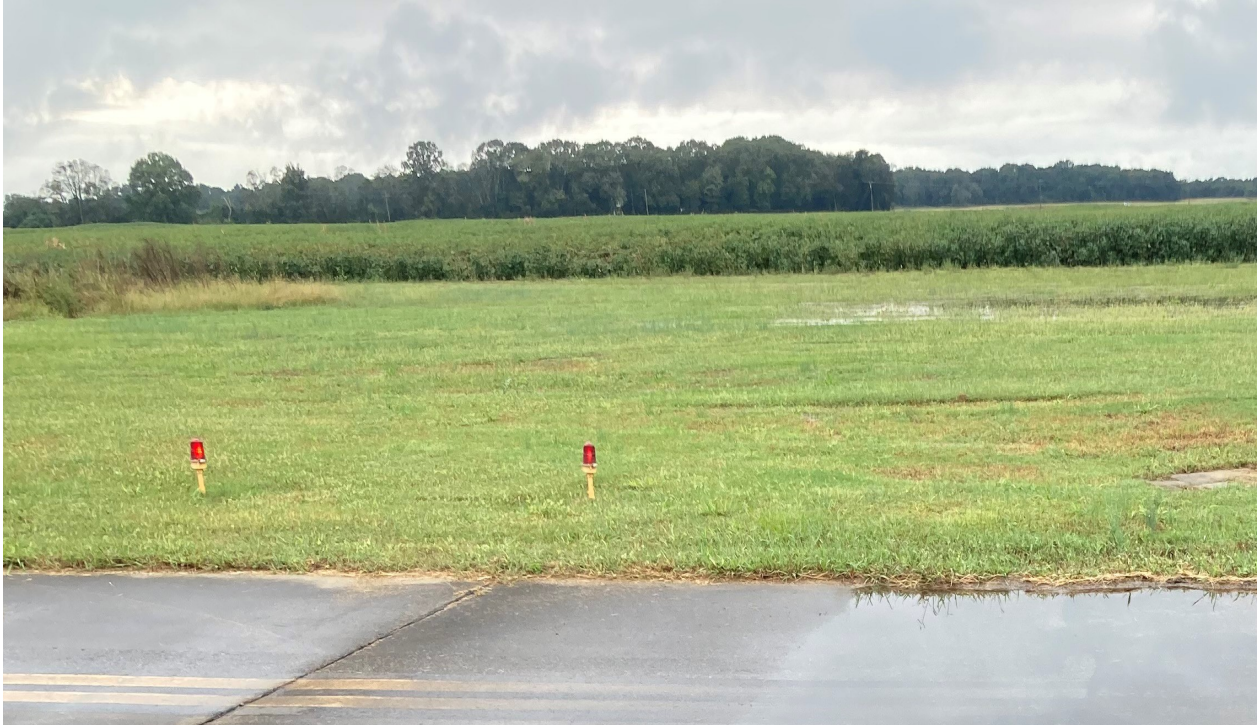
Photo # 1 – Runway 13 Approach

- Runway 13 – No obstructions (See Photo # 1)
- Runway 31 – No obstructions (See Photo # 2)
- Runway 18 – No obstructions (See Photo # 3)
- Runway 36 – No obstructions (See Photo # 4)

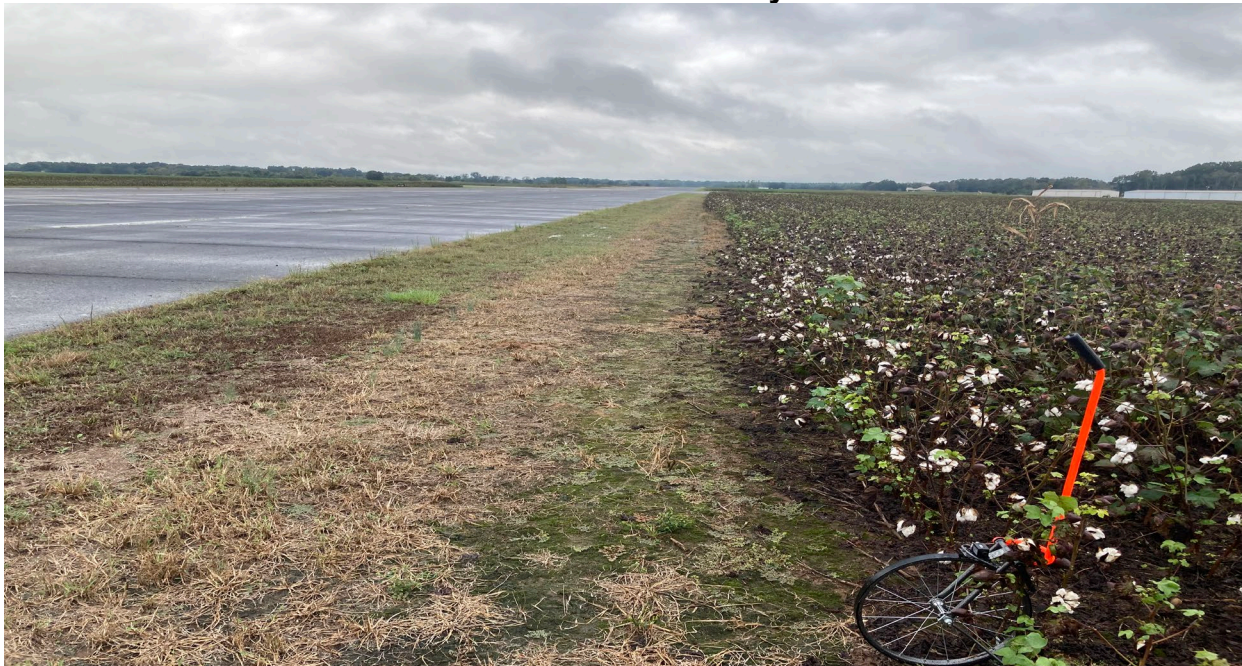
Photo #5 –RWY 18/36 Primary Surface

- The Primary Surface on Runway 18/36 is violated by crops growing 90 feet from the runway centerline on both sides (See Photo #5).

- Farming is taking place within the Primary Surface (See Photo #5). To plant and harvest these crops, non-airport vehicles must move through these areas, which is prohibited.
- Farming equipment is being stored on the airport apron near the northern T hangars (See Photo #29 and #30).
- A truck and trailer are parked unattended on a taxiway near the approach end of Runway 18 (See Photo #31).
- An airport gate was left open by a vehicle leaving airport property.

- Cease all farming related activities within the Primary Surface.
- Note: This has been an issue for several years, and the airport sponsor has failed to correct this safety hazard.

- Prohibit non aeronautical activity on the *ALL* airport surfaces.
- Ensure airport tenants and contractors are following proper airport security protocols.

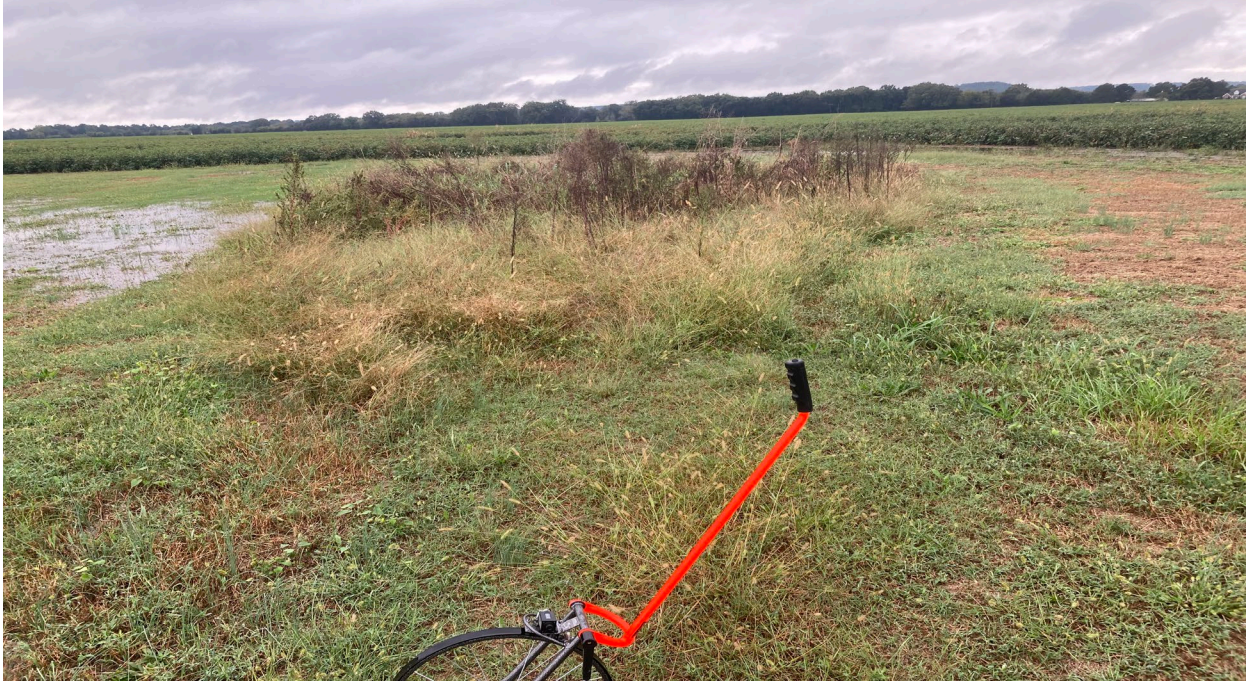
- A large hump is present off the approach end of Runway 13 (See Photo #6)
- A drainpipe running across the approach end of Runway 13 is collapsing, resulting in large holes in the Runway Safety Area (RSA) (See Photo #7). The holes found during the inspection were 80 feet and 122 feet from the runway end.
- Rocks and debris are piled on an old drain grate (See Photo #8).

Photo #6—Hump in Runway Safety Area

- Proceed with planned drainage improvements.
- Grade hump in RSA smooth and compact.

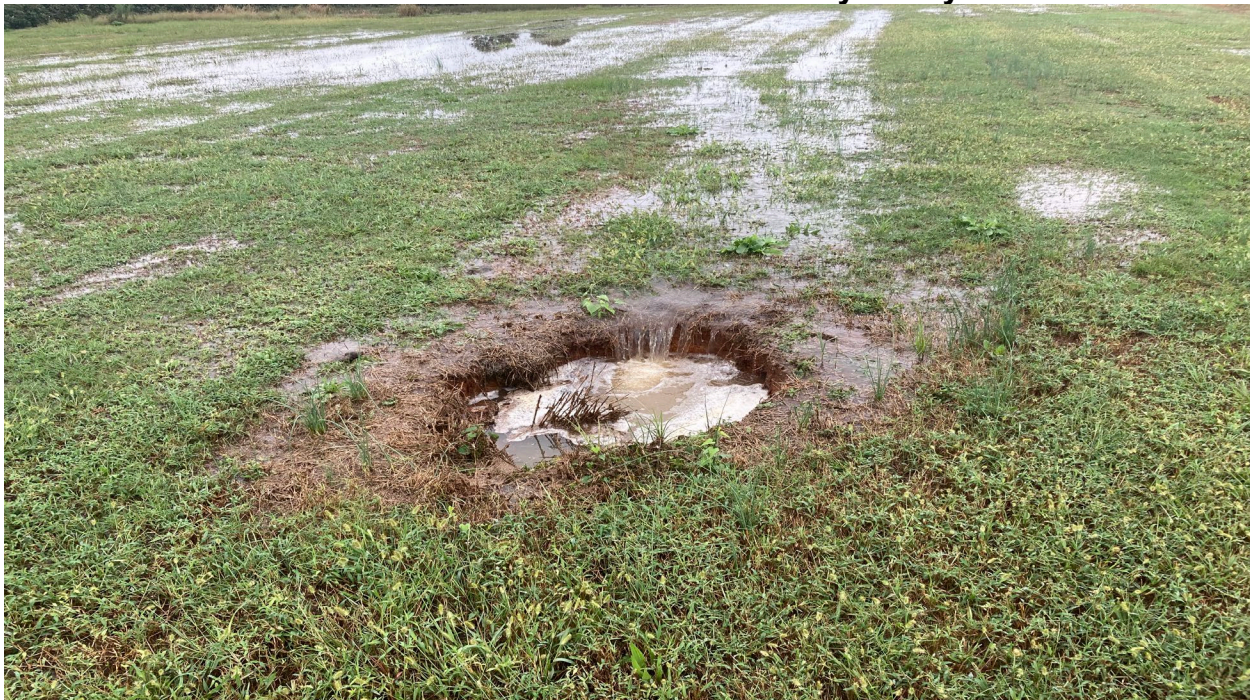
Photo #7 – Second Hole Found in Runway Safety Area

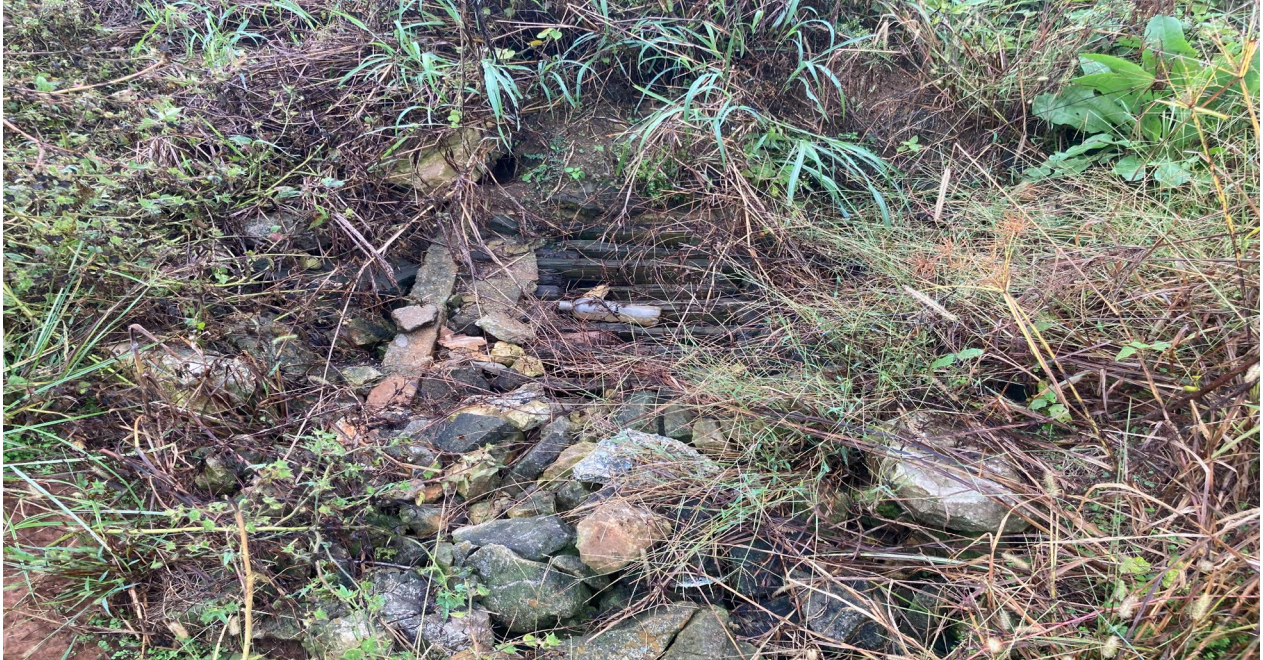
Photo #8 – Rocks and Debris on Drain Grate

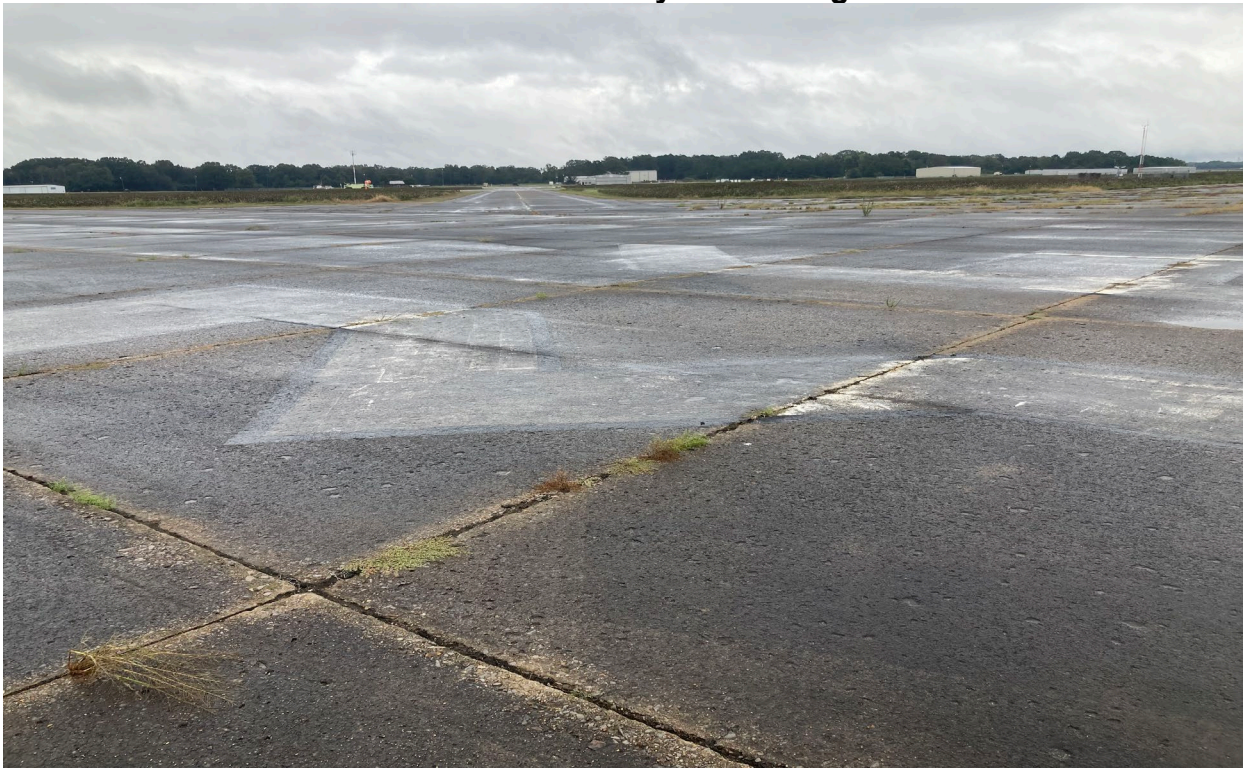
Photo #9 – Runway 36 Markings

- Runway 18 markings are in **FAIR** condition.
- Runway 36 markings are in **POOR** condition (See Photo #9).
- Runway 13/31 markings are in **FAIR** condition (See Photo #10).
- Taxiway markings are in **POOR** condition.
- Apron/Taxiway markings are in **POOR** condition and **almost completely obscured** (See Photo #11).
- Yellow Xs on the closed runway are in **POOR** condition and **almost completely obscured**. Some areas not marked (See Photo #12).
- Barricades used on closed runway are not standard and non frangible, causing a hazard (See Photo #13).

- Taxiways, Apron, and Xs on Closed Runway should be remarked.
- Only those areas of the Apron previously deemed safe for taxiing should be remarked.
- Markings should be re-applied in accordance with FAA AC 150/5340-1M.
- Proper, low profile, reflective barricades should be used in accordance with FAA AC 150/5370-2G.

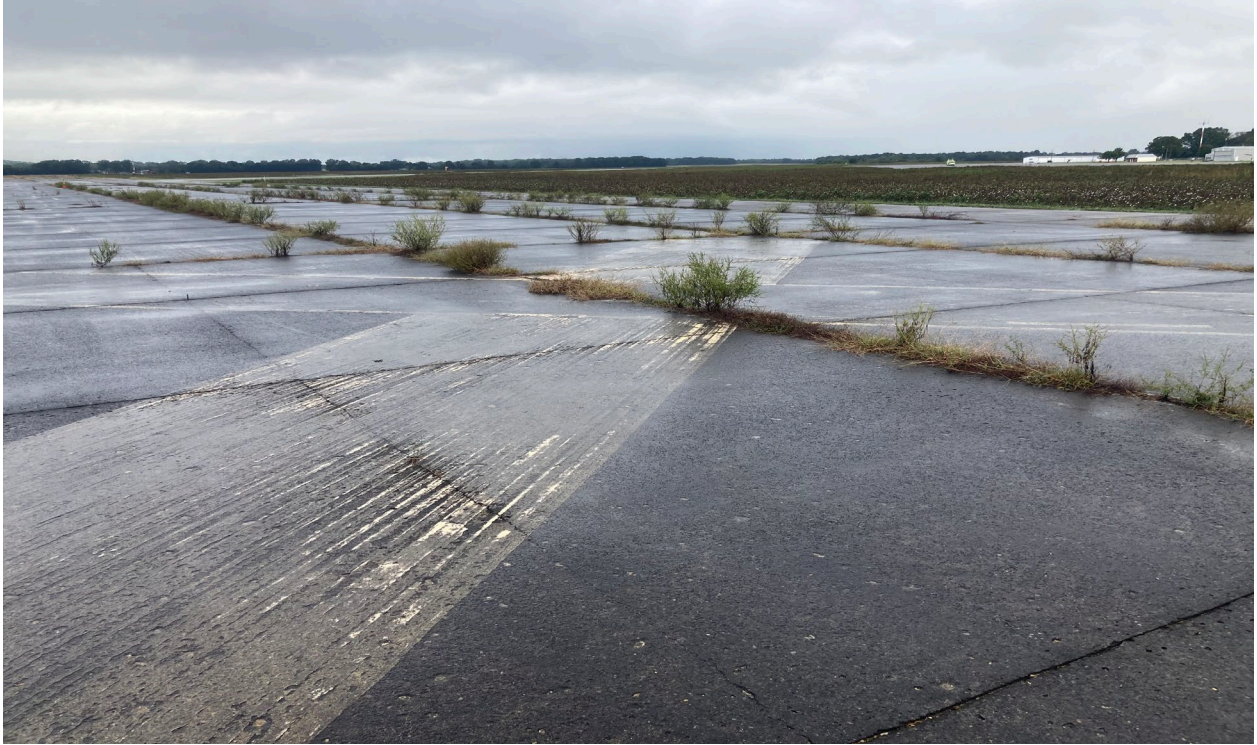
Photo #12 – Faded X's on Closed Runway

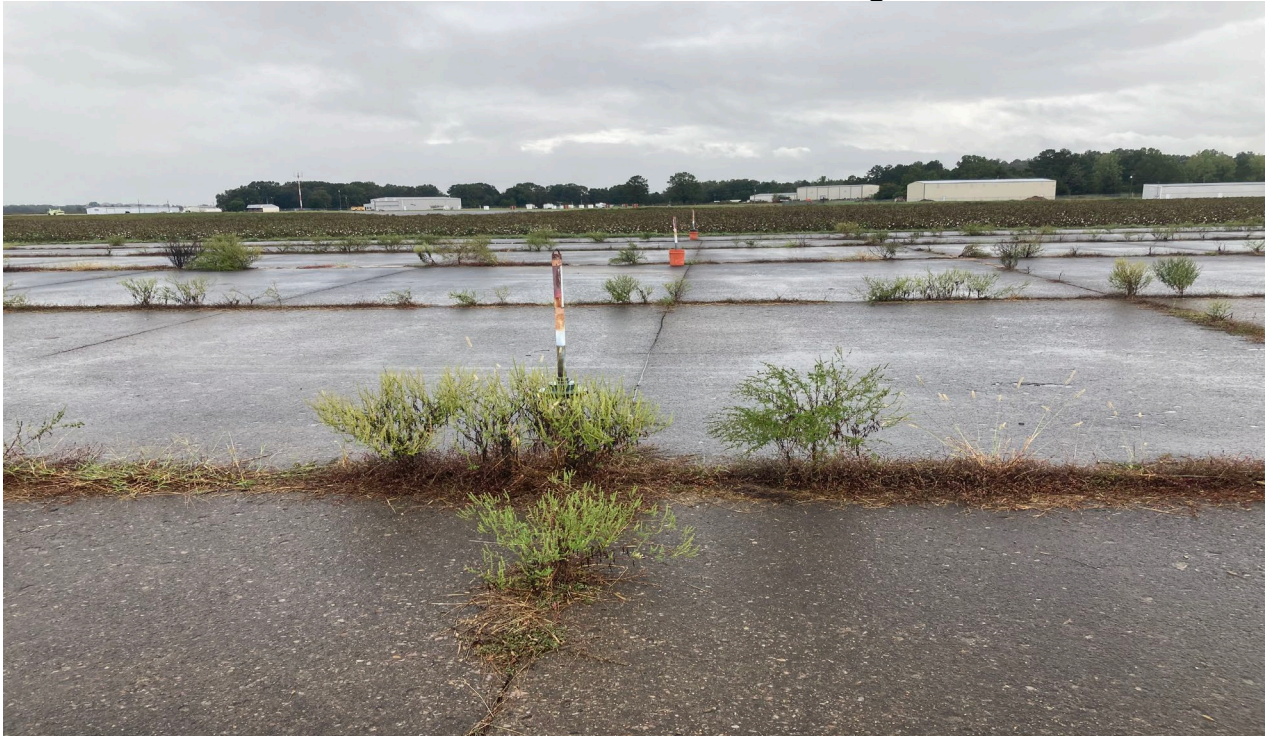
Photo #13 – Non-Standard Barricades Causing FOD Hazard

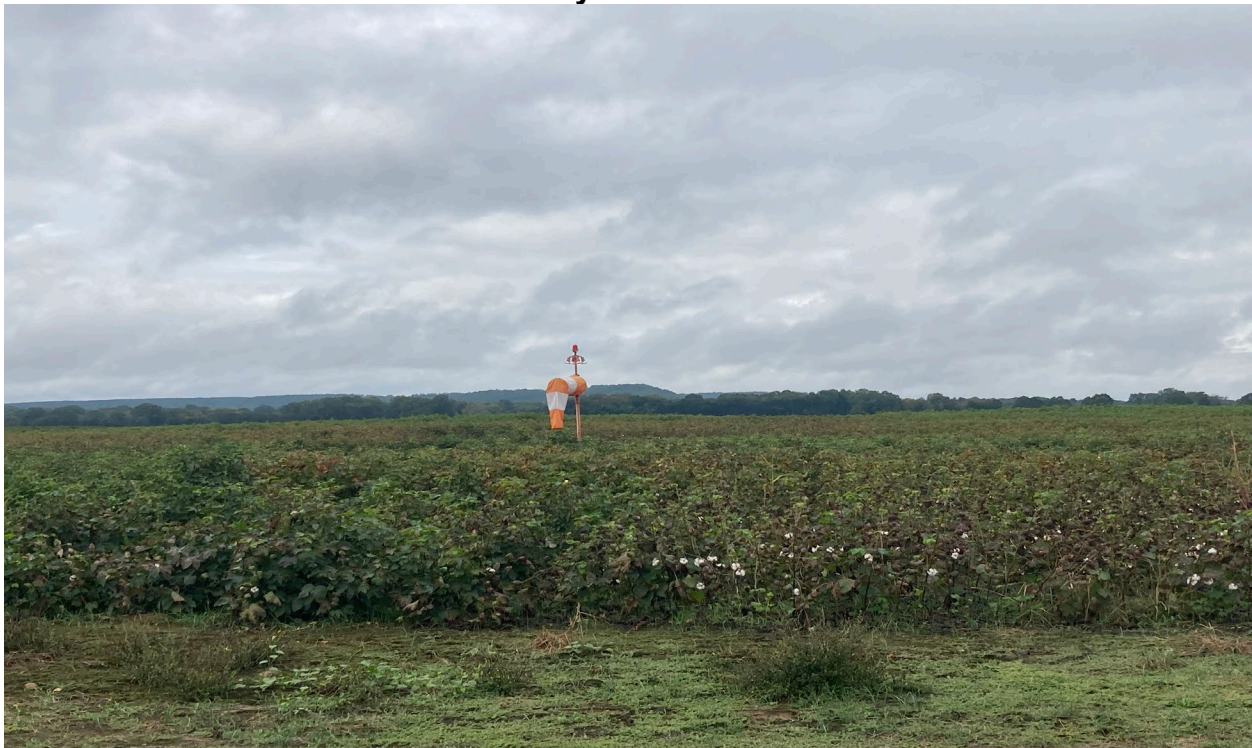
Photo #14 – Primary Wind Direction Indicator

- The wind direction indicators (windsocks) are in **GOOD** condition (See Photo #14 and #15).

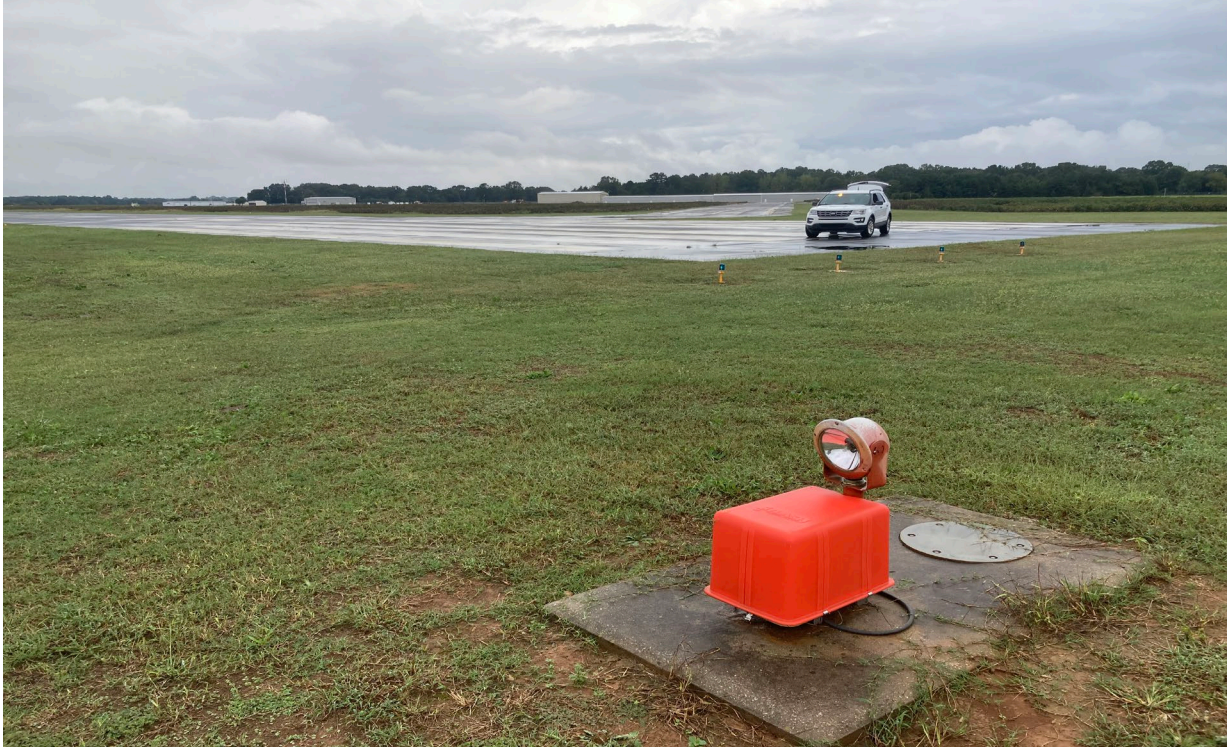
Photo #16 – Runway 31 REIL

- Runway and threshold lights are all operable.
- One REIL on Runway 31 is missing, the other is inoperable and misaligned (See Photo #16).
- One REIL on Runway 13 is missing, the other is inoperable.

- Repair/replace inoperable lights

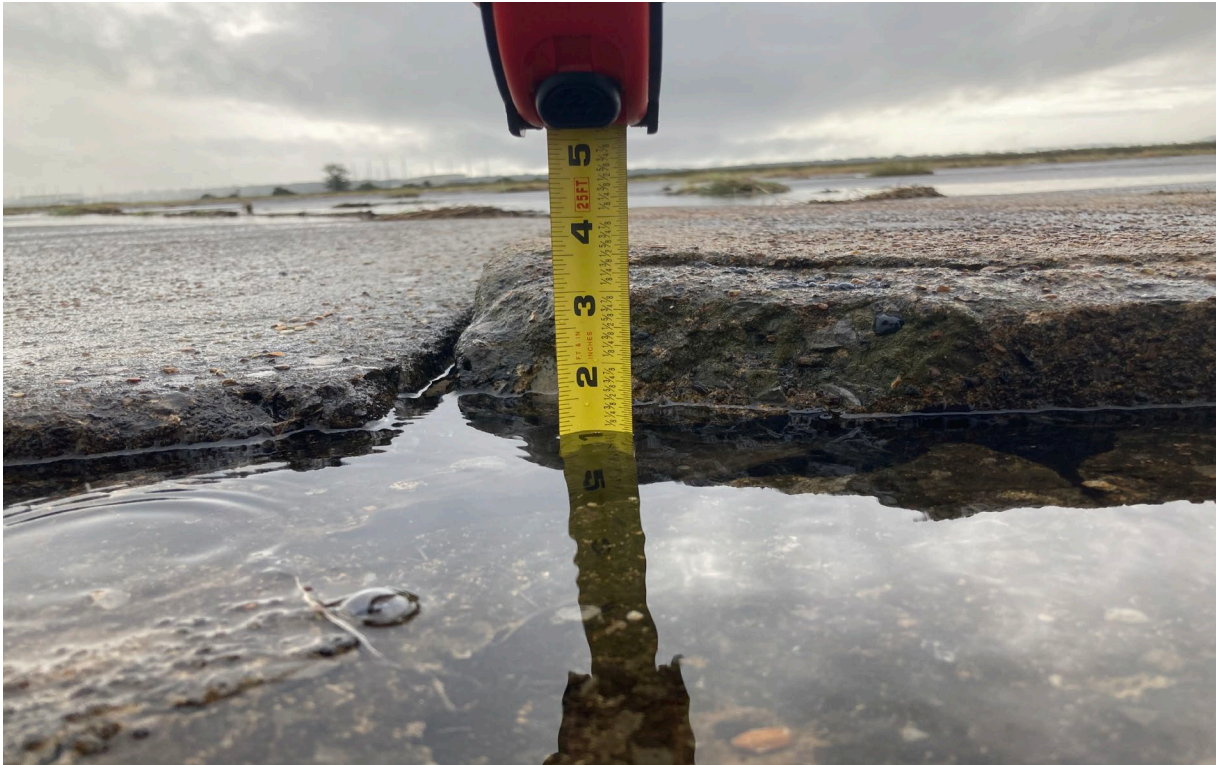
- Blocks containing drainage fixtures have shifted, causing surface variations greater than 3 inches and rendering drainage fixtures ineffective, leading to standing water on the apron (See Photo #17 and Photo #18).

Photo #17 – Drain Slab Shift

- **Runway 18/36- Recommended CLOSURE of Runway 18/36 due to the adverse conditions that exist.** There is an elevated threat posed to aircraft directional control and a high risk of aircraft damage caused by FOD. These safety deficiencies have been listed in previous reports and safety deficiencies have not been corrected.
 - FAA AC 150/5370-10H requires that the height of adjacent concrete slabs not exceed a height of $\frac{1}{4}$ ". The slab height differences are now beyond those limits.
- A pavement project should be planned for the main apron and Runway 13/31.
- Areas that are safe for aircraft movement on the apron should be identified and areas that are experiencing failure should be closed to aircraft movement.
- FOD should be removed from airport surfaces.
- Vegetation should be removed from airport surfaces.

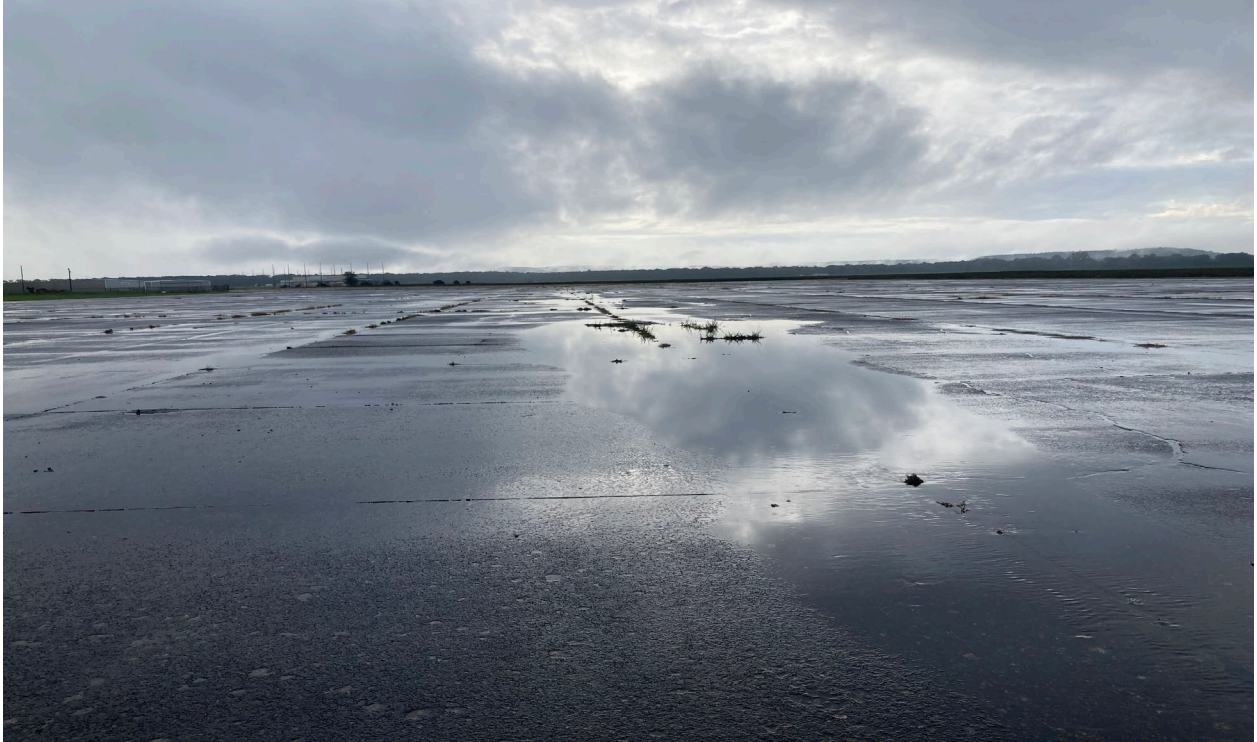
Photo #18 – Standing Water on Apron

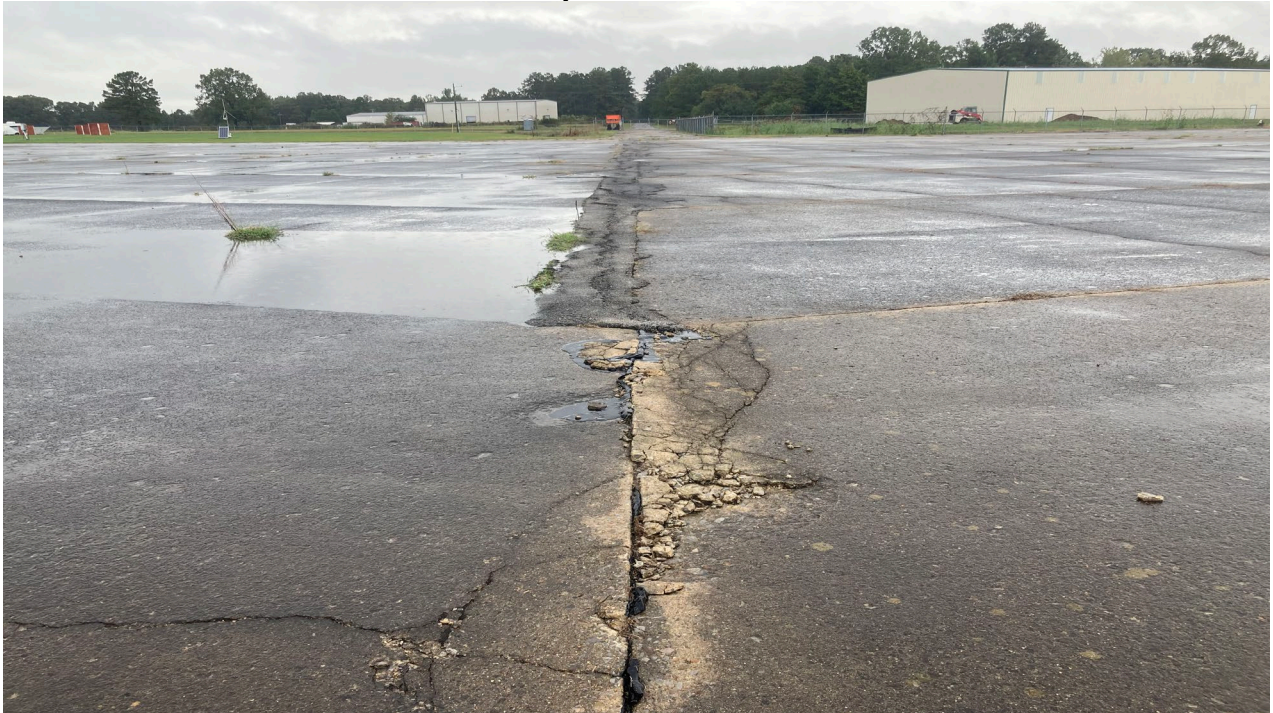
- The apron is presenting severe cracking, spalling, scaling and pavement failure in some areas. These pavement conditions are causing large quantities of foreign object debris (FOD) (See Photo #19).

Photo #19 – Apron Pavement Failure

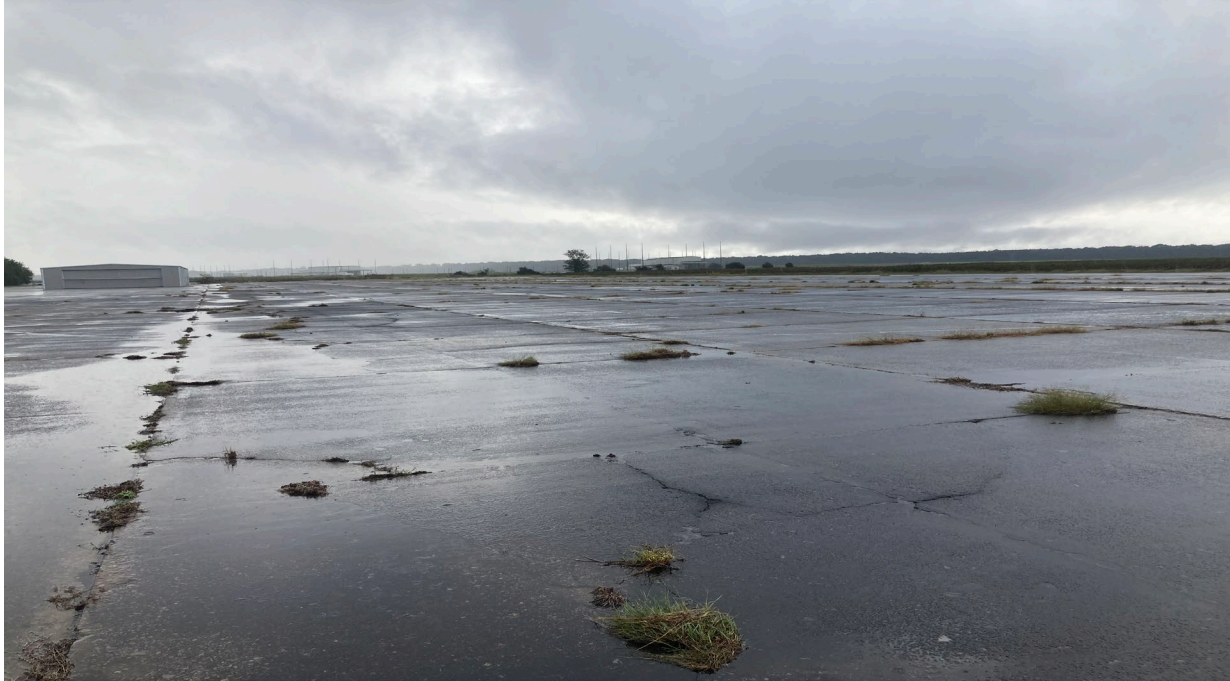
- There is tall vegetation growing through joints on the ramp (See Photo #20).
- Taxiway pavement surfaces are in overall **POOR** condition with pop-outs and some scaling. Some FOD and vegetation growth is present on the taxiways.

Photo #20—Vegetation on Apron

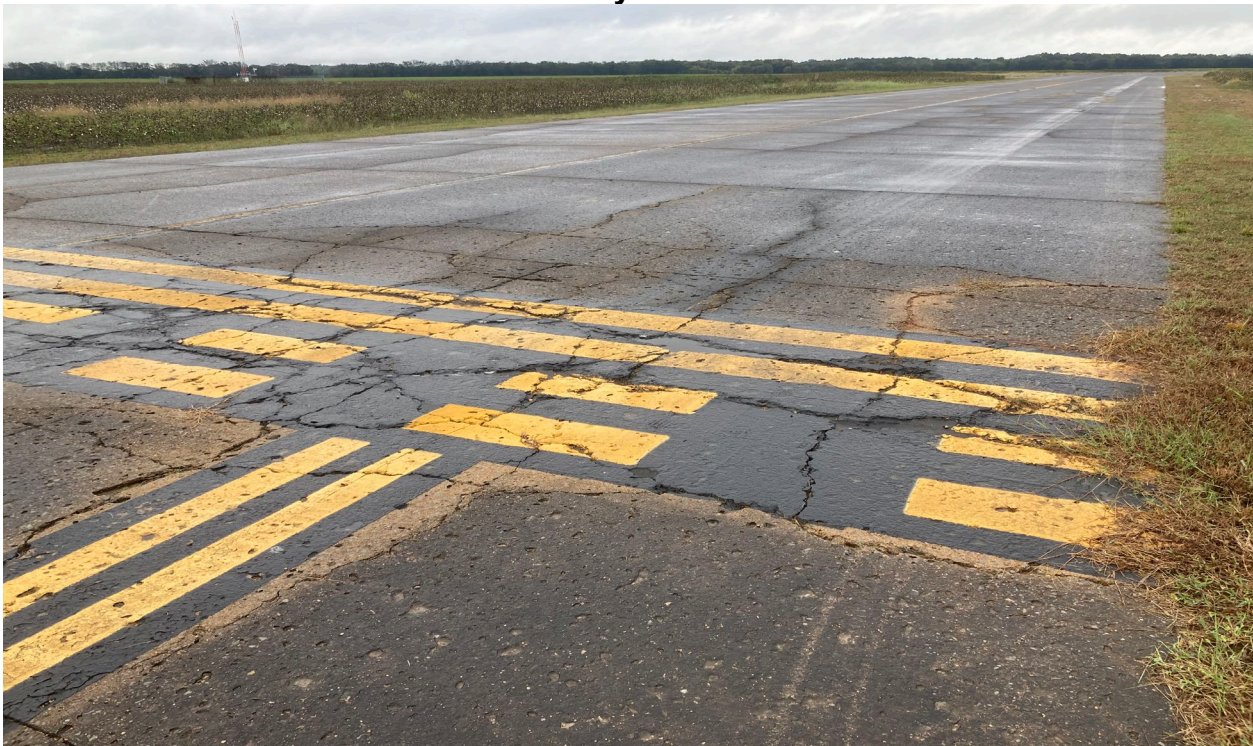
- Taxiway C at the Runway 13/31 hold short line is experiencing extensive cracking and scaling, causing a FOD hazard (See Photo #21 and #22).
 - Taxiway southeast of the midfield taxiway to Runway 13/31 is experiencing pavement FAILURE on one section and a faded yellow X is present from a past closure (See Photo #23).

Photo #21 – Taxiway C Pavement Failure

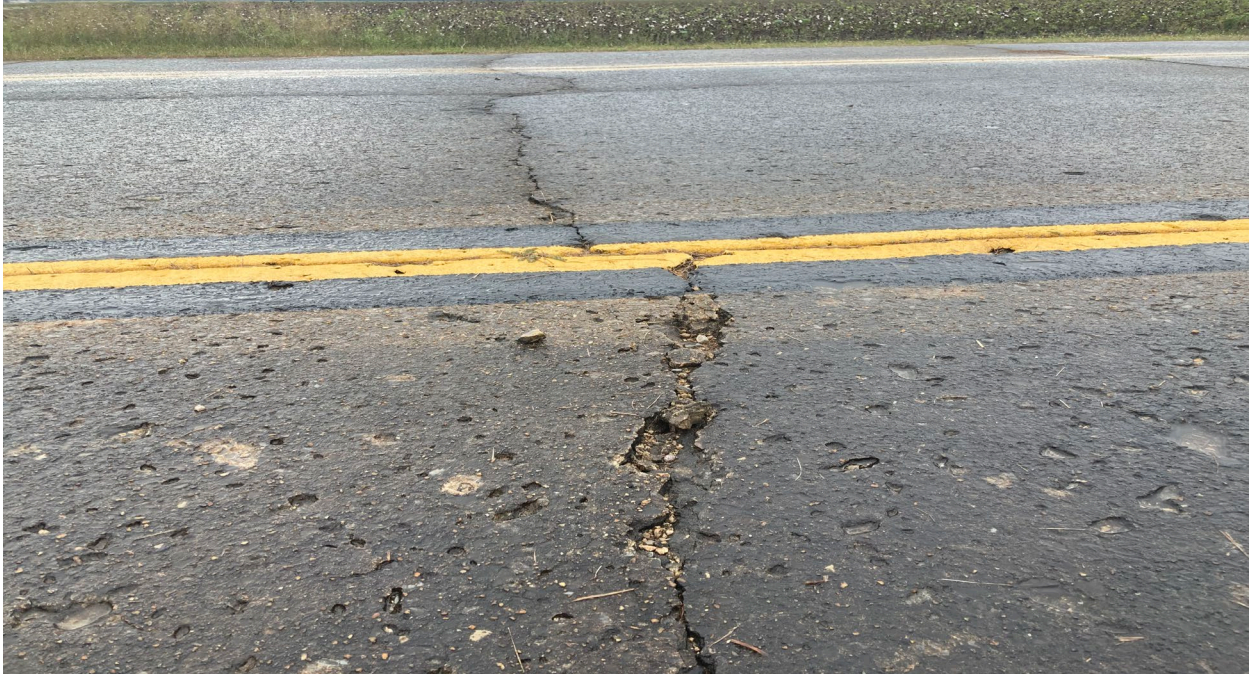
Photo #22 – Spalling on Taxiway C

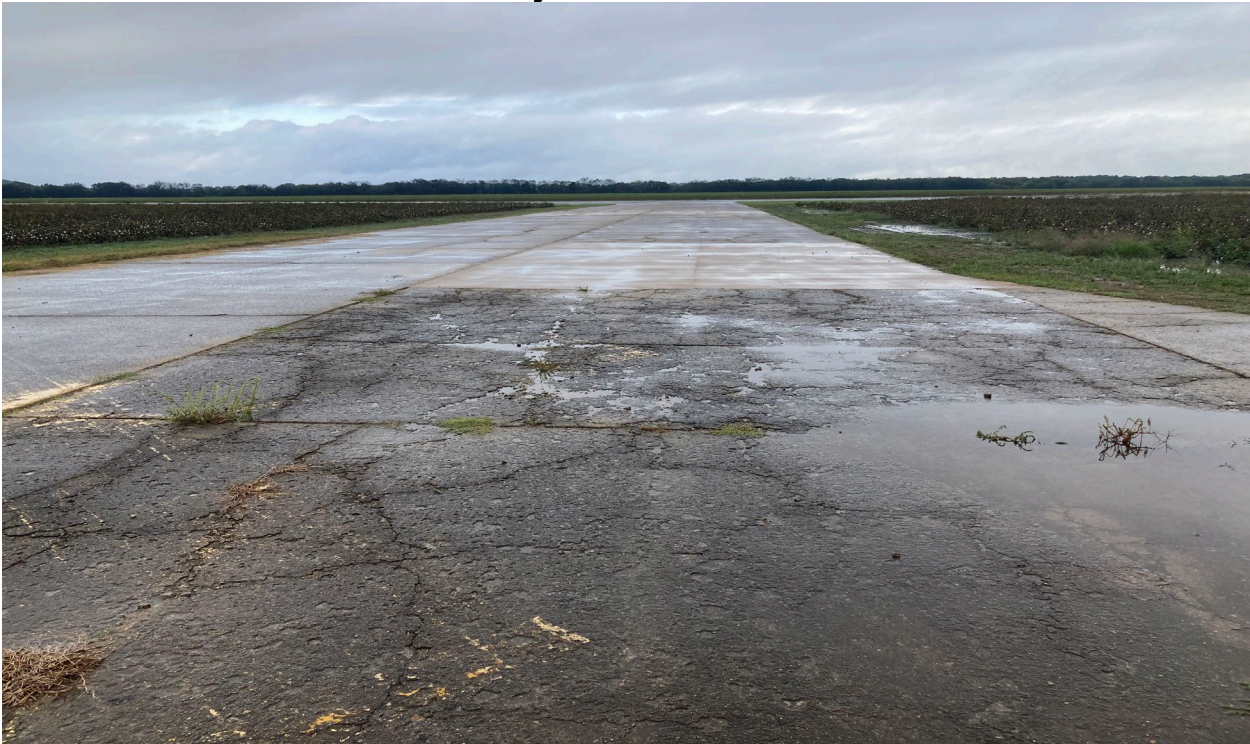
Photo # 23 – Taxiway Pavement Failure and Faded X

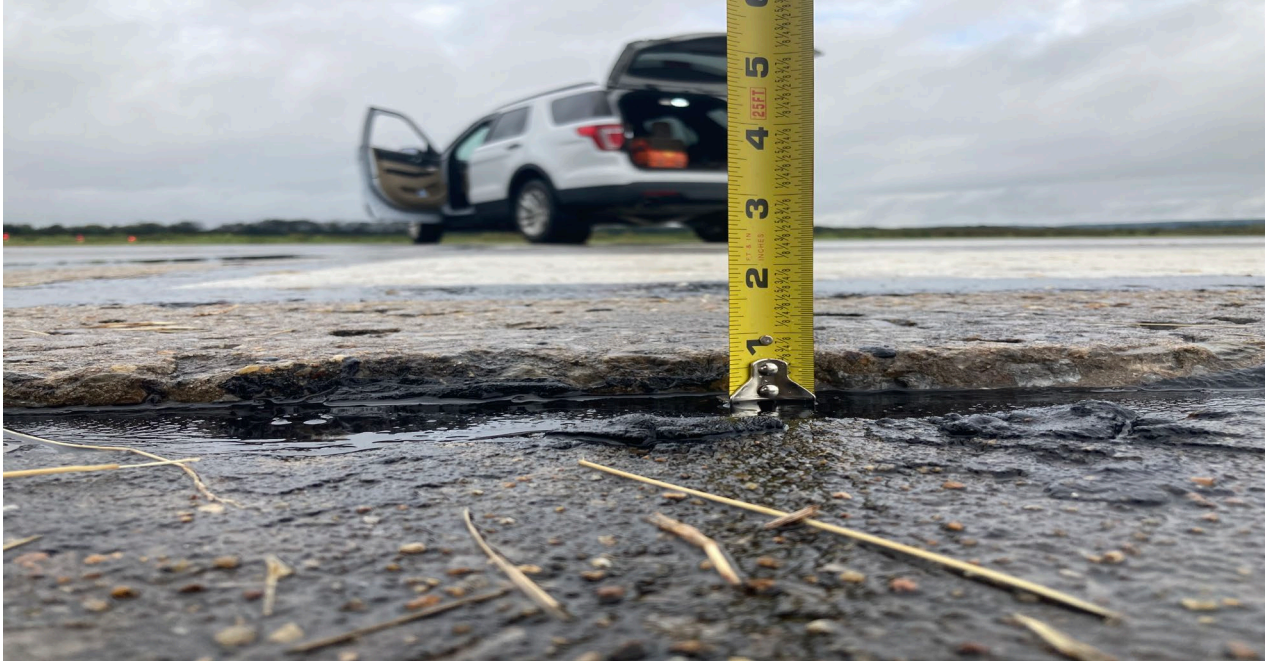
- Runway 13/31 is in **POOR** condition due to polishing, scaling, cracking, and vegetation growth. Concrete slabs are shifting near the approach end of Runway 31 causing a ¾" height difference (See Photo #24).

Photo #24 – Slab Shifting on Runway 13

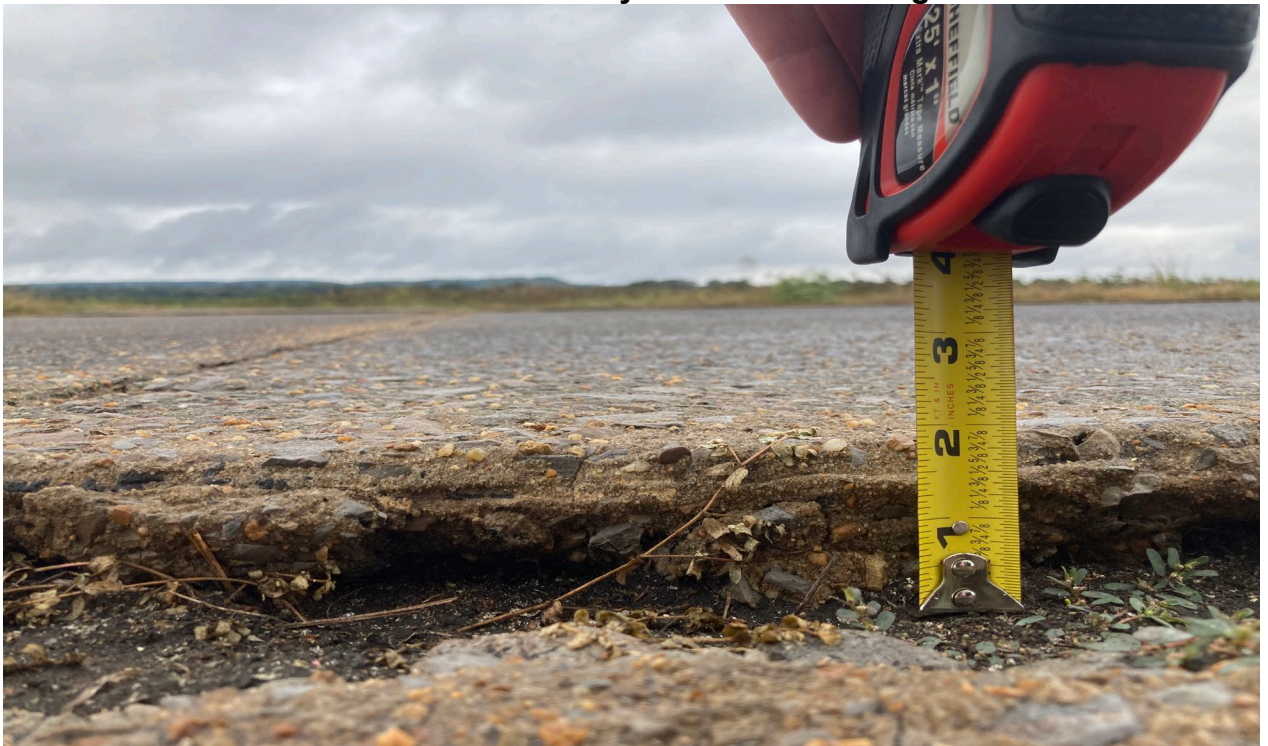
- Runway 18/36:
 - Concrete slabs are shifting near the RWY 36 identifiers and are approaching a two (2) inch height difference (See Photo #25). This extends on each longitudinal joint for approximately 200 feet. Slabs are also separating as much as 3 inches. This condition could quickly become a safety issue as directional control of an aircraft could be affected.

Photo #25 – Runway 18/36 Slab Shifting

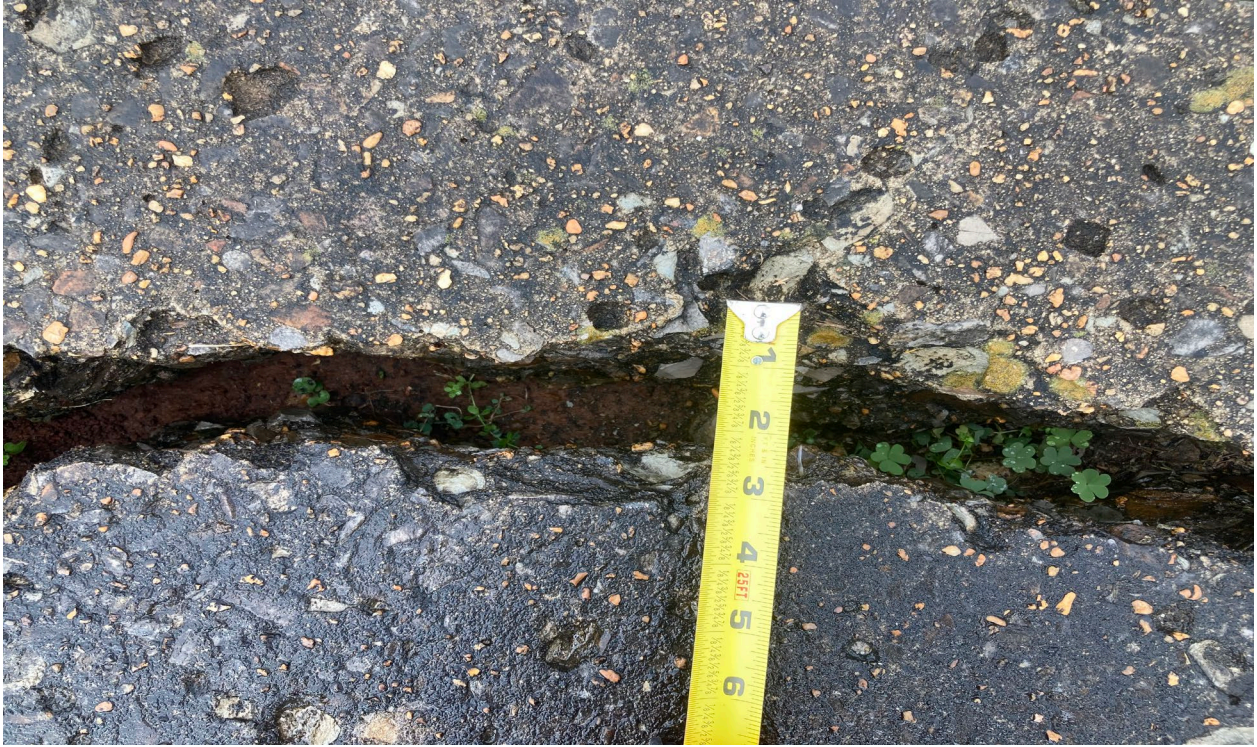
- RWY 18/36 surfaces are experiencing severe scaling and spalling, along with excessive pop-outs and a large crack nearly 2 ½ inches wide and 6 inches deep, exposing the runway subgrade (See Photos #26 and #27). These conditions are resulting in large chunks of concrete becoming FOD and posing an extreme risk to aircraft (See Photo #28). Additionally, the surface variations caused by these conditions could cause an aircraft to lose directional control or damage landing gear components.

Photo #26 – Runway 18/36 Cracking

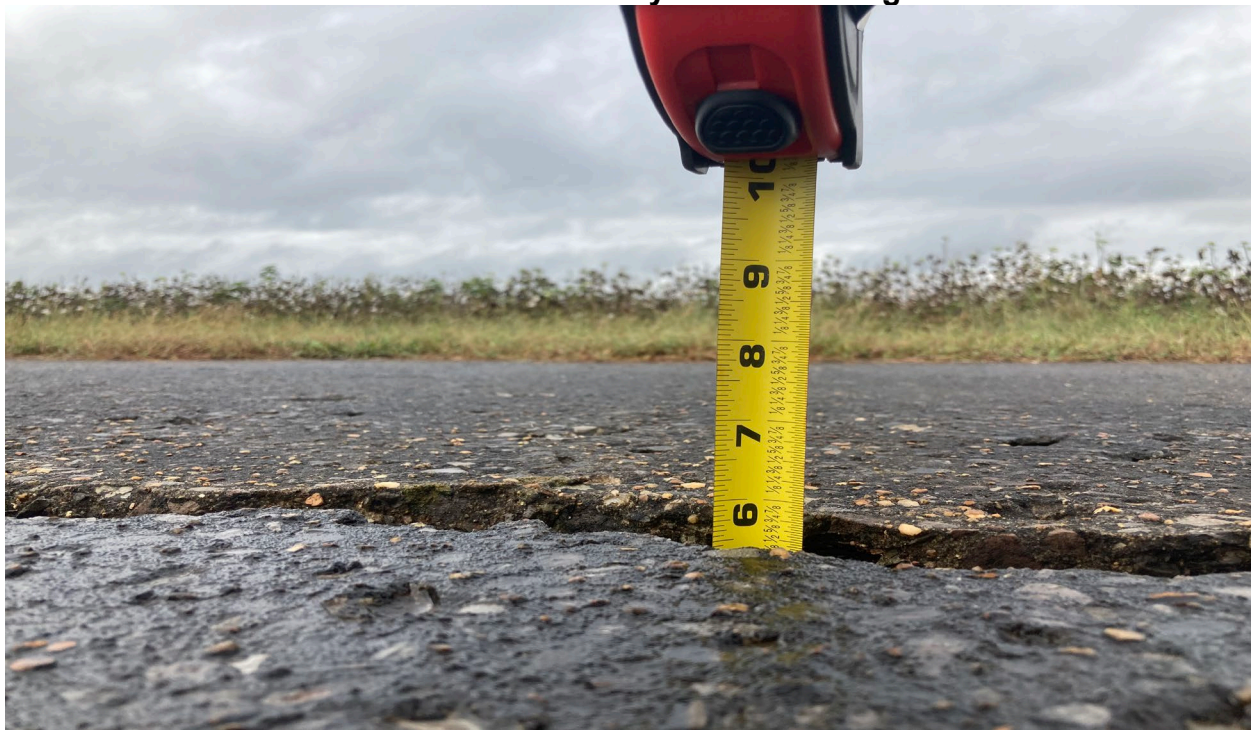
Photo #27 – Runway 18/36 Cracking

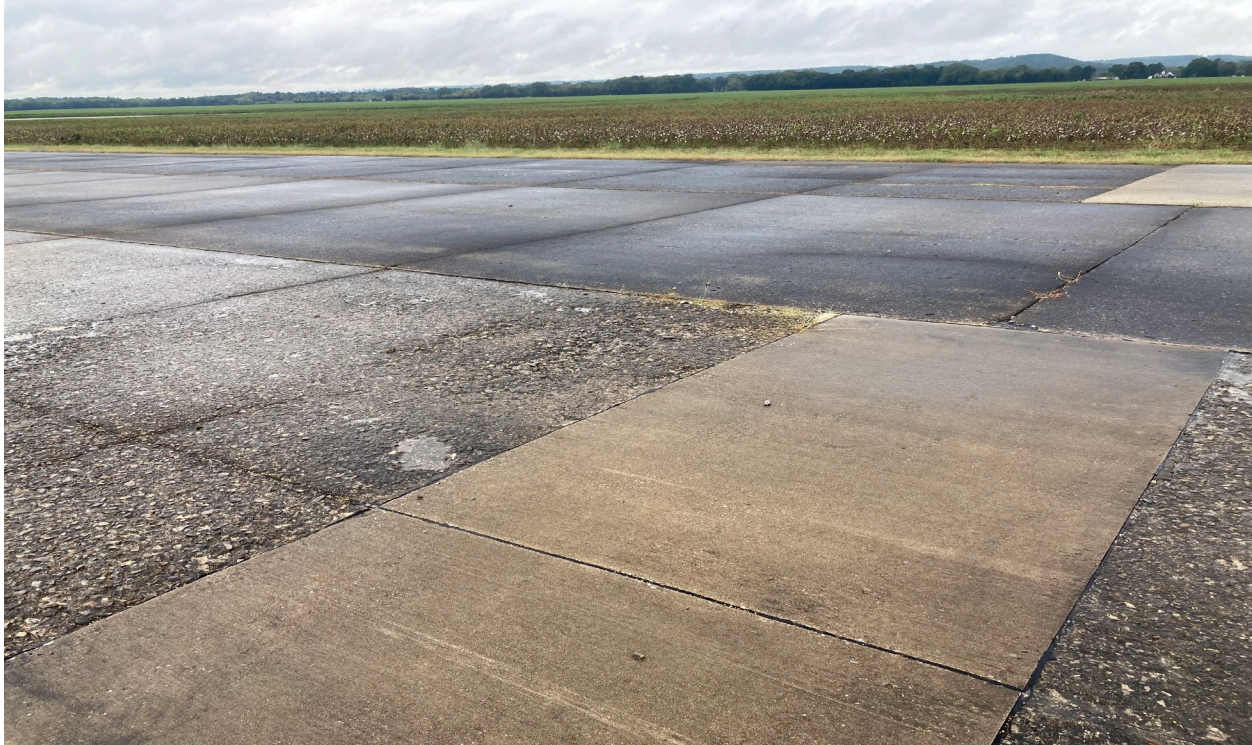
Photo #28 – Runway 18/36 Scaling and FOD

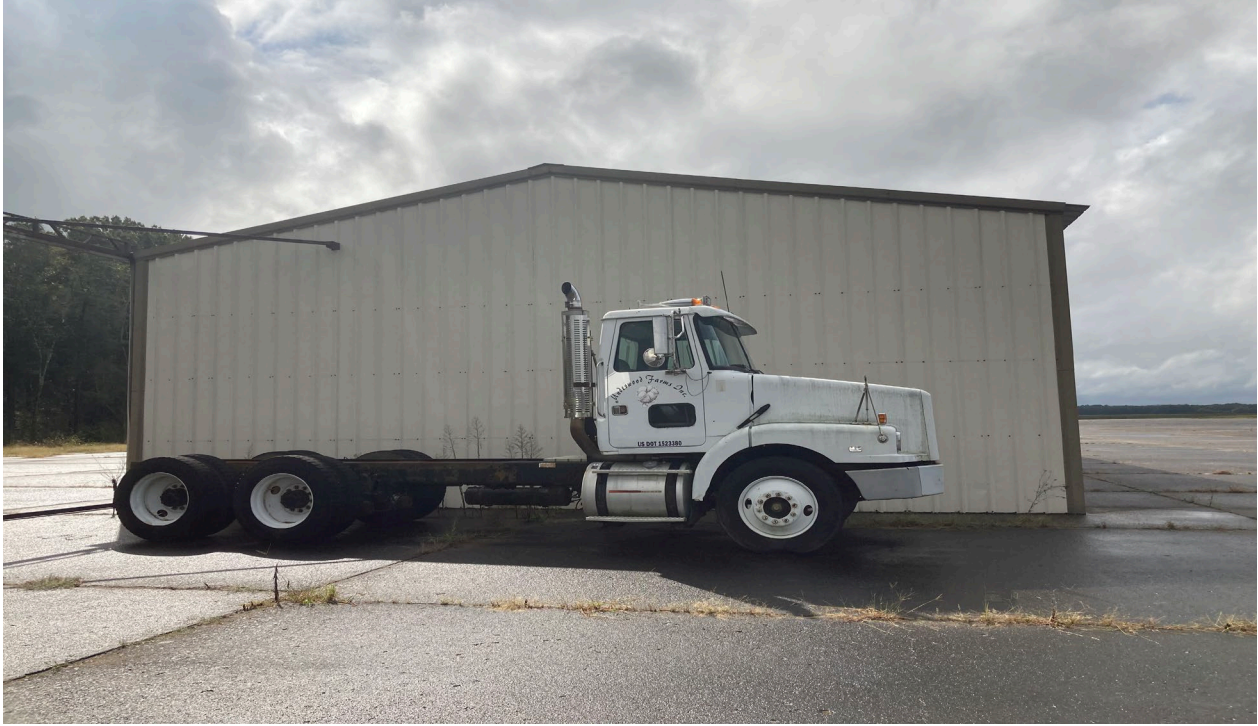
Photo #29 – Farming Equipment Stored on Airport Property
