**Subject: Annual Inspection Report
Courtland Airport (9A4)**

**Annual Inspection Report
Courtland Airport (9A4)
Courtland, Alabama**

October 5, 2021

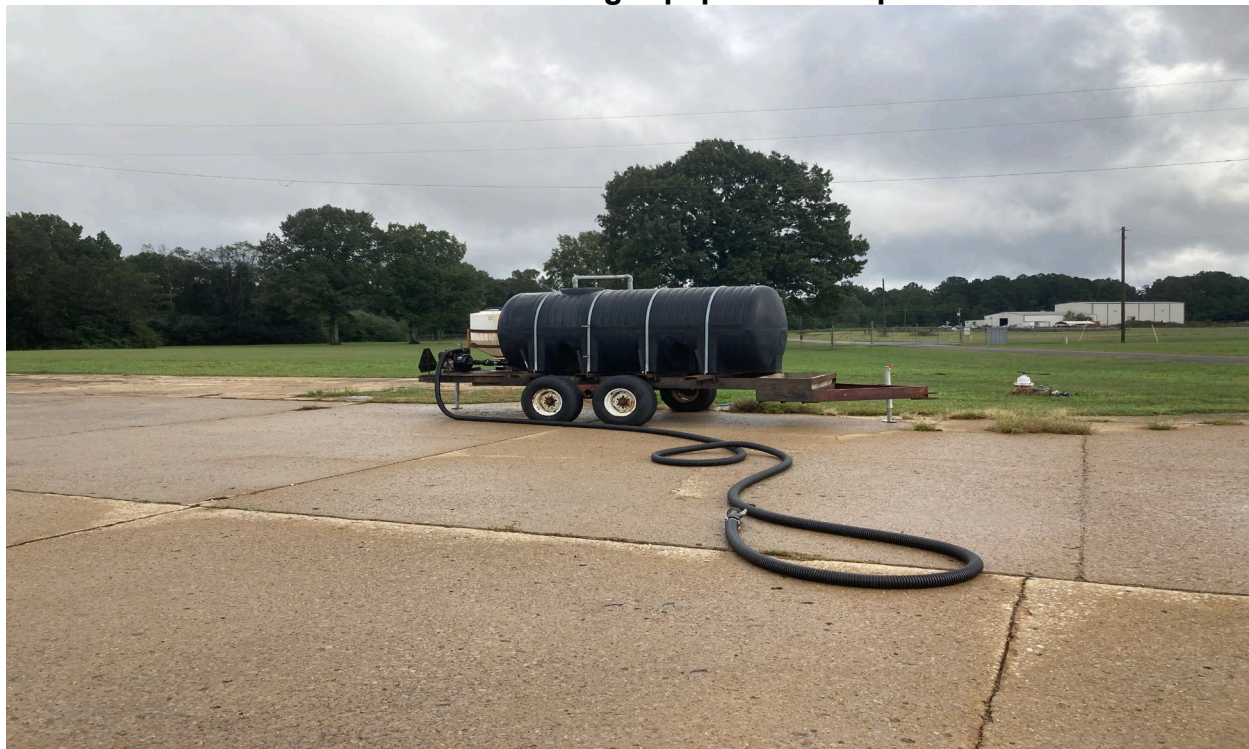
- Farming is taking place within the Primary Surface (See Photo #5). To plant and harvest these crops, non-airport vehicles must move through these areas, which is prohibited.
- Farming equipment is being stored on the airport apron near the northern T hangars (See Photo #29 and #30).
- A truck and trailer are parked unattended on a taxiway near the approach end of Runway 18 (See Photo #31).
- An airport gate was left open by a vehicle leaving airport property.

Photo #30 – Farming Equipment on Apron

- Prohibit non aeronautical activity on the *ALL* airport surfaces.
- Ensure airport tenants and contractors are following proper airport security protocols.

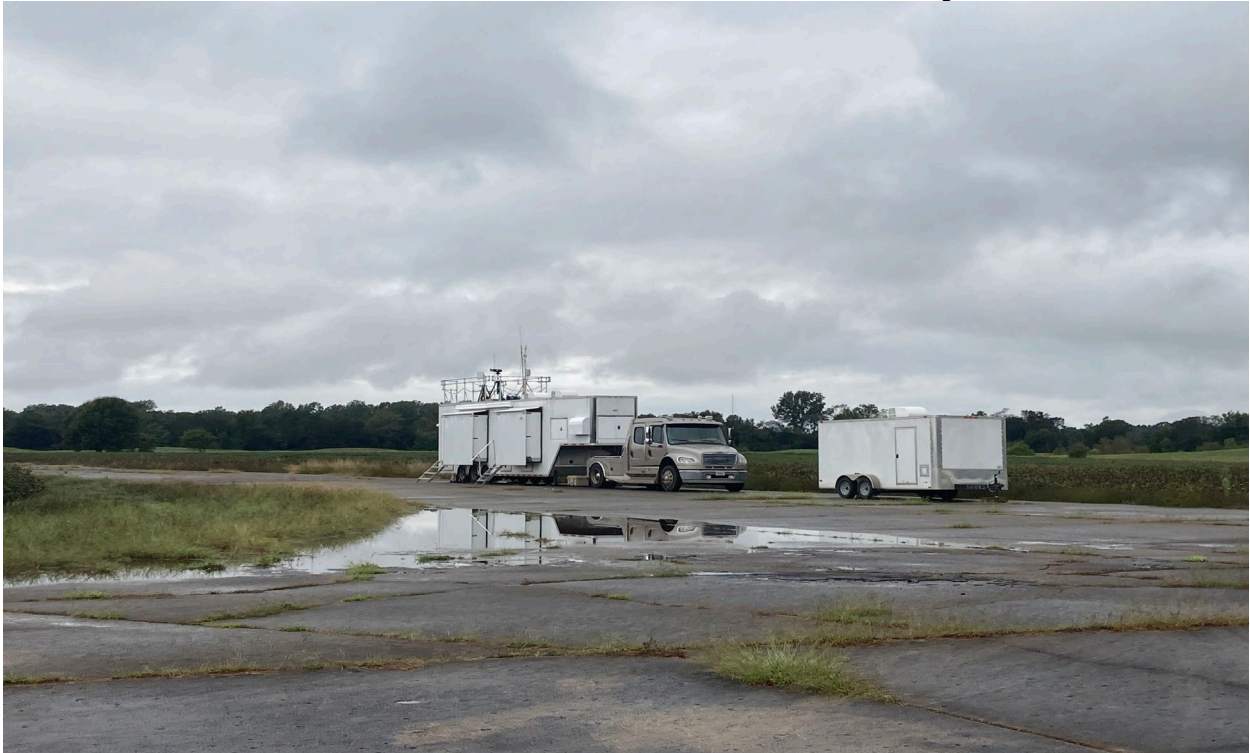
Photo #31 – Unattended Vehicle on Taxiway
