Subject: Annual Inspection Report Jeremiah Denton Airport

November 2, 2022

ANNUAL INSPECTION REPORT

JEREMIAH DENTON AIRPORT DAUPHIN ISLAND, ALABAMA

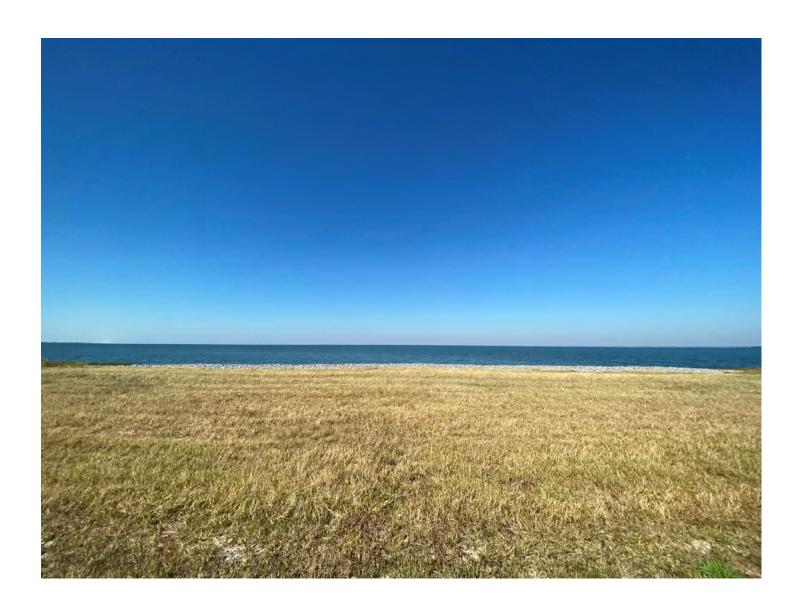
Approach and Departure Paths—RUNWAY 12

No ALDOT obstructions located in the Approach/Departure Path of Runway 12.

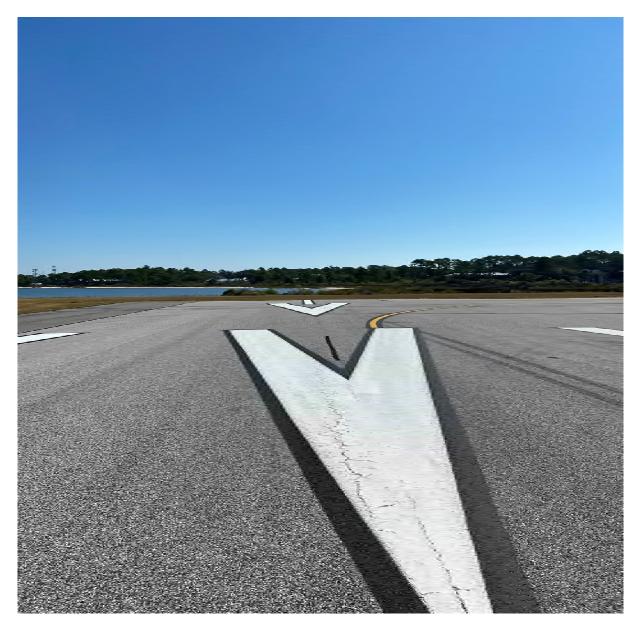
Approach and Departure Paths—RUNWAY 30

No ALDOT obstructions located in the Approach/Departure Path of Runway 30.

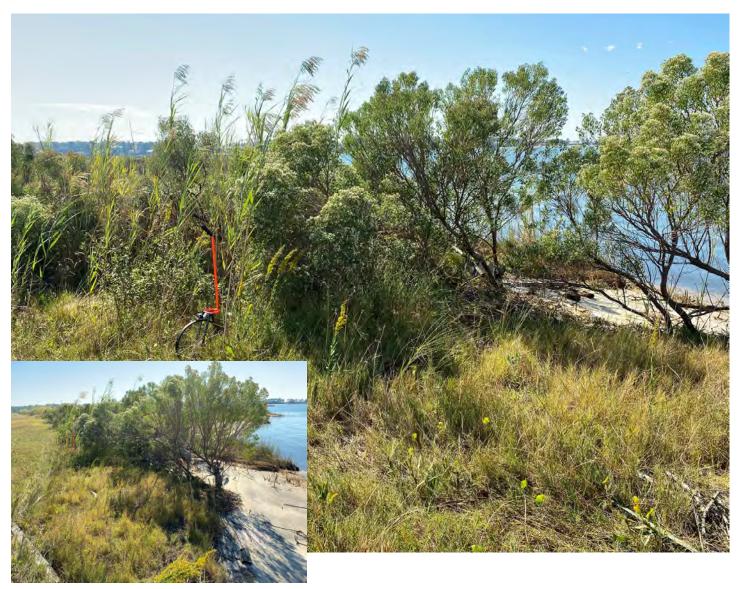
Primary Surface

Maintenance Required: There is a small portion of the airfield that can only provide 119 feet of clear primary surface instead of the required 125 feet. Tall grass and brush are growing in this area near a bluff that slopes down to a beach. This area should be cleared if possible and monitored closely to ensure that the tall grass and brush do not encroach further.

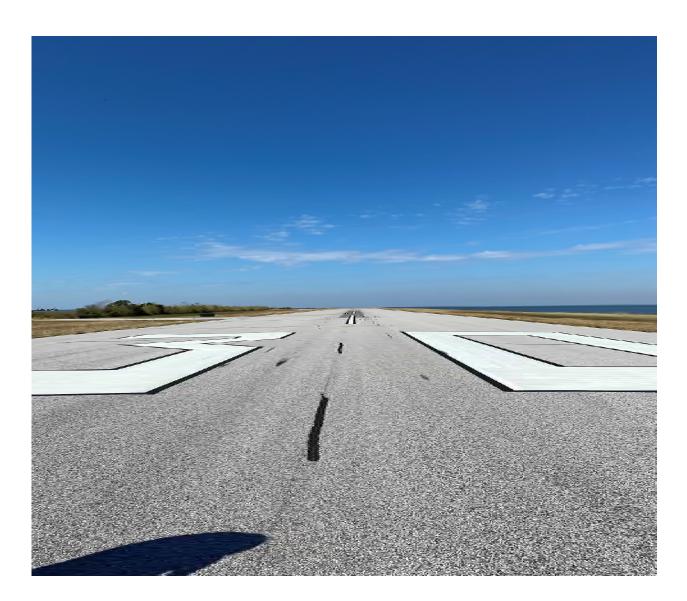
Airport Markings

Runway markings are in **GOOD** condition.

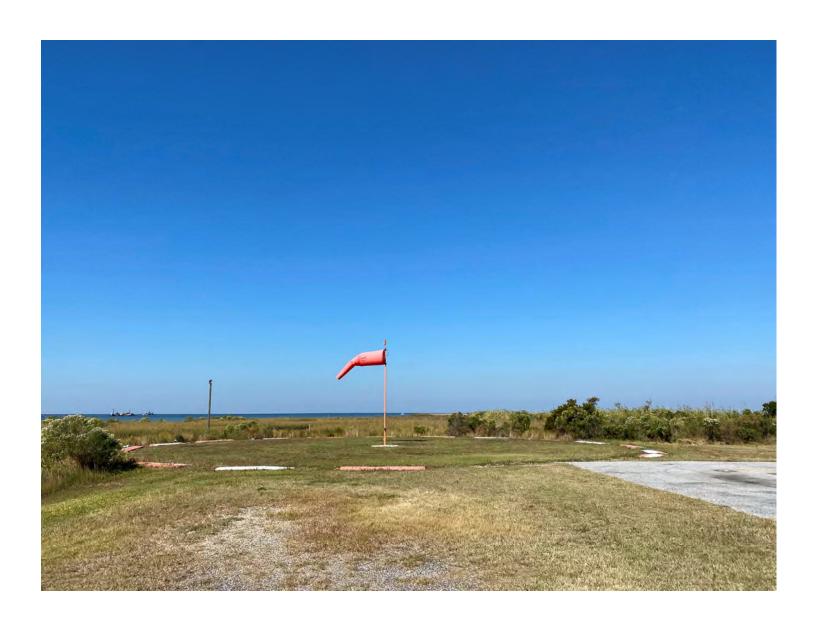
Wind Direction Indicator

Wind direction indicator is in **GOOD** condition.

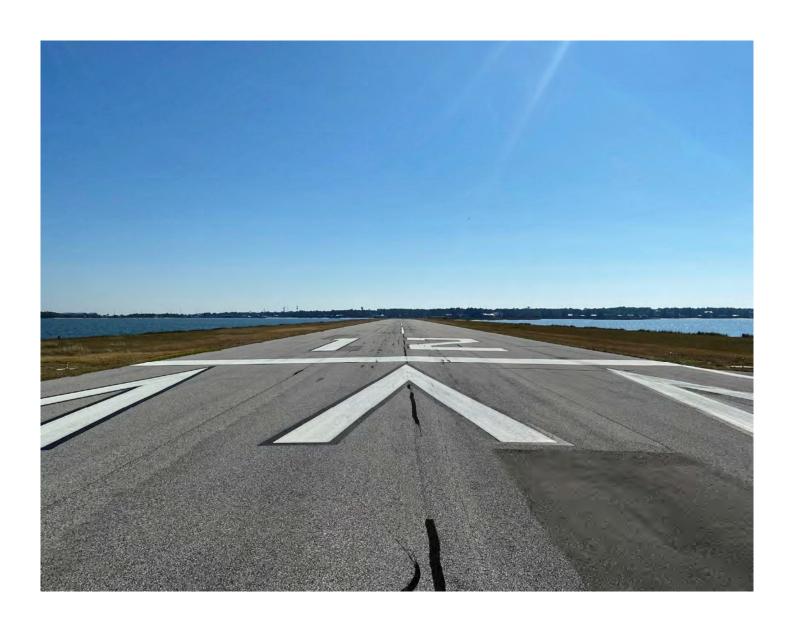
Runway, Taxiway and Apron Conditions—RUNWAY Administrative Code 450-9-1-.12(7)

Runway surface is in **GOOD** condition.

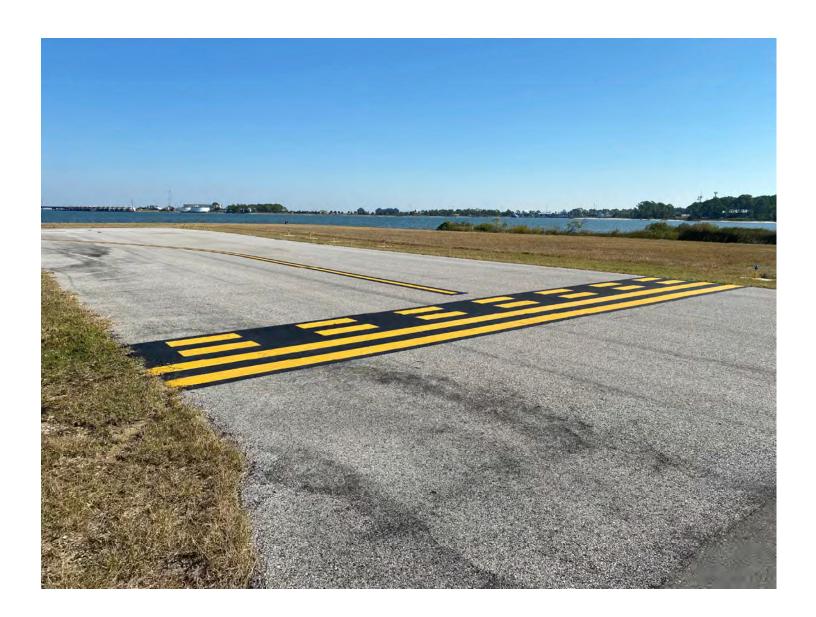
Runway, Taxiway and Apron Conditions—TAXIWAY Administrative Code 450-9-1-.12(7)

Taxiway surface is in **GOOD** condition.

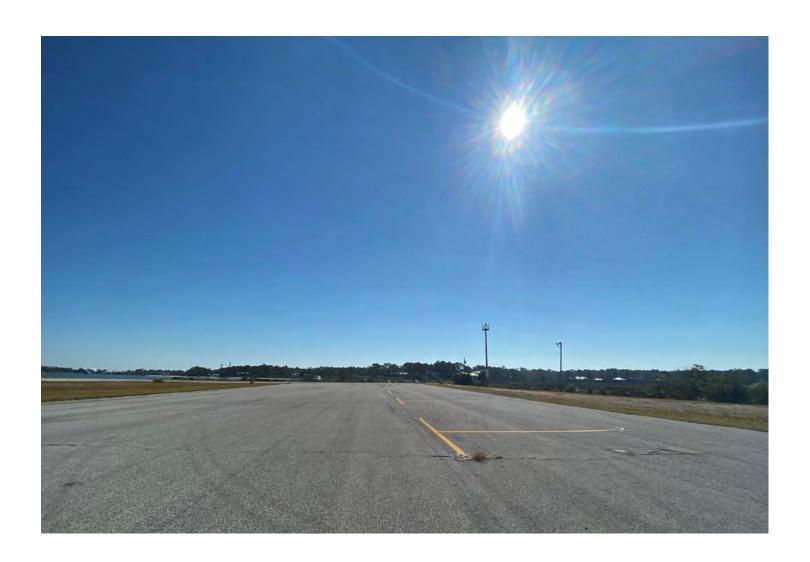
Runway, Taxiway and Apron Conditions—APRON Administrative Code 450-9-1-.12(7)

Apron surface is in **GOOD** condition.

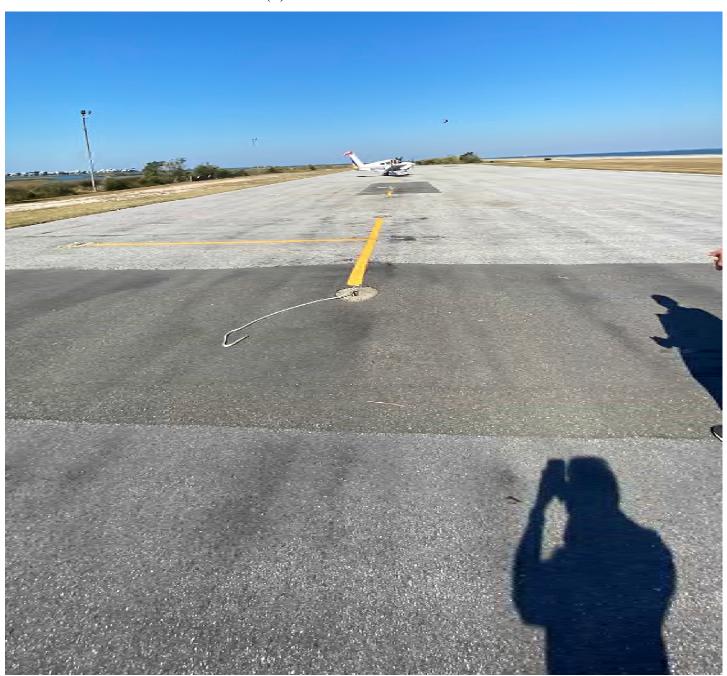
Fueling Area Requirements

N/A: There is no fuel service at this airport

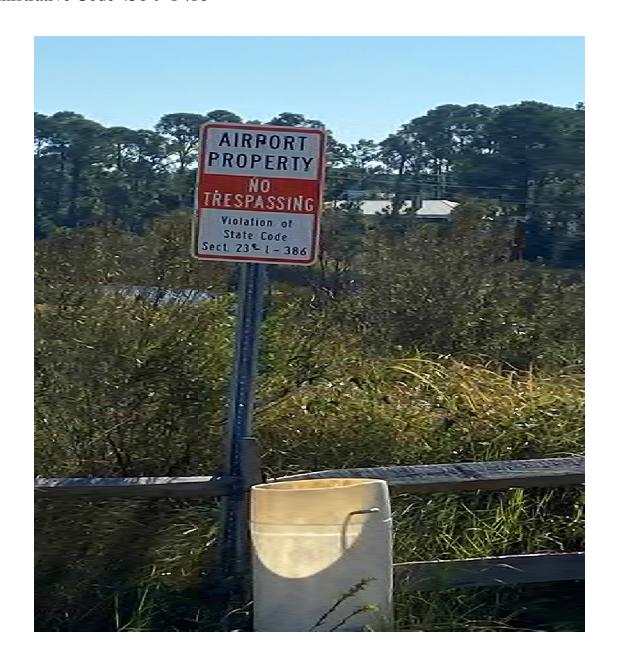
Prohibited Activities

No prohibited activities were observed during this inspection.

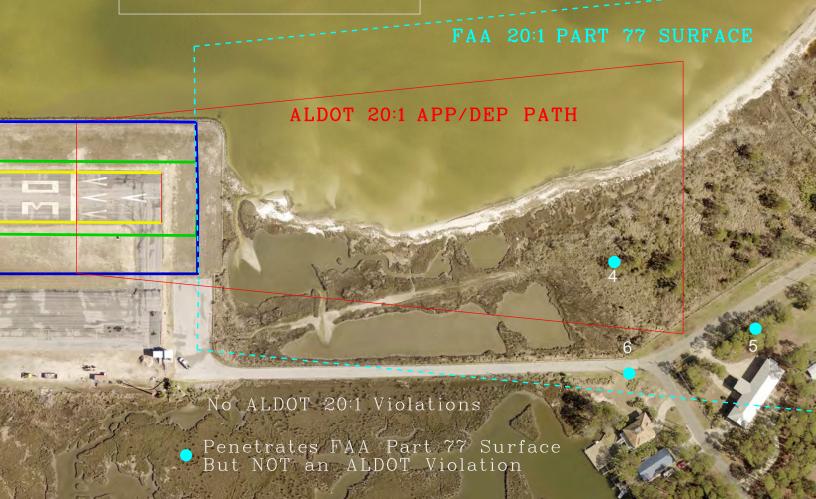
JEREMIAH DENTON AIRPORT Dauphin Island, AL November 2, 2022 RWY 30 Obstruction Evaluation

- 4. Tree 34' Abv. RWY
 747' From Rwy End
 106' Left of CL
 20:1 Obst. Clnc. (FAA)
- 5. Tree 61' Abv. RWY End 979' From RWY End 216' Left of CL 15:1 Obst. Clnc. (FAA)
- 6. Pole 37' Abv. RWY End 771' From RWY End 290' Left of CL 19:1 Obst. Clnc. (FAA)
