**Subject: Annual Inspection Report**  
**Marion County – Rankin Fite Airport (HAB)**

# Annual Inspection Report

October 22, 2020

***Marion County – Rankin Fite Airport  
(HAB)  
Hamilton, Alabama***

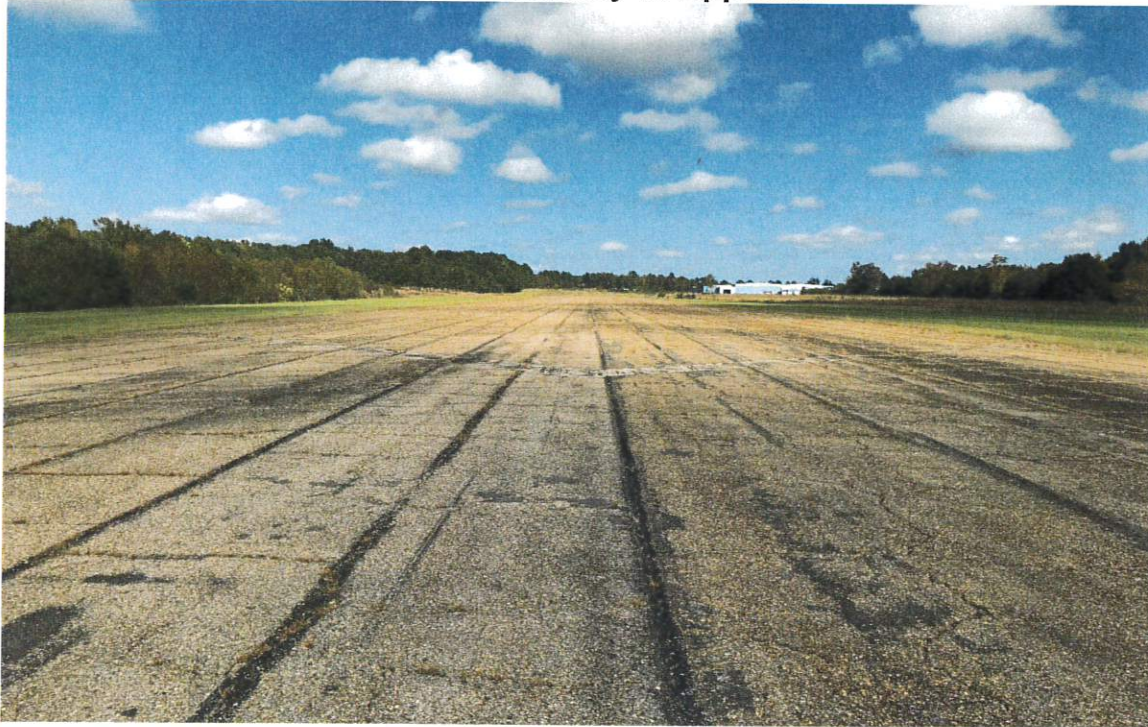
Photo #1 – Runway 18 Approach

- Runway 18– No obstructions (See Photo #1).
- Runway 36 – Tree labeled #6 violates the Required 20:1 Approach and Departure Path. Tree labeled #1 is not an ALDOT obstruction violation, however, it will be very soon if not removed. Trees and shrubs in yellow dashed box are recommended for removal to prevent future obstructions (See Photo #2 and Appendix 2).

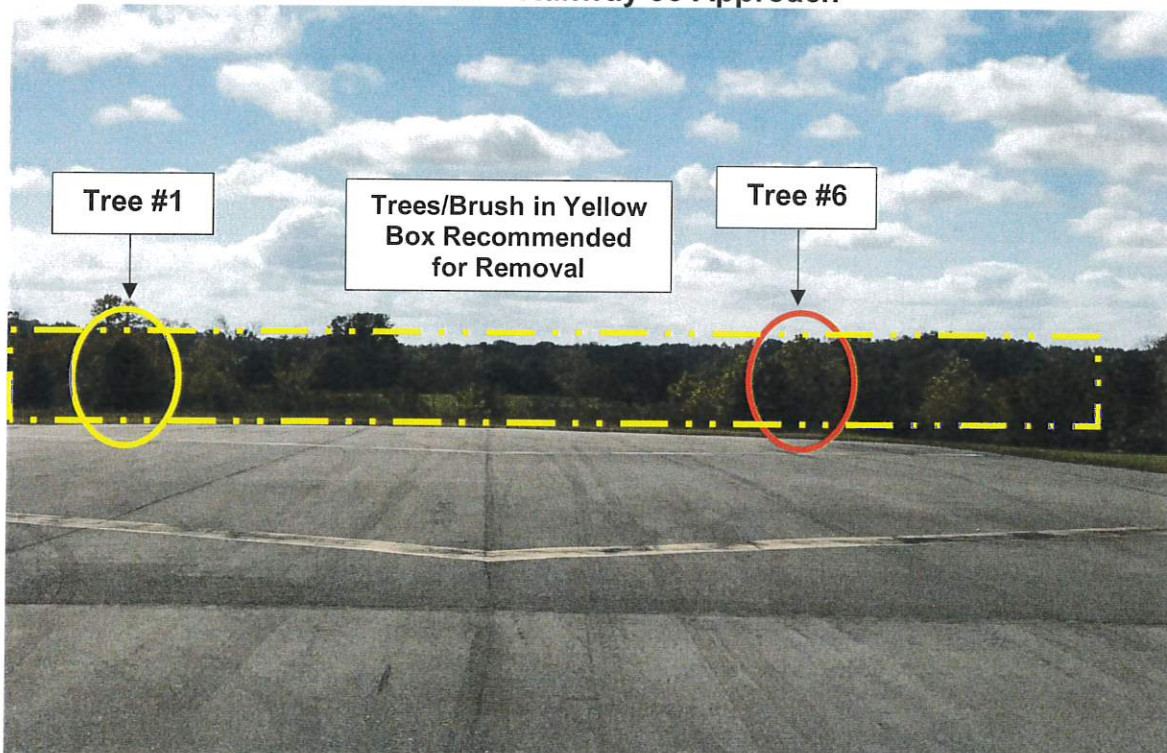
Photo #2 – Runway 36 Approach

Attached you will find a copy of the Annual Inspection Report. As noted in the report, the airport **does not meet** the requirements for the issuance of an operating license. There are trees obstructing the Required 20:1 Approach Departure Path to Runway 36. Therefore, the Airport Operating License is being **withheld** until the obstruction identified in the report is removed. There are several maintenance items detailed in the report that should be addressed as soon as possible.

A review of photos provided by the airport sponsor has concluded that the noted obstructions to the Required 20:1 Approach/Departure Path on Runway 36 have been removed. As a result, the airport now **meets** the requirements for an operating license. The operating license for the airport is **re-issued** and is in full effect. A signed license certificate will be mailed separately within a few weeks.

- Remove all obstructions to the Required 20:1 Approach and Departure Path.
- *Note: The obstructions detailed in this report are representative and may not include all obstructions in the Approach and Departure Path.*

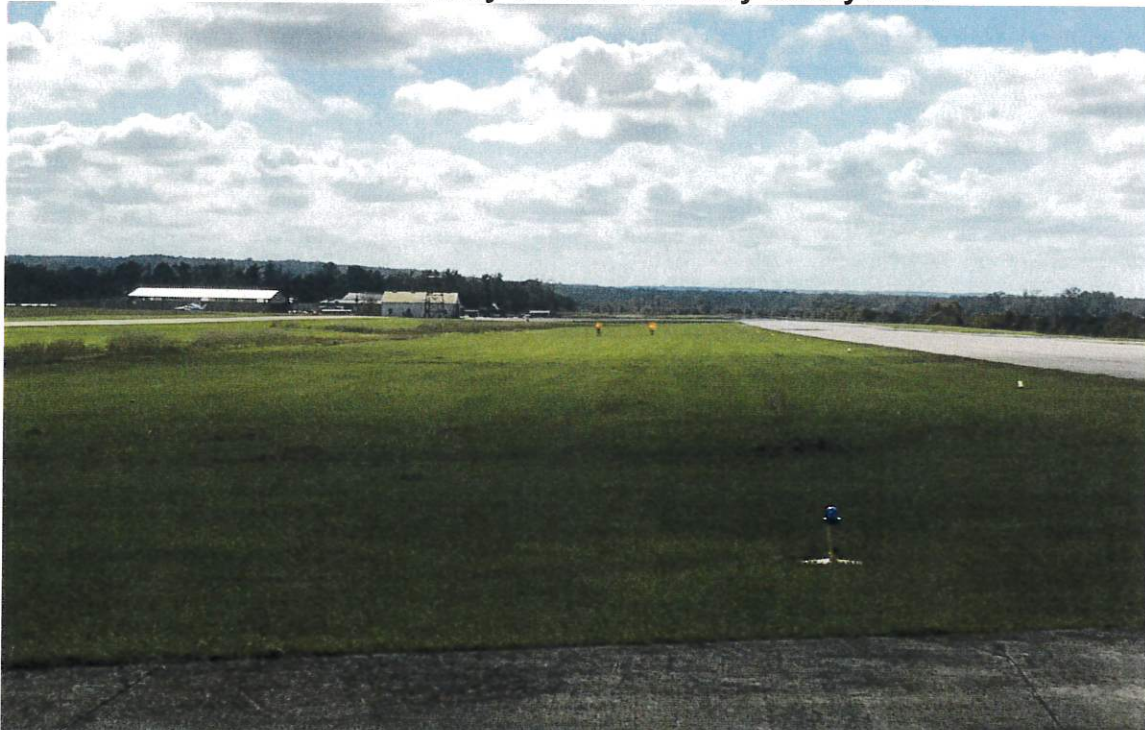
**Photo #3—Primary Surface/Runway Safety Area**

- The primary surface **meets** state licensing requirements (See Photo #3).

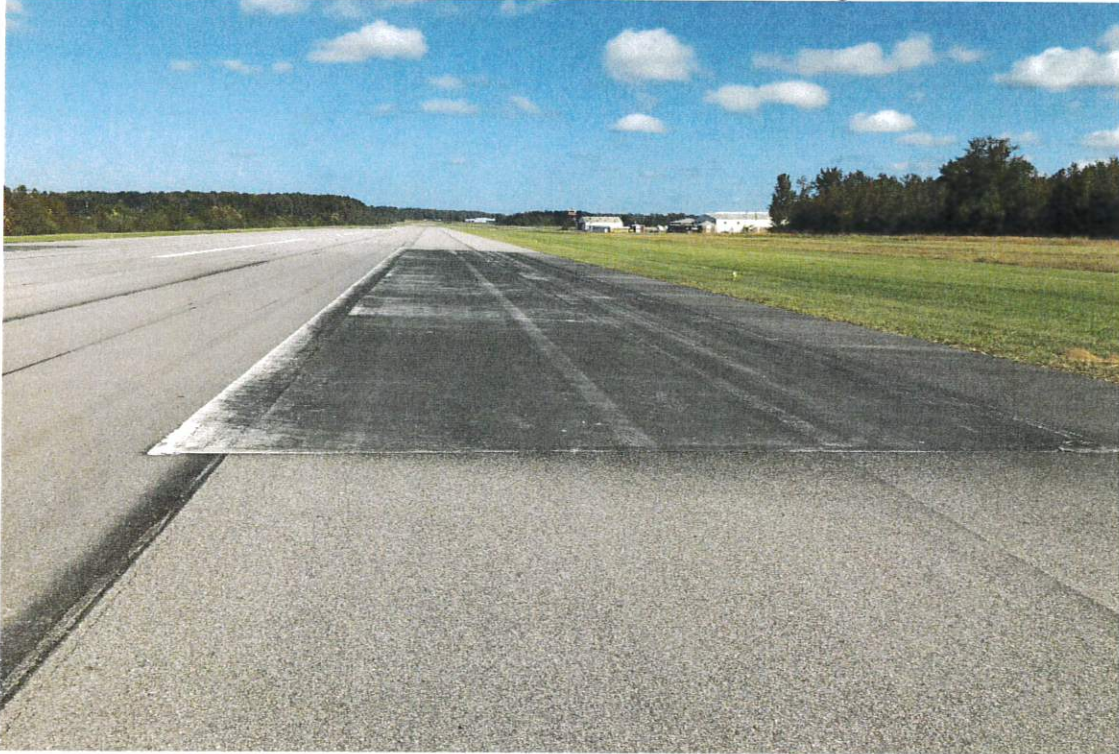
**Photo #4 – 1000 Ft. Aim Point Marking**

- The runway markings are in **FAIR** condition; however, they are approaching **POOR** condition. The runway markings are becoming obscured due to rubber, soot, and algae deposits (See Photos #4 and #5).
- Taxiway markings and apron markings are in **FAIR/POOR** condition (See Photos #6 and #7).

- Clean taxiway and apron markings. If unable to clean, replace in accordance with FAA AC 150/5340-1M.

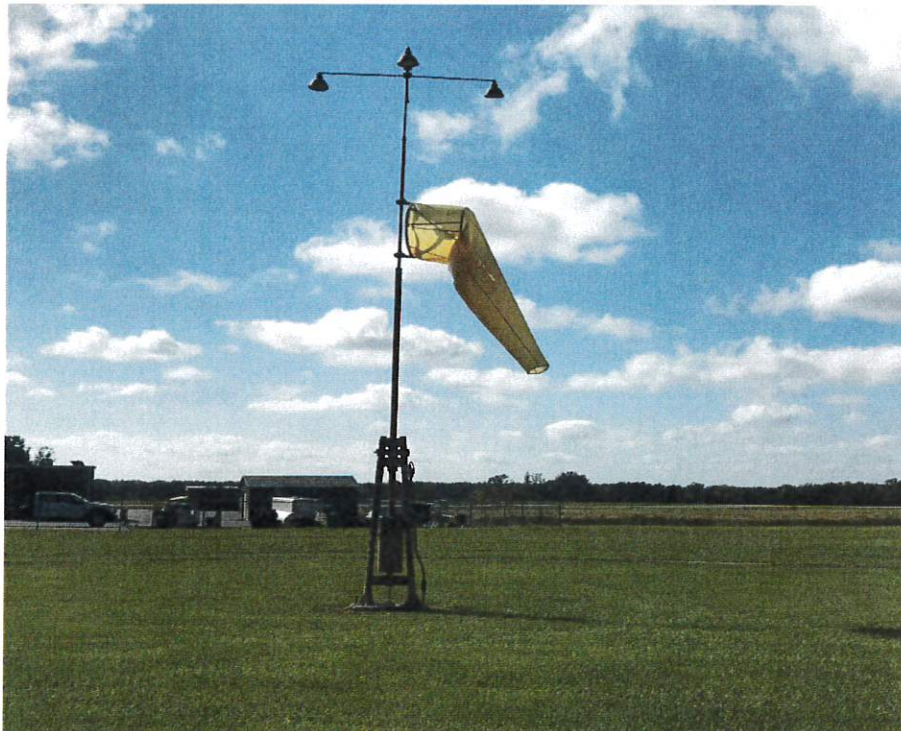
Photo #8 – Wind Direction Indicator

- The wind direction indicator is in **POOR** condition due to fading (See Photo #8).
- One light from the fixture is missing, but a repair was already scheduled.
- Segmented circle is faded.

- Replace windsock.
- Repair light- was underway.
- Repaint segmented circle white.

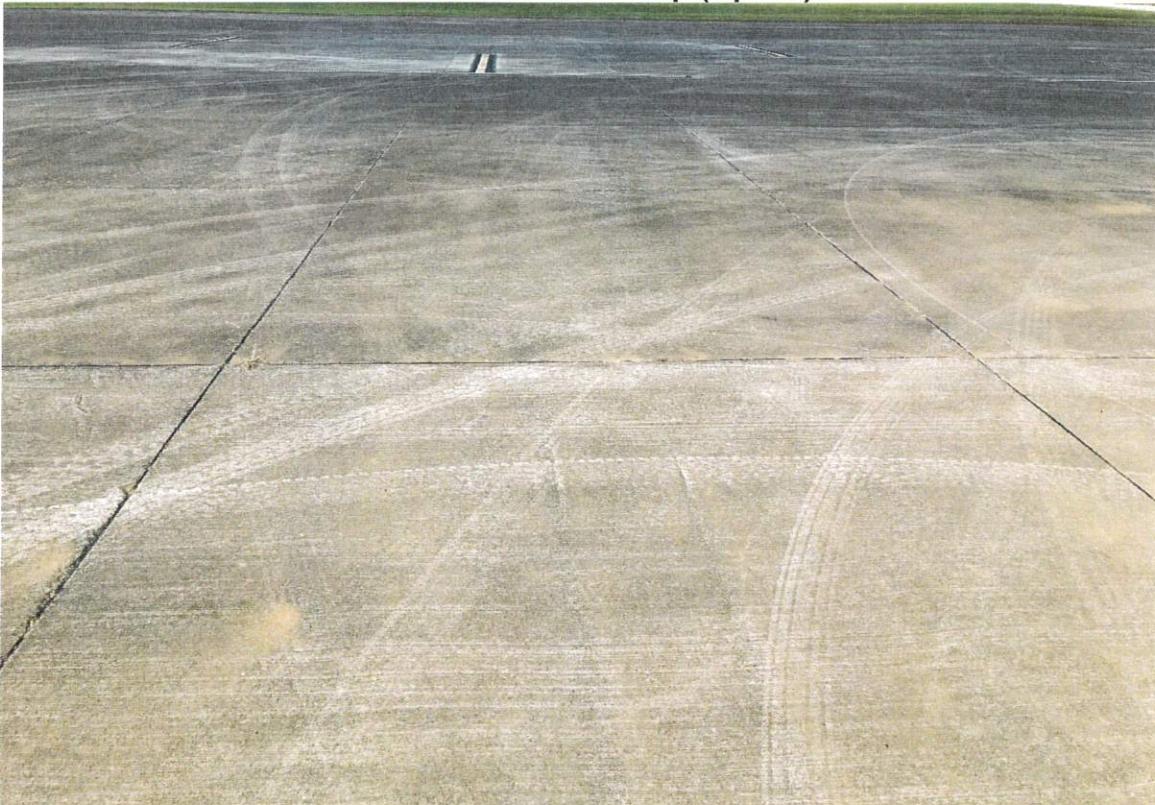
**Photo #9 – Main Ramp (Apron)**

<b>Ramp</b>	The main ramp is in <b>GOOD</b> condition, with some slight surface wear (See Photo #9). The secondary (old) ramp is in mostly <b>FAIR</b> condition with some areas in <b>POOR</b> condition (See Photos #10 and #11). The secondary ramp is exhibiting cracking of medium severity and areas of excessive raveling, along with vegetation growth.
<b>Taxiways</b>	<b>GOOD</b> with some slight surface wear and weathering (See Photo #12).
<b>Runway</b>	<b>GOOD.</b>

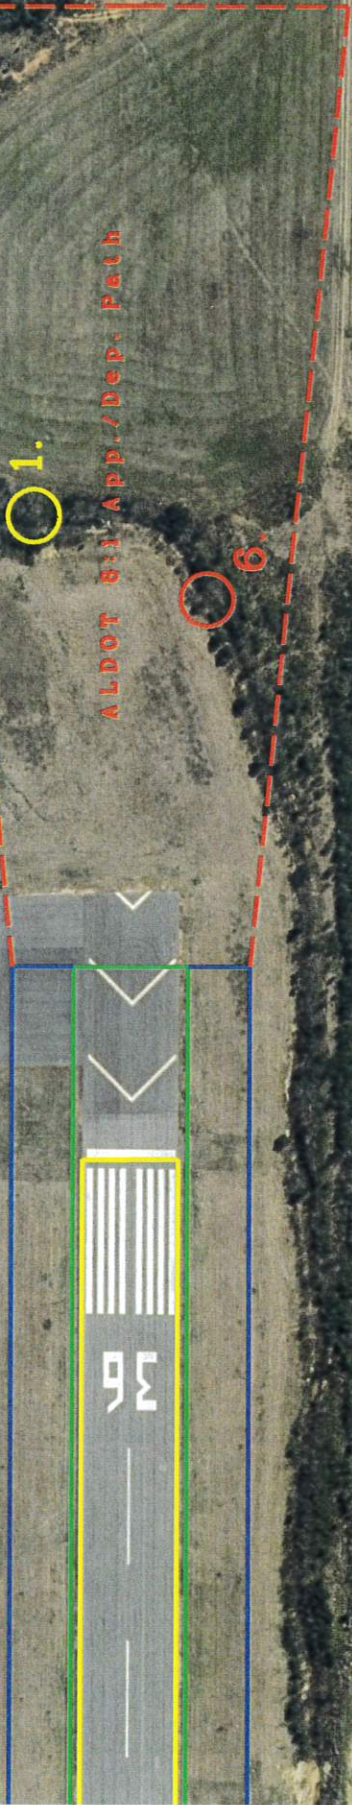
**HAMILTON-RANKIN FITE AIRPORT  
HAMILTON, AL  
OCTOBER 22, 2020  
RWY 36 OBSTRUCTION EVALUATION**

1. Tree 23' Abv. RWY End  
678' From RWY End  
106' Right of Cntln.  
20:1 Obst. Clnc.  
• Not an ALDOT Violation
6. Tree 21' Abv. RWY End  
588' From RWY End  
79' Left of Cntln.  
18:1 Obst. Clnc.
