Subject: Annual Inspection Report

Hartselle-Morgan County Regional Airport (3M0)

ANNUAL INSPECTION REPORT

December 8, 2021

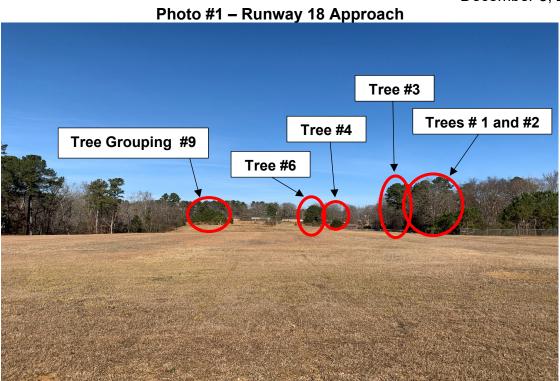
Inspection Results: VIOLATION

- Runway 18 Trees identified as #1, #2, #3, #4, #6, and #9 violate the Required ALDOT 20:1 Approach/Departure Path (See Photo #1 and Appendix 2).
- ➤ Runway 36 Trees identified as #5, #7, and #8 violate the Required ALDOT 20:1 Approach/Departure Path (See Photo #2 and Appendix 3).

- Remove all obstructions within the Required ALDOT 20:1 Approach/Departure Path.
- Note: the obstructions detailed in this report are representative and may not include all obstructions in the Approach/Departure Path.

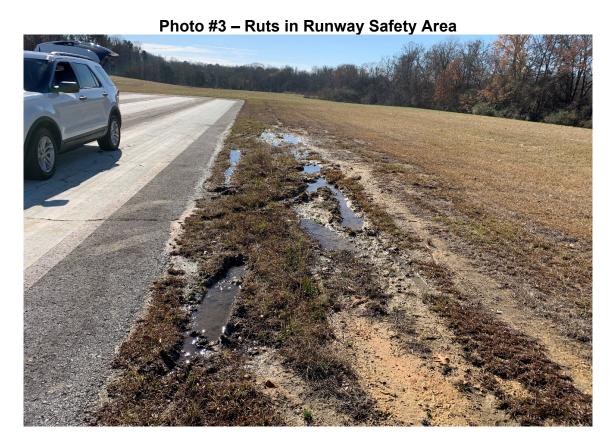
➤ There were large ruts discovered near the approach end of Runway 36, causing hazardous surface variations, measured between 38 feet and 45 feet left of the runway centerline (See Photo #3).

Fill in ruts and compact area smooth so that no hazardous surface variations exist.

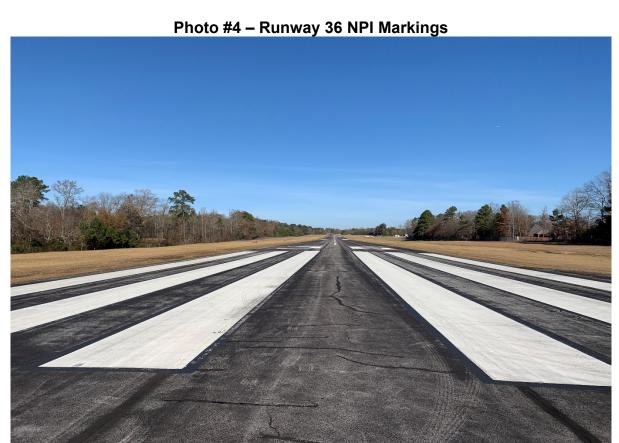
➤ The airport markings are in **GOOD** condition (See Photo #4).

Apron	FAIR. The apron is experiencing moderate weathering; however, the crack seals are holding up well. The apron near the hangars is experiencing extensive cracking and raveling (See Photo #6).	
Taxiways	N/A	
Runway	GOOD. The runway surface appears weathered; however, this is a visual effect of the previous surface treatment. The actual pavement is in good condition (See Photo #4).

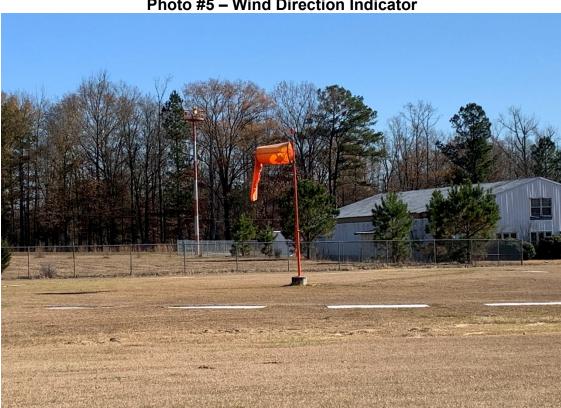
Photo #5 - Wind Direction Indicator

➤ The wind direction indicator (wind sock) is operational and in **FAIR** condition (See Photo #5).

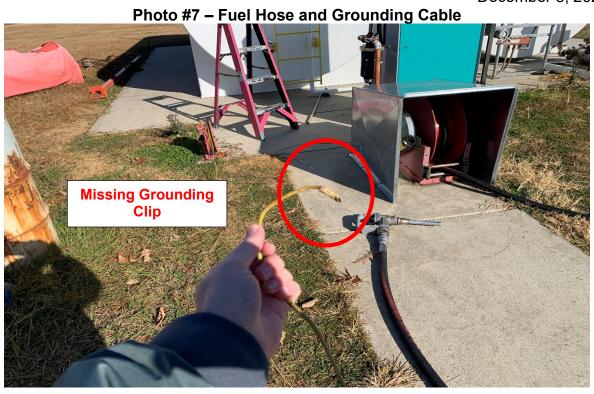
➤ The AVGAS fueling hose and grounding cable were improperly stored (See Photo #7). Additionally, the grounding cable does not have a clamp, so it cannot be used. This creates a potentially dangerous situation and should be corrected immediately.

- Attach new clamp to grounding cable immediately. The fuel system should not be used until this is done to prevent an explosion or fire.
- ➤ Ensure fuel hose and grounding cable are completely reeled up and properly stored.
- ➤ Have fire extinguishers properly inspected and tagged. Inoperable or old fire extinguishers should be removed from the area and disposed of properly.
- ➤ Label AVGAS tank for contents, flammable, and no smoking.

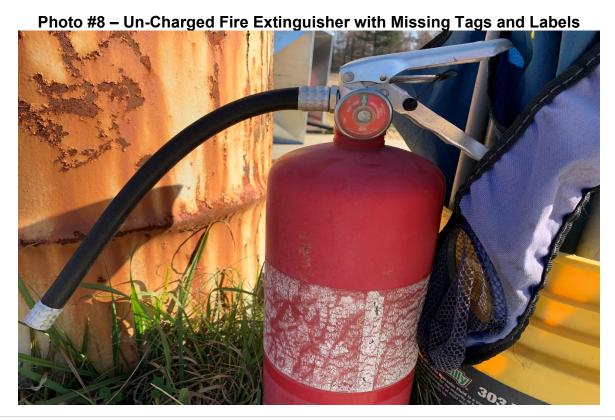
- Fire extinguishers at the fueling area did not have valid inspection tags. The fire extinguisher nearest the fueling area was not charged and appeared it could be in a trash pile (See Photo #8). This does not promote a safe fueling area.
- The AVGAS tank appears to have been recently painted, however, it was not labeled for contents (See Photo #9).
- While an emergency fuel shutoff is not required, it is highly recommended that one be installed. The available emergency fuel shutoff switch was padlocked, which would severely limit its use in an emergency situation when time matters (See Photo #10).
- In general, the fueling area is not being well maintained and could expose the airport to liability if an accident were to occur (Photo #11).
