Subject: Annual Inspection Report Frank Sikes Airport

June 27, 2023

ANNUAL INSPECTION REPORT

FRANK SIKES AIRPORT LUVERNE, ALABAMA

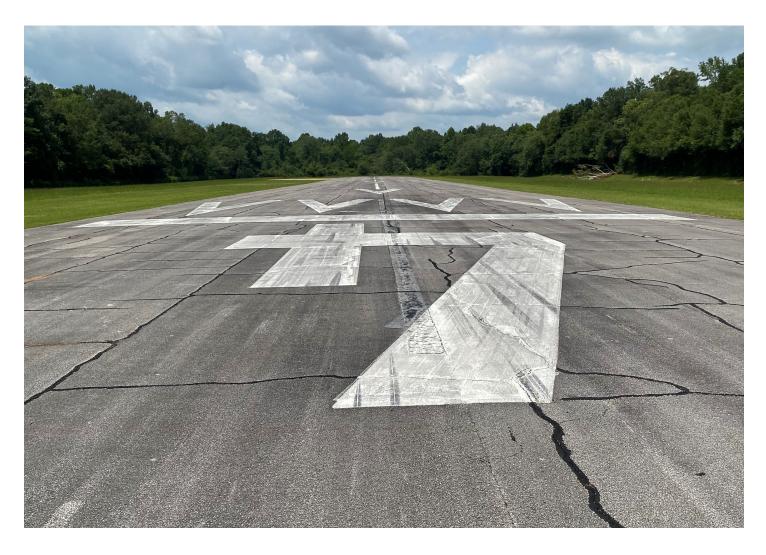
Approach and Departure Paths—RUNWAY 04

VIOLATION: There are penetrations to the ALDOT Approach/ Departure Path of Runway 04. Please see Appendix #2 for more information.

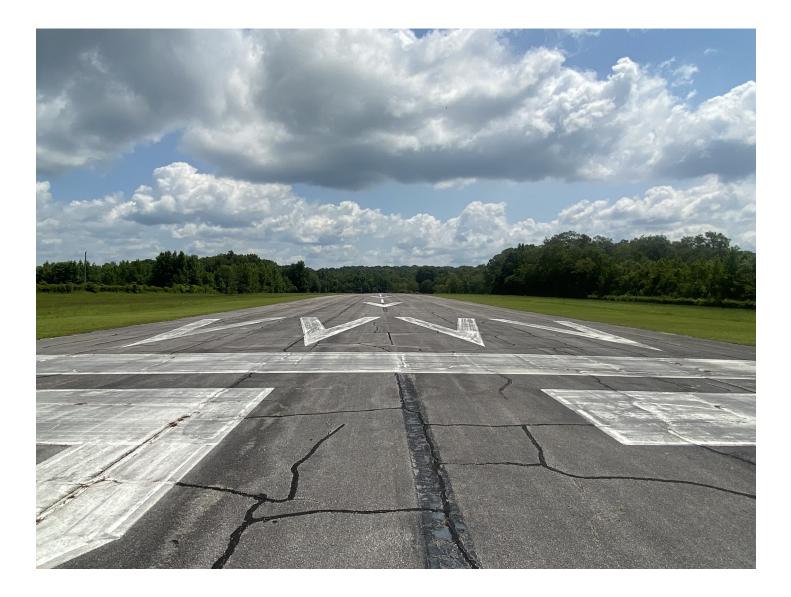
Approach and Departure Paths—RUNWAY 22

VIOLATION: There are penetrations to the ALDOT Approach/ Departure Path of Runway 22. Please see Appendix #3 for more information.

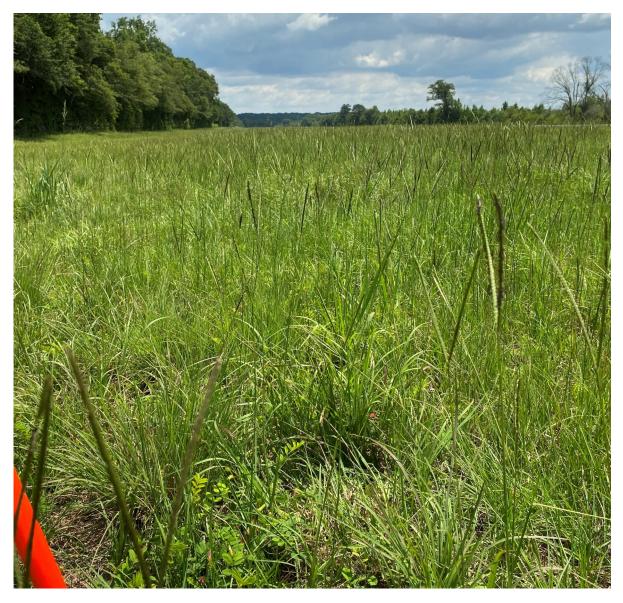
Primary Surface <u>meets</u> state licensing standards.

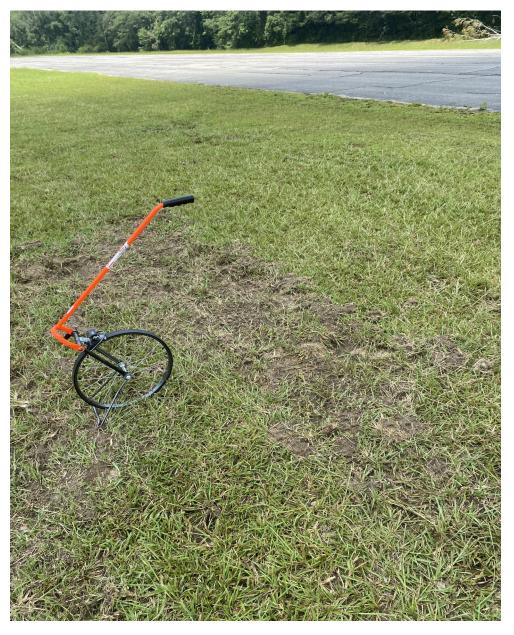
VIOLATION Runway Safety Area **Does Not Meet** state licensing standards. There are ruts located in the Runway Safety Area. Please repair ruts and ensure that the ground is level and smooth.

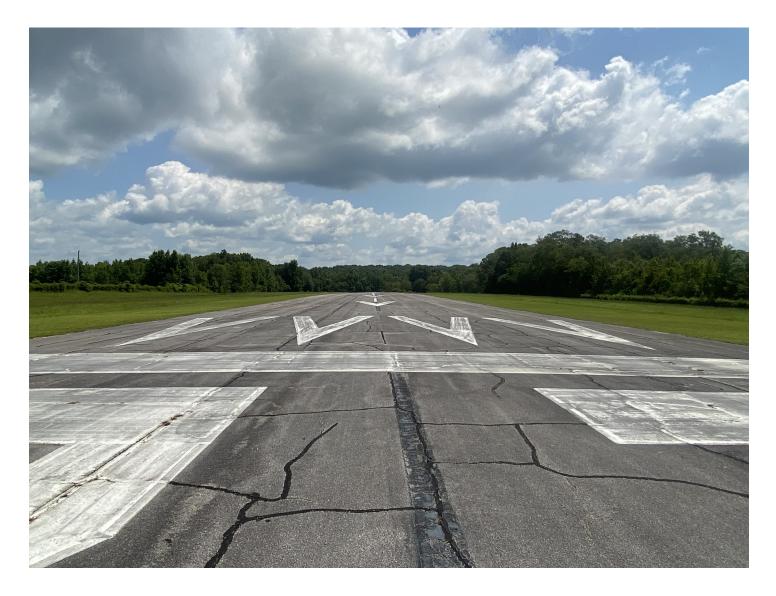
Airport Markings—Runway

Runway markings are in **FAIR** condition.

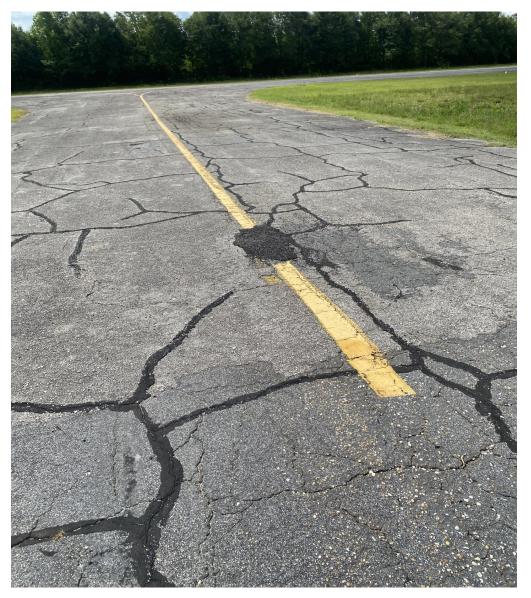
Airport Markings—Taxiway

Taxiway markings are in **FAIR** condition. Hold short line is missing and should be marked in accordance with FAA AC 150-5300-13B.

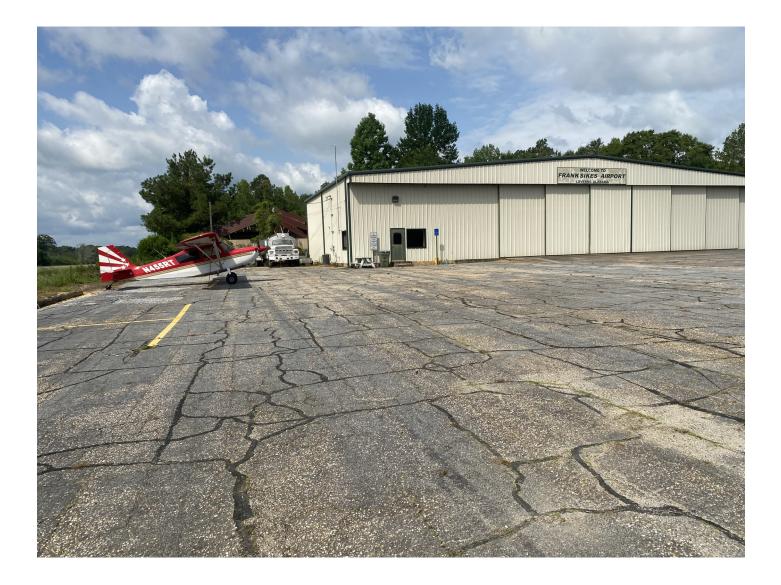
Airport Markings—Apron

Apron markings are in **FAIR** condition.

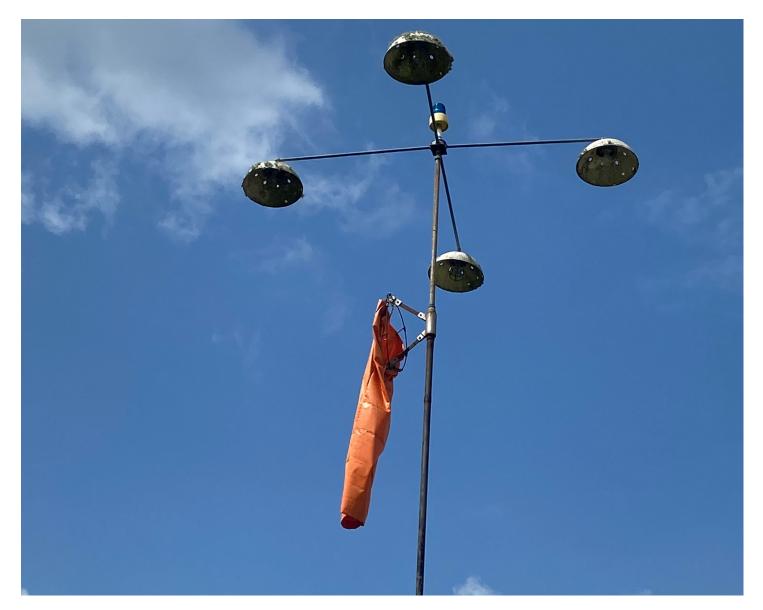
Wind Direction Indicator

Wind direction indicator is in <u>FAIR</u> condition. Please ensure that the windsock is lit for night time operations.

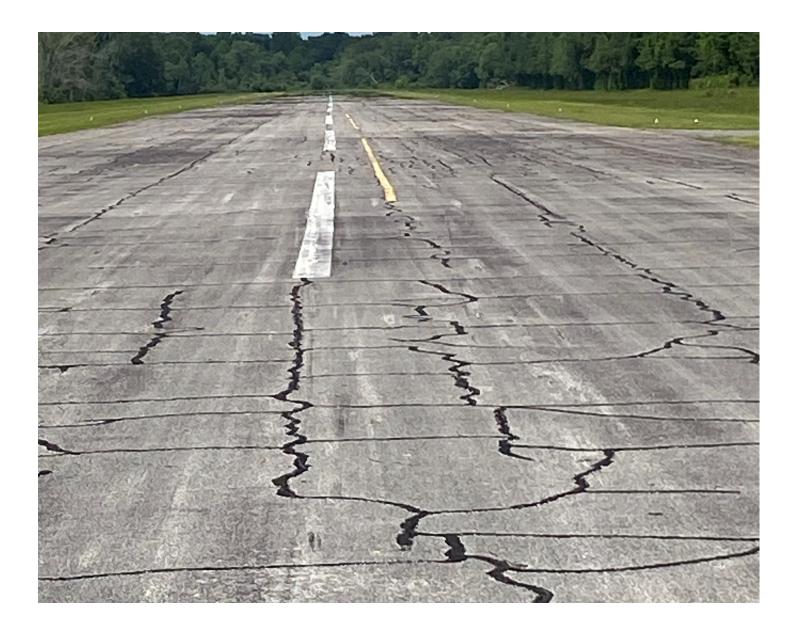
Runway, Taxiway and Apron Conditions—RUNWAY Administrative Code 450-9-1-.12(7)

Runway surface is in **FAIR** condition.

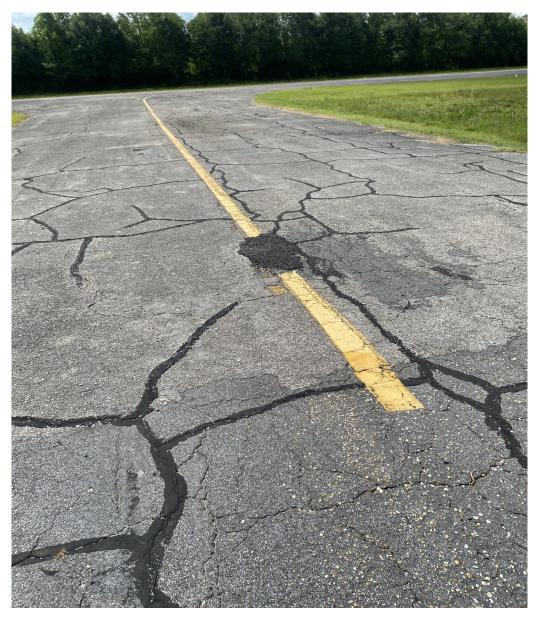
Runway, Taxiway and Apron Conditions—TAXIWAY Administrative Code 450-9-1-.12(7)

Taxiway surface is in **<u>POOR</u>** condition.

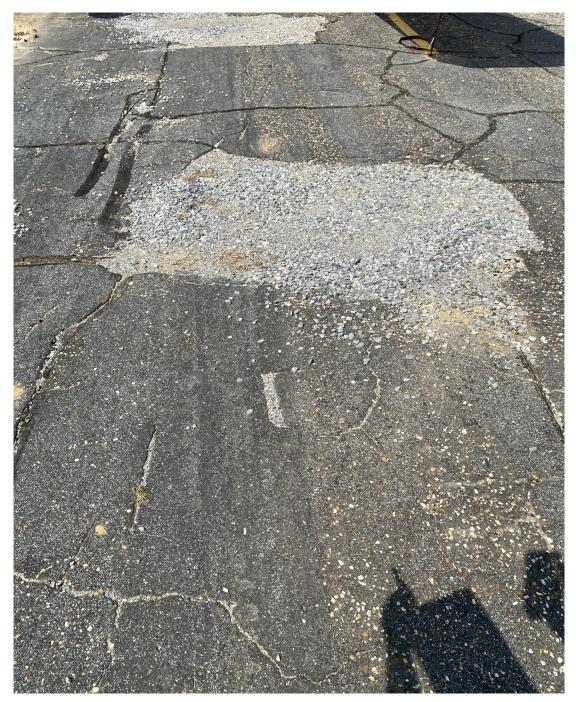
Runway, Taxiway and Apron Conditions—APRON Administrative Code 450-9-1-.12(7)

Apron surface is **<u>POOR</u>** in condition. Extensive longitudinal and transverse cracking, with complete failures in certain places.

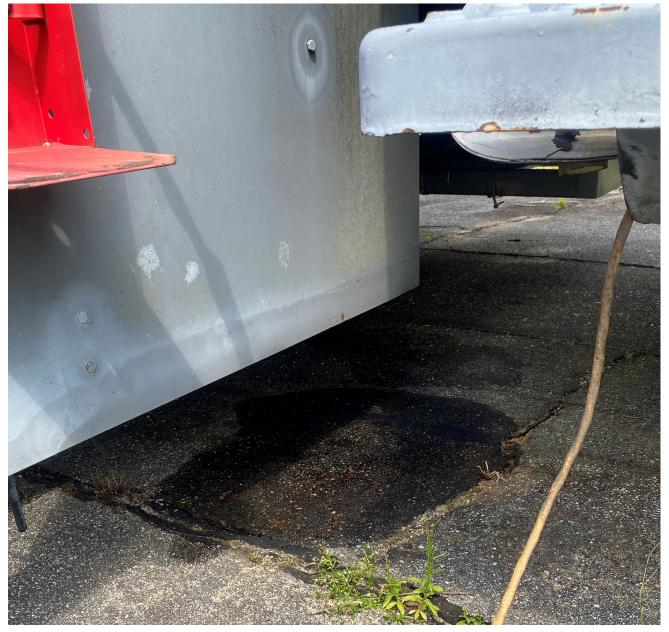
Fueling Area Requirements

One of the fuel trucks is leaking fuel onto the ground contaminating the soil underneath. Also, the State of Alabama Department of Agriculture may have additional requirements for fueling systems that were not considered during this inspection.

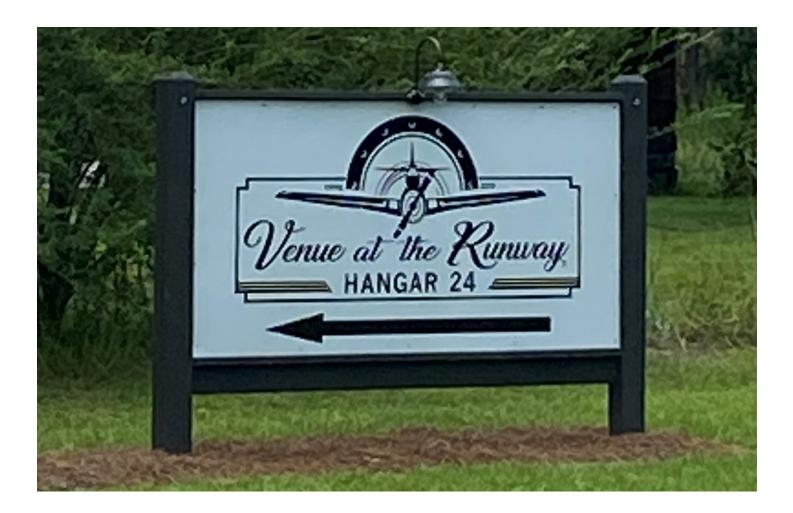
Prohibited Activities

There has been a pattern of trespassing on airport property. An airport should only be accessed by the airport personnel, pilots, and the tenants at the airport. There should <u>Never</u> be people trespassing on airport property to take photos on the runway.
