**Subject: Airport Re-Inspection Report**  
**Moton Field Municipal Airport (Tuskegee)**

**Subject: Annual Inspection Report**  
**Tuskegee (Moton Field) Municipal Airport**

# ANNUAL INSPECTION REPORT

# Annual Inspection Report Tuskegee (Moton Field) Municipal Airport Tuskegee, Alabama

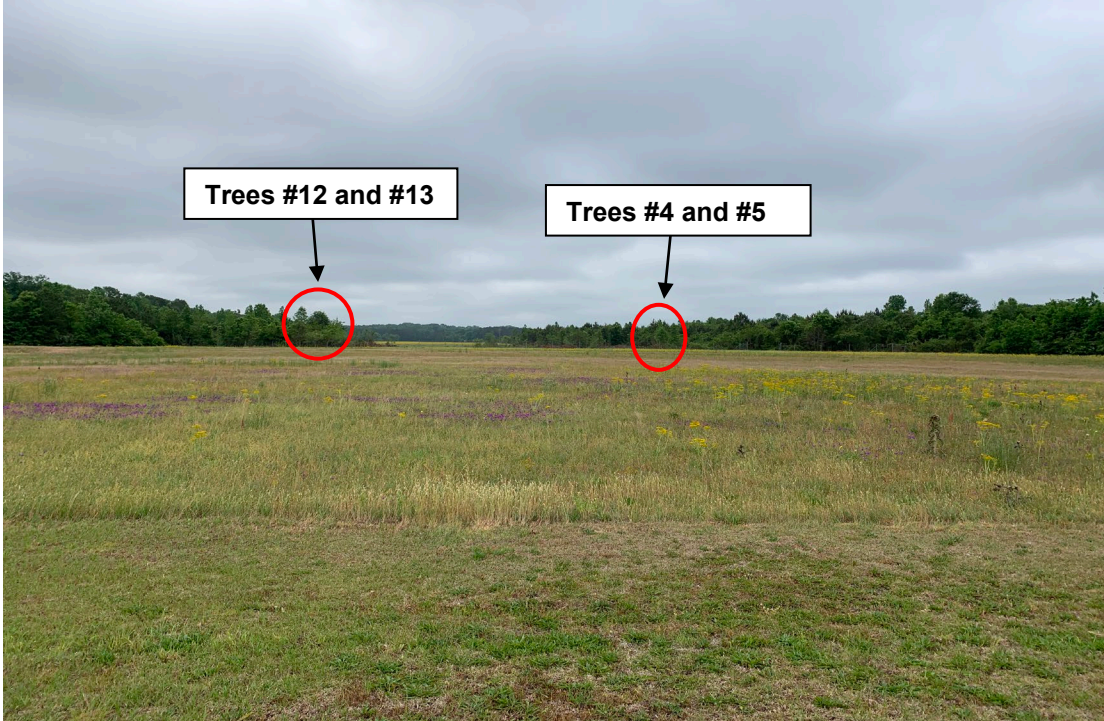
Photo #1 – Runway 31

- Runway 31 – Trees identified as #4, #5, #12, and #13 obstruct the Required ADLOT 20:1 Approach/Departure Path (See Photo #1 and Appendix #2).
- Runway 13 – No obstructions to Required ALDOT 20:1 Approach/Departure Path (See Photo #2).

- Remove all obstructions identified within the Required ALDOT 20:1 Approach/Departure Path as soon as possible.
- *Note: the obstructions detailed in this report are representative and may not include all existing obstruction violations. It is the responsibility of the airport sponsor to identify and remove all obstructions to the ALDOT Approach/Departure Path.*

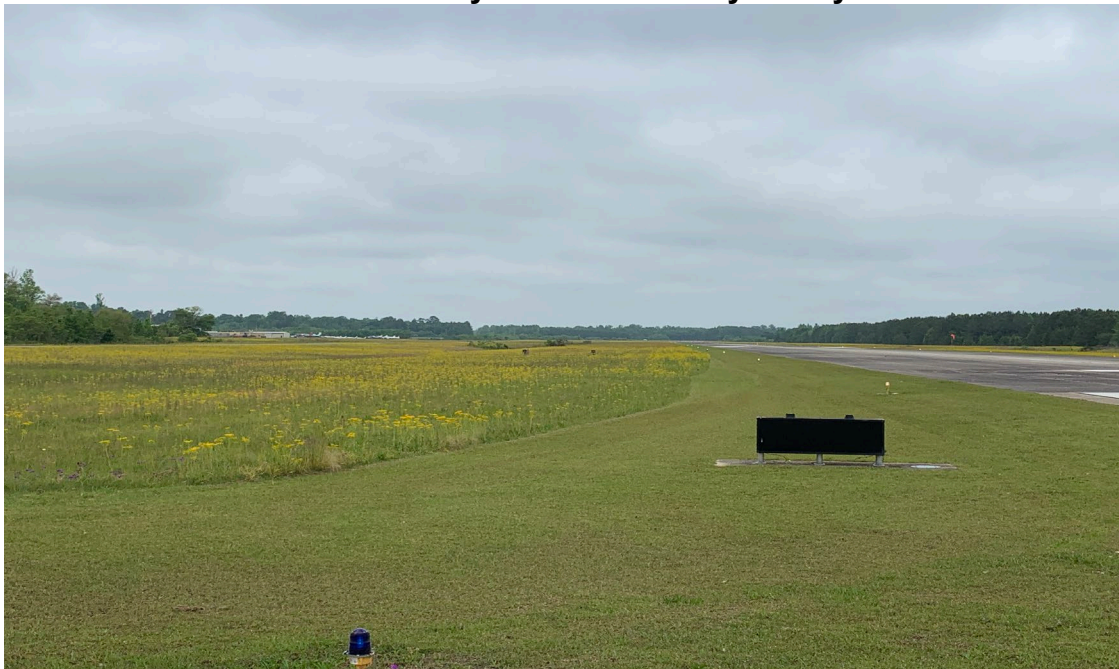
**Photo #3 – Primary Surface/Runway Safety Area**

- The Primary Surface **meets** state licensing requirements (Photo #3).

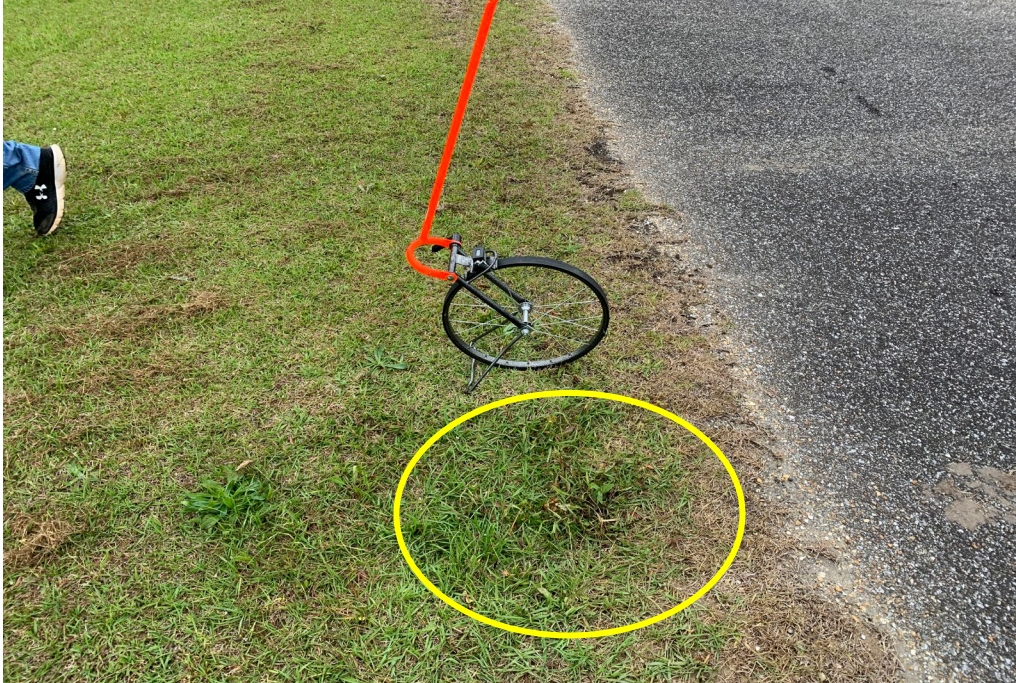
- The Runway Safety Area **meets** state licensing standards, however, there is a slight depression on the runway shoulder on the north side near mid-field due to a vehicle exiting the runway (See Photo #4).

Photo #4 – Depression on Runway Shoulder

- Fill in depression with sand and grade smooth.

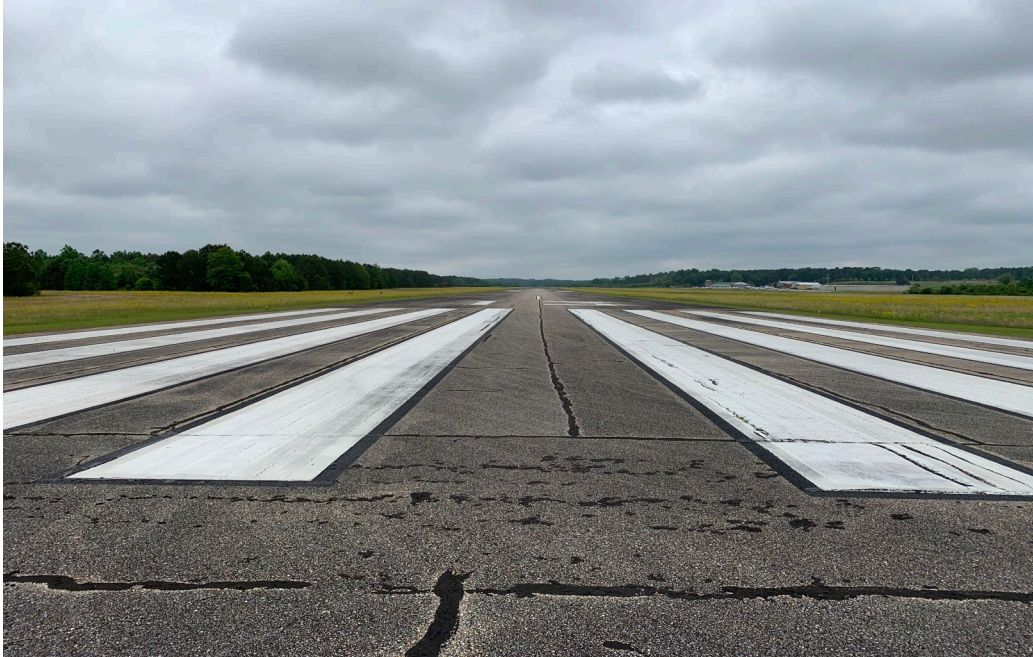
Photo #5 – Runway Markings RWY 13

- Airport markings are in **GOOD** condition (See Photo #5).

- The runway and taxiway pavements are in **FAIR** condition (See Photos #5 and #7). The pavement surfaces are experiencing moderate weathering, as well as some raveling in areas (See Photo #7). The main apron is in **GOOD** condition.

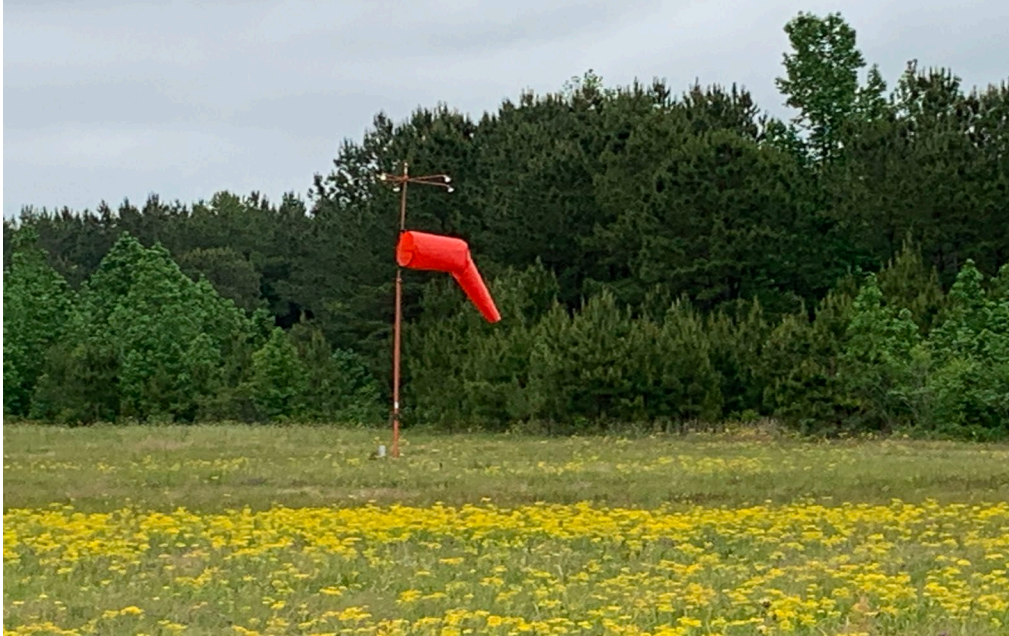
Photo #6 – Wind Direction Indicator

- The wind direction indicator (windsock) is operational and is in **GOOD** condition (See Photo #6).

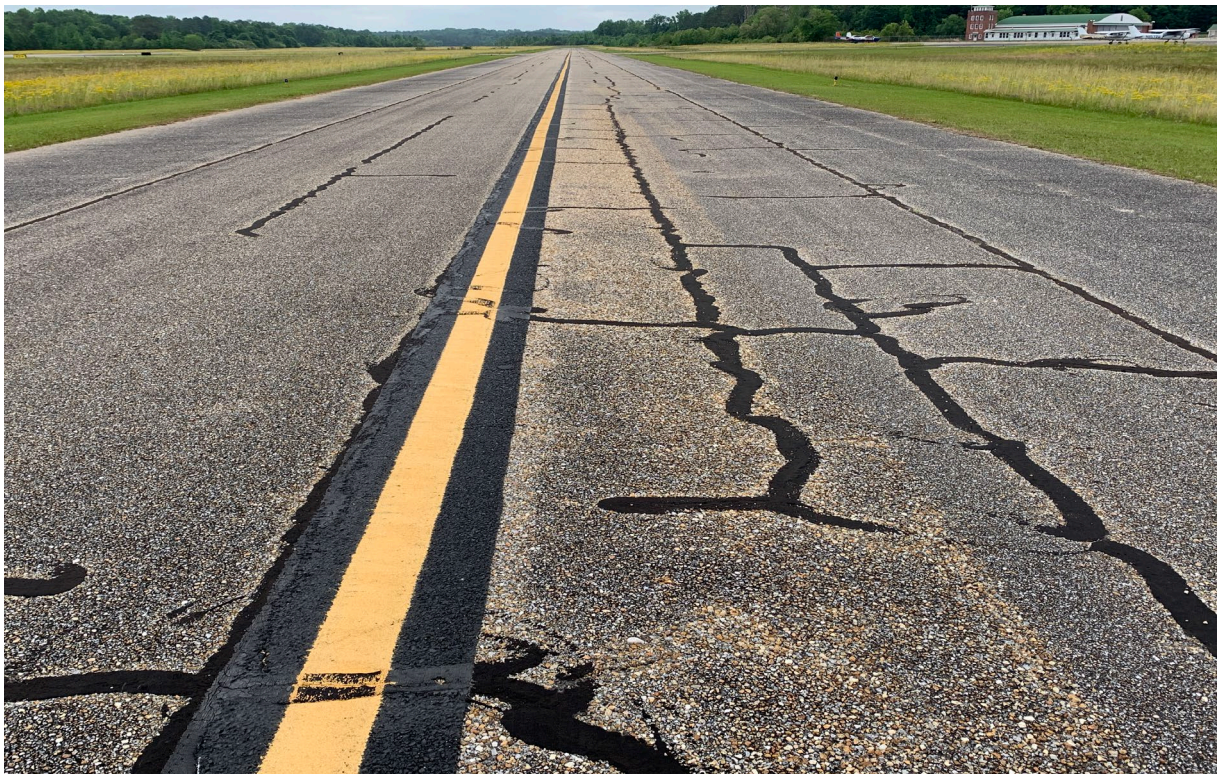
**Photo #7— Crack Seals**

- Proceed with pavement maintenance projects on airport's Capital Improvement Plan (CIP).

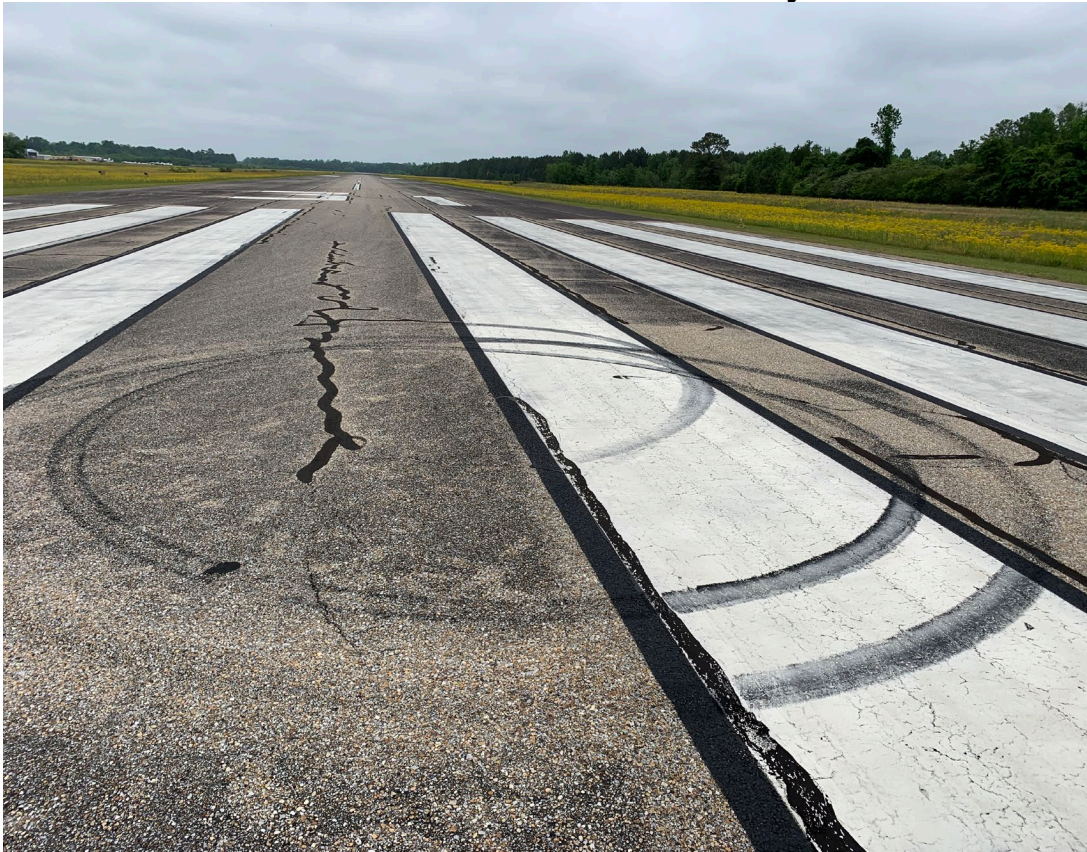
- There was evidence that a motorcycle performed a burnout near the threshold of Runway 31.

**Photo #8 – Tire Marks on Runway**

- Prohibit all unauthorized access to aircraft movement areas and ALDOT imaginary surfaces.

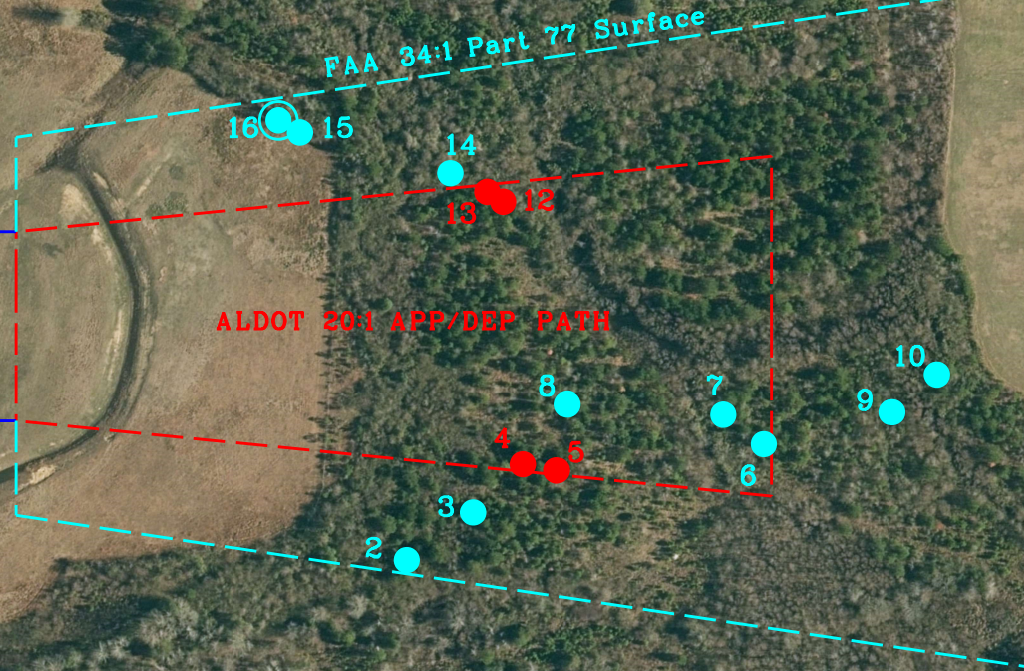
**TUSKEGEE-MOTON FIELD**  
**Tuskegee, AL**  
**May 4, 2022**  
**RWY 31 Obstruction Evaluation**

12. Tree 40' Abv. RWY  
 845' From RWY End  
 165' Right of CL  
 15:1 Obst. Clnc

4. Tree 35' Abv. RWY  
 871' From RWY End  
 182' Left of CL  
 18:1 Obst. Clnc

13. Tree 43' Abv. RWY  
 824' From RWY End  
 178' Right of CL  
 14:1 Obst. Clnc

5. Tree 38' Abv. RWY  
 915' From RWY End  
 191' Left of CL  
 18:1 Obst. Clnc
