Subject: Annual Inspection Report Lamar County Airport (M55)

Annual Inspection Report June 17, 2021

Lamar County Airport (M55) Vernon, Alabama

June 17, 2021

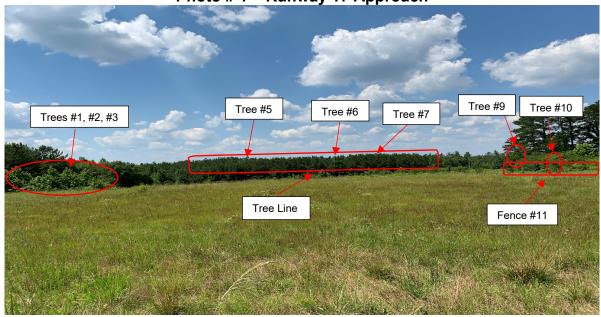
Photo # 1 – Runway 17 Approach

- Runway 17 Obstructions labeled Tree #1, #2, #3, a line of trees containing Trees #5, #6, #7, Trees #9, #10, and Fence #11 are violations to the ALDOT 20:1 Approach Surface (See Photo #1 and Appendix 2).
- Runway 35 Obstructions labeled Tree #1, #2, #3, #4, #5, #6, #7, #8, and #9 are violations to the ALDOT 20:1 Approach Surface (See Photo #2 and Appendix 3).

- > The Primary Surface is overgrown. Grass and brush exceeds 12 inches in height.
- Trees #1, #2, #3, #10, and a fence are close in obstructions violating the primary surface for Runway 17 (See Photo #1 and Appendix 2).
- Trees #1, #2, and #6 are close in obstructions violating the primary surface for Runway 35 (See Photo #2 and Appendix 3).

- Remove all obstructions within the ALDOT 20:1 Approach/Departure Path
- Obstructions detailed in this report are representative and may not include all obstructions.

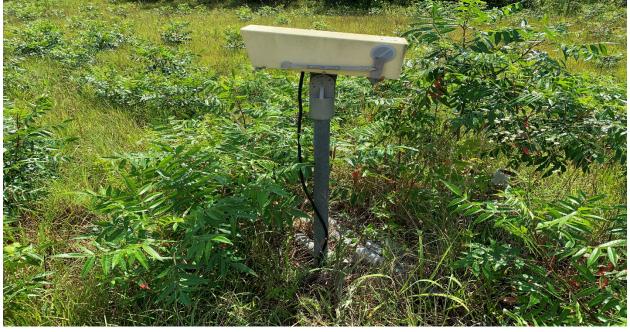
Photo # 3 – VGSI and Overgrown Brush

Old inoperative VGSI fixtures are located 70 feet from centerline at both runway ends. The fixtures are not frangible and are surrounded by loose metal poles (See Photo #3 and #4).

- Remove the inoperative VGSI fixtures and all associated materials from the primary surface.
- Remove close in obstructions from primary surface at both runway ends.
- Mow grass around Runway.

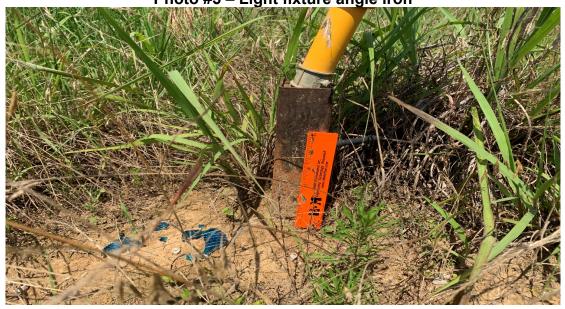
- Threshold light fixture angle iron at the approach end of Runway 17 is protruding approximately 8 inches (See Photo #5).
- The Runway Safety Area is overgrown, grass is higher than 12 inches.
 Photo #5 Light fixture angle iron

- Remove light fixtures or bring up grade around light bases in a manner that does not create any hazardous surface variations.
- > Mow grass surrounding the Runway.

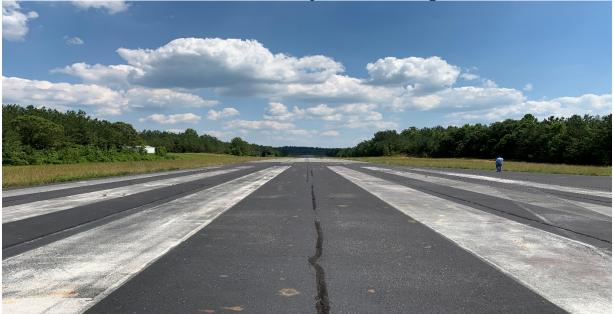
Photo # 6 – Runway 17 NPI Markings

> The airport markings are in **POOR** condition (See Photo #6 and #7).

Clean runway markings. If the markings are unable to be cleaned, the markings should be reapplied in accordance with FAA AC 150/5340-1M.

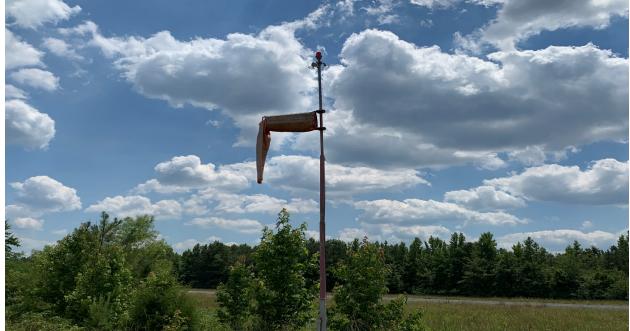
Photo # 8 – Wind Direction Indicator

- > The wind direction indicator is faded and torn (See Photo #8).
- > The light fixture is inoperative.

> Replace Windsock and repair lighting system

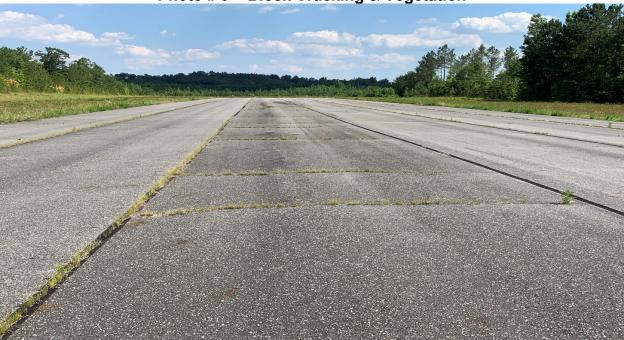
Photo # 9 – Block Cracking & Vegetation

- Runway pavement is in <u>POOR</u> condition due to cracking, vegetation, and failing crack seal. Some areas are showing block cracking, an early sign of pavement failure (See Photo #9).
- Taxiway pavement is in <u>POOR</u> condition due to cracking, vegetation, and an area of erosion that is washing away the taxiway subgrade (See Photo #10).
- Apron pavement is in <u>FAIR</u> condition due to cracking and vegetation (See Photo #11).
- Gravel is being washed onto the runway from water runoff, causing a foreign object debris (FOD) hazard (See Photo #12).

- Plan a pavement maintenance project to stop further pavement degradation and subsequent failure.
- > Repair taxiway section that is experiencing erosion damage.
- > Remove gravel and any other FOD from runway surface.
