Subject: Annual Inspection Report
St. Elmo Airport

ANNUAL INSPECTION REPORT

ST. ELMO MUNICIPAL AIRPORT

**Annual Inspection Report
St. Elmo Municipal Airport
St Elmo, Alabama**

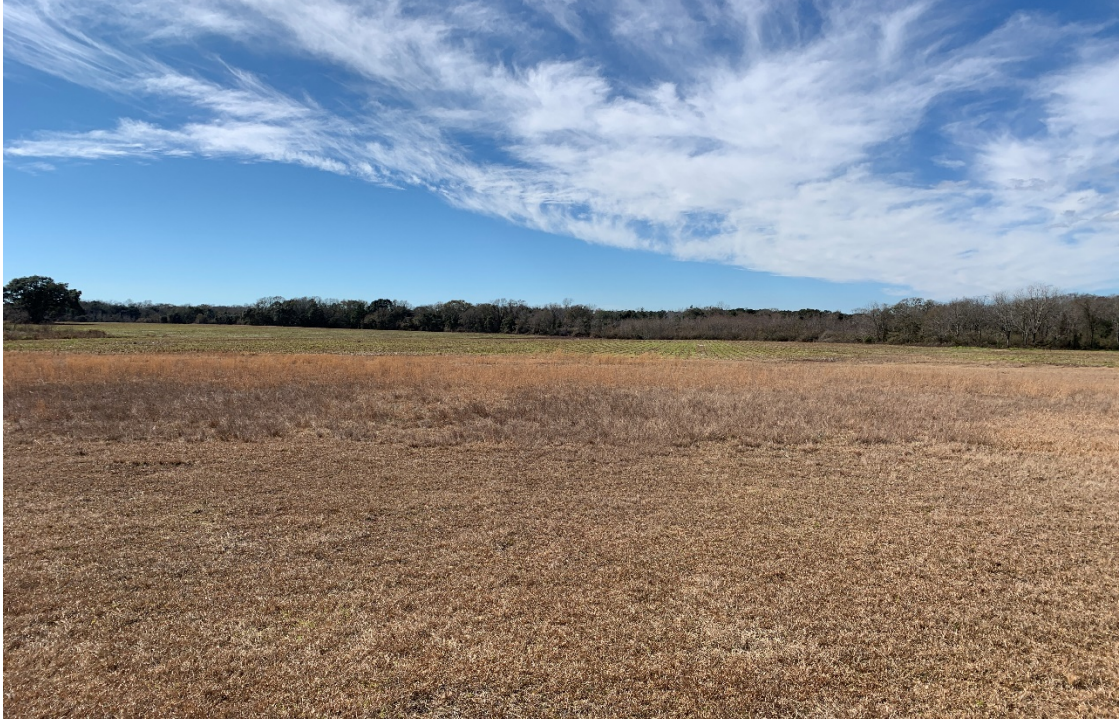
Photo # 1 – Runway 6 Approach

- Runway 06 – No obstructions (See Photo # 1).
- Runway 24 – No obstructions (See Photo # 2).

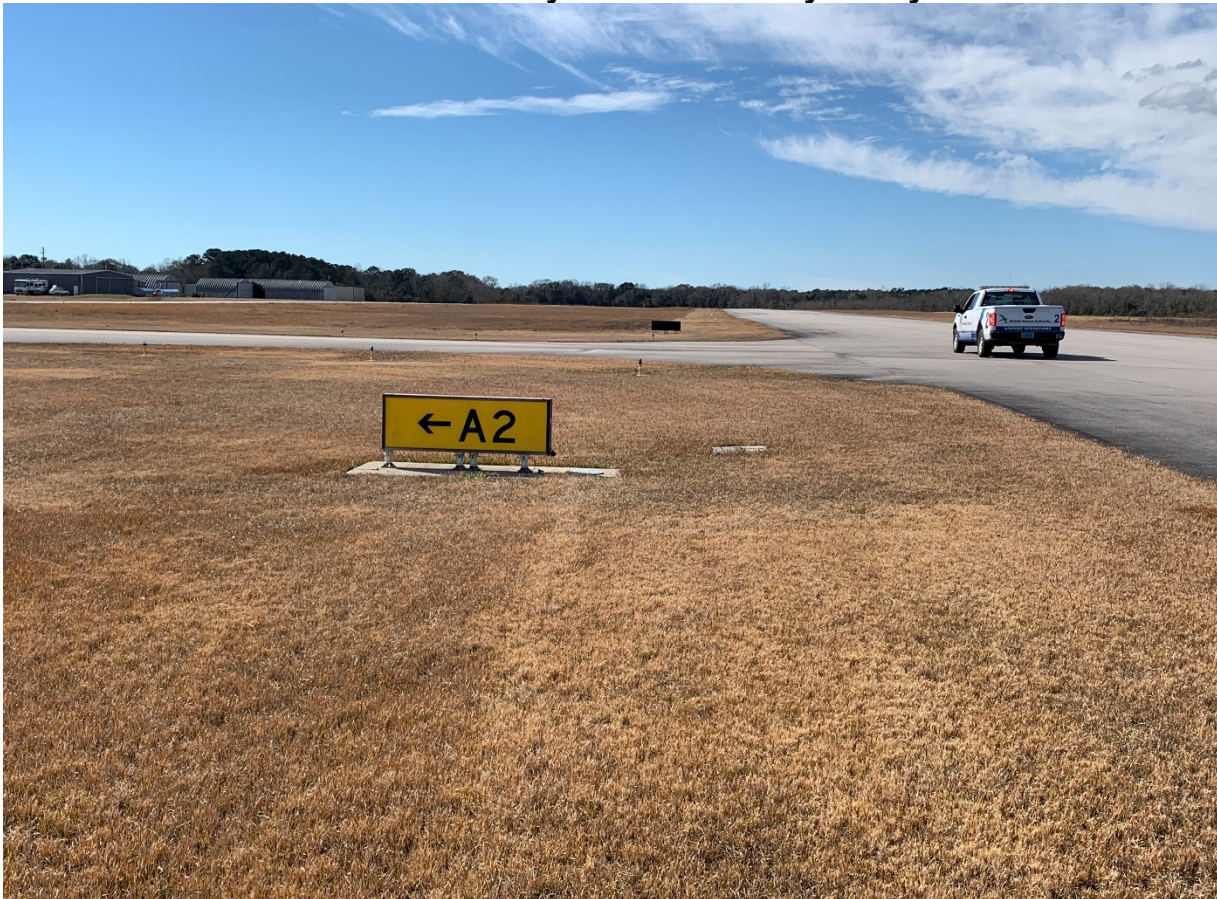
Photo # 3 – Primary Surface/Runway Safety Area

- The primary surface meets state licensing requirements (See Photo # 3).

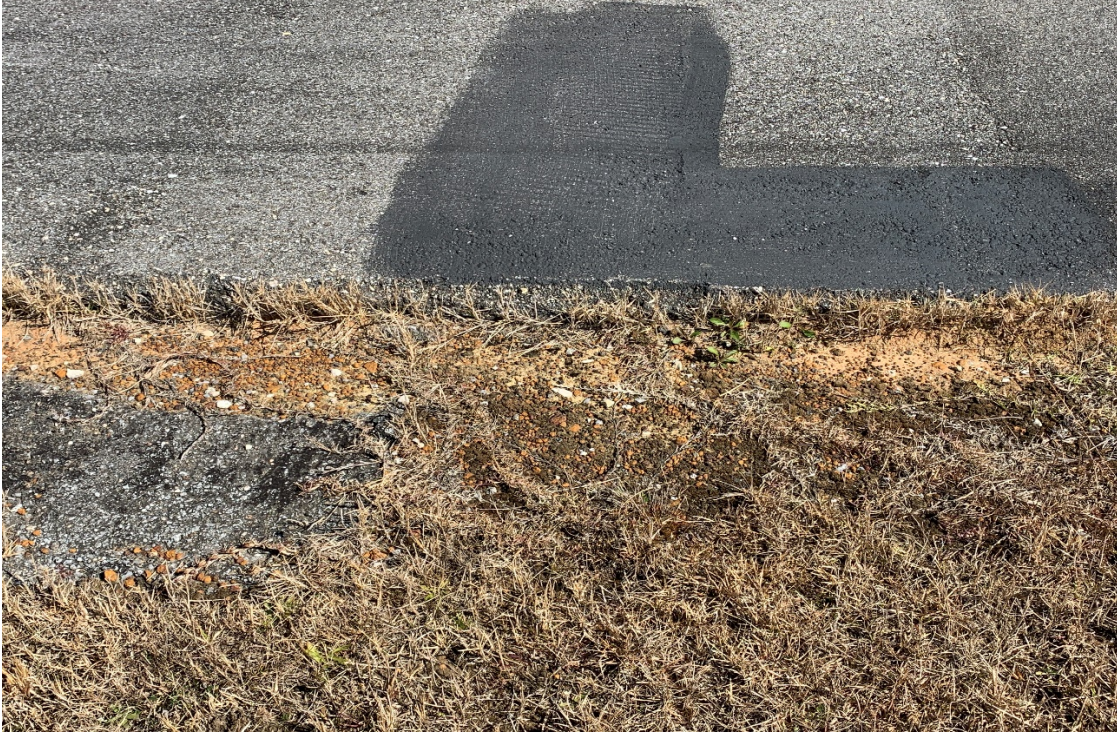
Photo # 4 – Erosion in Runway Safety Area

- The runway safety area ***meets*** state licensing standards. However, erosion is beginning to occur around the end of Runway 06, which is causing the pavement lip to become exposed (See Photo # 4).

- Monitor erosion around pavement to ensure no more than a 3-inch lip exists.

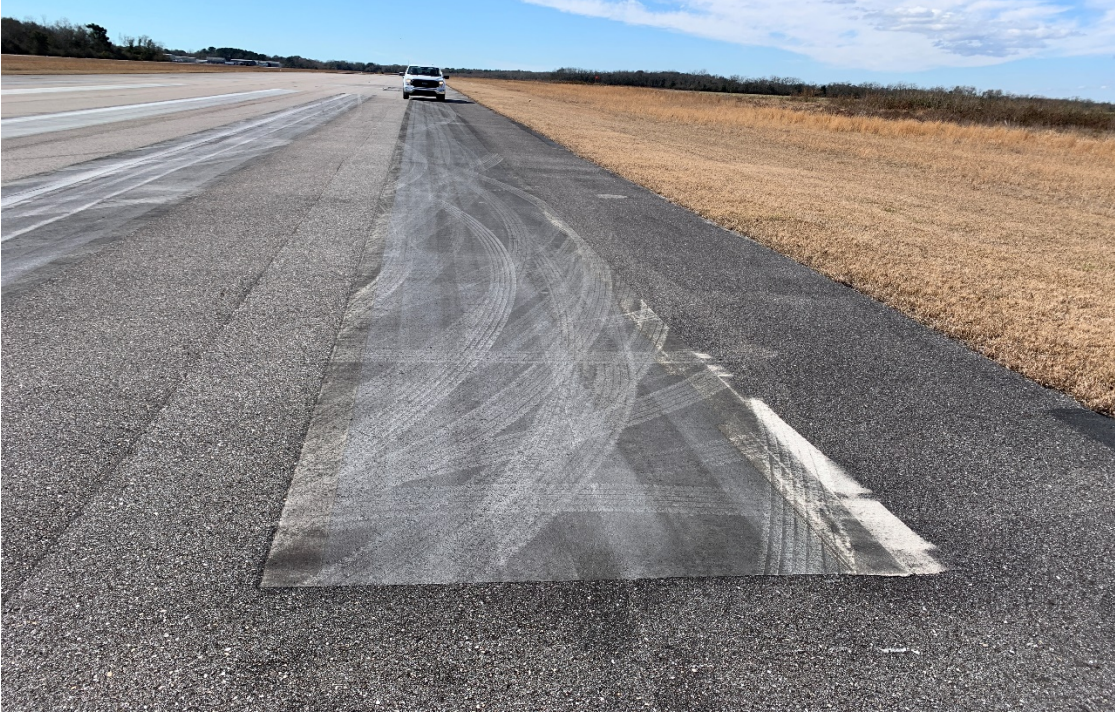
Photo # 5 – NPI Markings Runway 24

- The runway markings are in **POOR** condition (See Photos # 5 and # 6).
- The taxiway markings are in **GOOD** condition.
- The taxilane/apron markings are in **POOR** condition.

- The runway surface is in **GOOD** condition (See Photos # 5 and #6).
- Taxiway is in **GOOD** condition.
- The apron areas and taxi-lanes are in **FAIR** condition but are developing numerous depressions and water spots (See Photos # 8 and #9).

- Markings in poor condition should be cleaned or replaced in accordance with FAA AC 150/5340-1M.

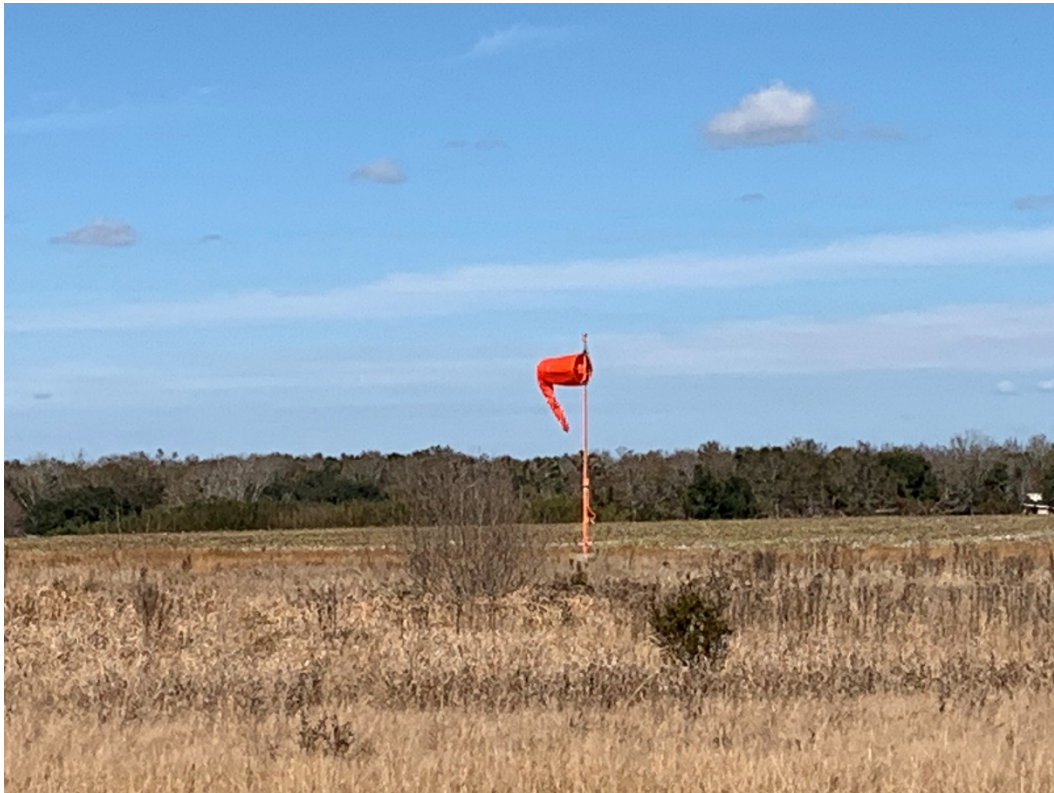
Photo # 7 – Wind Cone

- The wind direction indicator is operational and in **GOOD** condition (See Photo # 7).

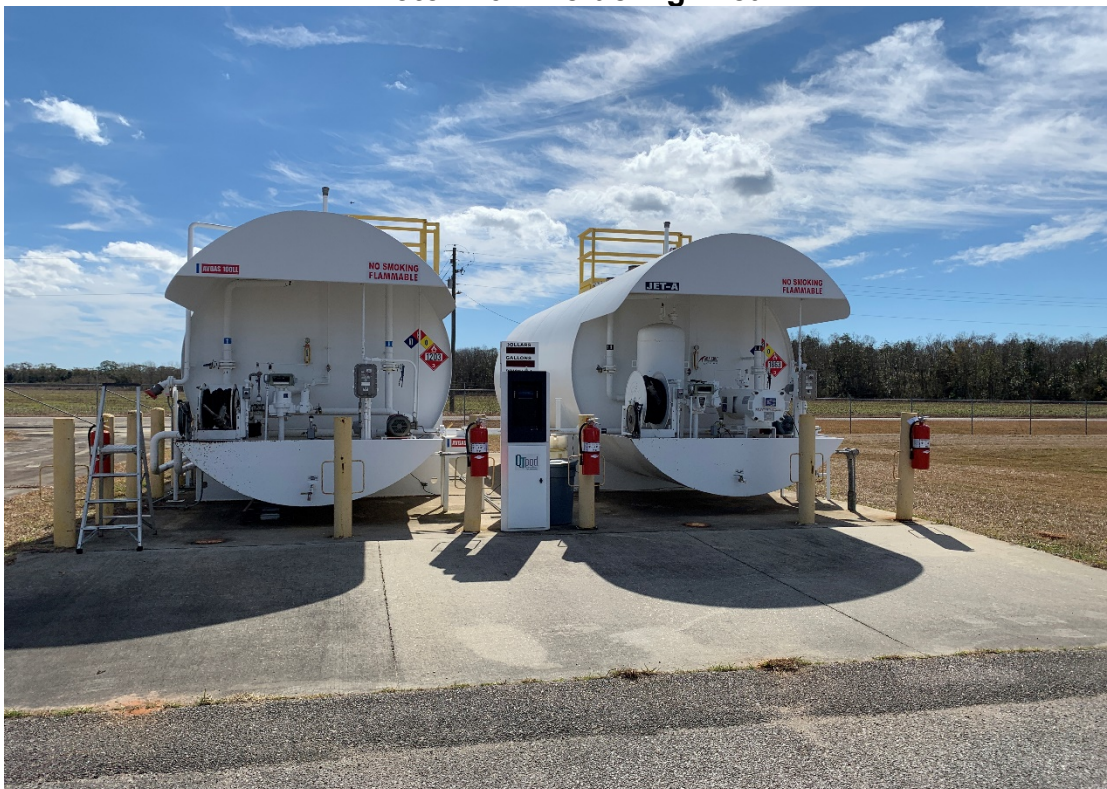
Photo #10 – Refueling Area

- The fueling area meets the requirements established by the Alabama Department of Transportation (See Photo # 10). However, the State of Alabama Department of Agriculture and Industries may have additional requirements for fueling systems that were not considered during this inspection.

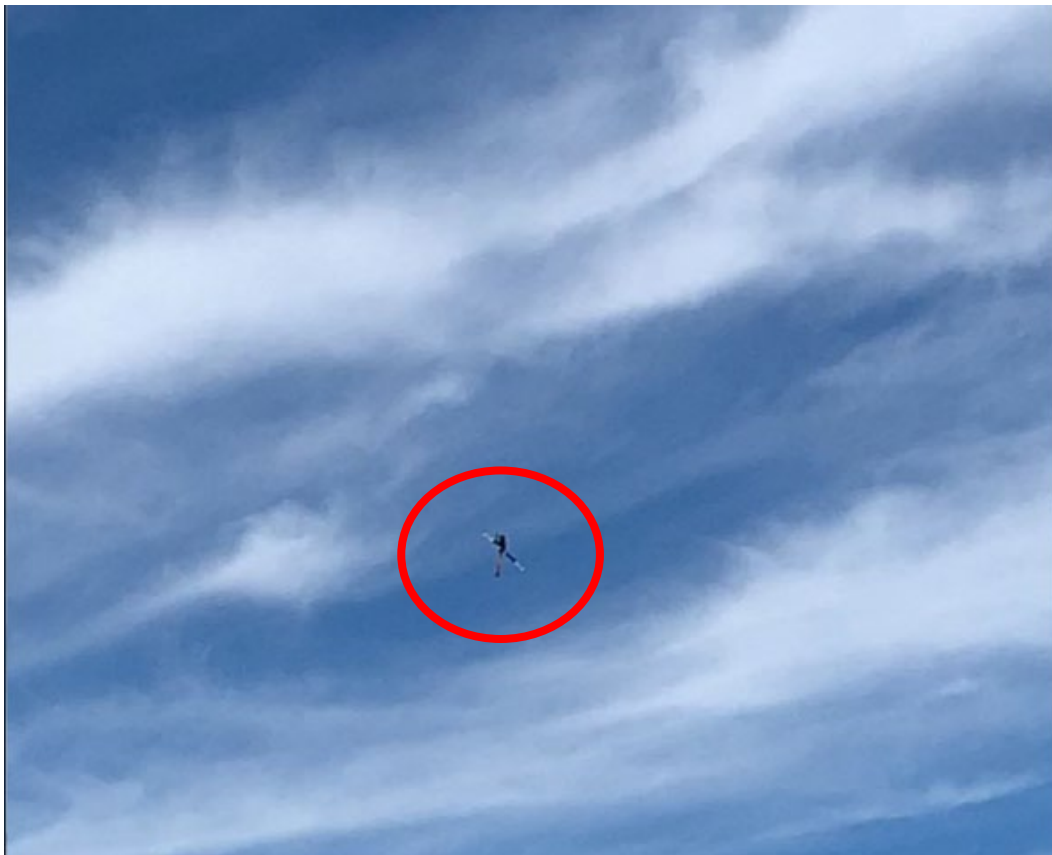
Photo # 11 – Tenant Flying RC Helicopter

- A tenant was observed flying a remote-control helicopter on the airport premises (See Photo # 11). Airport management was immediately notified, and the prohibited activity **was promptly addressed**.
