**Subject: Re-inspection Report**  
**Floralia Municipal Airport**

**Subject: Annual Inspection Report  
Floralia Municipal Airport**

# ANNUAL INSPECTION REPORT

**FLORALA MUNICIPAL AIRPORT (0J4)**  
**FLORALA, ALABAMA**

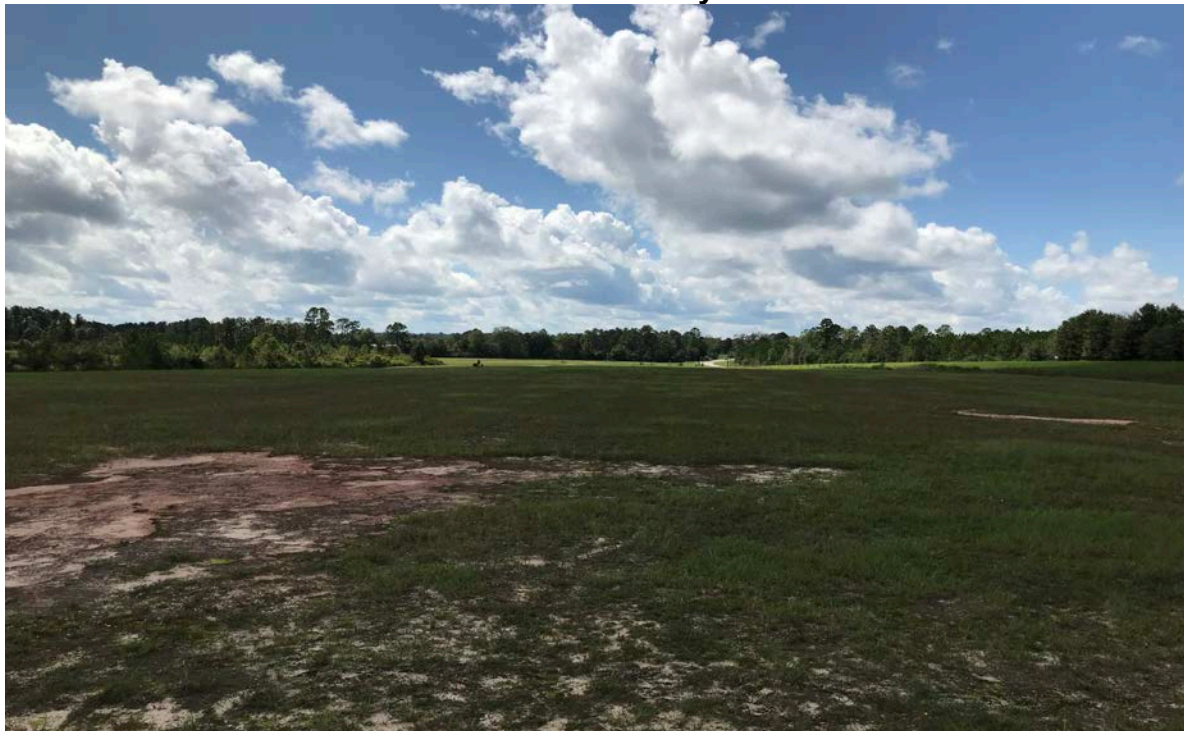
**Photo # 1 –Runway 4**

- Runway 4: No obstructions (See Photo #1)
- Runway 22: No obstructions (See Photo #2)

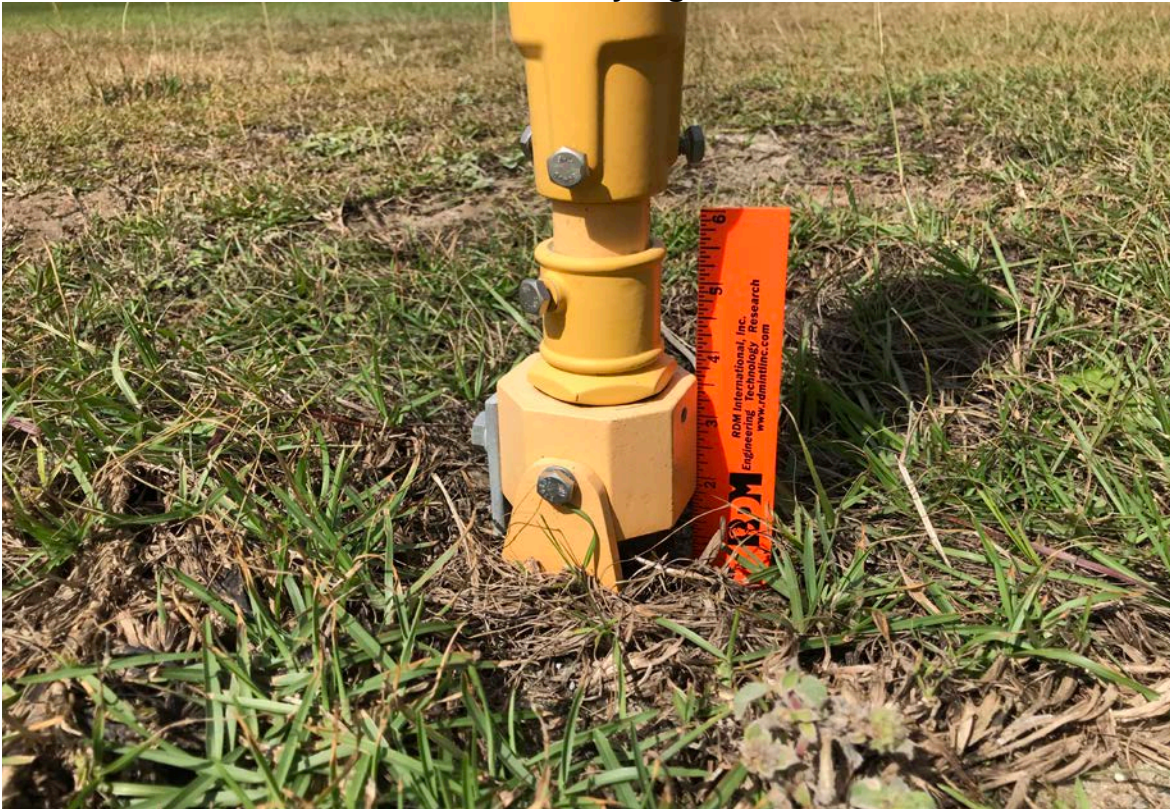
**Photo # 3 – Taxiway Light in RSA**

- The grade around two light fixtures (one taxiway light adjacent to the runway and a threshold light at end of Runway 04) has eroded causing the angle iron to be exposed more than three (3) inches above the surface (See Photos #3 and #4).
- There are signs of erosion at the approach end of Runway 04 that will lead to violations in the future if not corrected (See Photo #5).

On October 20, 2020, the airport consultant provided photo evidence of the corrective actions taken. After a review of these photos, it has been determined that the grade has been brought up in the RSA, correcting the safety deficiencies and arresting any erosion. The Floralia Municipal Airport now meets the requirements for an Airport Operating License. The License is issued and is in full effect. A license will be mailed to you within a few weeks.

- Bring grade up around lights so that any non-frangible components do not project more than three (3) inches above the surface.
- Arrest erosion.

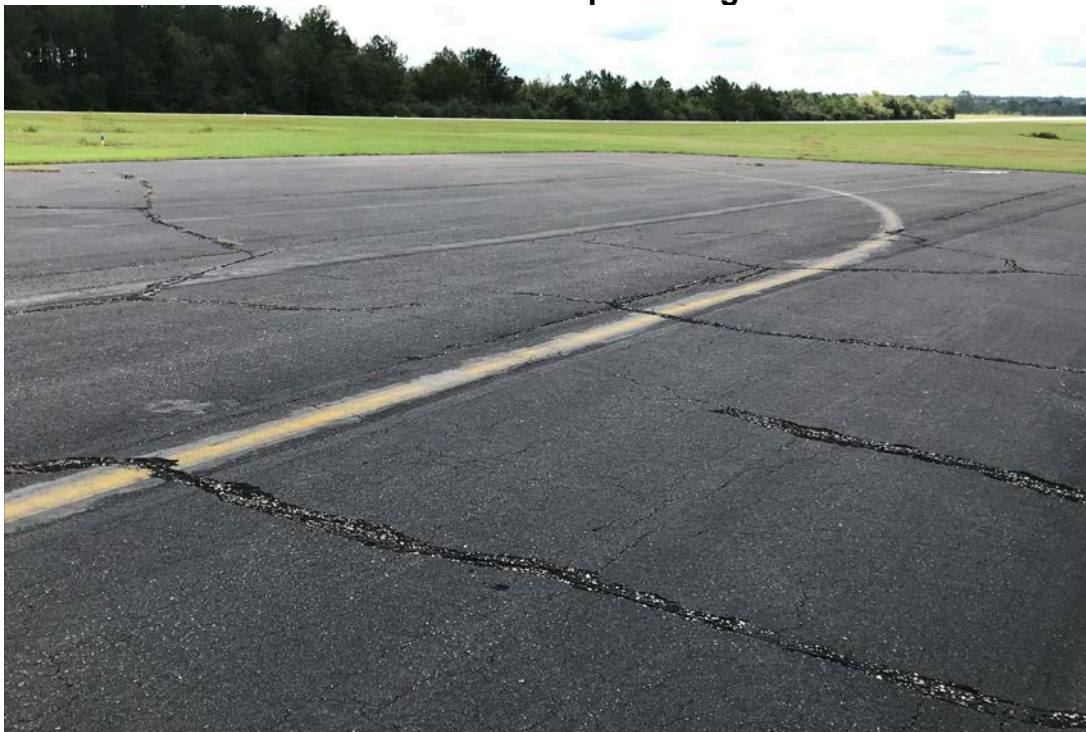
**Photo # 6 – Ramp Markings**

- Ramp and taxiway markings are in **FAIR** to **POOR** condition (See Photos #6 and #7).
- Runway markings are in **GOOD** condition (See Photo #8)

- Clean taxiway and ramp markings that are in poor condition. If unable to clean, remark in accordance of FAA AC 150/5340-1M.

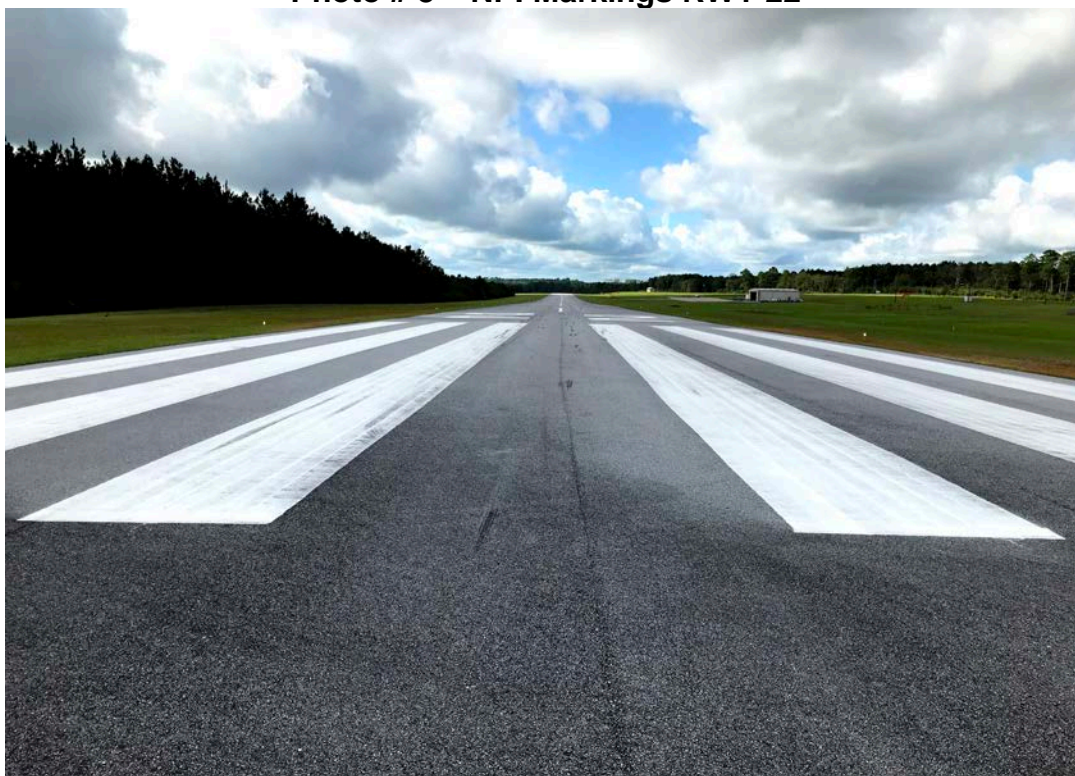
**Photo # 8 – NPI Markings RWY 22**

- The runway surface is in **GOOD** condition (See Photo #8).
- The apron surfaces are in mostly **FAIR** condition, with some areas in **POOR** condition. Apron surfaces are experiencing micro-surface cracking, raveling, polishing, slippage, and extensive helicopter skid damage (See Photos #10, #11, 12).
- Concrete hot-refueling ramp is in **POOR** condition with area of **FAILURE**. Surface contains multiple slab cracks, spalling, and shattered slabs (See Photos #13, #14, and #15).
- Even with the pavement deficiencies, there was very little foreign object debris (FOD) discovered.

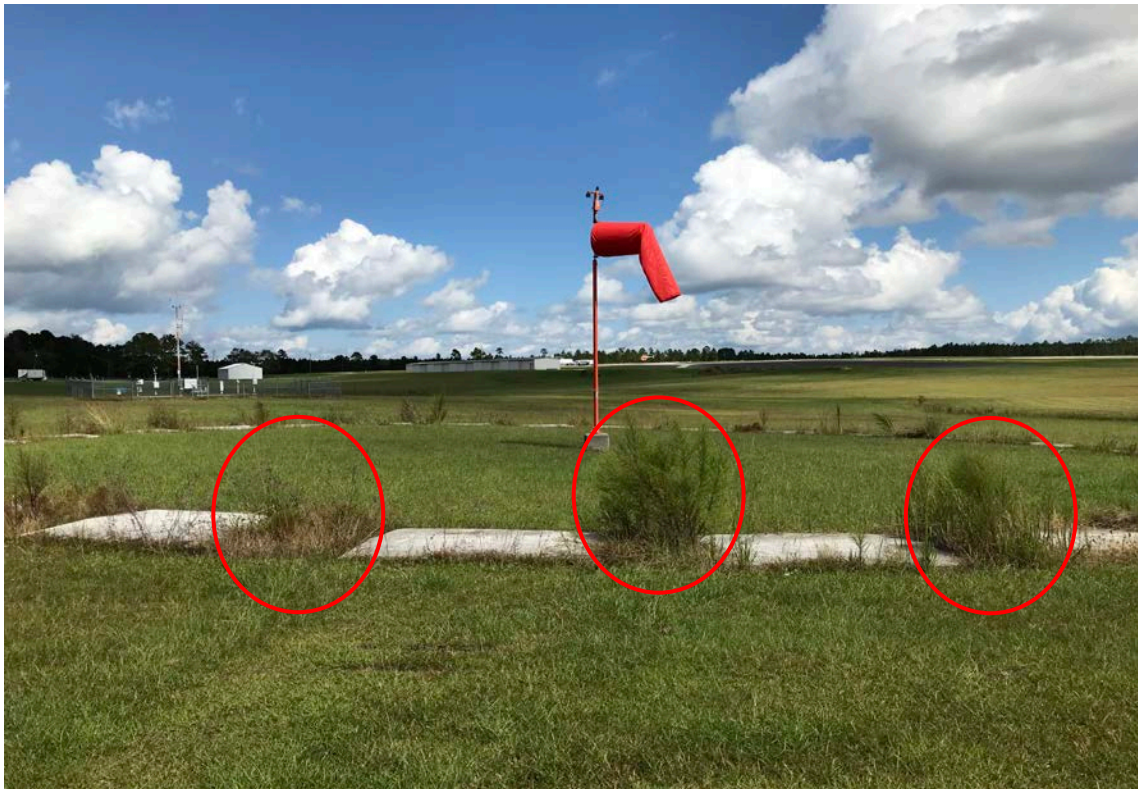
Photo # 9 – Wind Cone

- The wind direction indicator is in **GOOD** condition; however, the segmented circle is not being maintained (See Photo # 9).

- Remove vegetation and paint segmented circle white. The segmented circle should be maintained to be clearly visible from the air.

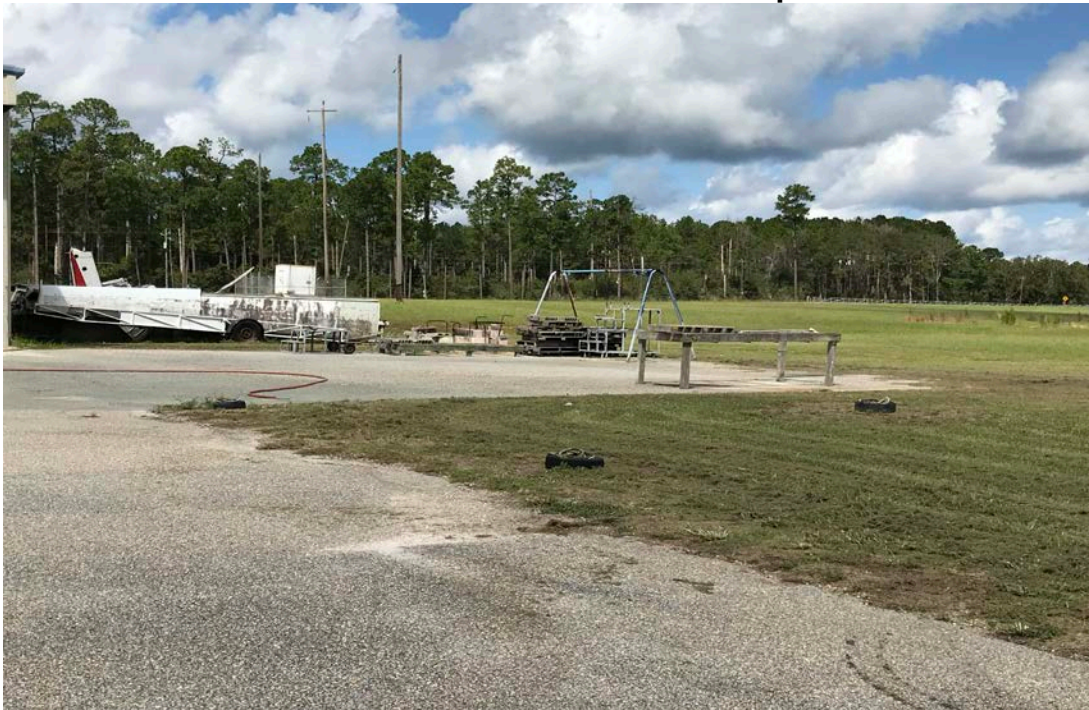
**Photo # 16 – Maintenance Ramp**

- No prohibited activities were observed during the inspection. However, there were some items being stored on the maintenance ramp (See Photo # 16).

- Aircraft parking areas should be used for aircraft parking only.
