**Subject: Annual Inspection Report
Fort Deposit/Lowndes County Airport**

ANNUAL INSPECTION REPORT

FORT DEPOSIT/LOWNDES COUNTY AIRPORT

FORT DEPOSIT, ALABAMA

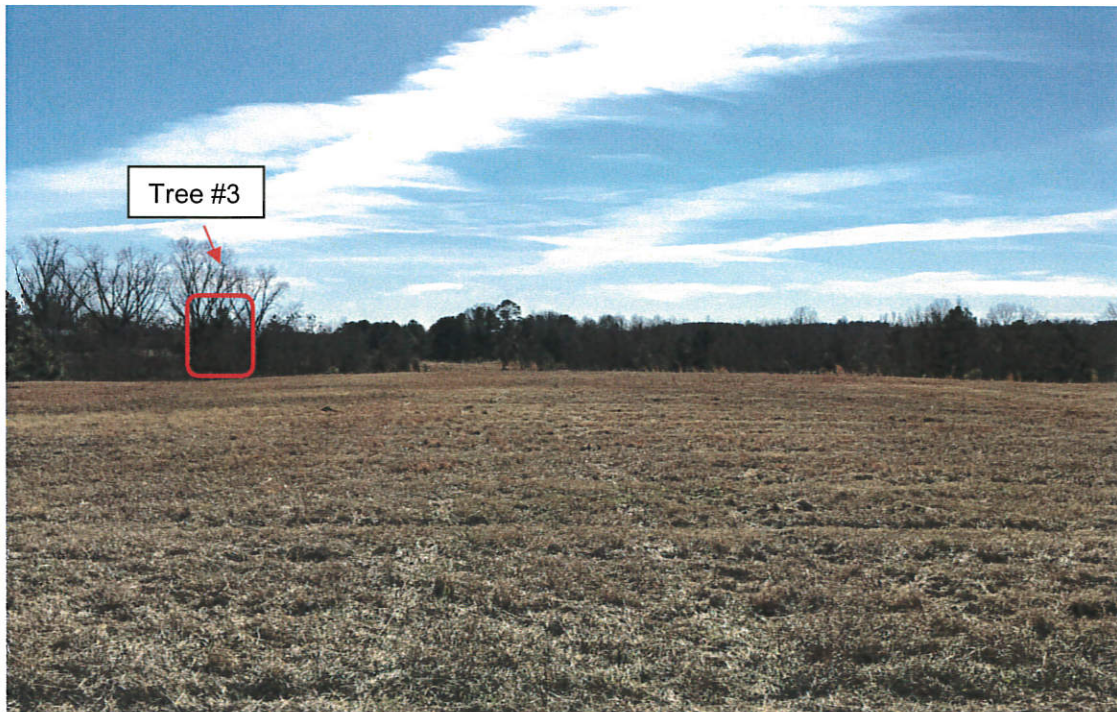
Photo # 1 – Runway 33 Approach

- Runway 33 – Trees identified as Tree #3 and Tree #6 are obstructions to the ALDOT 20:1 Approach/Departure Path (See Photo #1 Appendix 2).
- Runway 15 – Trees identified as Tree #6, Tree #9, Tree #10, and Tree #11 are obstructions to the ALDOT 20:1 Approach/Departure Path (See Photo #2, Appendix 3). Trees identified as Tree # 5 and Tree # 8 are not obstructions but will be obstructions by next year if not removed.

- Remove all obstructions to the 20:1 ALDOT Approach/Departure Path.

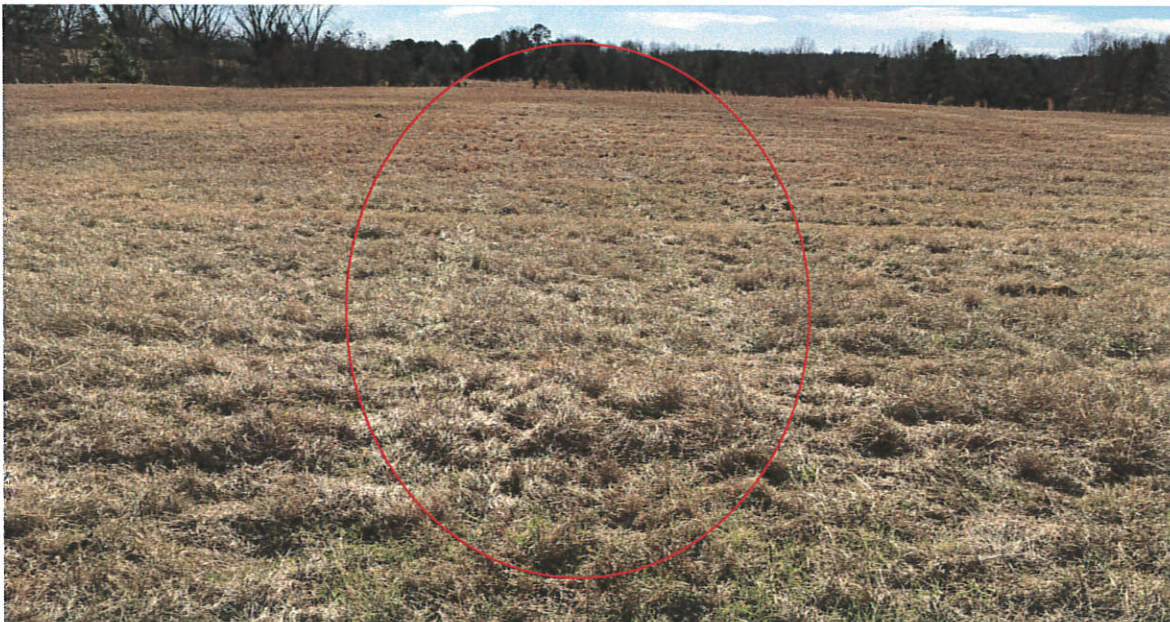
Photo #6—Driving in RSA

- The runway safety area does not meet state licensing requirements. There is evidence that vehicles have been driving through the safety area of both runway approaches to access the runway and airport property (See Photo #6 and #7).

- There were no prohibited activities observed during the inspection. However, signs that the airport has been used for other than aeronautical activities were observed. Tire tracks in the runway safety area and runway approaches was noted (See above Photo #6 and #7).

- Prevent unauthorized access within the Runway Safety Area.

- Restrict all unauthorized access.

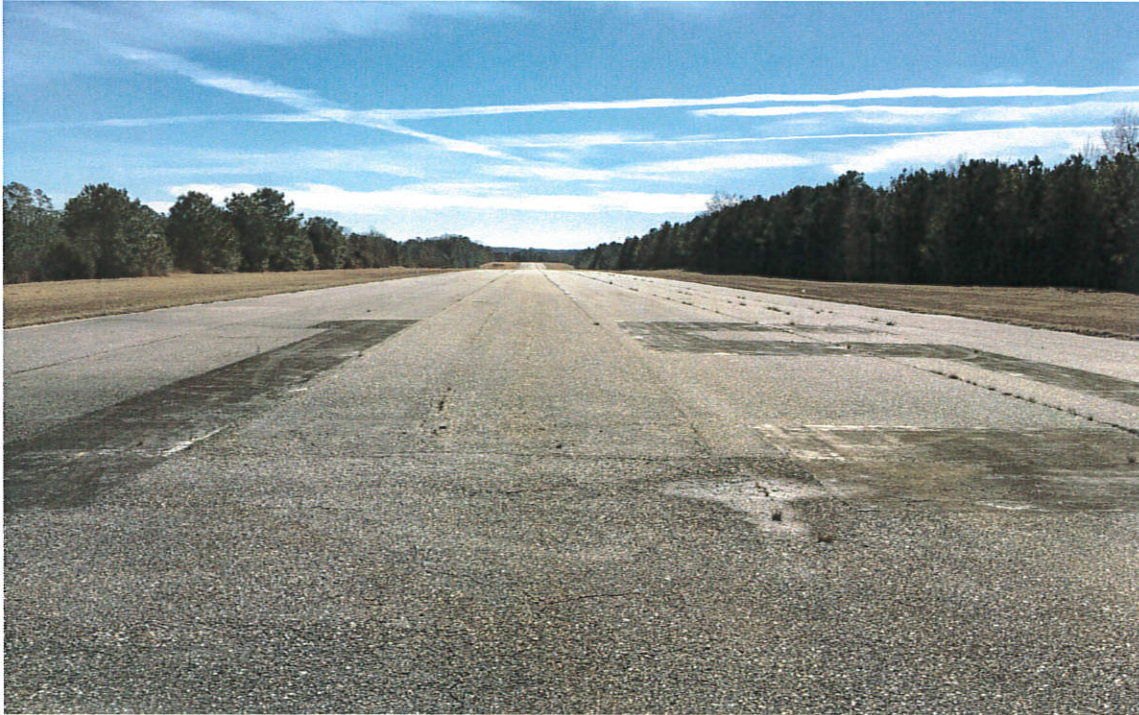
Photo #8 – Basic Markings Rwy 33

- The airport markings are in poor condition due to fading and algae growth (See Photo #8).

- Clean markings. If unable to clean, markings should be replaced in accordance with FAA AC 150/5340-1L.

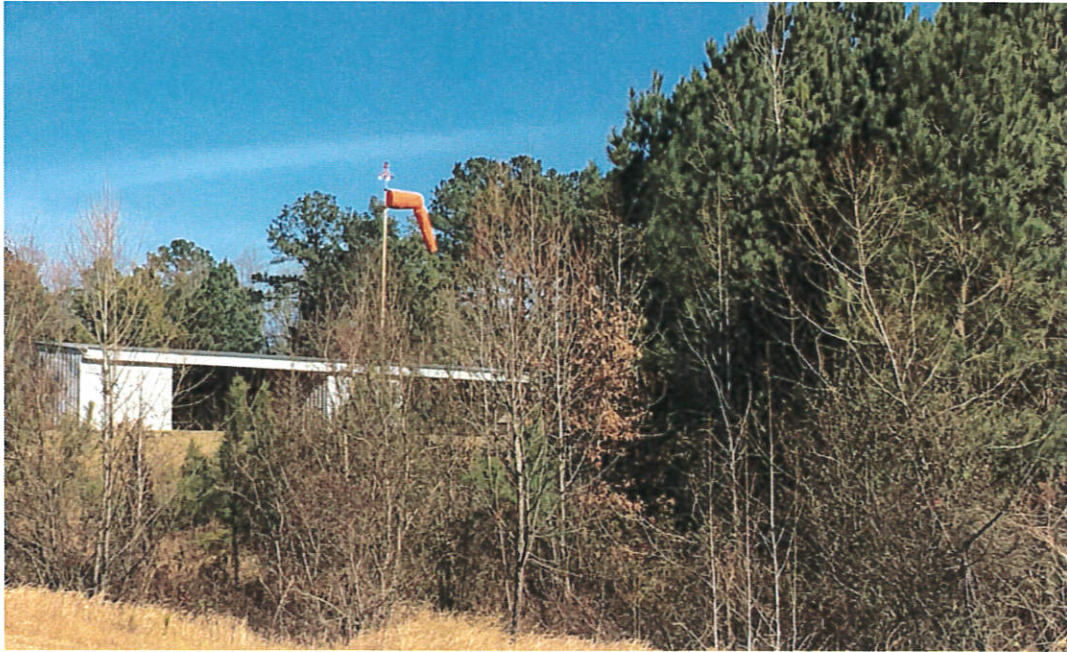
Photo #9 – Wind Cone

- The wind direction indicator (wind cone) is incapable of providing accurate wind data due to obstruction by trees (See Photo #9).

- Remove all obstructions so that the wind direction indicator provides accurate wind information.

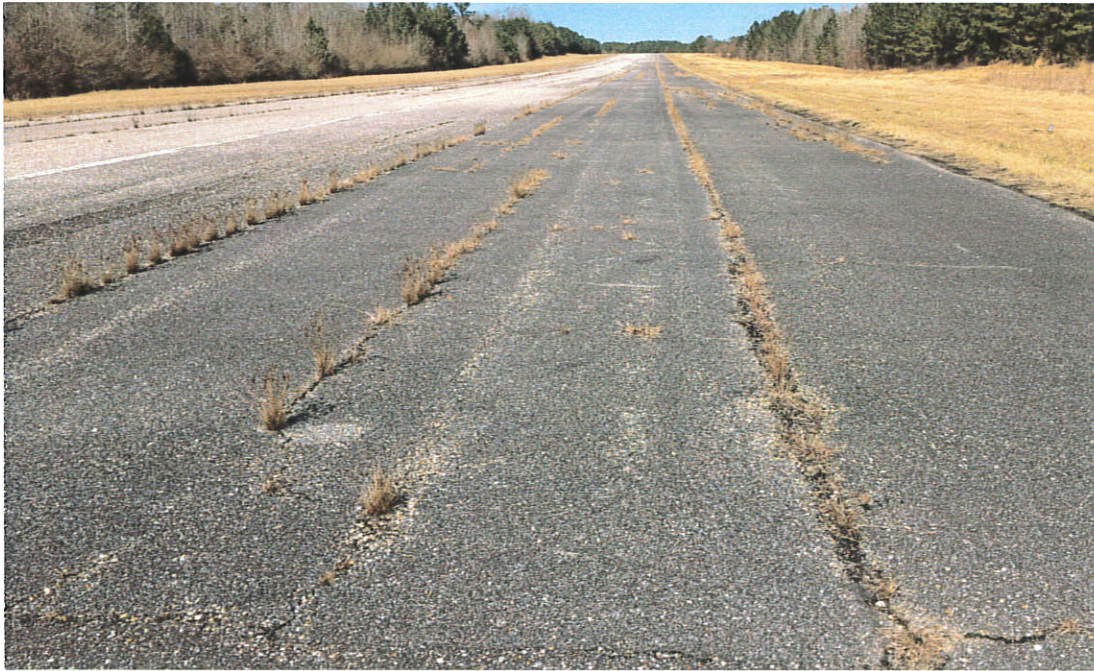
- The airport pavement surfaces are in POOR condition with most paving joint cracks containing vegetation and moderate raveling over the majority of the runway surface (See Photo #10).
- Bushes with thick limbs are growing through pavement cracks on the Runway 33 identifiers that pose series safety hazards to landing aircraft (See Photo #11, #12). (iPhone 6s for size reference)
- Rutting and depressions around Runway centerline are causing ponding issues throughout runway surface (See Photo #13).
- Centerline joint cracking is widening and creating foreign object debris (FOD) (See Photo #14).

Photo #10—Joint cracking containing vegetation

- Eradicate the vegetation, clean and seal the cracks.
- Remove FOD runway.
- It is recommended that action be taken to ensure pavement safety standards meet the requirements of the Aeronautics Bureau. Pavement failure will result in the immediate closure of the airfield by personnel of the Alabama Department of Transportation Aeronautics Bureau.

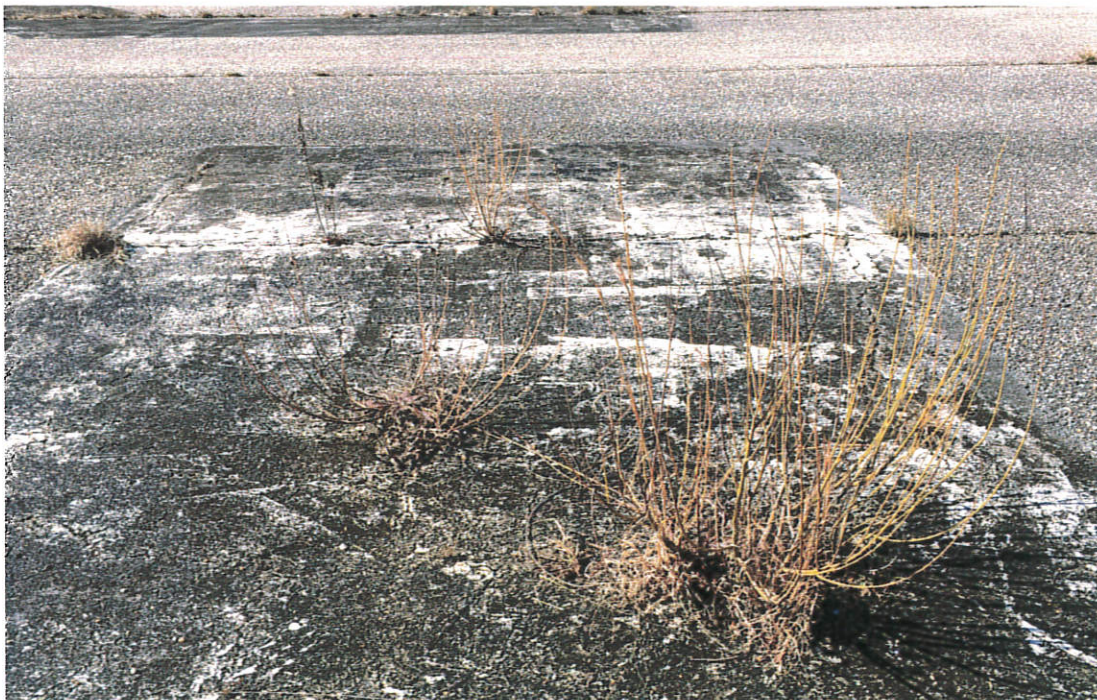
Photo #11—Brush growing through Runway 33 Identifiers

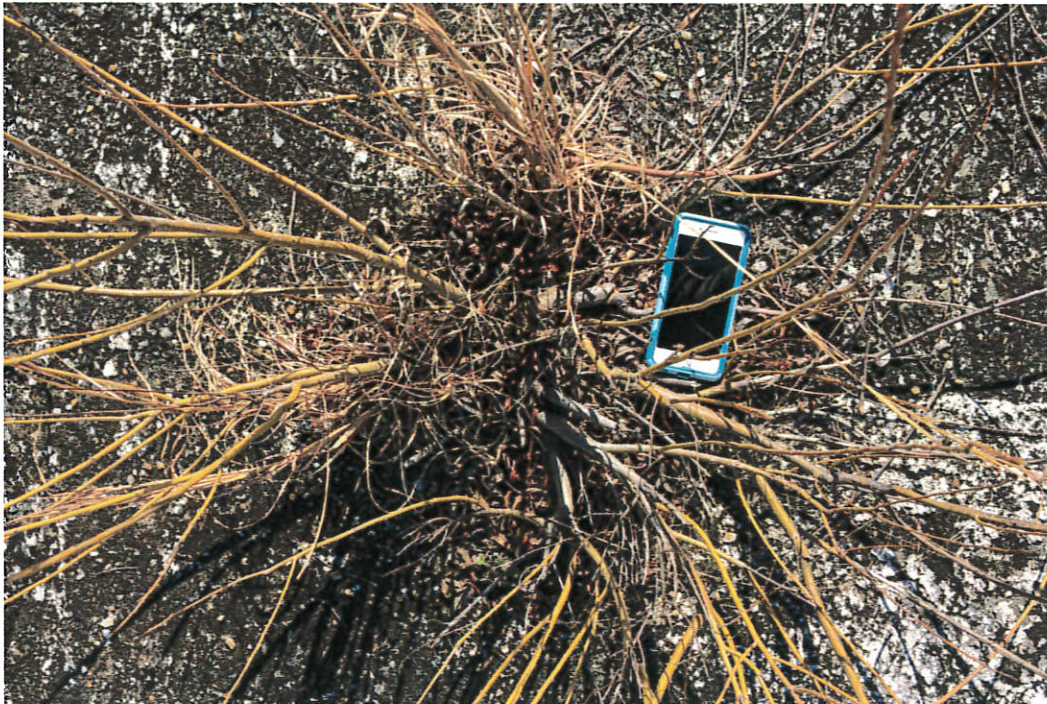
Photo #12— Brush growing through Runway 33 Identifiers

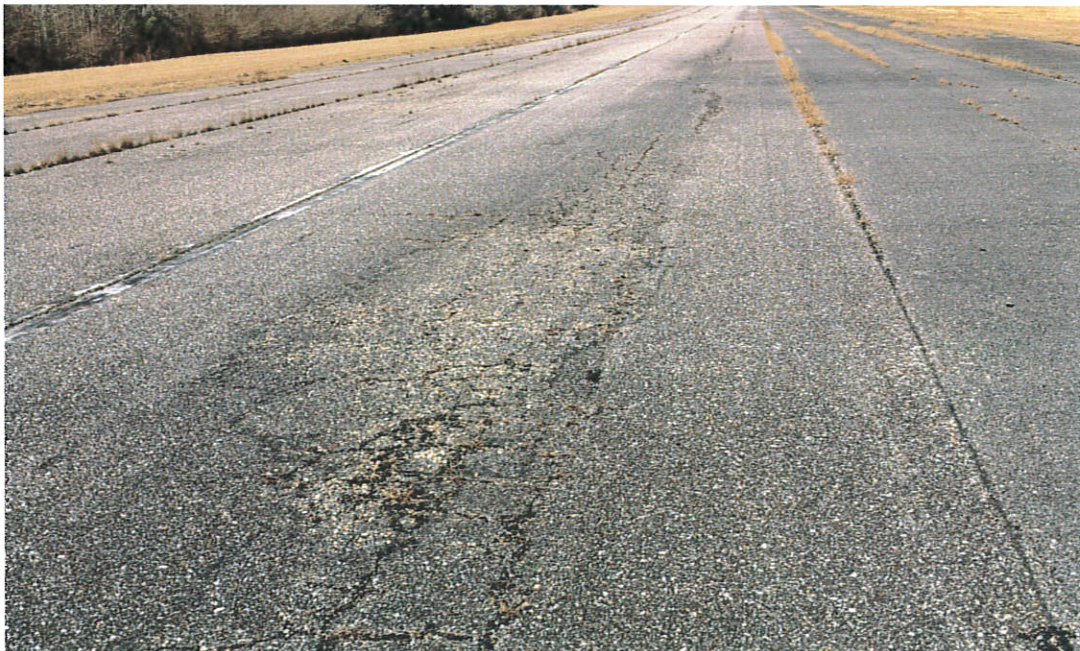
Photo #13—Rutting/Ponding on Runway
