**Subject: Annual Inspection Report
North Pickens Airport (3M8)**

Annual Inspection Report

April 15, 2021

North Pickens Airport (3M8)
Reform, Alabama

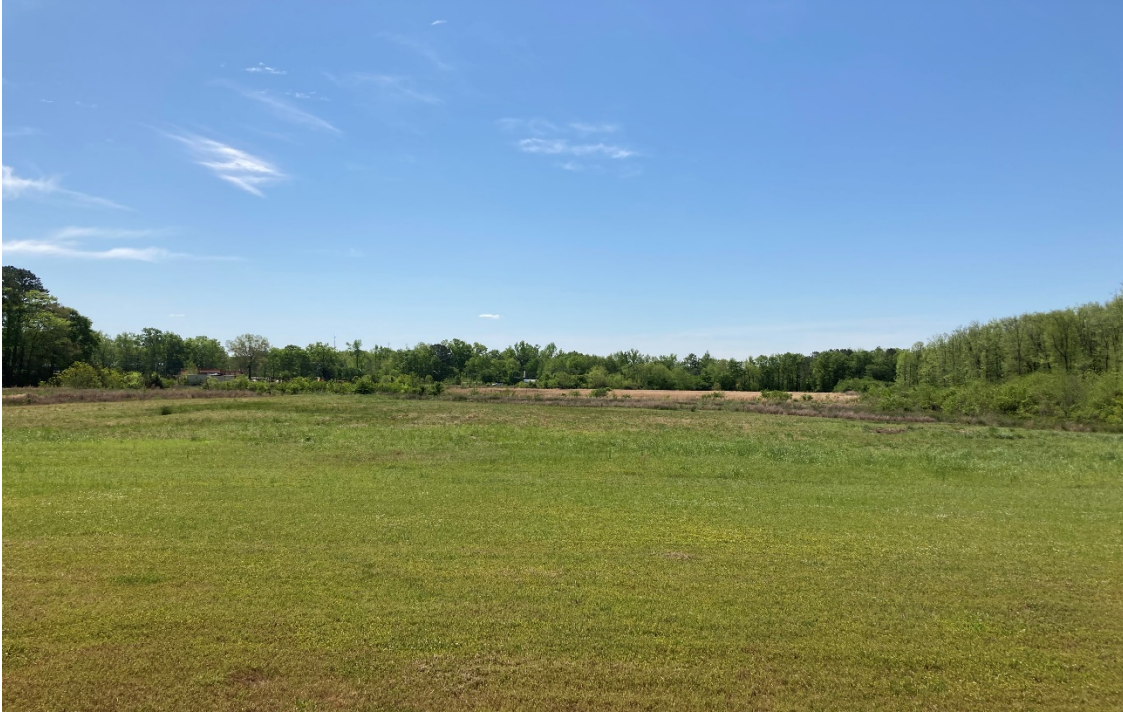
Photo #1 – Runway 01 Approach

- Runway 01- No obstructions (See Photo #1).
- Runway 19- Tree identified as Tree #9 and surrounding foliage is a violation to the ALDOT 20:1 Approach/Departure Path (See Photo #2).

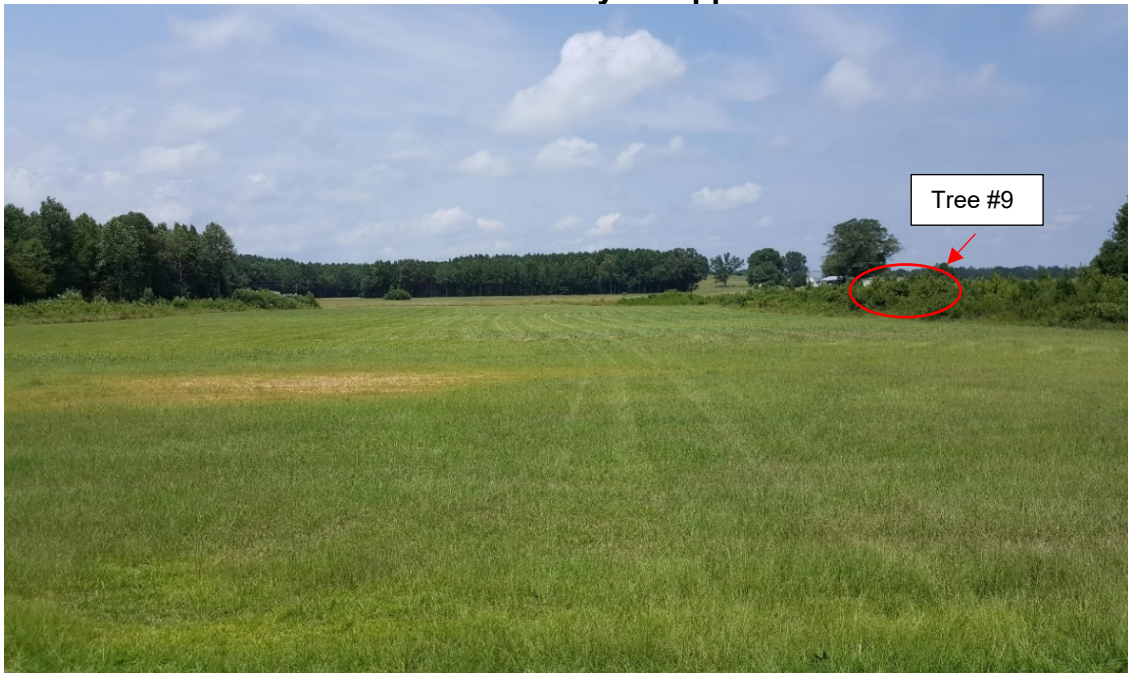
Photo #2 – Runway 19 Approach

9. Trees 9' Abv. RWY
313' From RWY End
112' L of CL
12:1 Obst. Clnc

- Remove all obstructions within the Required 20:1 Approach/Departure Path.
- The obstructions detailed in this report are representative and may not include all obstructions in the Approach/Departure Path.

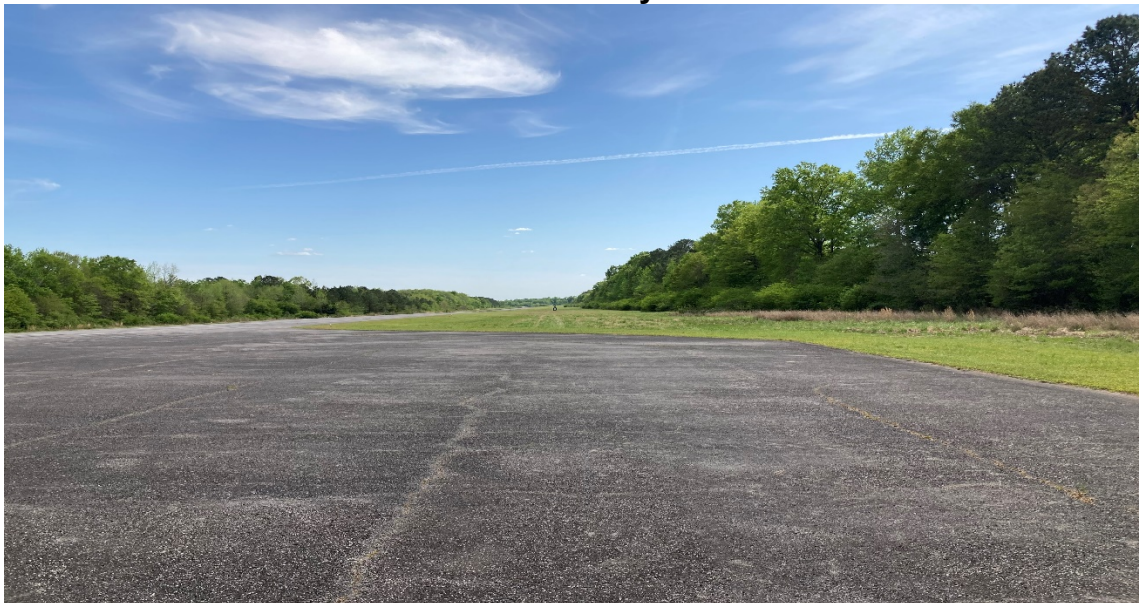
Photo #3 – Primary Surface

- The primary surface meets state licensing requirements (See Photo #3).

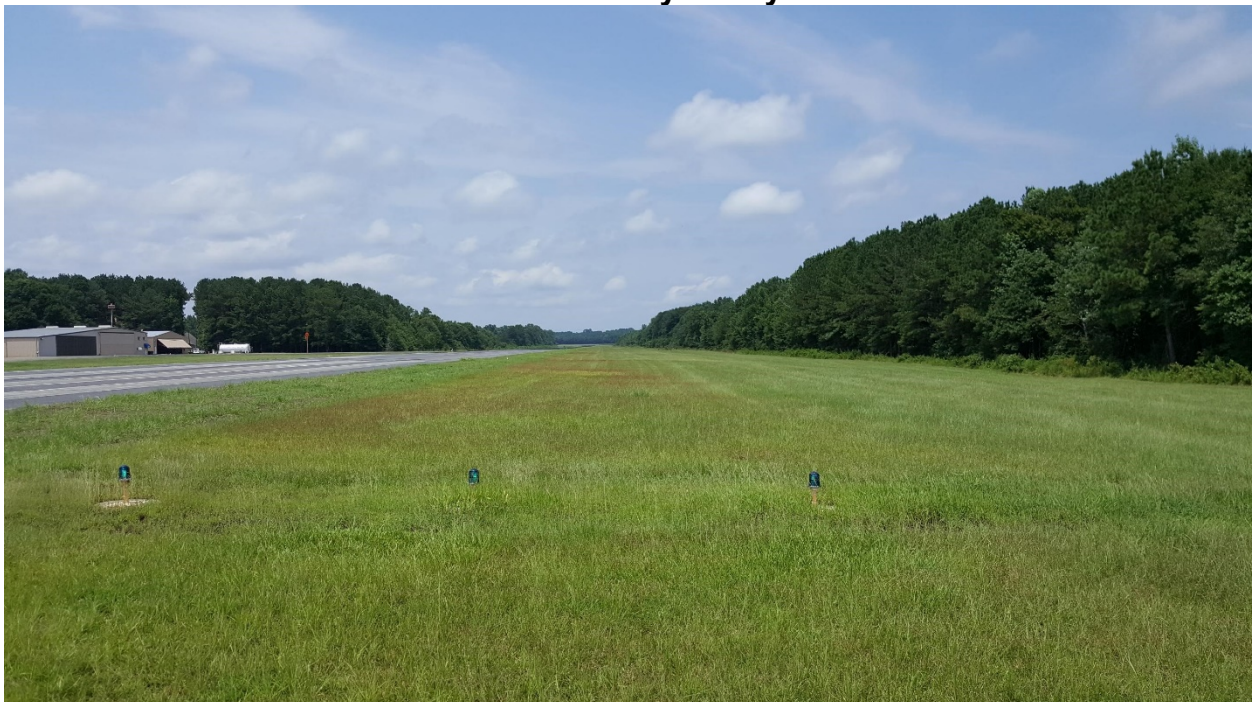
Photo #4 –Runway Safety Area

- The runway safety area meets state licensing requirements (See Photo #4).

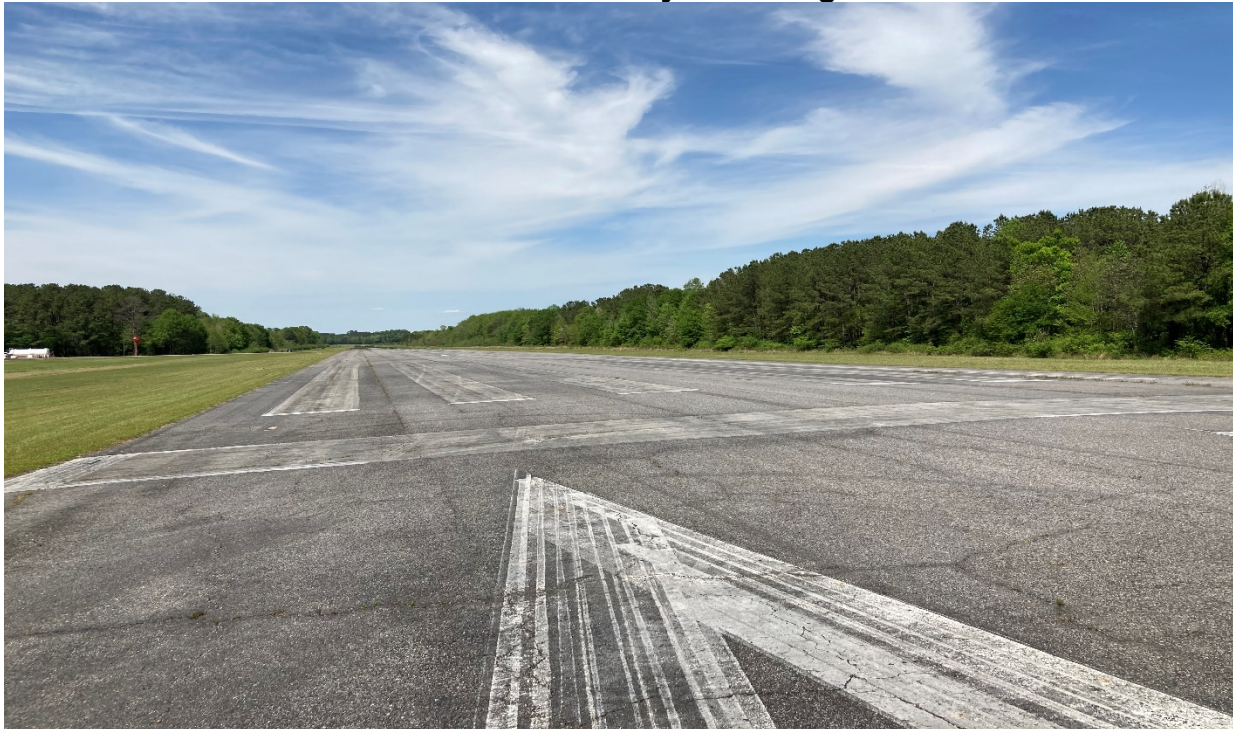
Photo #5 – Runway 1 Markings

- The airport markings are in **POOR** condition (See Photo #5).

- Proceed with pavement maintenance/remarking project detailed in the airport's Capital Improvement Plan (CIP).

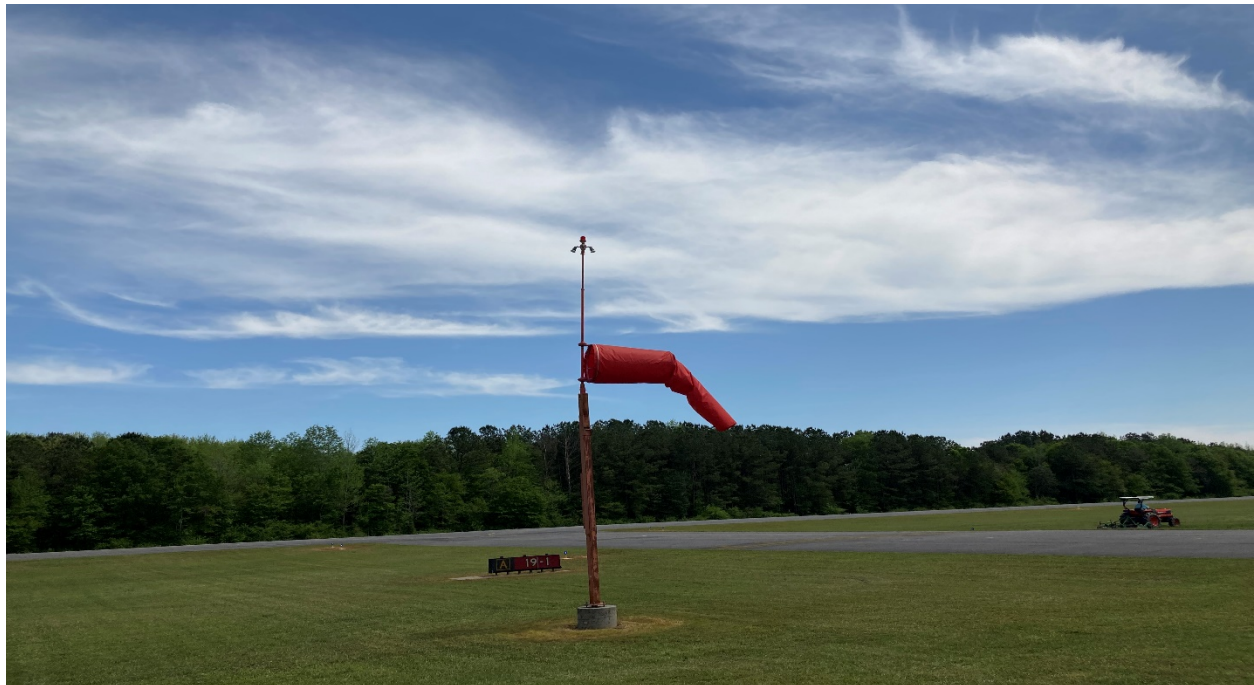
Photo #6 – Wind Direction Indicator

- The wind direction indicator (wind sock) is in good condition.

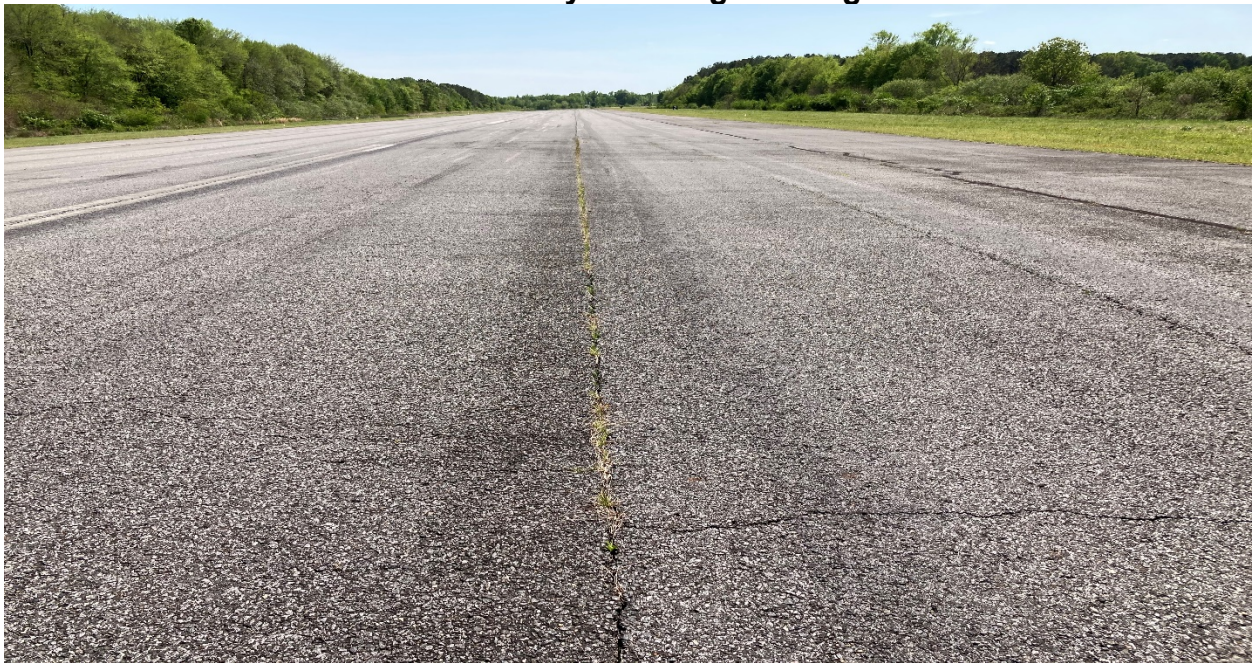
Photo #7 – Runway Cracking and Vegetation

- Apron pavement is in **fair** condition due to cracking and vegetation growth (See Photo #).
- Taxiway pavement is in **fair** condition due to cracking (See Photo #).
- Runway pavement is in **fair** condition due to cracking and vegetation growth (See Photo #).

- Proceed with pavement maintenance project detailed in the airport's Capital Improvement Plan (CIP).

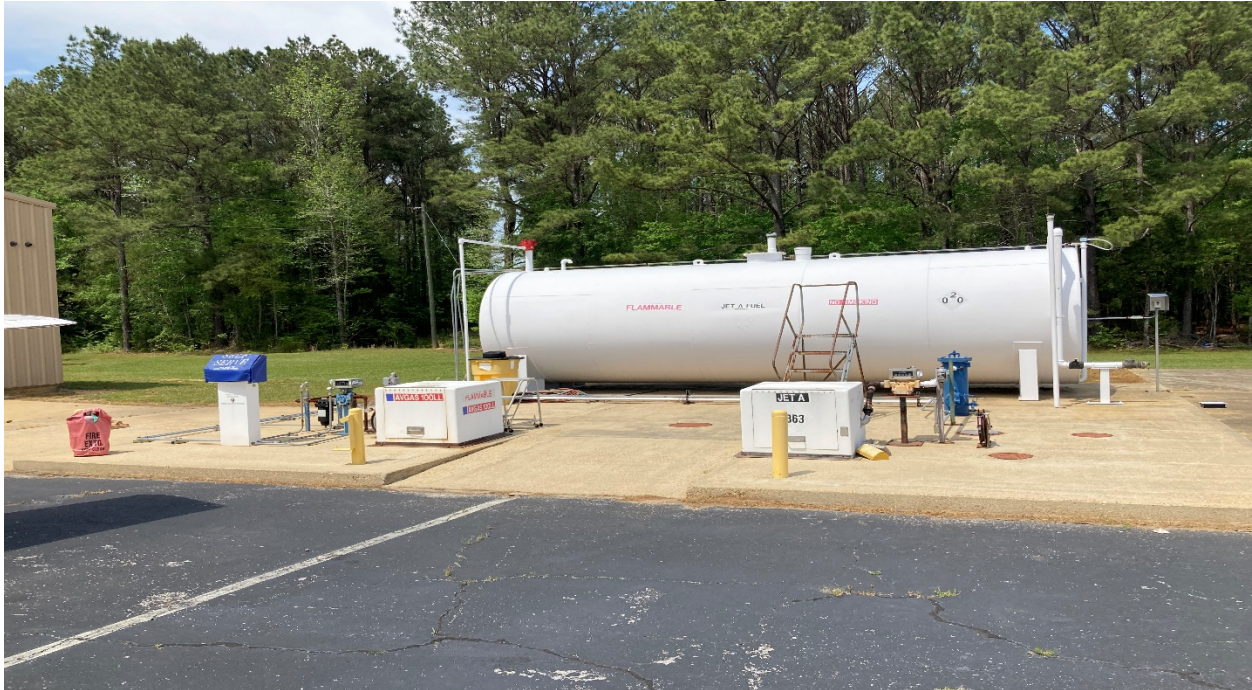
Photo #9 – Fueling Area

- While the fuel system meets the requirements established by the Alabama Department of Transportation Aeronautics Bureau, the State of Alabama Department of Agriculture and Industries may have additional requirements for fueling systems that were not considered during this inspection (See Photo #9).

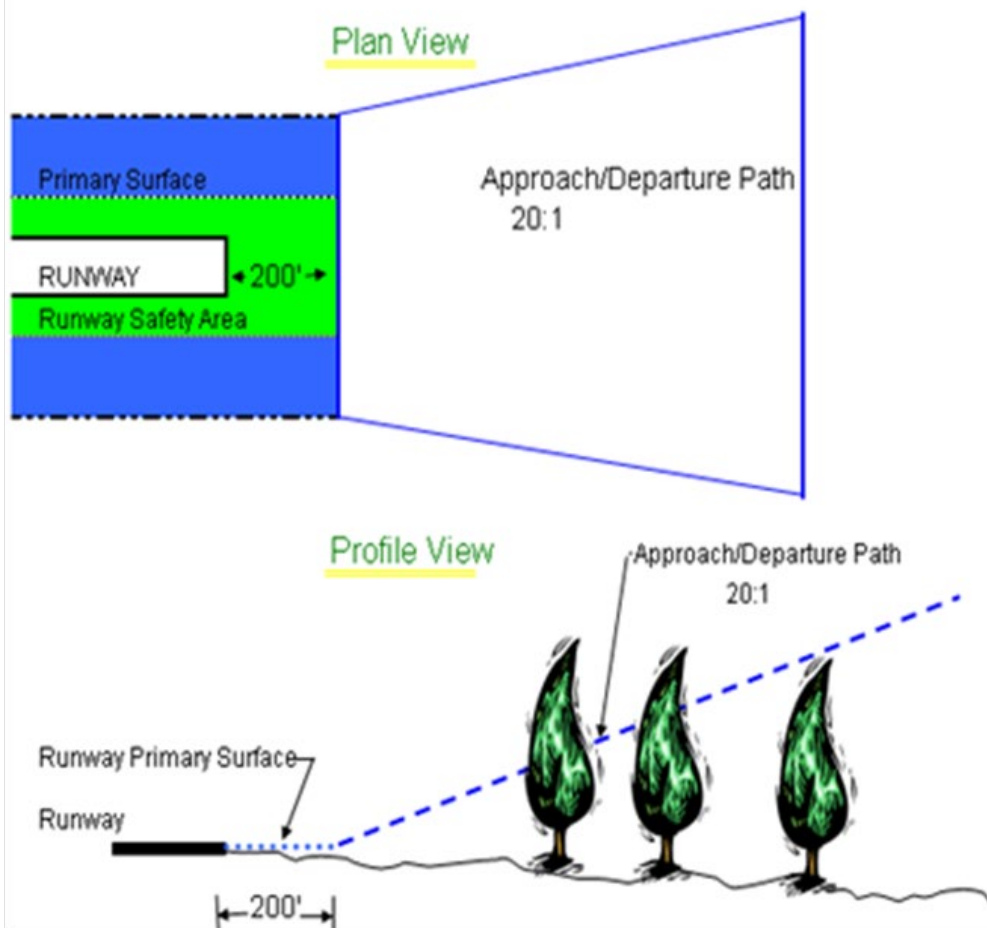
APPENDIX I

Approach and Departure Path Dimensions			
Inner Width	Outer Width	Length	Acreage
250 Feet	450 Feet	1,000 Feet	8.04 Acres
Primary Surface Dimensions			
250 Feet Wide Centered Along Runway Centerline			
Extending 200 Feet Past the Runway End			
Runway Safety Area Dimensions			
120 Feet Wide Centered Along Runway Centerline			
Extending 200 Feet Past the Runway End
