**Subject: Annual Inspection Report
Talladega Municipal Airport (ASN)**

**Annual Inspection Report
Talladega Municipal Airport (ASN)
Talladega, Alabama**

May 14, 2020

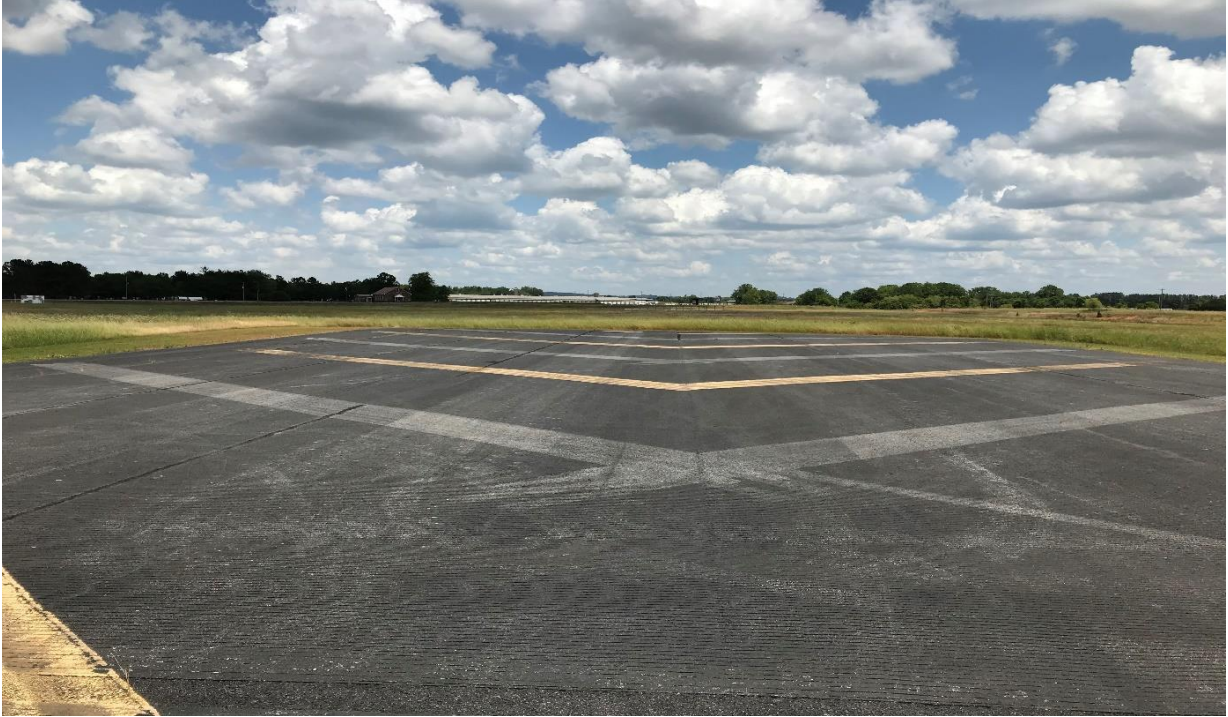
Photo #1 – Runway 04 Approach

- Runway 04 – No obstructions (See Photo #1).
- Runway 22 – No obstructions (See Photo #2).

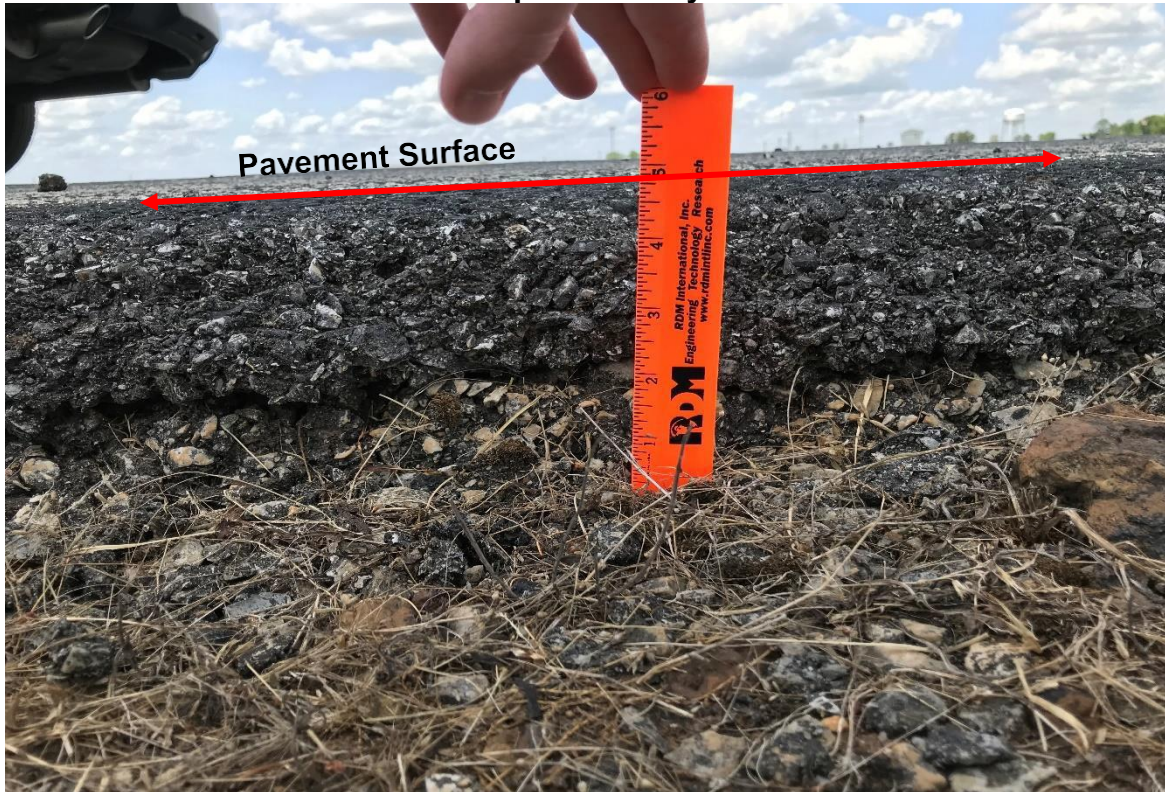
Photo #3 – Lip of Runway Pavement

- The runway safety area does not meet state licensing requirements.
- Lip of runway pavement exceeds three (3) inches in several areas (See Photo #3).

- The runway is in fair condition with paving lane cracking, thermal cracking, and aging crack seal (See Photo #7). Lip of runway pavement exceeds 3 inches (See Photo #3).
- The taxiway system is in overall fair condition, with a few areas rating poor and one area that is failing. The taxi lanes around the southwest hangars are in poor condition with block cracking and vegetation growth (See Photo #8). An area of taxiway between the fuel farm and main ramp is beginning to **fail** with raveling causing large amounts of foreign object debris (FOD) (See Photo #9). This area of taxiway should be **closed** to aircraft movement until this issue can be addressed.
- The main ramp is in fair condition and the northeast concrete ramp is in good condition.

- Bring up grade on runway shoulder so that there is a drop of three (3) inches or less.

- Recommended that taxiway between fuel farm and main ramp be closed to aircraft movement until pavement can be addressed.
- Correct runway surface drop-off.
- Keep taxiways clear of FOD.
- Contact airport engineer to plan a pavement maintenance project to correct taxiway safety hazards.

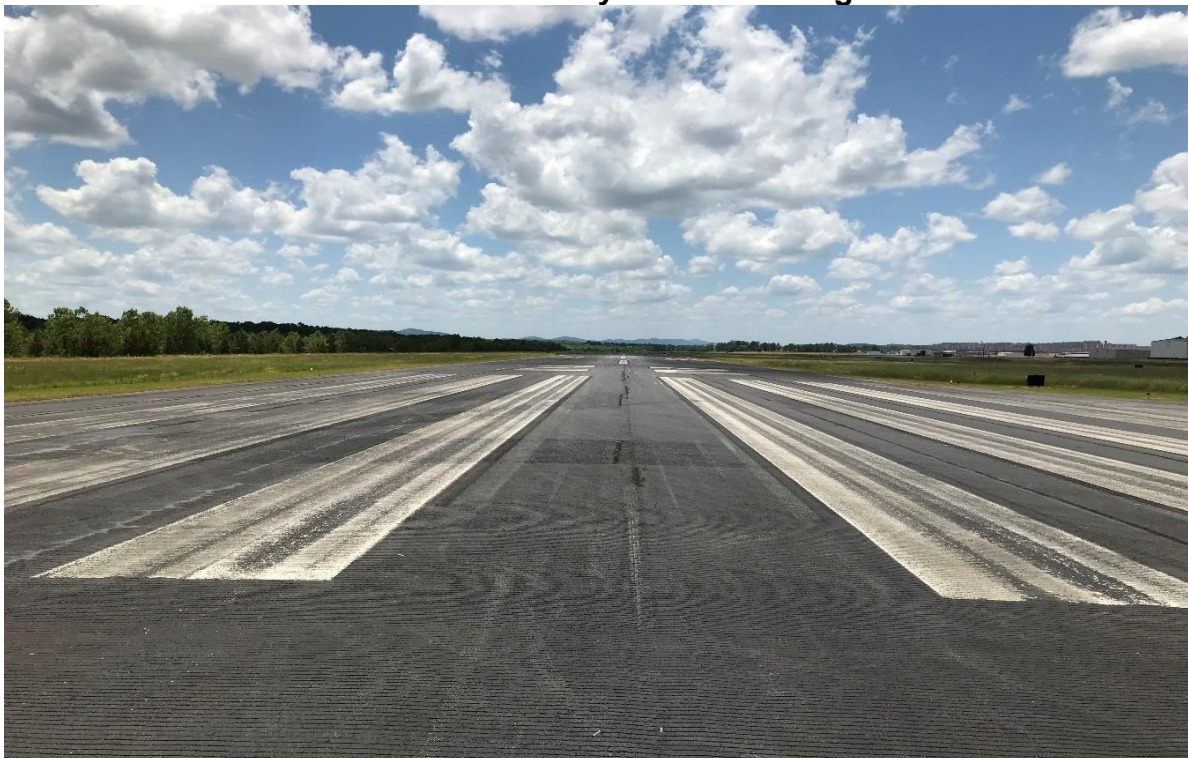
Photo #4 – Runway 04 PIR Markings

- The runway markings are in **FAIR** condition but are continuing to fade and will be **POOR** soon (See Photo #4).
- The taxiway markings are **FAIR** to **POOR** in some areas (See Photo #5)

- Clean markings. If unable to clean, replace markings in accordance with FAA AC 150/5340-1M.

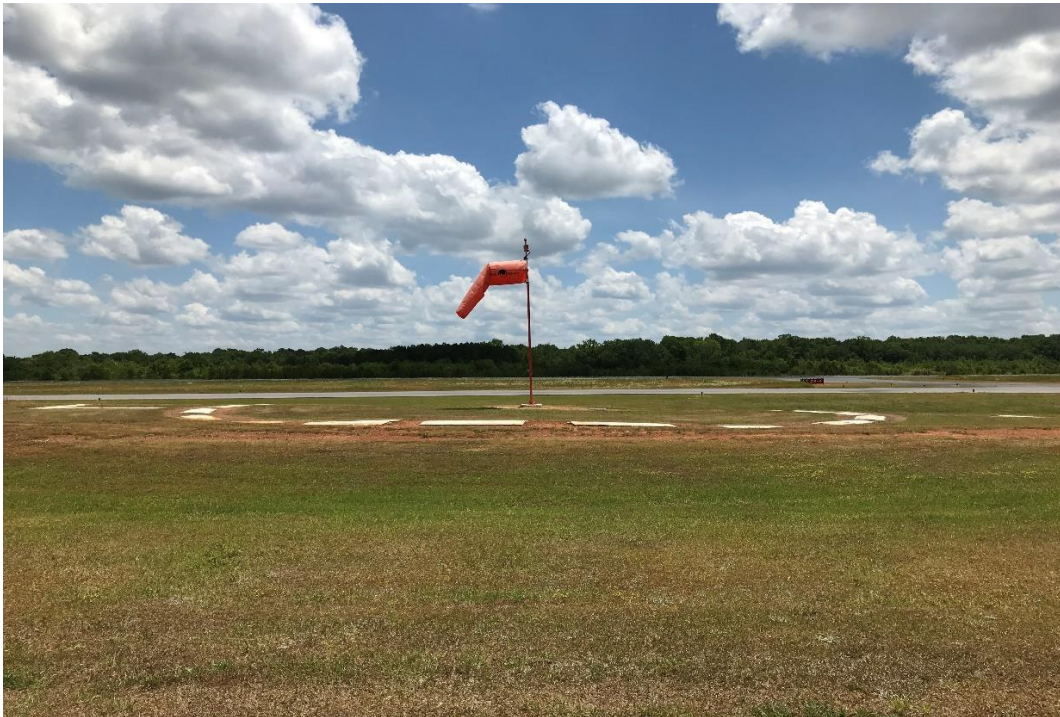
Photo #6 – Wind Direction Indicator

- The wind direction indicator (windsock) is operational and in **FAIR** condition (See Photo #6).

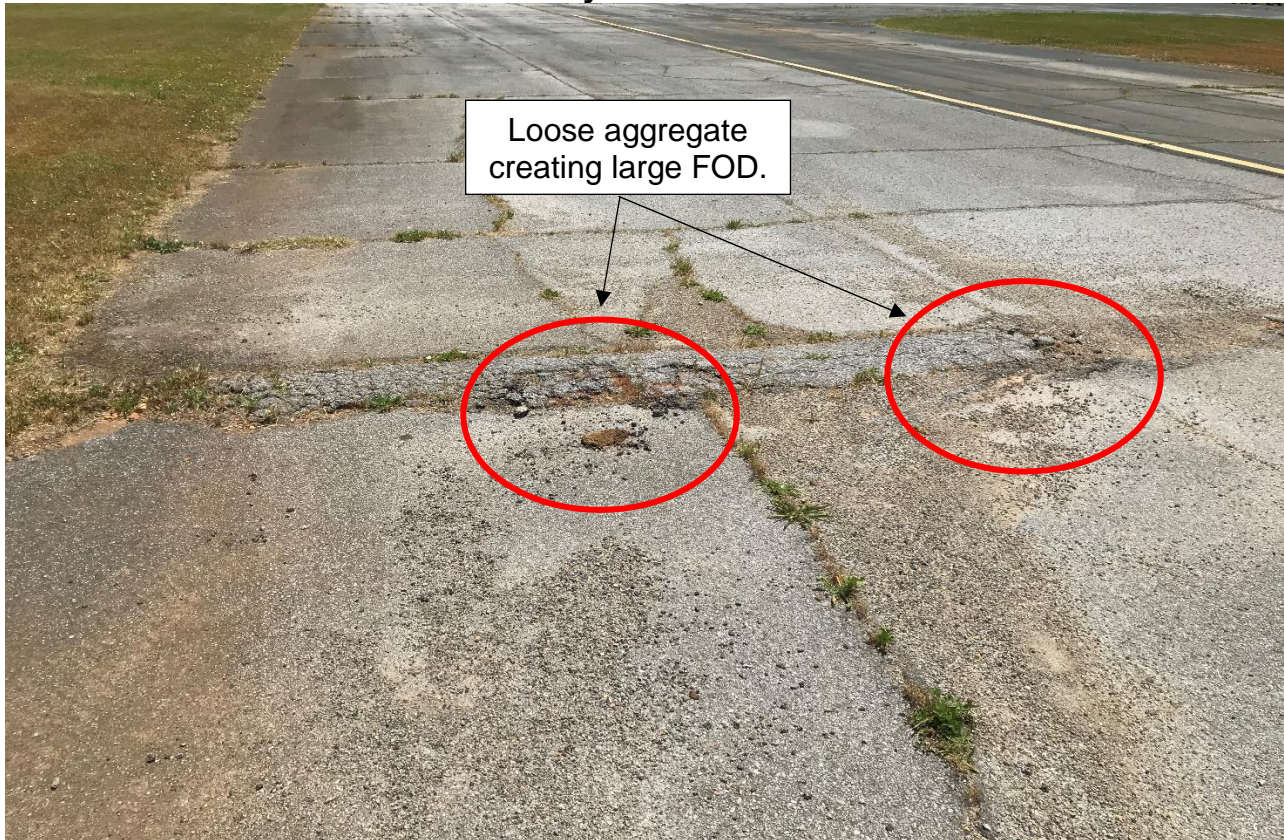
Photo #9 – Taxiway Failure Near Fuel Farm

The Runway Safety Area does not meet state licensing specifications and non-aeronautical storage was observed during the inspection. There are also several maintenance items detailed in the report that should be addressed as soon as possible. One such item is a portion of taxiway between the fuel farm and the main ramp that is experiencing pavement failure. Closure of that section of taxiway to aircraft movement is highly recommended.

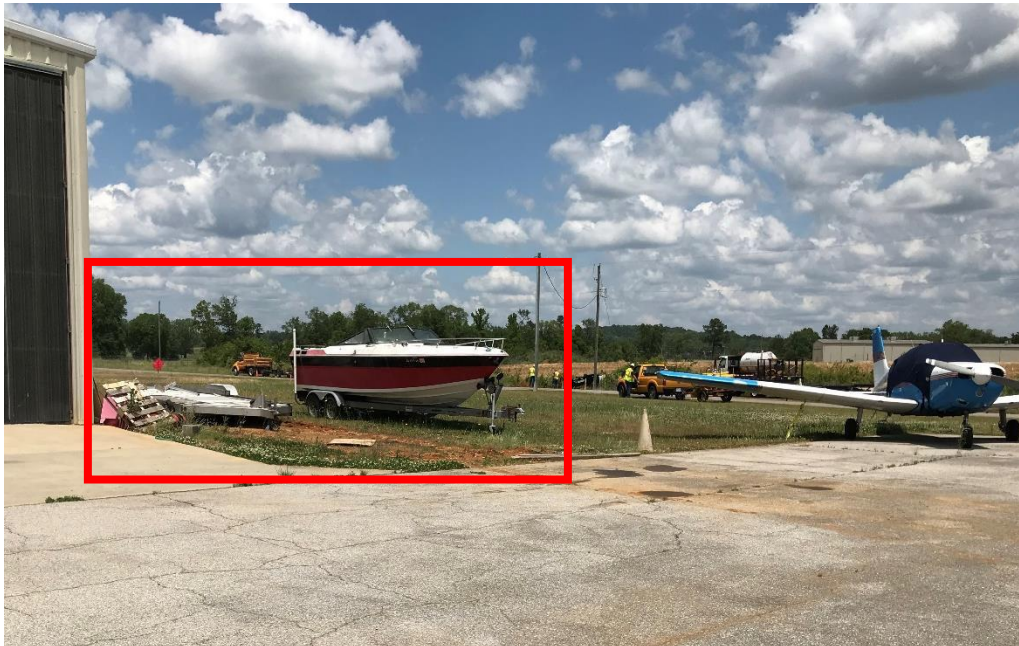
Photo #10 – Boat

- A boat and multiple boat trailers were observed near the midfield hangars (See Photo #10). This constitutes storage that is non-aeronautical in nature.
- Construction vehicles and equipment were staged by the midfield hangars, without proper markings or barricades (See Photo #11).

- Remove boat from airport premises.
- Move construction vehicles from aircraft movement area or mark them in accordance with FAA AC150/5210-5D. All Construction areas should be marked or barricaded in accordance with FAA AC150/5370-2G.
