Alabama Statewide Airport Pavement Management Program Update

Franklin Field (07A)

Final Report

February 2022

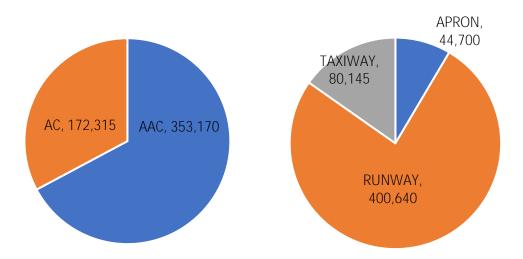
Figure ES-1: Pavement Area (sf) by Surface Type and Branch Use.

There are 5 branches and 6 sections within 07A approximately 0.53 million square feet (sf). Figure ES-1 shows the distribution of the pavement network by surface type and branch use.

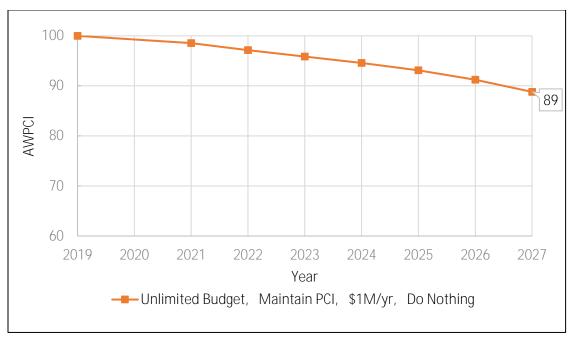
Figure ES-2: M&R Funding Levels.

The PAVER database was updated with 2019 condition data, maintenance and repair (M&R) policies, and unit costs; which were then used to evaluate the effect of multiple funding levels on the overall future pavement condition. Figure ES-2 presents the forecasted 07A network PCI values for each funding level. Since the overall PCI is 100, all scenarios have the same effect on future condition, with no repairs identified.

Since the overall PCI is 100, all scenarios have the same effect on future condition, with no repairs identified.

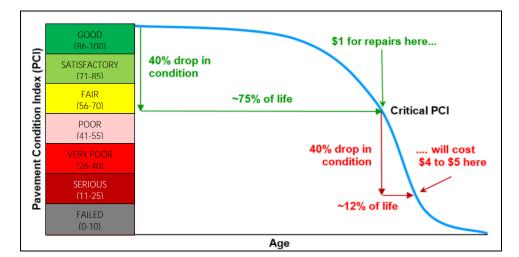
Figure 1.1: Pavement Management Concept.

In examining the lifespan of a 2015 years. After that point, the rate of deterioration of pavements accelerates sharply as the age of the pavement increases, and within five years, the pavement may deteriorate to the point of failure. In order to extend pavement life, maintenance and repairs need to be scheduled and performed before u

Pavement Condition Index (PCI) is between 60 and 70 for general aviation airports. If the work is done before deterioration accelerates, the cost of rehabilitation can be reduced as shown in Figure 1.1.

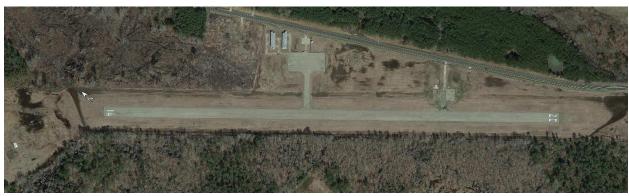
Figure 2.1: Franklin Field.

07A is a General Aviation (GA) airport located approximately 5 miles west of Union Springs. The airport was activated in May 1963 and is owned by Bullock County and managed by the Franklin Field Airport Authority. Figure 2.1 shows an aerial image of the airport.

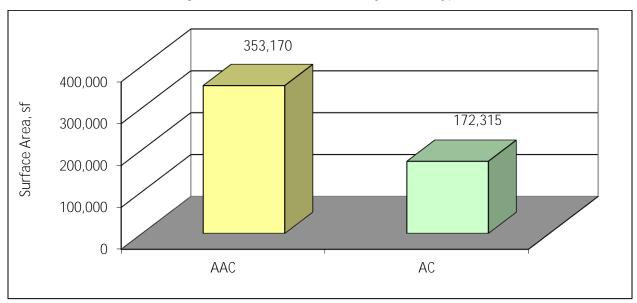
Figure 2.2: 07A Pavement Area by Surface Type.

Figure 2.2 shows the distribution by surface type. Figure 2.3 presents the distribution by pavement use (e.g. runway, taxiway, and apron).

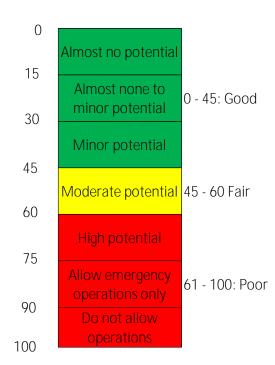
Figure 3.1: FOD Potential Rating Scale.

The FOD index was developed by the US Air Force and is described in detail in the US Army Corp of Engineers Engineering Technical Letter (ETL) 04-09, Pavement Engineering Assessment (EA) Standards. Loose objects on an airfield pavement surface resulting from pavement distresses can be detrimental to aircraft engines, specifically engines that are low to the ground. The objects are ingested into the engines causing costly damage and presenting a safety hazard. Not all pavement distresses create a FOD potential. Therefore, an additional index was identified that uses the results of the PCI distress survey. As shown in Figure 3.1, the scale ranges from 0 to 100 with 0 being no FOD potential. Note that the FOD index uses a simplified three color scale.

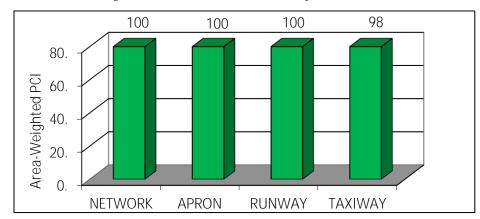
Figure 3.2: Pavement Condition by Branch Use.

Figure 3.2 presents the area-weighted PCI by use and the overall airside network.

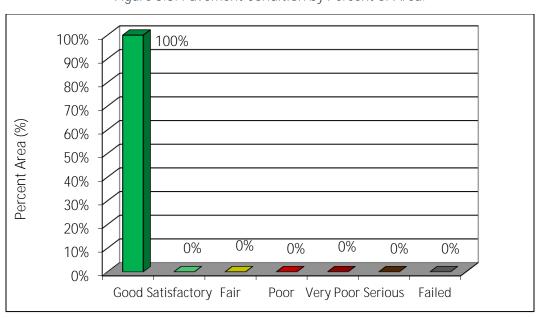
Figure 3.3: Pavement Condition by Percent of Area.

Figure 3.3 shows the distribution of the 07A pavement network by condition. None of the network is in h

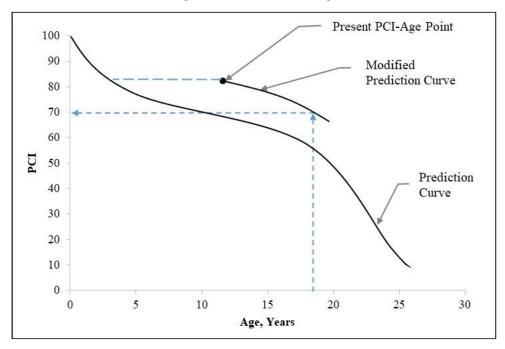
Figure 4.1: PCI Forecasting.

Prediction models are used at the section level to compute future conditions based on the typical performance of the pavement sections that are included in each model. Future condition is computed by defining its position relative to the prediction model. The section prediction curve, or equation, is drawn through the current PCI-age point for each specific section. Since the shifted curve will run parallel to the computed prediction model, the predicted condition can be computed for any future age. Figure 4.1 is an illustration of this process.

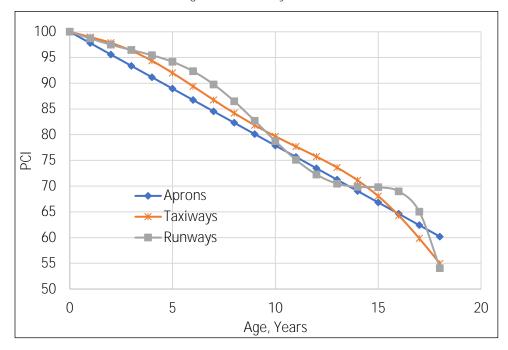
Figure 4.2: Family Curves.

Prediction models provide an effective way to compute future pavement performance based on past and current conditions, and pavement maintenance and rehabilitation practices. As new PCI inspection surveys are conducted, these models should be updated accordingly. In the case of the Alabama statewide airport pavement network, the best fit family curves were developed for each region by grouping pavements according to branch use (e.g. runway, taxiway) and surface type (e.g. AC, AAC, and APC). The family curves for ALDOT were developed based on branch use and are presented in Figure 4.2.

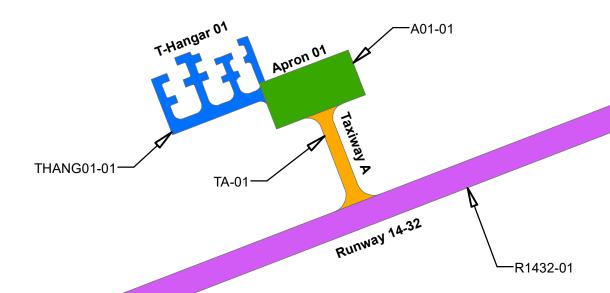
Fi	igure B1A	Branch Identification			
	All About	ENGINEER KP/M F	DATE	May 2021	MAP NUMBER Page 1
	Pavements, Inc. (API) www.allab.outpavements.com Telephone: 217-586-2765 FAX: 217 586-1967	REVISED JM	SCAL	1 in = 300 ft	FINAL

Legend Section Boundary Branch Identification Apron 01 Union Springs Runway 14-32 Union Springs Taxiway A Union Springs Taxiway Hangar 01 Union Spring Taxiway Turnaround RW14 UnionSpring
