ALABAMA
DEPARTMENT OF TRANSPORTATION

Subject: Annual Inspection Report
South Alabama Regional Airport

**Annual Inspection Report
South Alabama Regional Airport at Bill Benton Field
Andalusia, Alabama**

March 22, 2021

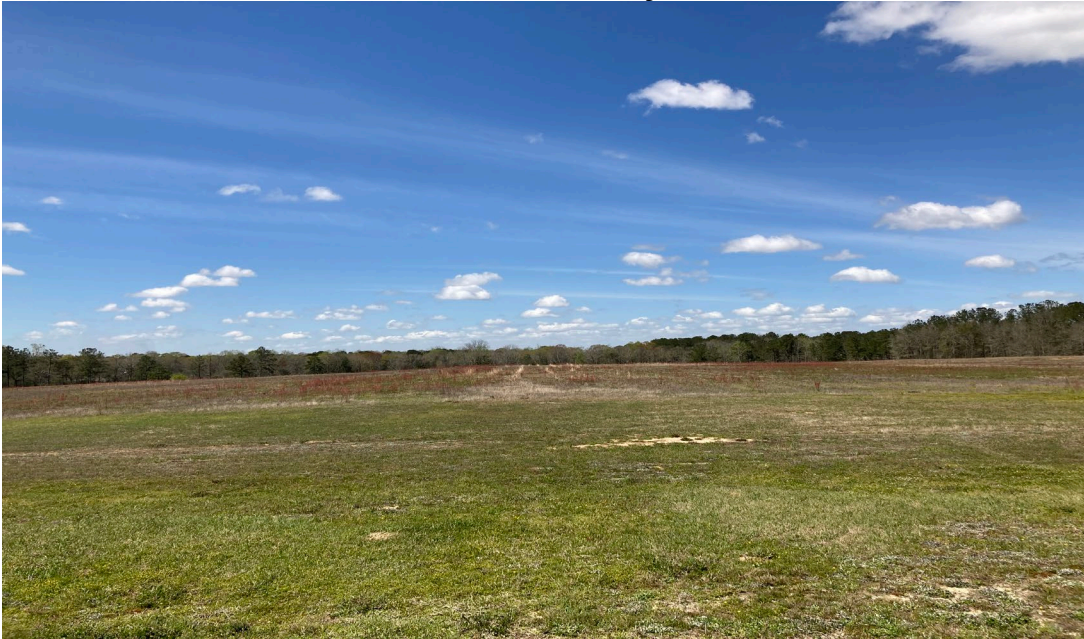
Photo # 1-Runway 11

- Runway 11: No obstructions (Photo #1).
- Runway 29: No obstructions (Photo # 2).

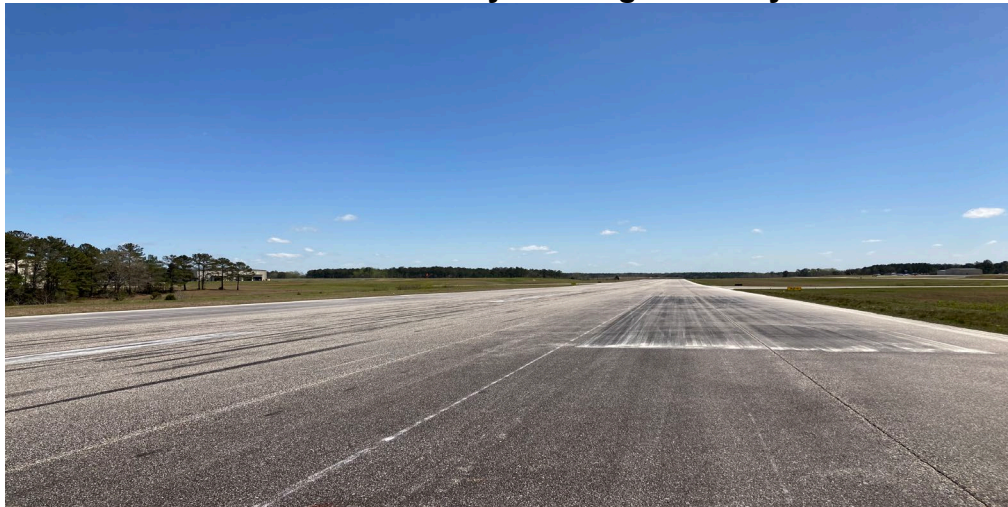
Photo #3-Runway Markings Runway 11

- The runway markings on Runway 11 are in **poor** condition. Markings are becoming dark and gray due to some form of contamination. The contamination is either a microbial (fungal and algal) growth or dirt (See Photo #3).
- The runway markings on Runway 29 are in **good** condition; however, rubber is starting to accumulate around the centerline(See Photo #4).
- Taxiway markings on Alpha taxiway are in **fair** to **poor** condition due to fading over time(See Photo #5).

- Clean markings. If unable to clean, markings should eventually be replaced in accordance with FAA AC 150/5340-1M.
- Consider a rubber removal project in the future.
- Re-mark taxiways in accordance with FAA AC 150/5340-1M.

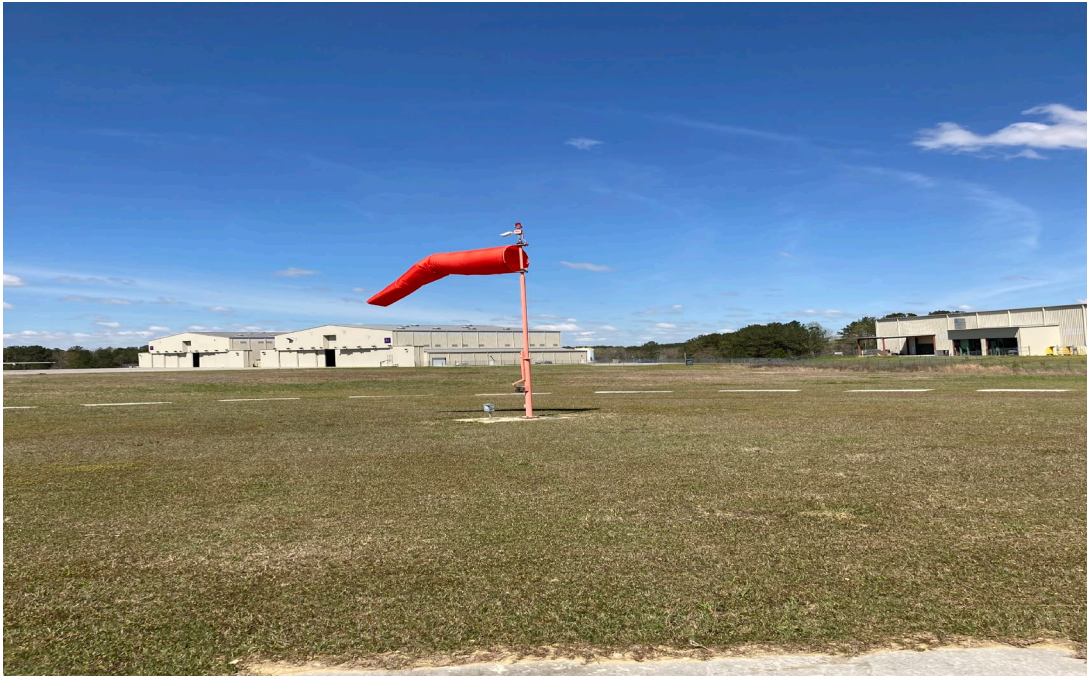
Photo #6 – Wind Cone

- The wind direction indicator (wind cone) is operational and in **good** condition (Photo #6).
- The segmented circle is showing signs of wear and paint has faded over time.

- Consider repainting the segmented circle.

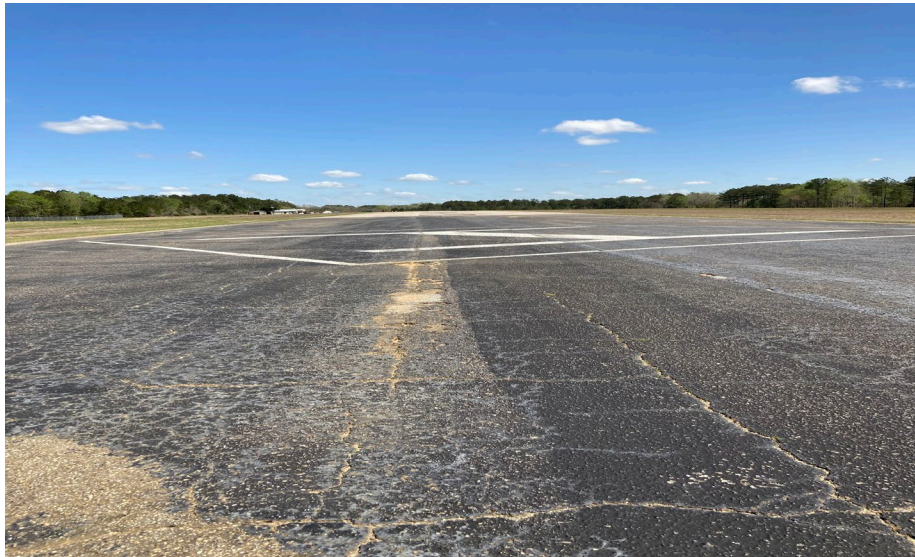
Photo #7-Pavement Failure Around Southern H

- The runway surfaces are in **good** condition.
- The taxiway is in **fair** condition.
- The apron is in overall **good** condition; however, pavement surface south of the helicopter refueling pads and around the southern Helipad is in **poor** condition, showing signs of pavement **failure**, causing a possible Foreign Object Debris (FOD) risk to aircraft (See Photo #7).

- Plan a pavement maintenance project for the affected surface.

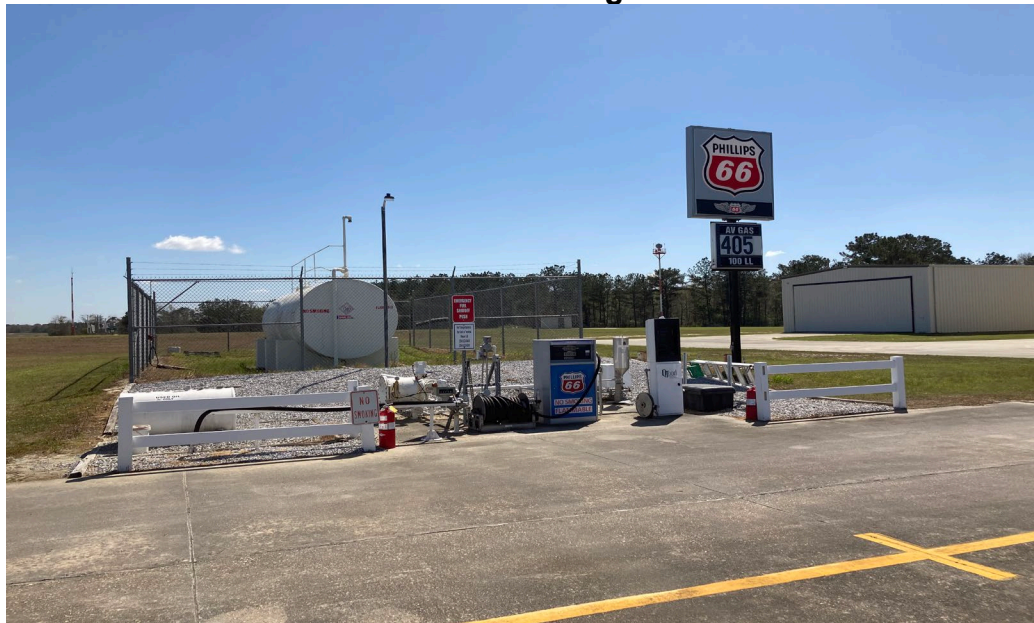
Photo #8-Fueling Area

- All fueling areas (airport and heliport) meet the requirements established by the Alabama Department of Transportation. However, the State of Alabama Department of Agriculture and Industries may have additional requirements for fueling systems that were not considered during this inspection (See Photo #8).

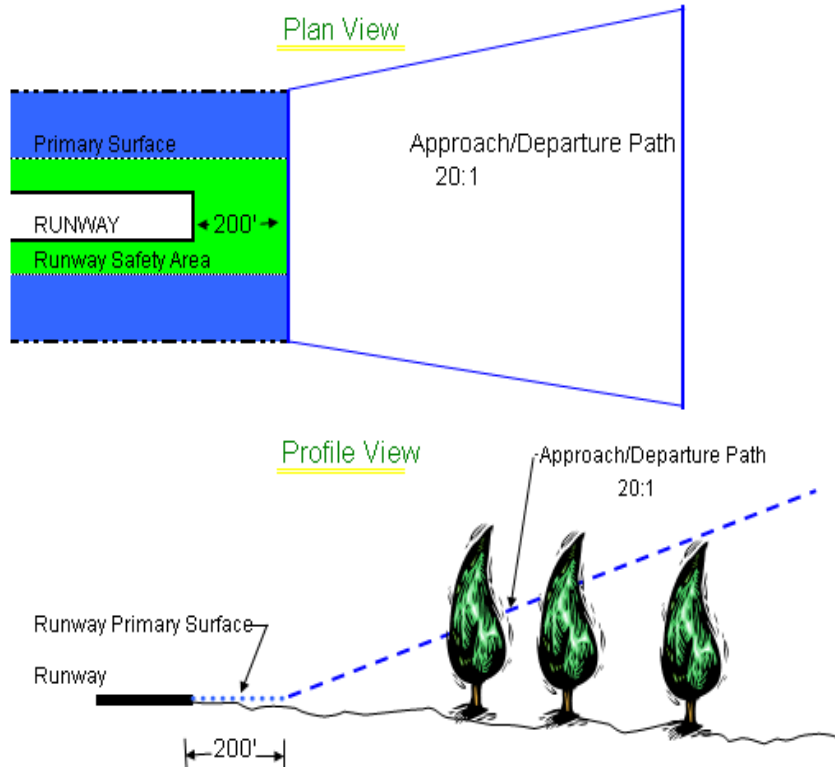
APPENDIX 1

Approach and Departure Path Dimensions			
Inner Width	Outer Width	Length	Acreage
250 Feet	450 Feet	1,000 Feet	8.04 Acres
Primary Surface Dimensions			
250 Feet Wide Centered Along Runway Centerline			
Extending 200 Feet Past the Runway End			
Runway Safety Area Dimensions			
120 Feet Wide Centered Along Runway Centerline			
Extending 200 Feet Past the Runway End
