**Subject: Annual Inspection Report
Brewton Municipal Airport**

**Annual Inspection Report
Brewton Municipal Airport
Brewton, Alabama**

February 28, 2022

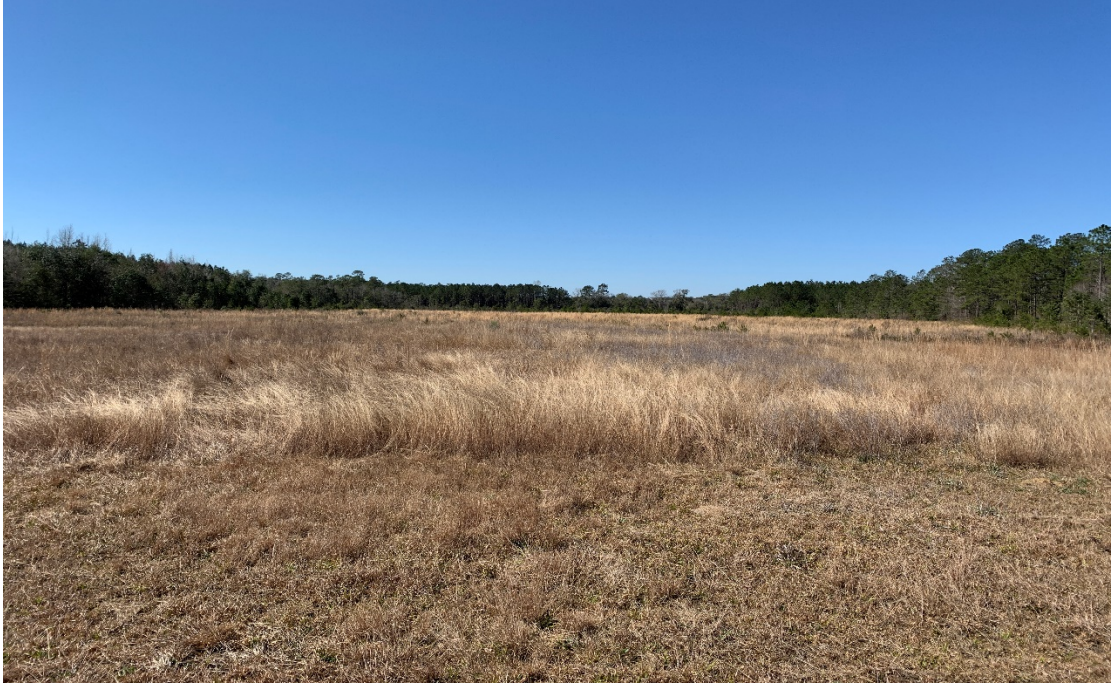
Photo # 1 - Runway 6 Approach

- Runway 06 – No obstructions (See Photo #1).
- Runway 24 – Trees identified as #5, #12, and #14 violate the Required ALDOT 20:1 Approach/Departure Path (See Photo #2 and Appendix 2).
- Runway 12 – No obstructions (See Photo #3)
- Runway 30 – No obstructions (See Photo #4).

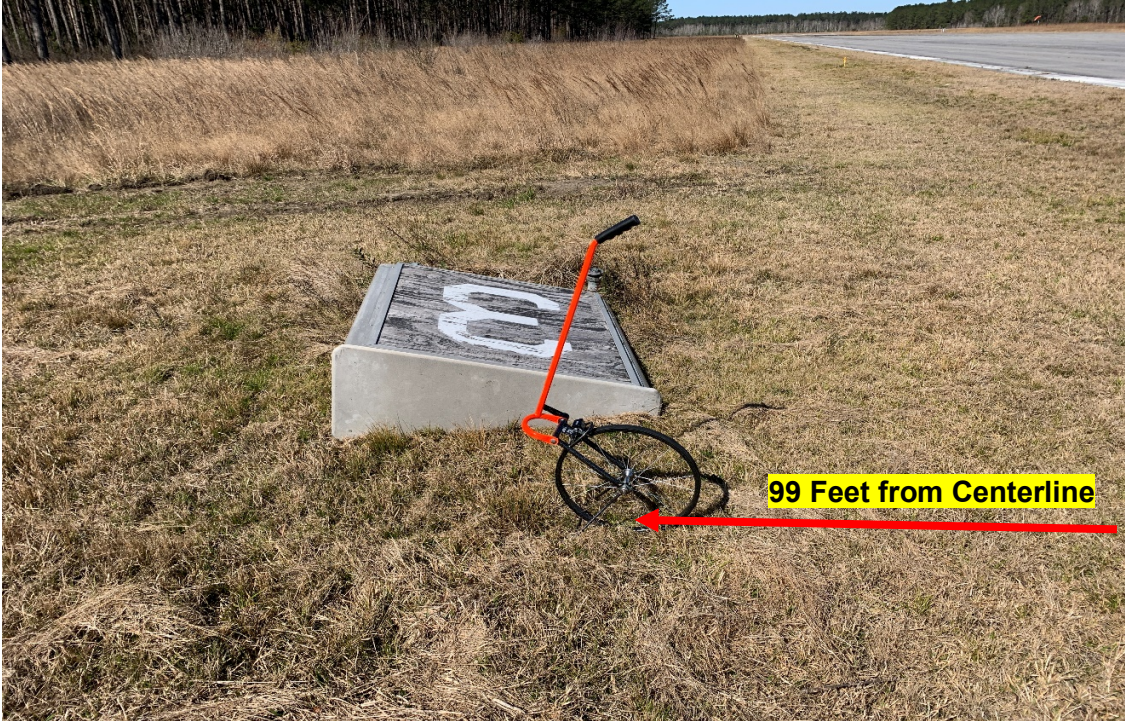
Photo #5 - Primary Surface Runway 12/30

- A runway distance remaining sign was discovered knocked off its frangible mounts, on its side within the Primary Surface (See Photo #5).
- There is vegetation encroaching upon the Primary Surface of Runway 06 at 125 feet left of centerline (near approach end RWY 06) (See Photo #6)
- A large rut was discovered near the intersection of Runways 12/30 and 6/24, 77 feet from the centerline of Runway 12/30 near the concrete pull-off (See Photo #7). While the trench does not constitute a Primary Surface violation, by definition of the ALDOT Administrative Code for Airports, it does pose a hazard to any aircraft that might depart the runway surface.

- Remove runway distance remaining sign and replace on mounts.
- Fill in rut and compact smooth.
- Remove all trees/shrubs/excessive vegetation growth within the Primary Surface.

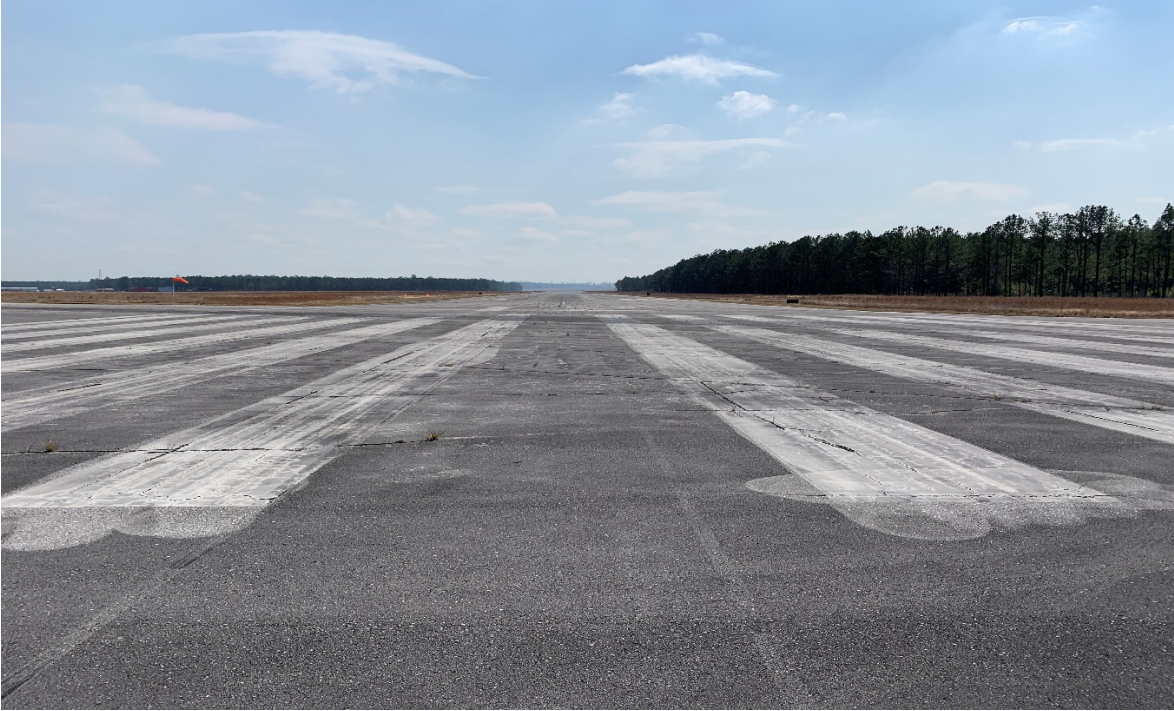
Photo #8 – Runway 12 Markings

- Runway 6/24 and 12/30 markings are in **FAIR** condition but are becoming obscured by algae growth/rubber deposits/fading (See Photo #8). Centerline markings on both runways are becoming **POOR** due to rubber deposits. (See Photo #9).
- Taxiway markings are in **GOOD** condition following the recent project (See Photo #10).
- An aircraft was observed using the old, closed runway (18/36) as a taxiway. The old runway is becoming littered with foreign object debris (FOD) as the pavement continues to degrade. Aircraft should be discouraged from using this pavement.

- Old Runway 18/36 should be marked closed to aircraft movement in accordance with FAA AC 150/5340-1M and the closed taxiway should be barricaded to prevent unintentional use.
- Plan a rubber removal project or pressure wash runway markings, PARTICULARLY the centerline stripes.

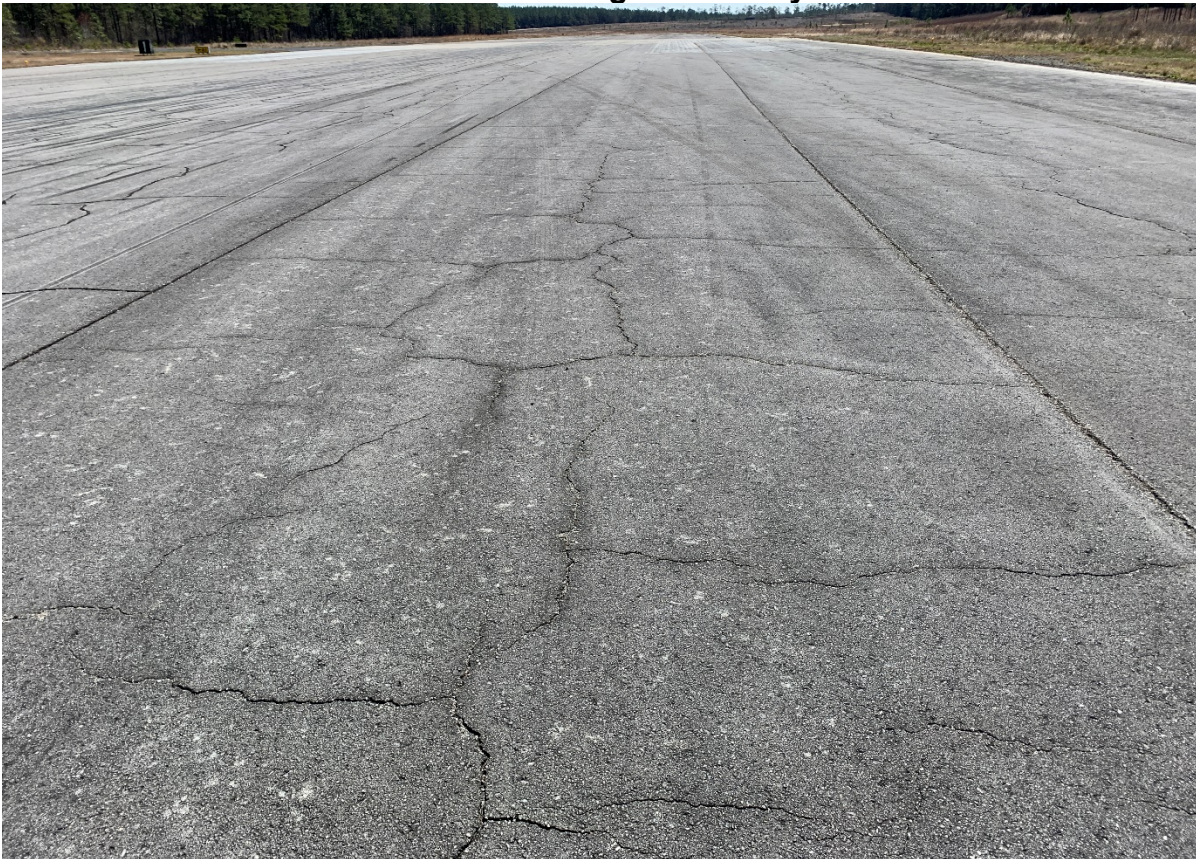
Photo #11—Cracking on Runway 12/30

- Airport Surfaces were inspected with the following results:
 - Runway 12/30 is in **POOR** condition with extensive longitudinal and transverse cracking and block cracking (See Photo #11).
 - Runway 06/24 is in **FAIR** condition, experiencing moderate longitudinal and transverse cracking.
 - Taxiway, apron, and taxilanes are in **EXCELLENT** condition (Photo #12).

- Pavement maintenance projects should be planned for Runways 12/30 and 06/24.

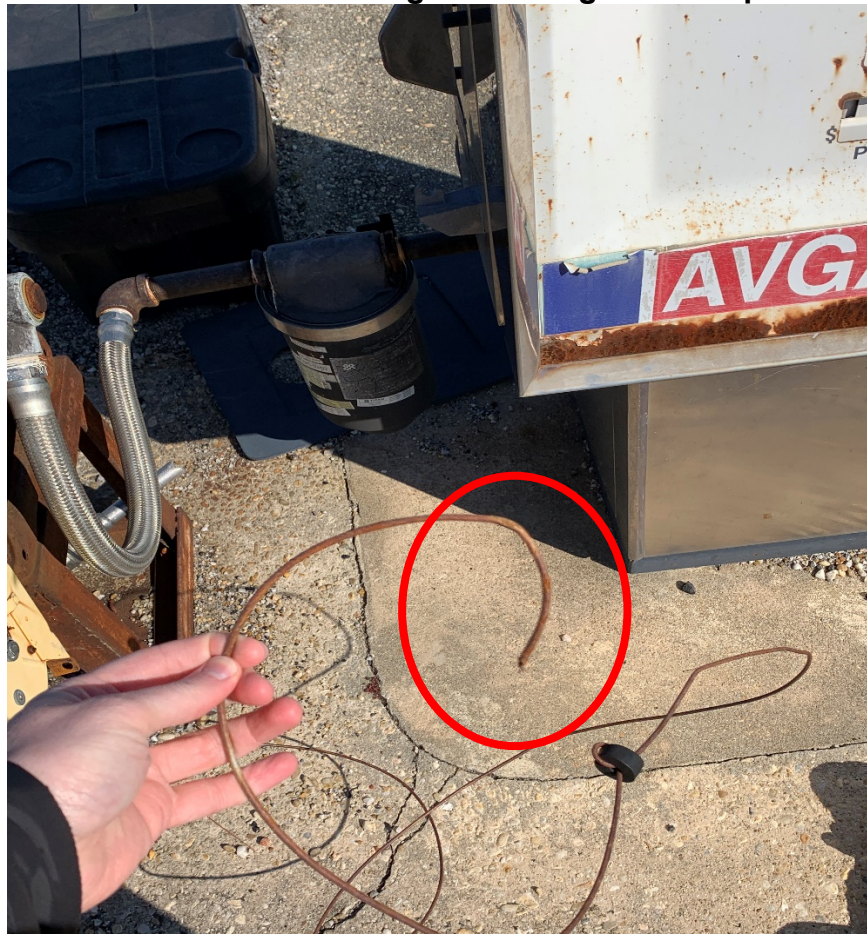
Photo #13—Missing Grounding Cable Clip

- The grounding cable clip was missing (See Photo #13)

- Replace bonding cable clip immediately.

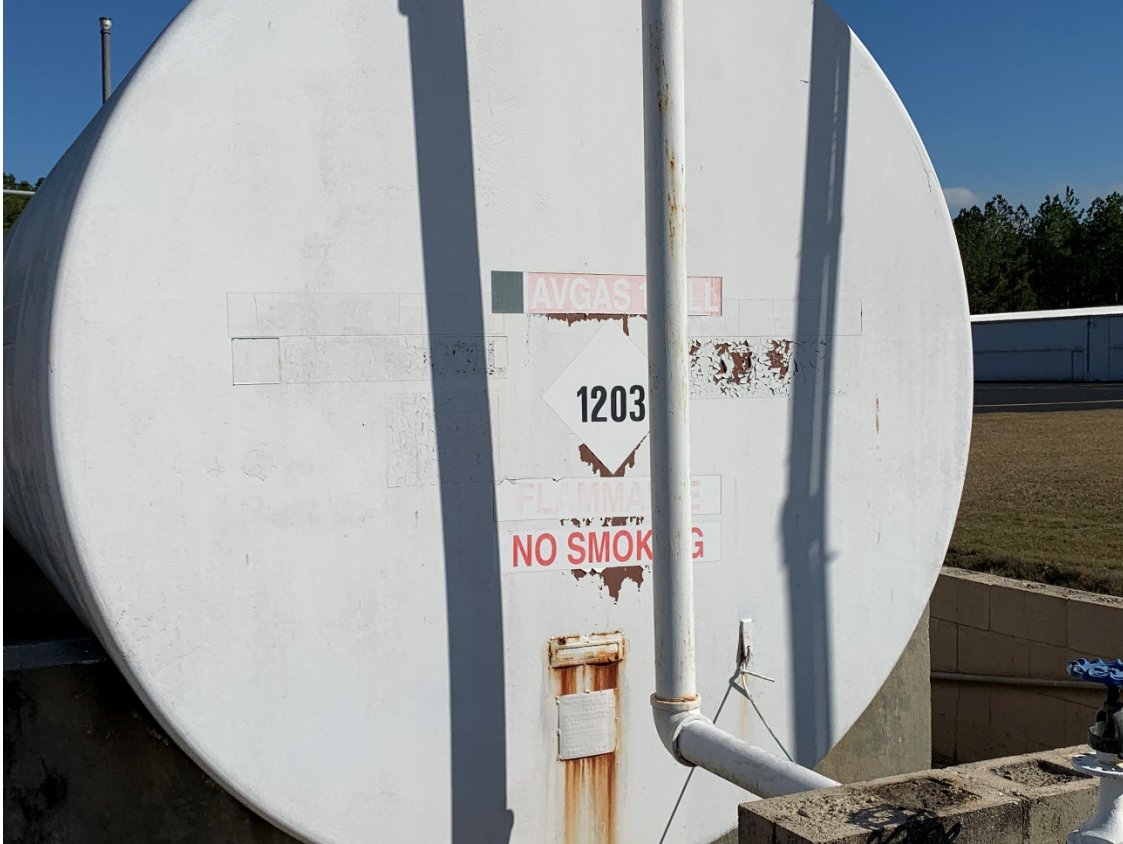
Photo #14 – Fuel Tank Contents Label Faded

- Some fire extinguishers at self-serve area did not have proper inspection tags, while others did.
- Tank content labels were severely faded (See Photo #14).

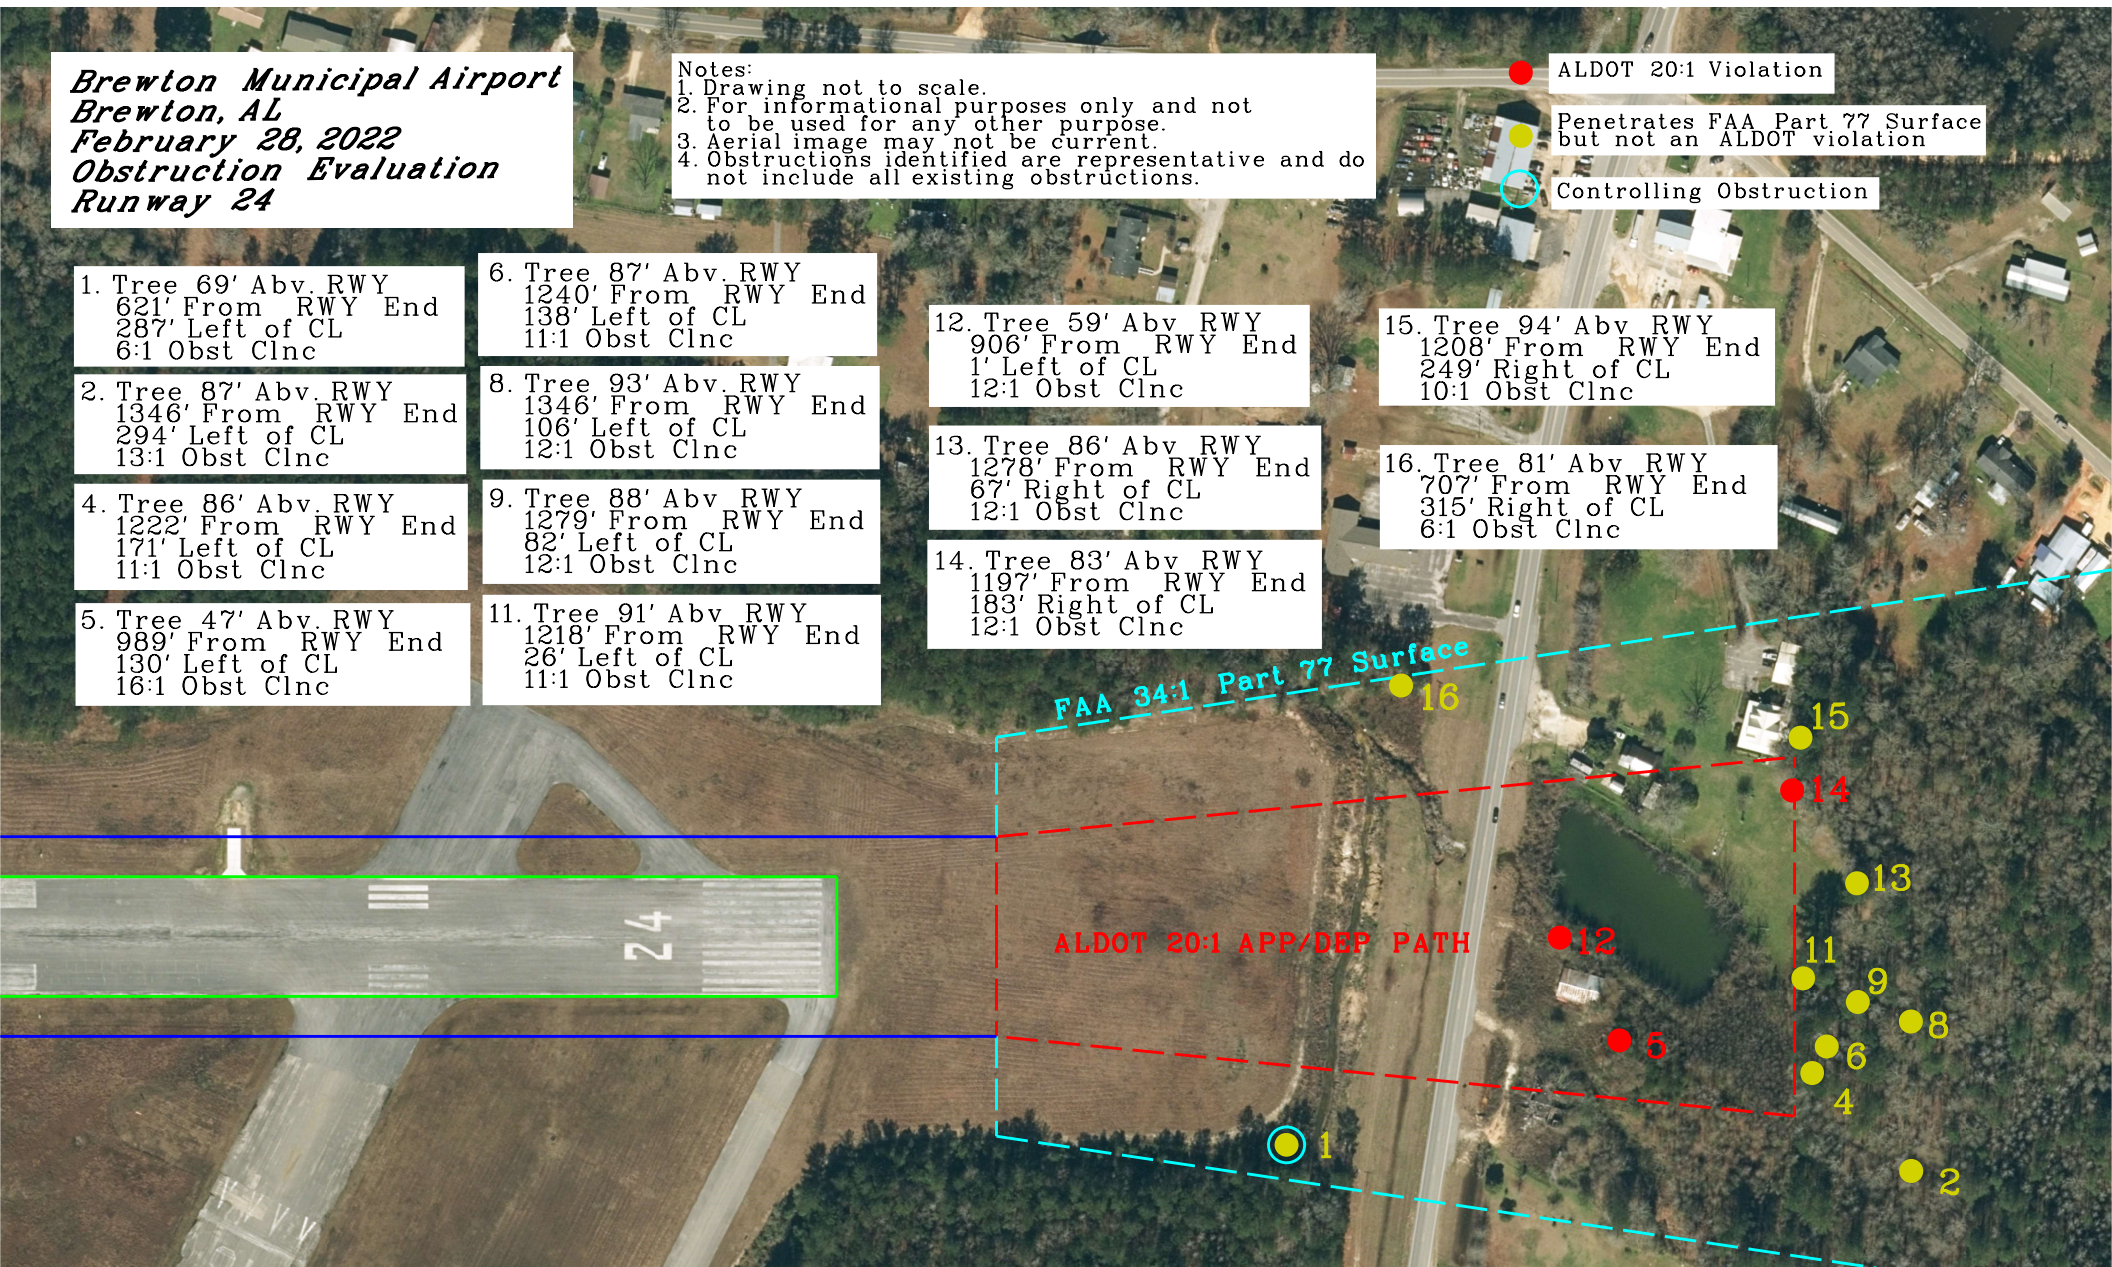
**Brewton Municipal Airport
Brewton, AL
February 28, 2022
Obstruction Evaluation
Runway 24**

1. Tree 69' Abv. RWY
621' From RWY End
287' Left of CL
6:1 Obst Clnc

6. Tree 87' Abv. RWY
1240' From RWY End
138' Left of CL
11:1 Obst Clnc

2. Tree 87' Abv. RWY
1346' From RWY End
294' Left of CL
13:1 Obst Clnc

8. Tree 93' Abv. RWY
1346' From RWY End
106' Left of CL
12:1 Obst Clnc

4. Tree 86' Abv. RWY
1222' From RWY End
171' Left of CL
11:1 Obst Clnc

9. Tree 88' Abv. RWY
1279' From RWY End
82' Left of CL
12:1 Obst Clnc

5. Tree 47' Abv. RWY
989' From RWY End
130' Left of CL
16:1 Obst Clnc

11. Tree 91' Abv. RWY
1218' From RWY End
26' Left of CL
11:1 Obst Clnc

12. Tree 59' Abv. RWY
906' From RWY End
1' Left of CL
12:1 Obst Clnc

15. Tree 94' Abv. RWY
1208' From RWY End
249' Right of CL
10:1 Obst Clnc

13. Tree 86' Abv. RWY
1278' From RWY End
67' Right of CL
12:1 Obst Clnc

16. Tree 81' Abv. RWY
707' From RWY End
315' Right of CL
6:1 Obst Clnc

14. Tree 83' Abv. RWY
1197' From RWY End
183' Right of CL
12:1 Obst Clnc
